National Dam Inspection Program.
Upper Donohoe Dam (now Referred to as)
Twin Lakes Number 2 Dam, NDS I.D.
PA-001478), Ohio River Basin, Little
Cragtree Creek, Westmoreland County,
Pennsylvania. Phase I Inspection
Report.

PHASE I REPORT
NATIONAL DAM INSPECTION PROGRAM

Upper Donohoe Dam: NDS I.D. No. PA-00478

Owner: Westmoreland County
State Located: Pennsylvania (PennDER I.D. No. 65-55)
County Located: Westmoreland
Stream: Little Crabtree Creek
Inspection Date: 13 December 1978
Inspection Team: GAI Consultants, Inc.
570 Beatty Road
Monroeville, Pennsylvania 15146

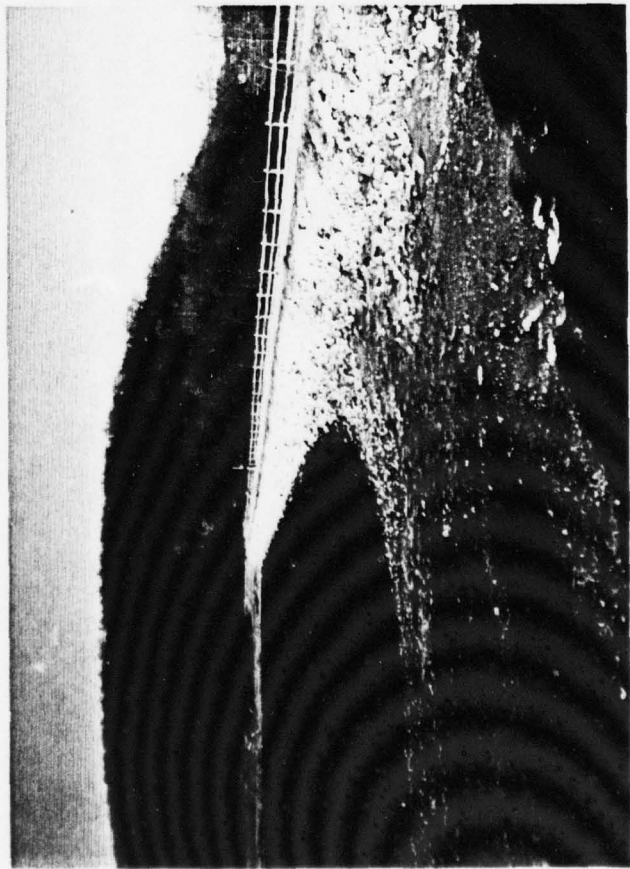
3

b. Embankment. The visual inspection indicates the embankment is in poor condition. Some seepage flow and localized saturated areas were observed along the downstream toe to the right of the valve house in spite of the drawn down status of the reservoir. Just to the right of the valve house, the outlets of two cast iron toe drain pipes were observed discharging about 2-3 gallons per minute from the left drain and approximately 5 gallons per minute from the right drain. A full evaluation of the quantity and extent of leakage could not be determined due to the drawn down condition of the reservoir at the time of the inspection (see Photograph 3).

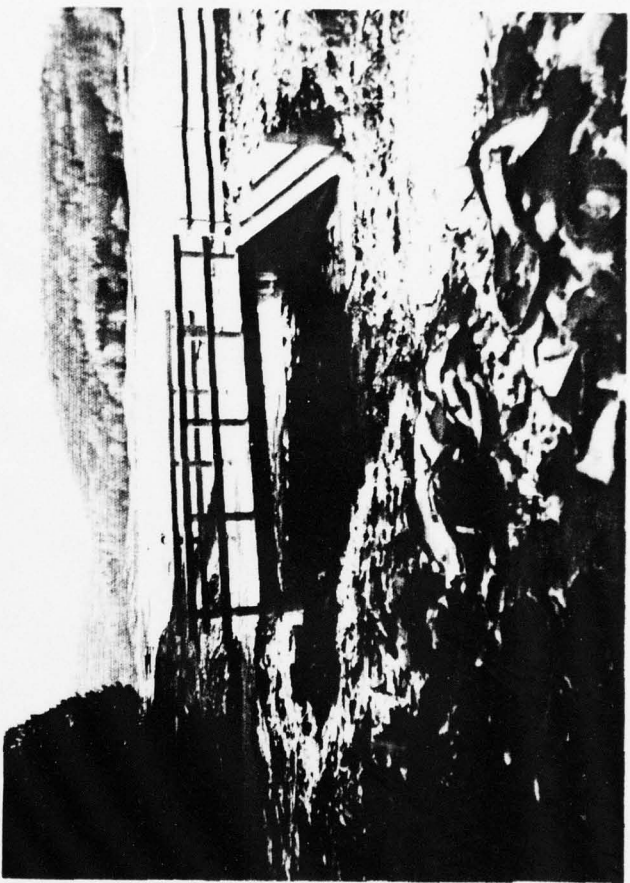
1. Spillway Structure. The spillway was completely reconstructed in 1977. Based on visual observations, the new spillway structure is in good condition (see Photographs 4 and 5).

1. Spillway. The concrete spillway structure at the right abutment is in good condition. Concrete surfaces are in good condition with no evidence of cracking, spalling, or other deterioration. The discharge channel is obstructed, poorly maintained and in need of remedial repair.

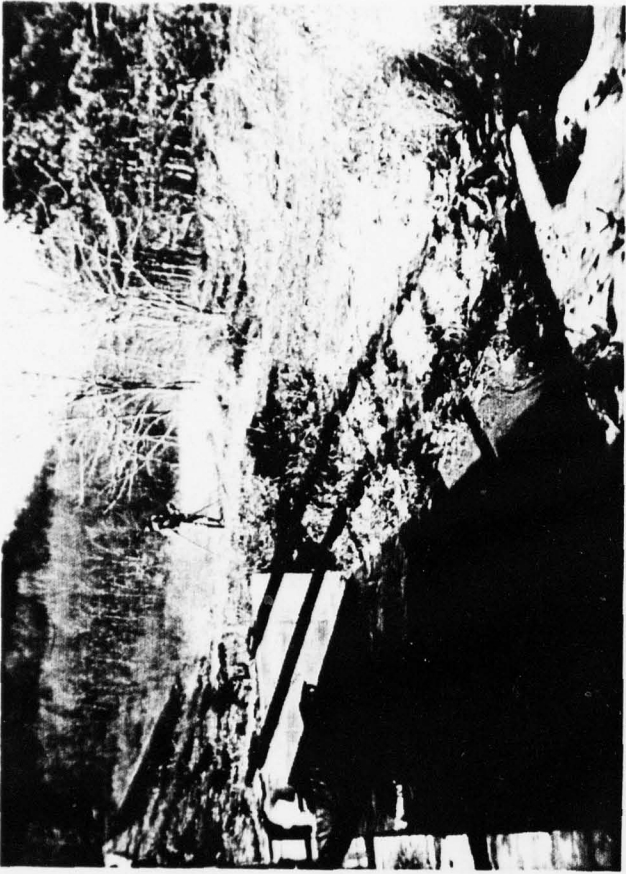
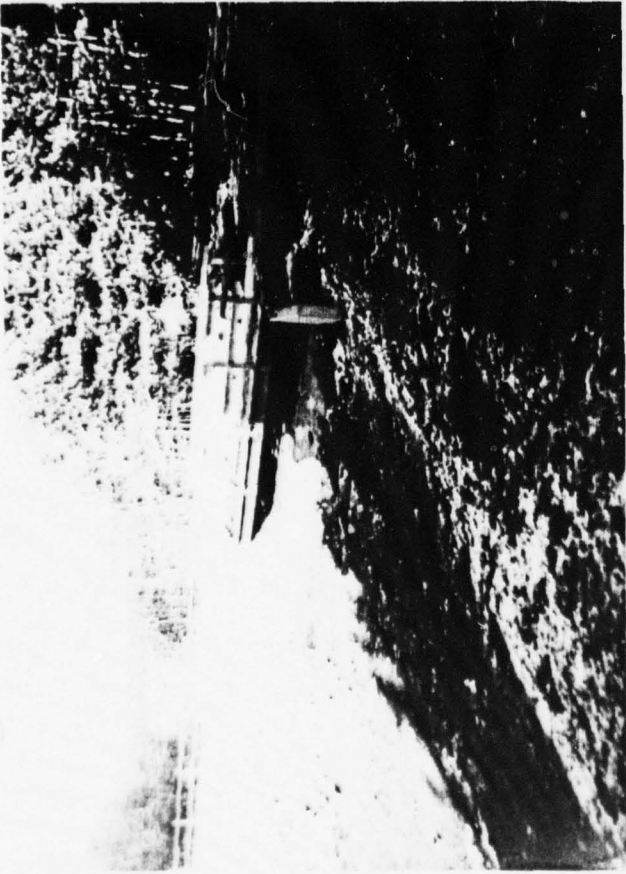
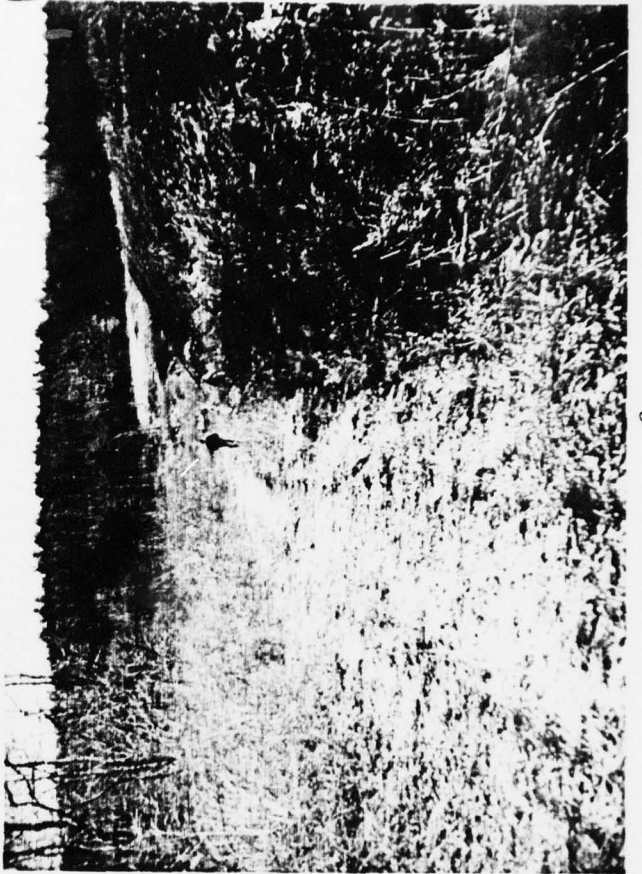
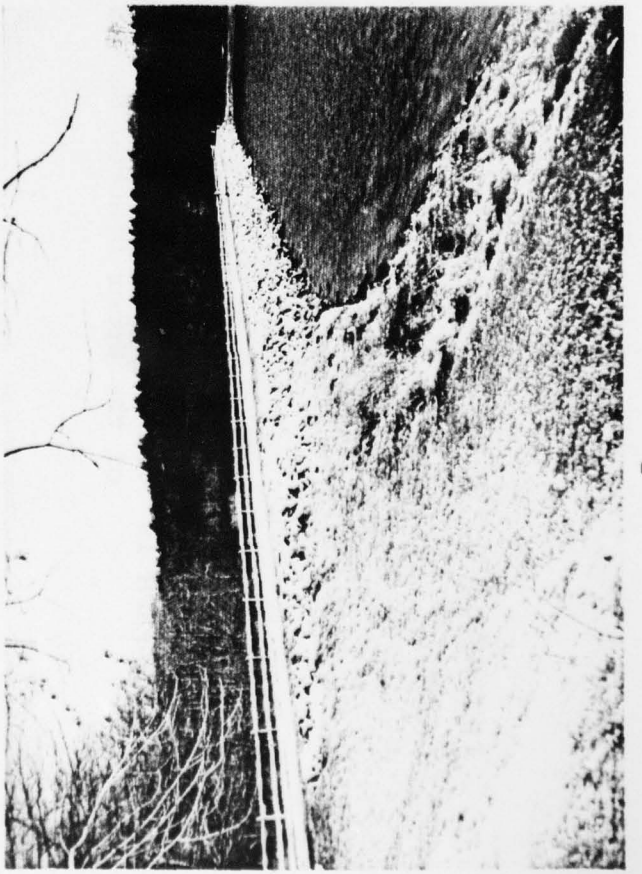
e. Downstream Channel. The concrete spillway structure discharges into a trapezoidal-shaped channel cut into natural ground on the right abutment (see Photograph 6). The channel is somewhat irregular with low and partially breached sidewalls on the downslope side. About 35 feet downstream of the spillway is a temporary construction road built across the channel. It is possible that modest discharges through the spillway could cause overtopping of the channel sidewall at the road crossing resulting in at least part of the flow being discharged near the toe of the dam. Approximately 250 feet downstream of the spillway, the channel discharges directly into the reservoir of Twin Lakes No. 1 Dam.

Based on visual observations, the recently constructed spillway is considered to be in good condition. Several deficiencies were noted that include: 1) several inches of sediment lining the channel bottom of the concrete spillway; 2) a temporary earth road crossing the discharge channel about 35 feet downstream of spillway control section; 3) a breach of the left channel sidewall at the road; and, 4) an irregular shaped unlined discharge channel. The above conditions could adversely affect the operation of the spillway (Appendix C, Sheets 14 and 15); however, for the purpose of the analysis, all of the deficiencies were neglected as it is assumed that they will be corrected in the proposed rehabilitation program.

c. Remove the temporary earth road that presently crosses the discharge channel approximately 35 feet downstream of the spillway control. In addition, repairs to the breached left spillway sidewall at this location should be implemented. The thin layer of sediment lining the bottom of the concrete spillway channel should be removed.
