6AI CONSULTANTS INC MONROEVILLE PA
NATIONAL DAM INSPECTION PROGRAM. TWIN LAKES NUMBER 1 DAM (NDS1.--ETC(U)
APR 79

PHASE I INSPECTION REPORT
NATIONAL DAM INSPECTION PROGRAM

PHASE I REPORT
NATIONAL DAM INSPECTION PROGRAM

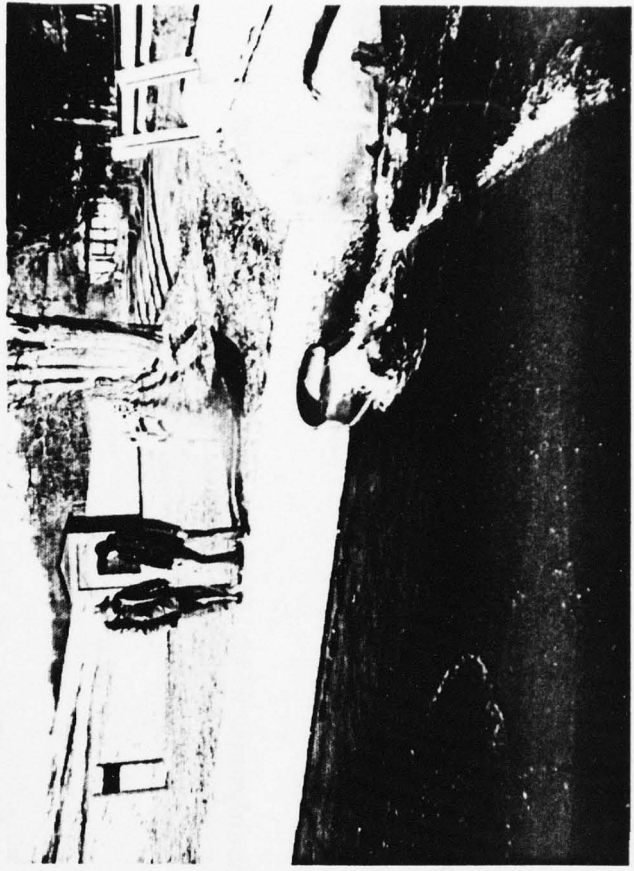
A manhole located on the crest just left of the spillway provides access to a 30-foot vertical reinforced concrete shaft, the bottom of which houses the manually operated gate valve. An extension on the valve stem permits operation from the top of the manhole. At the time of the inspection, the manhole was filled with water to elevation 1085.1 or approximately 5.9 feet below normal pool (see Photograph 10). Despite the flooded condition, the valve was operated by county personnel in the presence of the inspection team. The valve appeared to function normally as water was observed issuing from the outlet conduit at the base of the spillway channel (see Photograph 4).

PHOTOGRAPH 4 View of outlet works discharging near toe of spillway.

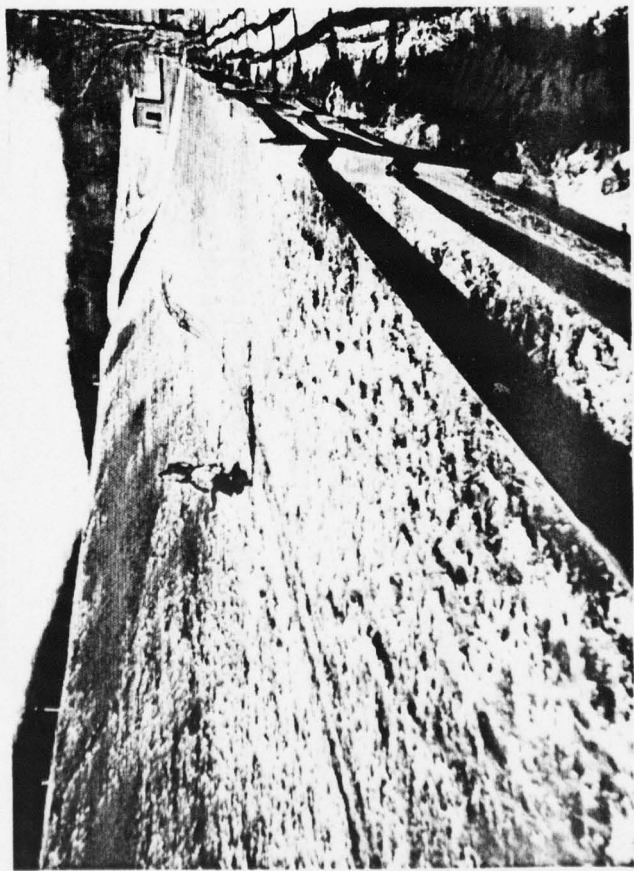
b. Embankment. The visual inspection suggests the embankment to be in good condition. Minor seepage, however, was observed along the downstream toe, particularly to the right of the spillway section (see Photograph 3). Despite the localized saturated areas, no signs of sloughing, erosion, or free flowing water were observed on or immediately below the embankment. A slag-gravel roadbed protects the crest against damage from occasional vehicular use. The downstream slope is covered with grass that requires little maintenance other than occasional mowing (see Photograph 1). The riprap is durable and well graded and provides adequate slope protection.

PHOTOGRAPH 3 View looking west along the downstream toe of the embankment. Inspection team personnel are within areas of noticeable saturation.

d. Monitor wet areas across the downstream embankment face on a continual basis. If seepage increases or turbidity occurs, the condition should be evaluated and necessary remedial measures implemented.

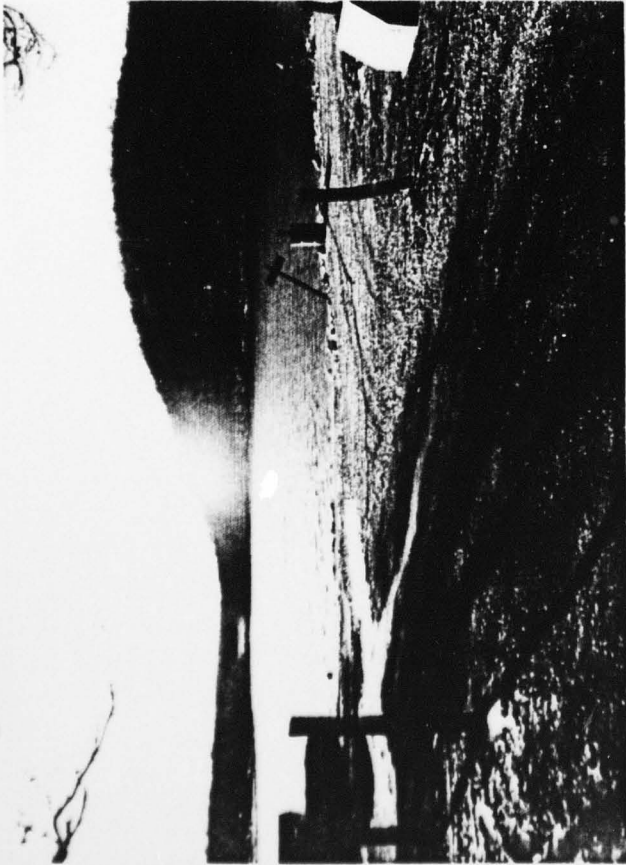
9

d. Reservoir Area. The general area surrounding the reservoir is characterized by gentle to moderate slopes that are partially wooded. No signs of slope distress were observed (see Photograph 9).

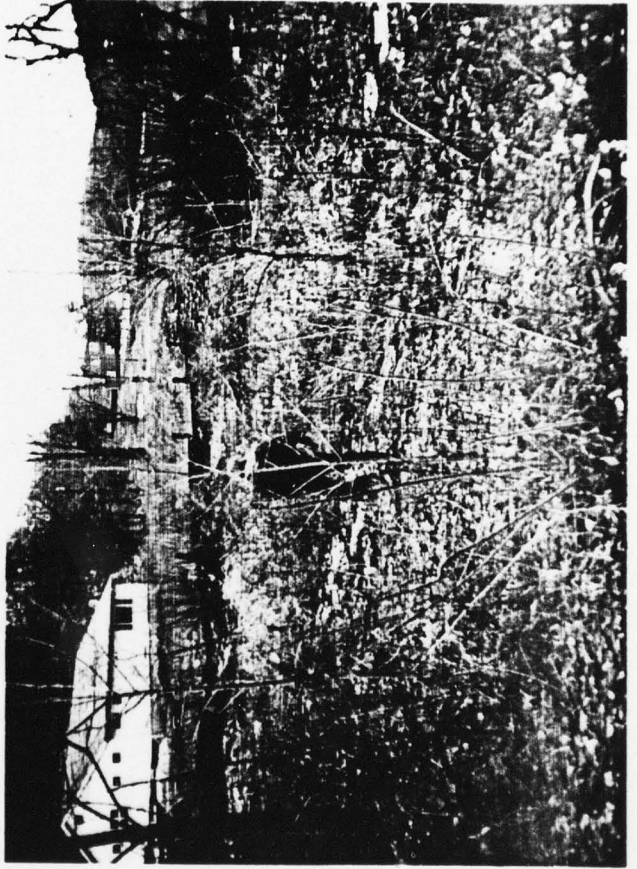
11

Flow discharged into the stream beyond the embankment follows a gently sloping course through a lightly wooded rural area. Approximately 2,500 feet downstream of the dam is the first house that could be affected by a dam failure (see Photograph 11). Many mobile homes are also located within the floodplain in this area. It is estimated that within this reach more than one hundred people could be affected by an embankment breach. Therefore, the hazard classification of the facility is considered to be "high".

View, looking south, of a permanent dwelling approximately 2,500 feet downstream of the dam.
