BRADY'S RUN DAM

NDI I.D. NO: PA-257
DER I.D. NO: 4-35

PHASE I INSPECTION REPORT
NATIONAL DAM INSPECTION PROGRAM

(11) MAY 1979

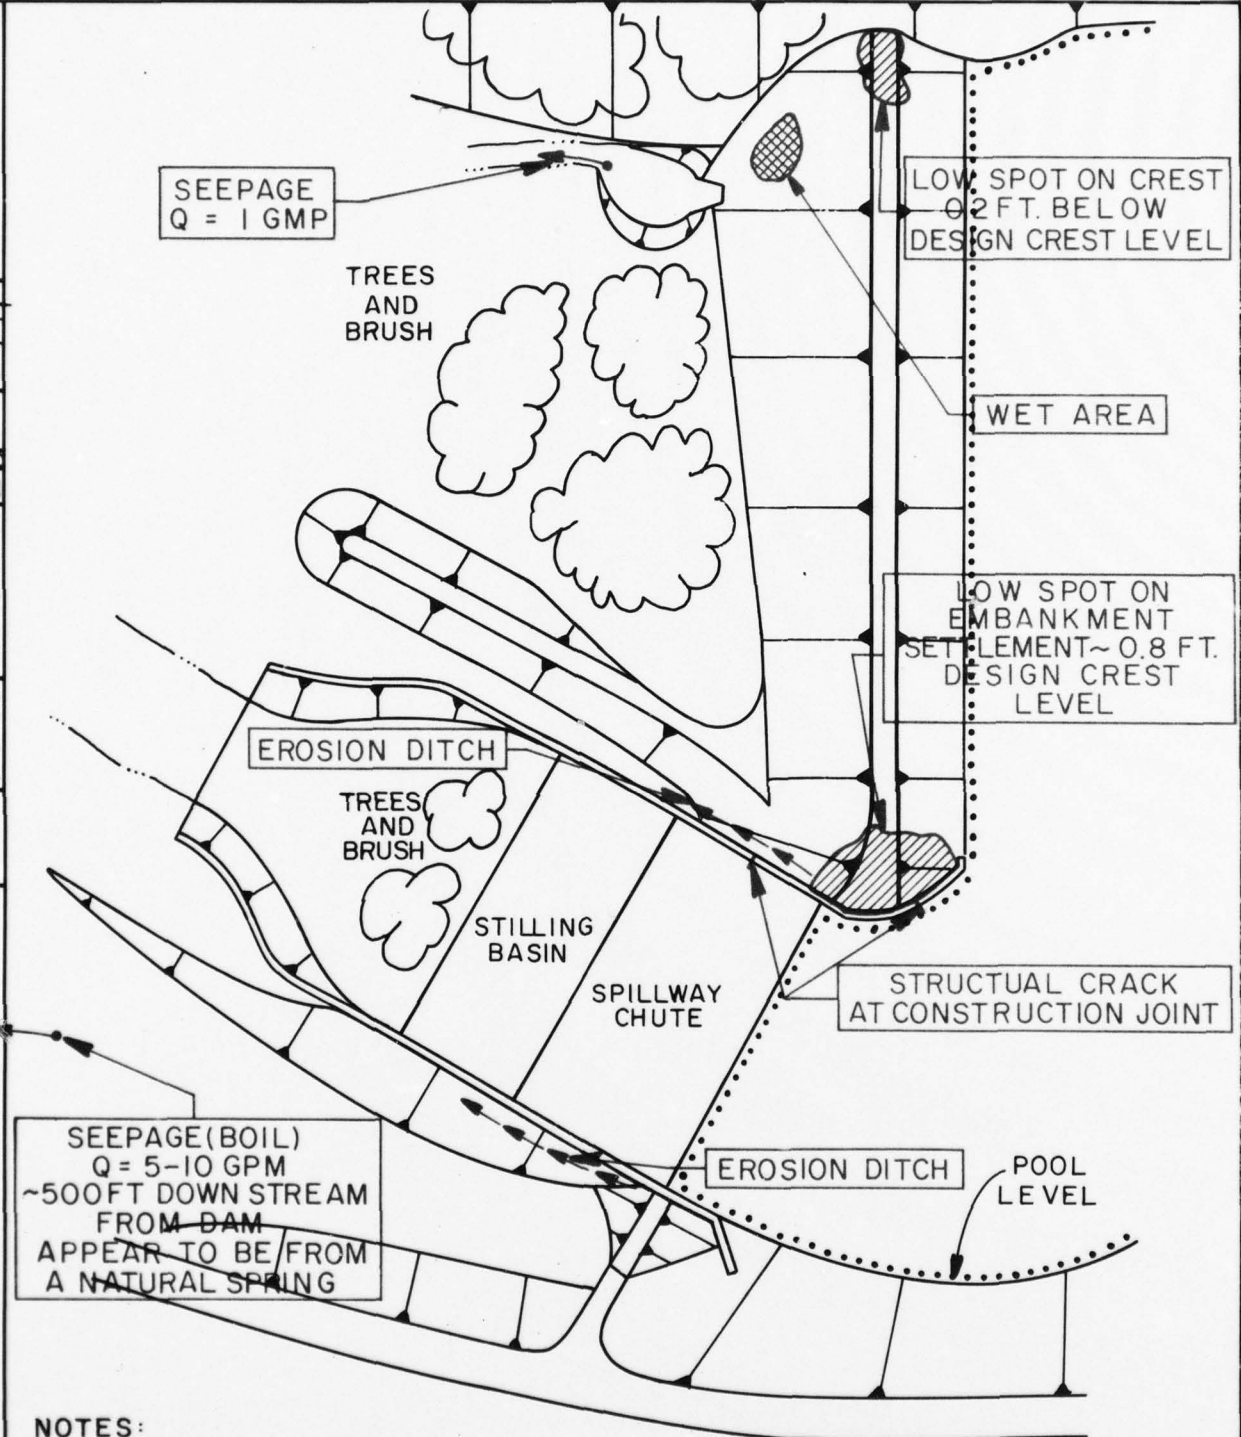
1. SPILLWAY FREEBOARD (MEASURED FROM LOWSPOT ON CREST) = 9.0 FEET.
2. POOL LEVEL DATE OF INSPECTION: 0.2 FEET ABOVE SPILLWAY CREST.

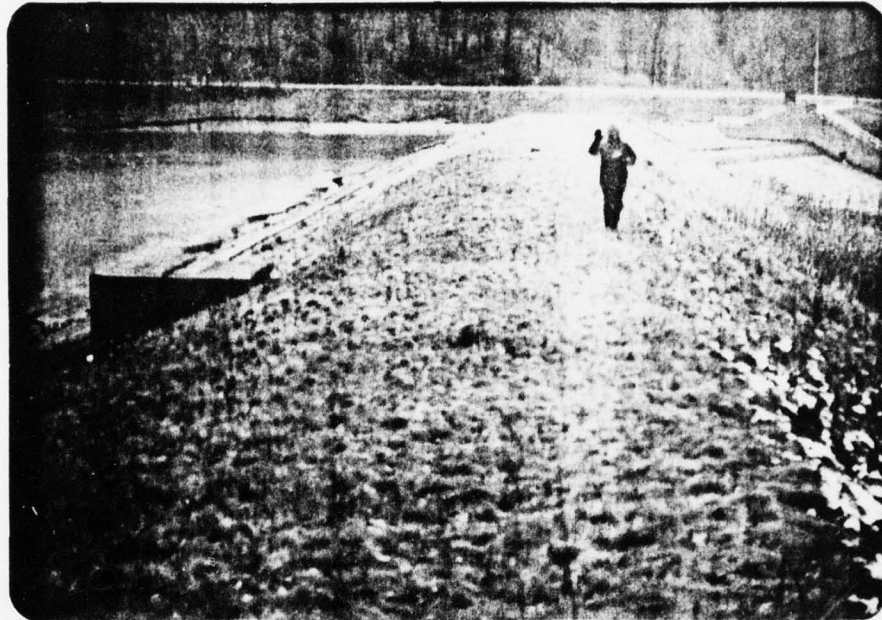
Photograph No. 1
Crest (looking north).

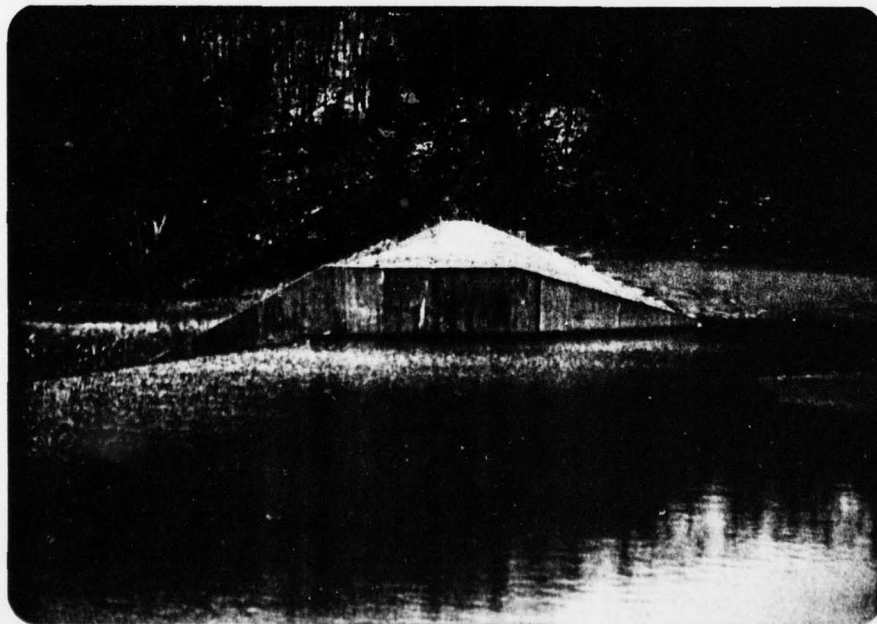
The portion of the embankment adjacent to the spillway retaining walls was found to have settled. This settlement appears to be related to tilting and displacement of the adjacent retaining walls. This settled area is approximately 10 to 15 feet wide and starts from the upstream face of the dam and continues over the crest and partially downstream. The top of the dam was surveyed relative to the spillway crest elevation and the settled area adjacent to the spillway wall was found to be 0.8 foot below the design freeboard level. The second low area was found adjacent to the right abutment and was 0.2 foot below the design crest level. The remainder of the crest was 0.2 to 0.9 foot above the design freeboard level.

Photograph No. 2
Crest (looking south); spillway in foreground.

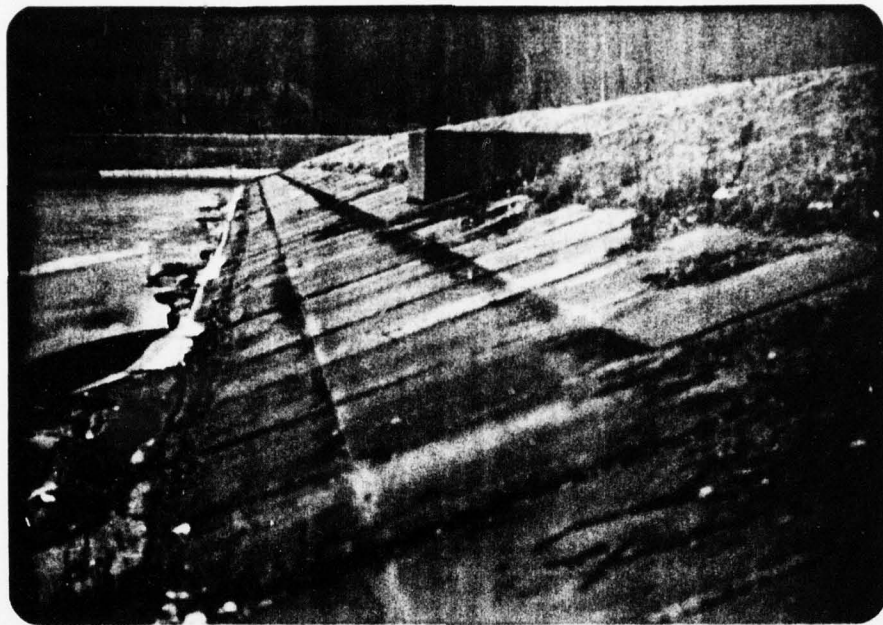
Photograph No. 3
Upstream slope protection.

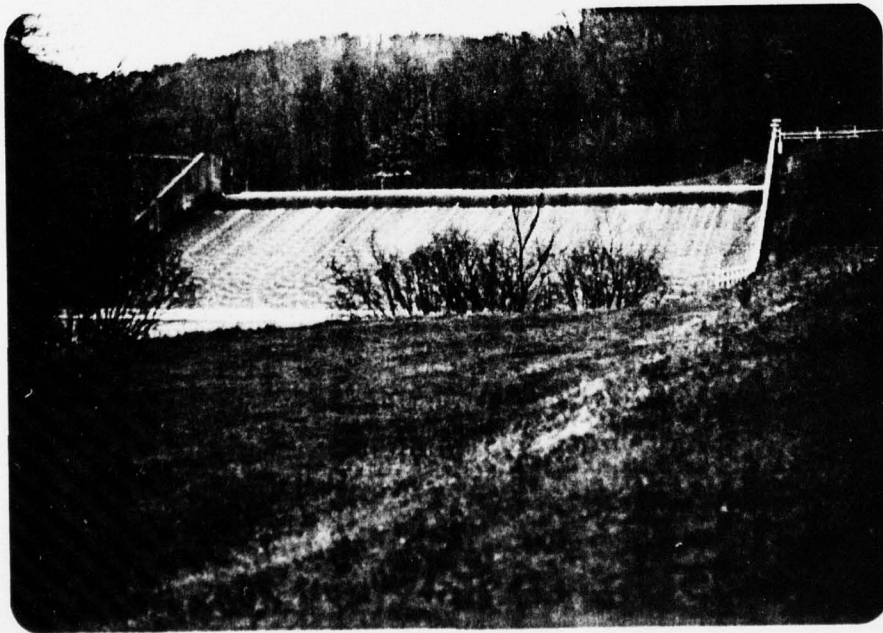
c. Appurtenant Structures. The appurtenant structures were examined for deterioration or other signs of distress and obstructions that would limit flow. In general, the visible portions of the spillway and the outlet works are considered to be in fair condition. Two structural cracks were observed at the construction joint of the right spillway walls. At the construction joint upstream from the spillway control section, the adjacent panels of the wall have separated and moved horizontally approximately one inch relative to each other.

(2) Appurtenant Structures. Presence of structural cracks on the right spillway walls and associated settlement of the embankment behind the wall raises some concern as to the continued stability of these walls. It is considered that remedial work should be performed to avoid further structural distress to these walls.

Photograph No. 4
Spillway.

1. Necessary remedial work should be performed on the right spillway wall to avoid further structural distress and to insure continued stability of these structures.
2. Operational condition of the outlet works sluice gate should be evaluated and necessary maintenance performed.
3. Low spots on the embankment and erosion ditches on each side of the spillway chute should be filled.
4. Around-the-clock surveillance should be provided during unusually heavy runoff and a formal

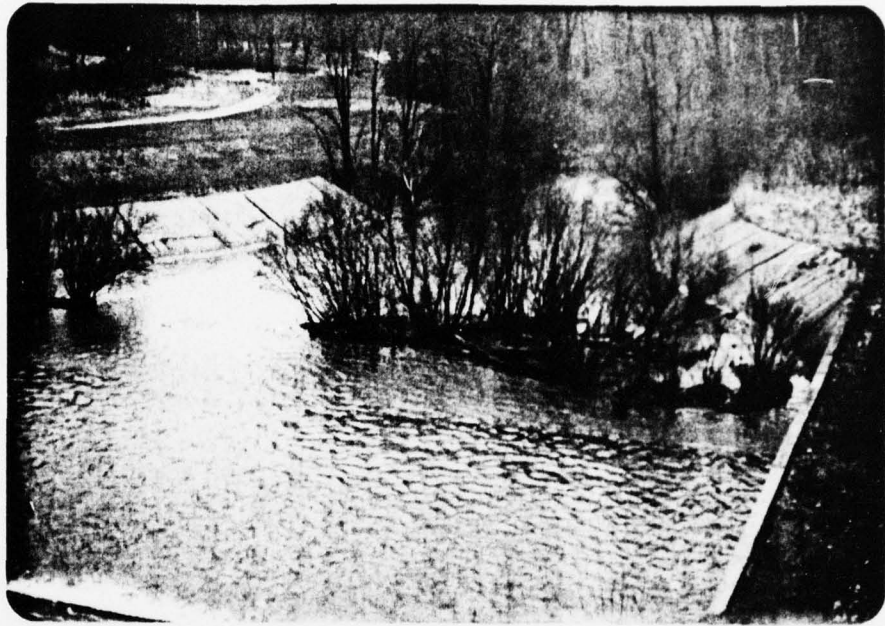
Photograph No. 5
Spillway, plunge pool.

5. The trees and brush should be removed from the spillway discharge channel.
6. The wet area on the embankment and the seepage points should be periodically observed to document if the conditions are changing.
7. The dam and appurtenant structures should be inspected regularly and necessary maintenance performed.

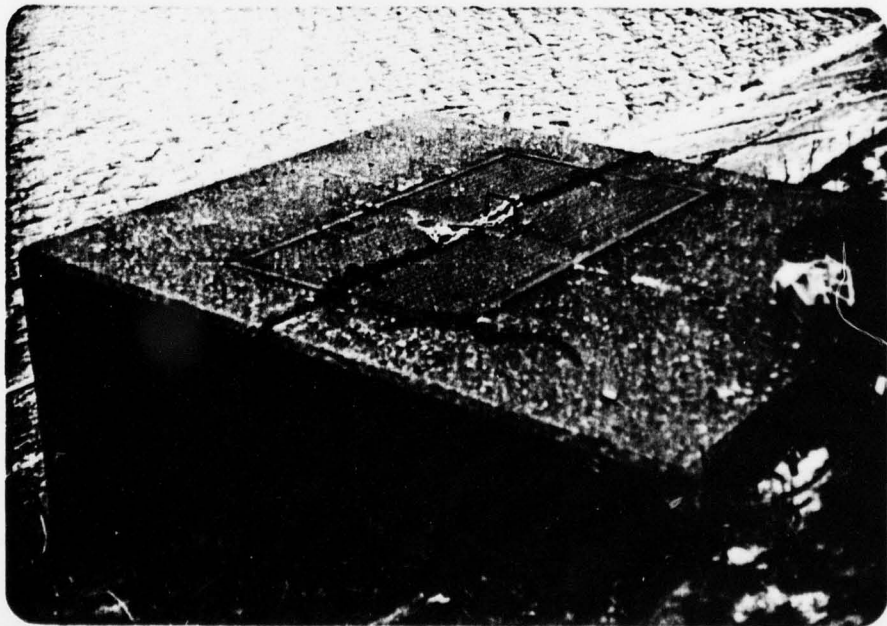
Beaver County personnel reported that, to their knowledge, the outlet conduit sluice gate has not been operated since the construction of the dam. The control tower access hatch has apparently jammed and could not be opened. Therefore, the operating equipment inside the control tower could not be observed.

Photograph No. 6
Blow-off conduit valve chamber.

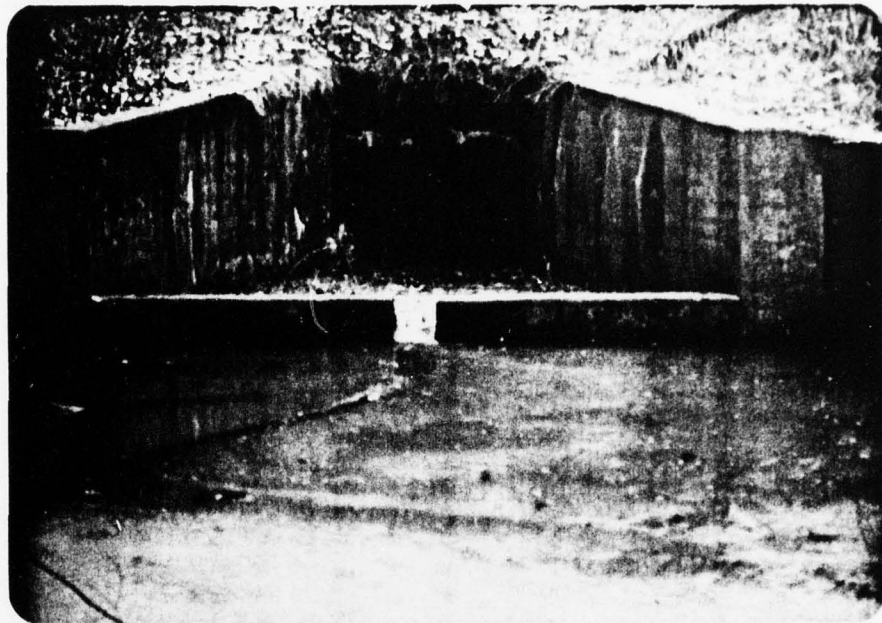
Photograph No. 7
Blow-off conduit and outlet structure.

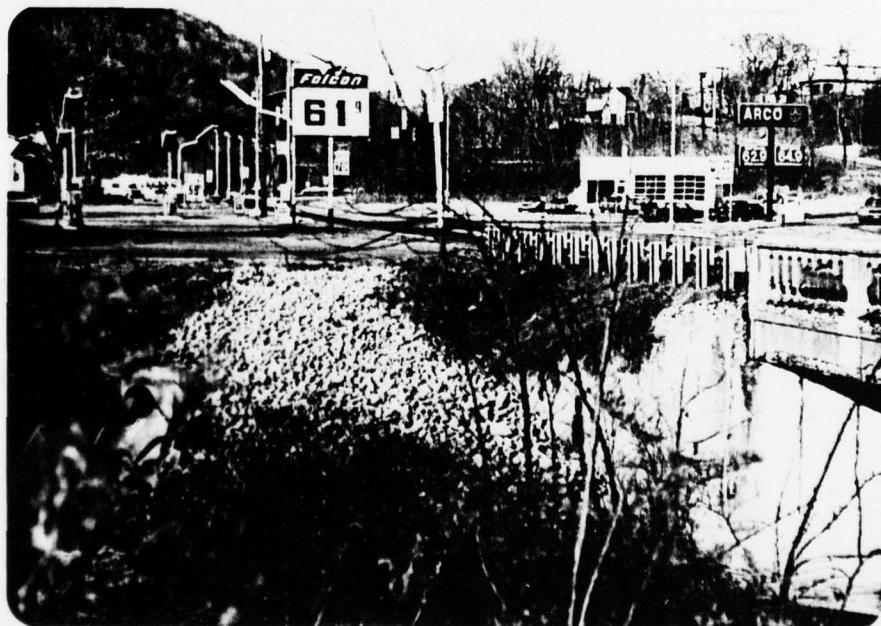
Photograph No. 8
Potential damage area about 3 miles downstream.
