SALT RUN RESERVOIR DAM

NDI No. PA 00392

PHASE I INSPECTION REPORT  
NATIONAL DAM INSPECTION PROGRAM

February 1979

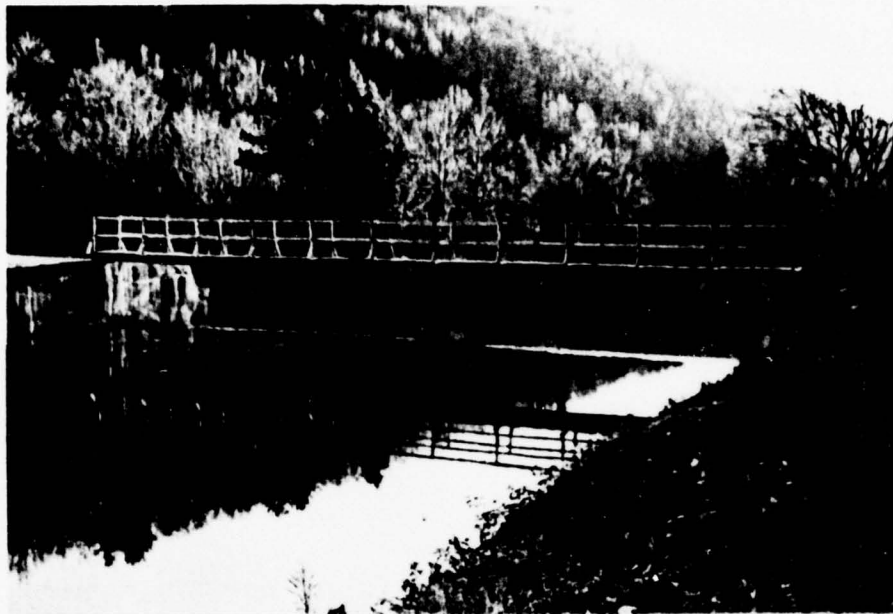
VISUAL EXAMINATION OF	OBSERVATIONS	REMARKS OR RECOMMENDATIONS
CONCRETE WEIR	The 65-ft. long concrete weir is in poor condition. It has been patched with gunite which is now cracked and spalled in numerous locations.	The concrete should be repaired and inspected periodically.
APPROACH CHANNEL	Channel is earth-lined. No debris, restrictive vegetation or erosion was noted.	
DISCHARGE CHANNEL	Consists of a 106-ft. long concrete channel exiting into a natural stilling basin. The concrete in the channel and retaining walls is in poor condition; cracking and spalling has taken place at several locations.	The channel and retaining walls were repaired with gunite; however, the sections repaired have deteriorated and should be repaired.
BRIDGE AND PIERS	A wooden, foot bridge is located above the spillway crest. One 2.1-ft. wide concrete pier is located near the center of the bridge. The clearance between the spillway crest and bridge deck is about 7.0 ft.	The bridge is not a serious restriction to high flows passing through the spillway.

**PHOTO 1. Upstream View of Spillway**

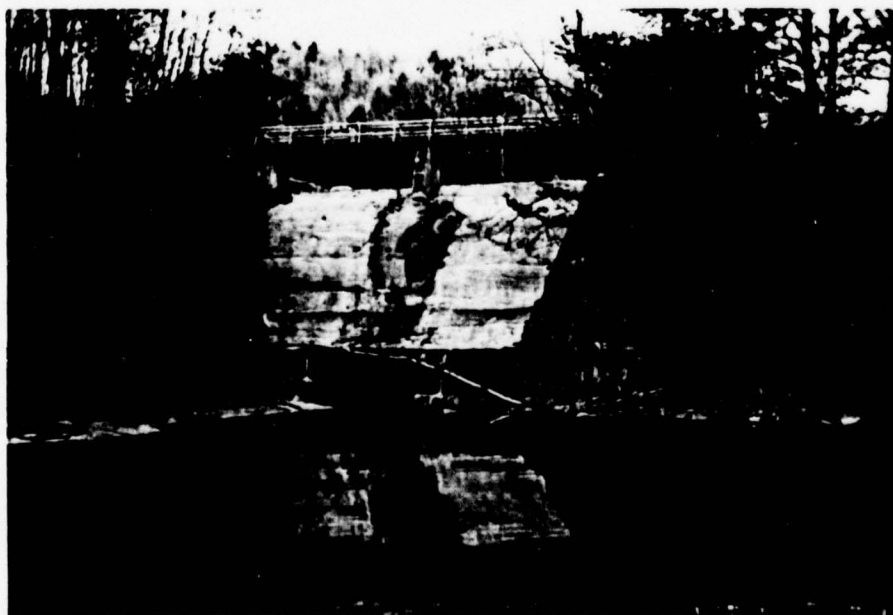
The concrete in the spillway is in poor overall condition. Previously, some areas were repaired with gunite; however, the gunite has deteriorated and loosened, and should be repaired. Other areas of the concrete have spalled and cracked in the interim, and should be repaired.

**PHOTO 2. Downstream View of Spillway**

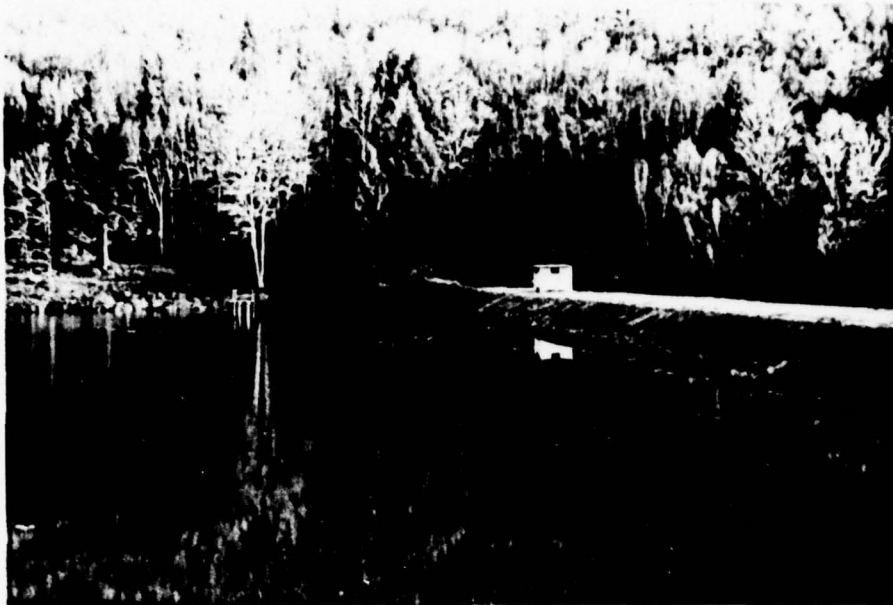
**PHOTO 3. View of Upstream Slope  
(Intake Riser at Left-Center of Photo)**

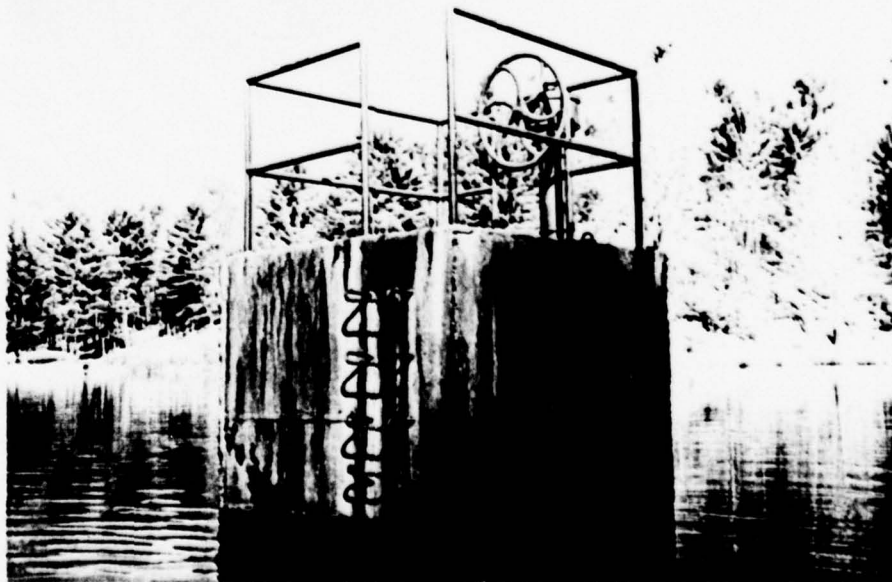
- c. Appurtenant Structures - The concrete intake structure is located approximately 100 feet upstream from the centerline of the dam. Minor spalling of the concrete has occurred on the edges of the structure. This spalling is not considered to present a problem at the present time, but it should be repaired as a part of routine maintenance in the future. Presently, access to the intake structure is attained by using a row boat available at the dam site.

**PHOTO 4. Close-Up View of Intake Riser**

- 1) Repair the spalled concrete on the intake structure.
- 2) Develop and implement a maintenance schedule for all facilities.

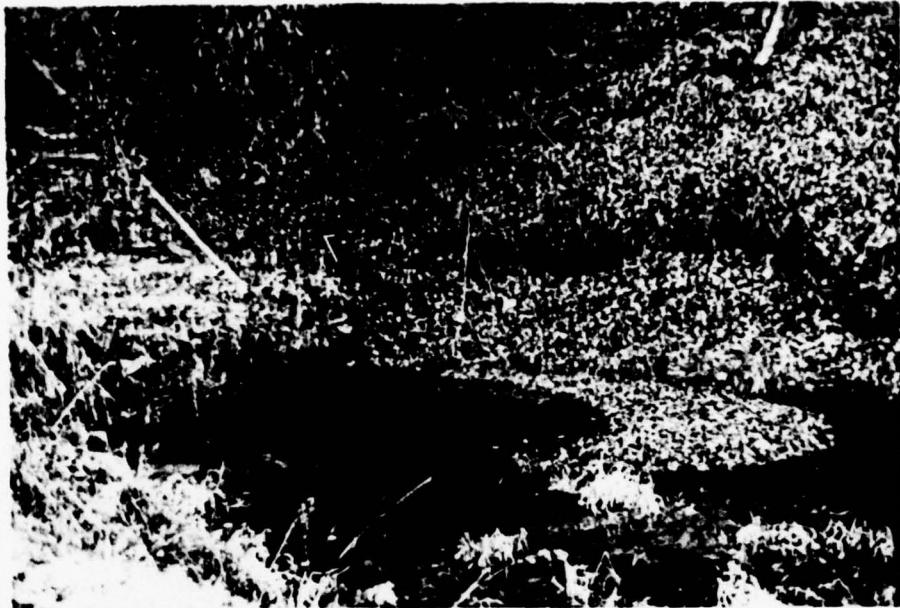
VISUAL EXAMINATION OF	OBSERVATIONS	REMARKS OR RECOMMENDATIONS
CONDITION OF CONCRETE SURFACES IN OUTLET CONDUIT	30-in. cast-iron outlet pipe exits near left abutment of dam; no excessive deterioration of the pipe (at the exit) was observed.	
INTAKE STRUCTURE	Concrete intake structure is located approximately 100 ft. upstream from centerline of dam. Minor spalling has occurred on the edges of the structure; no other deterioration was observed.	Spalling of concrete does not represent a problem at this time.
OUTLET STRUCTURE	Stone head wall, at outlet, is in fair condition; head wall is covered with vegetation.	Vegetation at outlet structure does not restrict flow from outlet pipe.
OUTLET CHANNEL	No debris or vegetation is constricting the outlet channel. Some siltation has occurred in the channel near the outlet structure. The channel joins the main stream channel a short distance downstream. Minor erosion on left hillside along channel.	Silt should be removed periodically.

**PHOTO 5. View of Outlet Pipe and Head Wall**

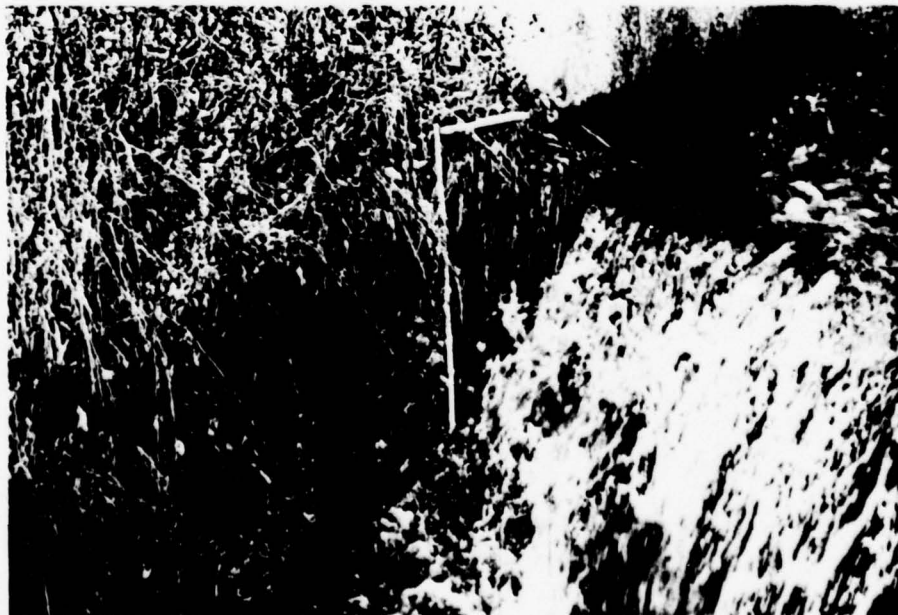
The end of the right training wall of the spillway and the lower right channel slab are undermined. According to the design drawings, the downstream channel slab of the spillway was constructed on in situ or embankment materials. The downstream end of the slab was observed to be constructed on a hand-placed, hard shale, rock fragment foundation. No drainage outlets or filters (transition zones) are shown on the design drawings for the spillway slab. Therefore, the potential for undermining and failure of the slab exists as evidenced by the observed undermining of the end of the right side of the spillway. The undermining should be repaired soon.

SPILLWAY FOUNDATION	The spillway crest is constructed on a concrete core wall. The spillway channel slab rests on in situ or embankment materials. The downstream end of the spillway channel slab rests on a constructed shale foundation. The end of the right spillway training wall and channel slab is undermined.	Proper drainage outlets and filters have not been provided. With the present design, potential for undermining and failure of the slab exists. The undermining at the right end should be repaired.

**PHOTO 6. View of Right End of Spillway Showing Undermining**

- g) Provide copies of the emergency procedures to all operational personnel and instruct the personnel on their use.
- 4) Repair the undermined area at the end of the right side of the spillway.
