SAUL RUN DAM

NDI No. PA 00251  
PennDER No. 43-48

PHASE I INSPECTION REPORT  
NATIONAL DAM INSPECTION PROGRAM

April 1979

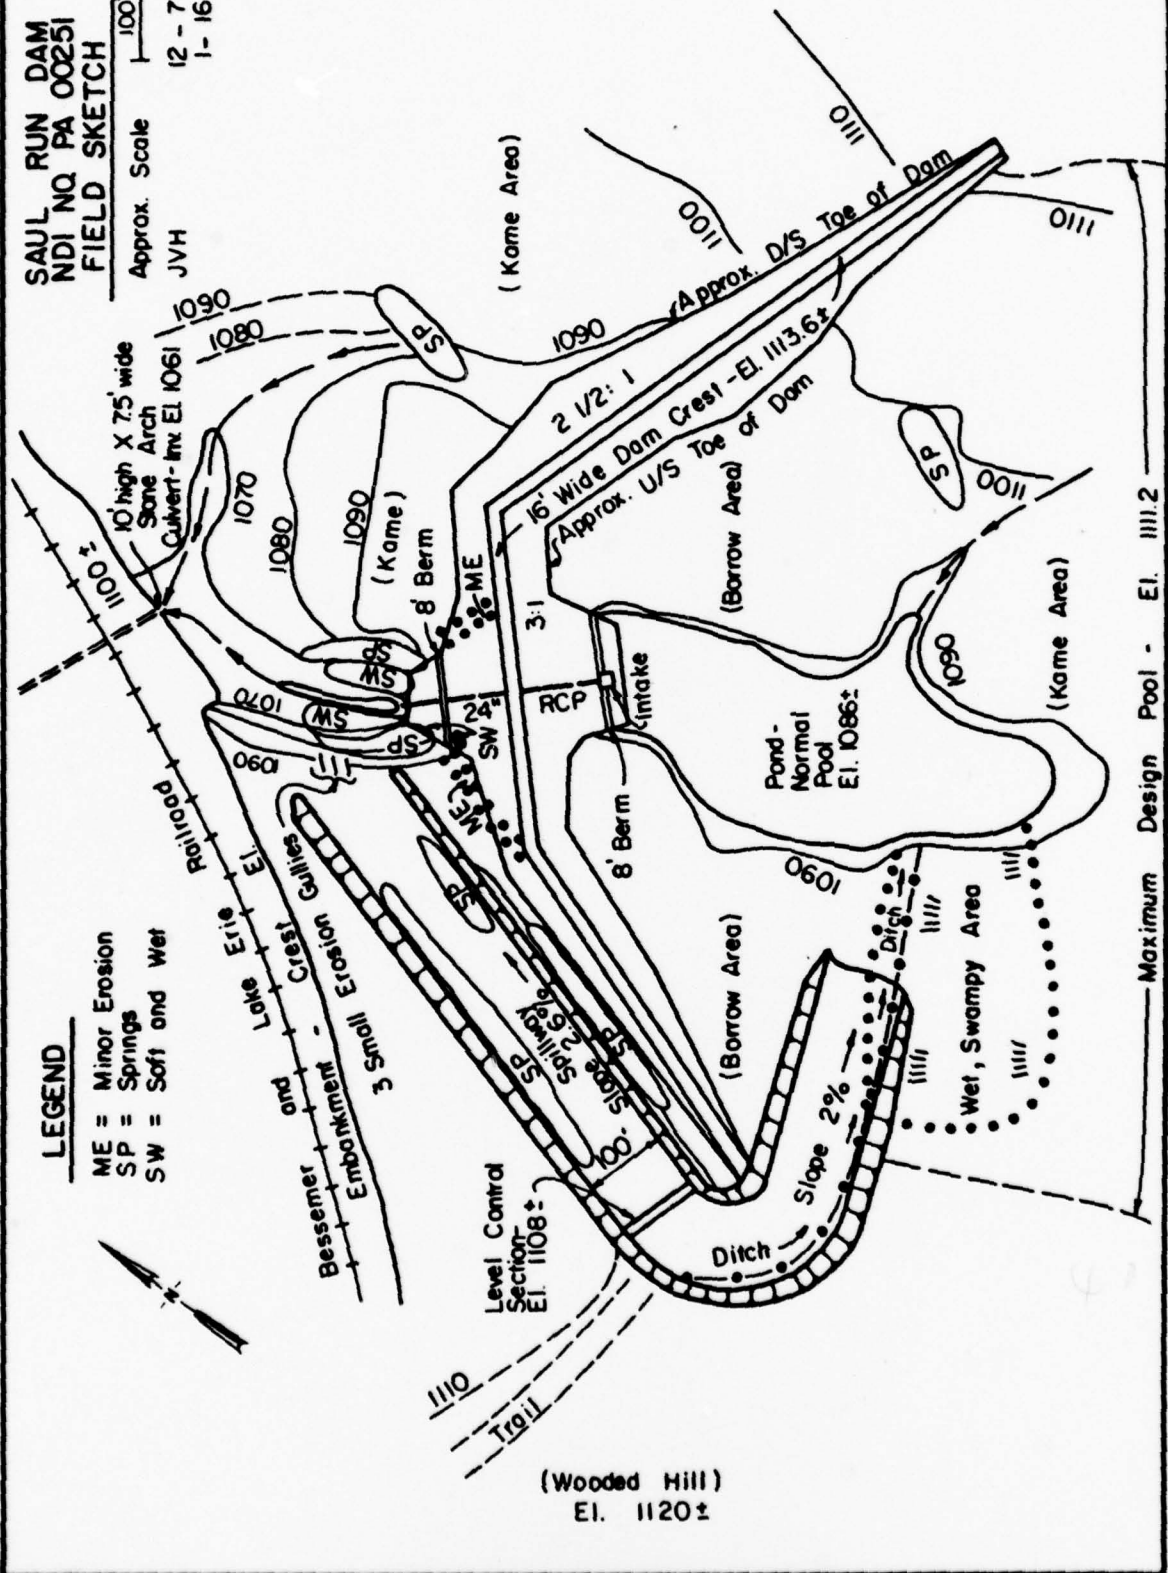
- ME = Minor Erosion
- SP = Springs
- SW = Soft and Wet

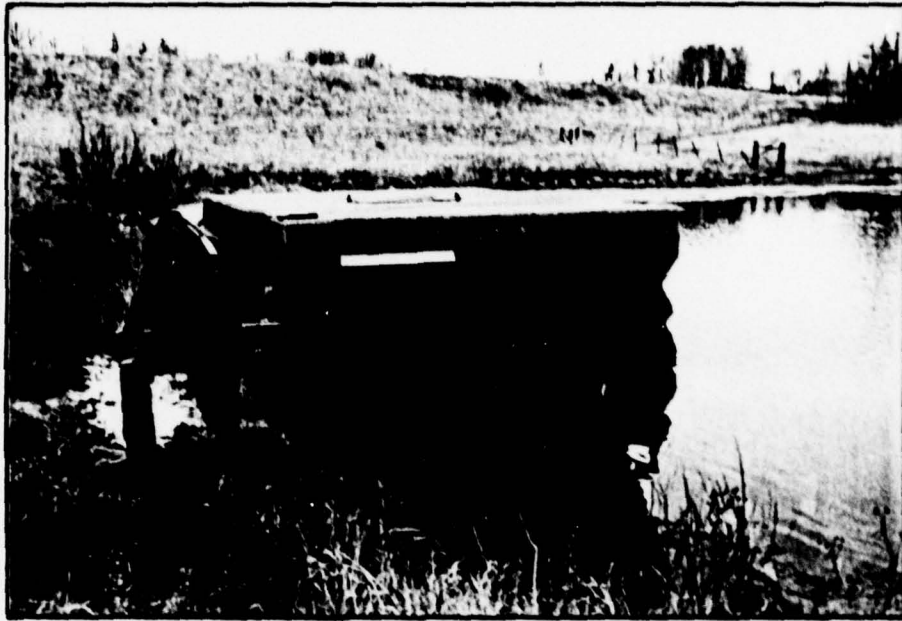
PHOTO 3. Close-up of Intake Structure

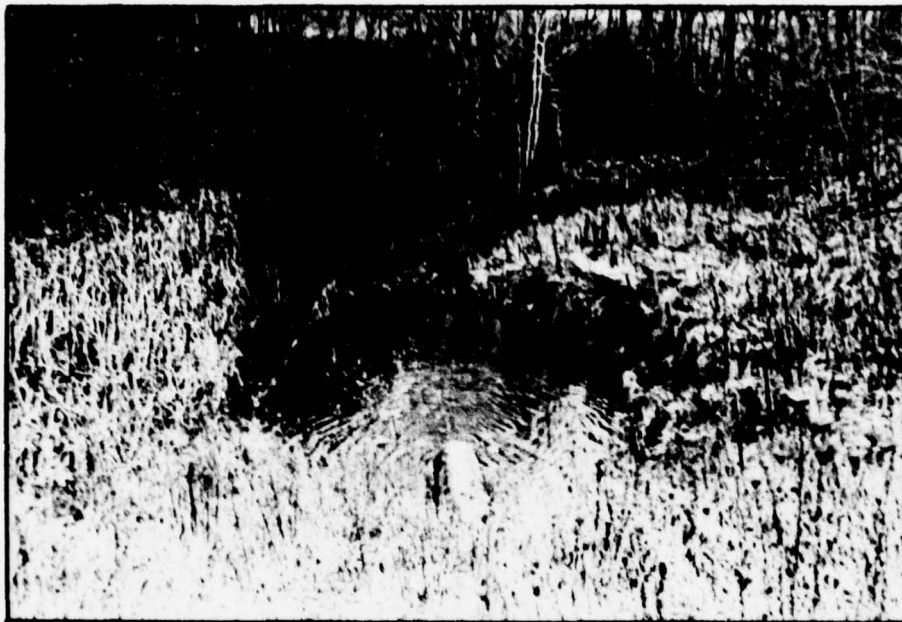
**PHOTO 5. View Downstream over Plunge Pool**

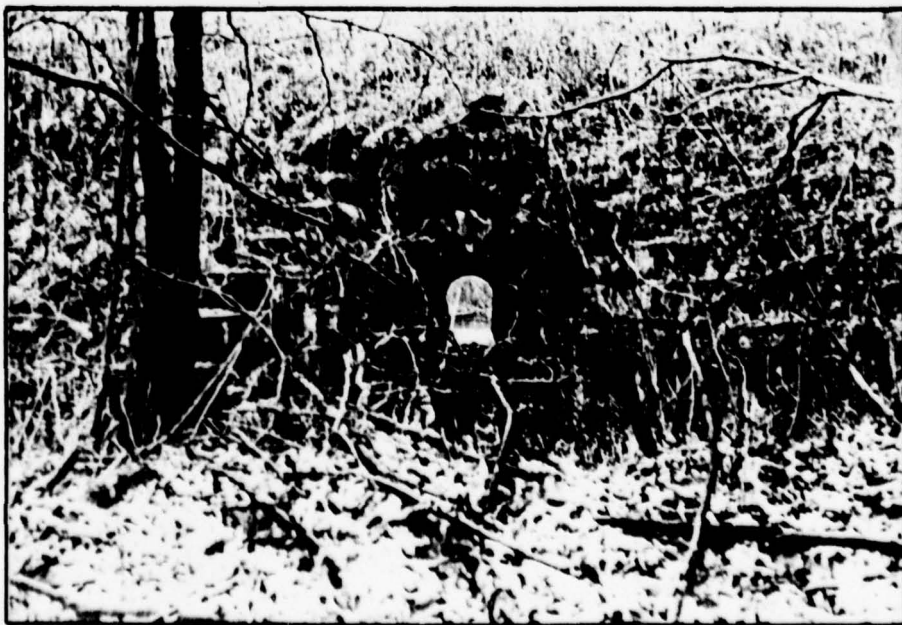
**PHOTO 6. Stone Arch Culvert beneath Railroad**

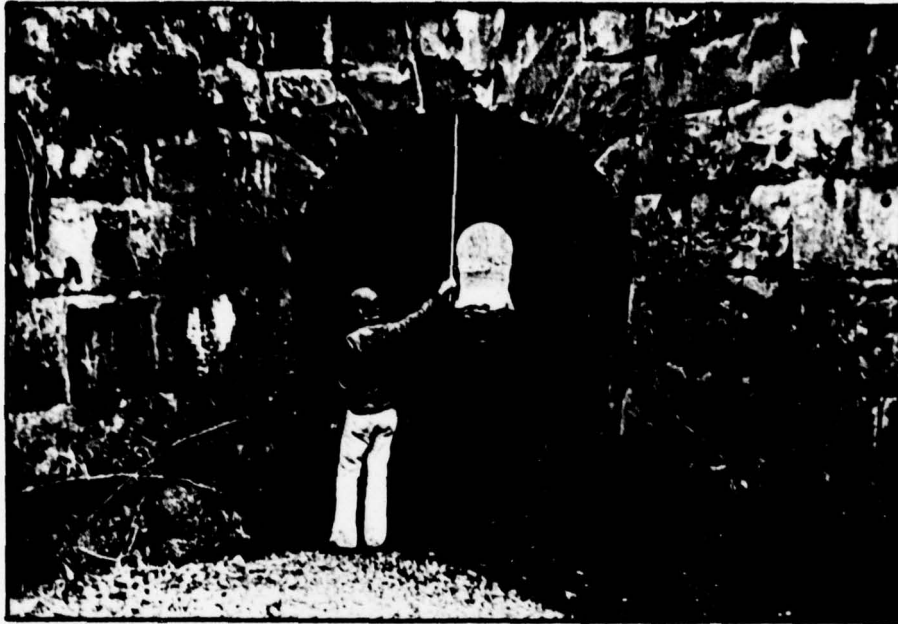
**PHOTO 7. Close-up of Railroad Culvert**
