LOFTY RESERVOIR DAM

NDI NO. PA-00681
DER NO. 54-1

**PHASE I INSPECTION REPORT
NATIONAL DAM INSPECTION PROGRAM**

Berger Associates, Inc.
Harrisburg, Pennsylvania

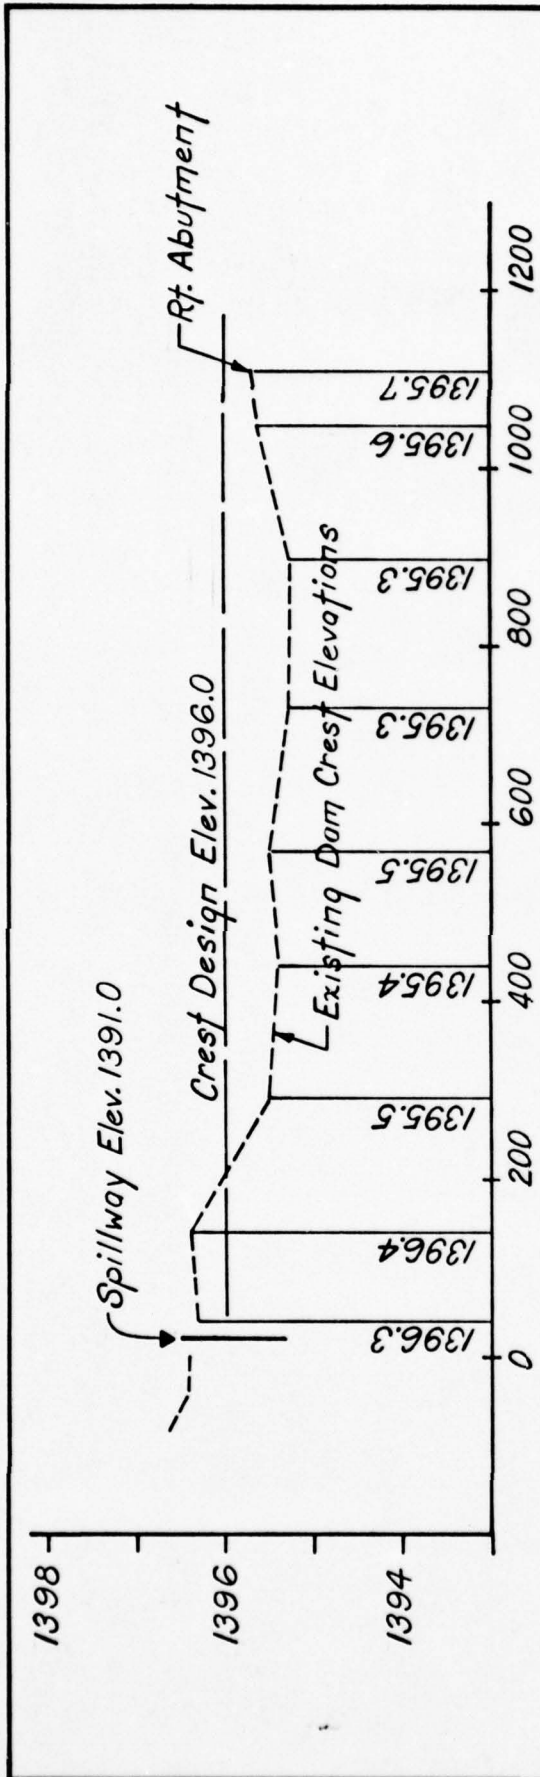
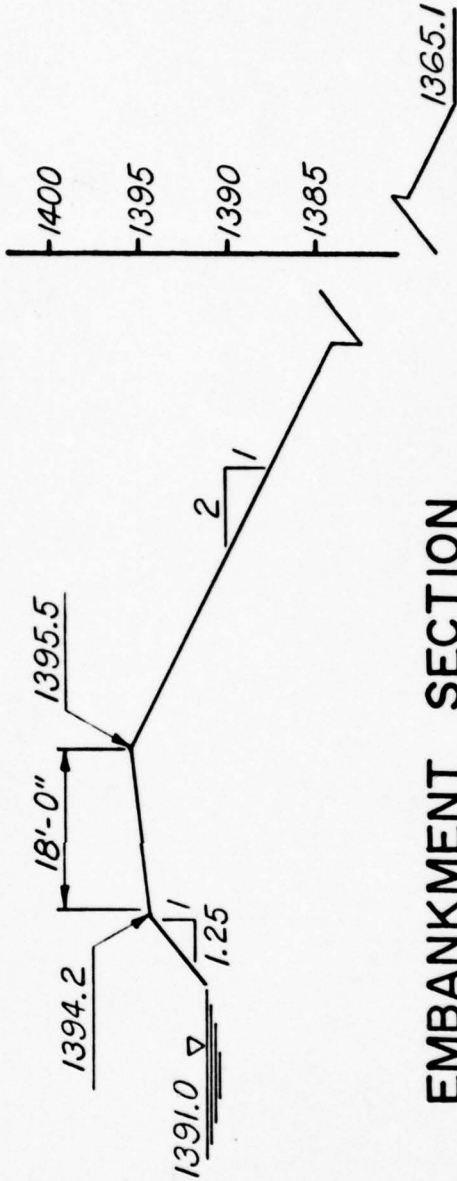
PLATE A-I

The visual inspection of this dam did not detect any evidence of structural instability of the embankment. Erosion of the slopes over the years has created an undulating type condition along the slope surface. The slope angle on the downstream side is reasonably uniform. The slope, measured by survey instrument during this inspection, showed an average angle of 26° (2H to 1V). The upstream slope is somewhat steeper, measured at 1.25H to 1V to the waters edge. This steeper slope is apparently the result of filling along the crest over the years in an attempt to maintain a uniform crest elevation. The upstream slope appears to become flatter below the water level. A surveyed profile shows a variation of crest surface elevations across the dam to a maximum of 0.7 foot below the design crest level. Refer to Plate A-I, Appendix A for plot of survey information.

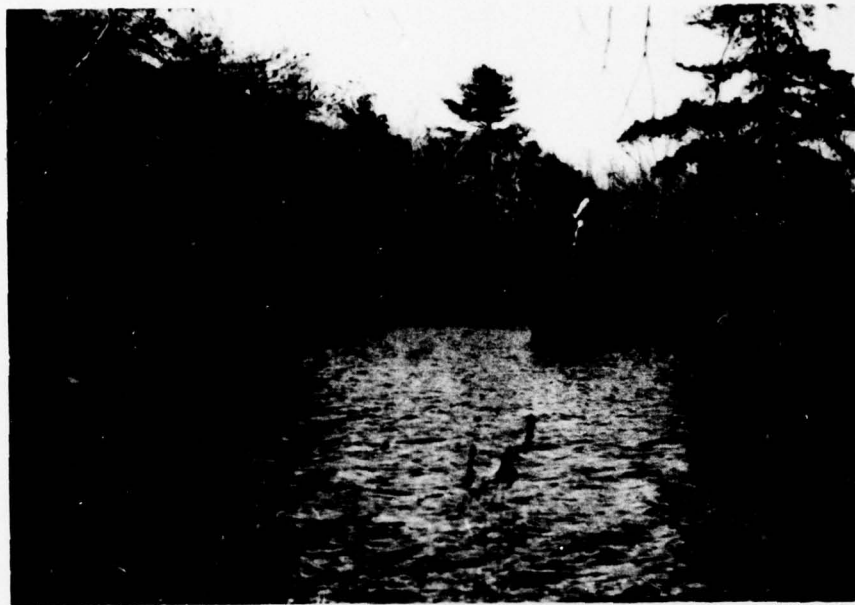
OBSERVATIONS AND REMARKS
A. APPROACH CHANNEL	Some debris, tree stumps, several large rocks, coarse gravel.
B. WEIR: Crest Condition Cracks Deterioration Foundation Abutments	Some debris on crest, tree trunks, weathers, some cracks. Left abutment good condition - two cracks, had been patched, appears stable; right abutment more deterioration, concrete crumbling near the top, had been covered with thin layer of bituminous material which is also deteriorating.

Spillway Approach Channel

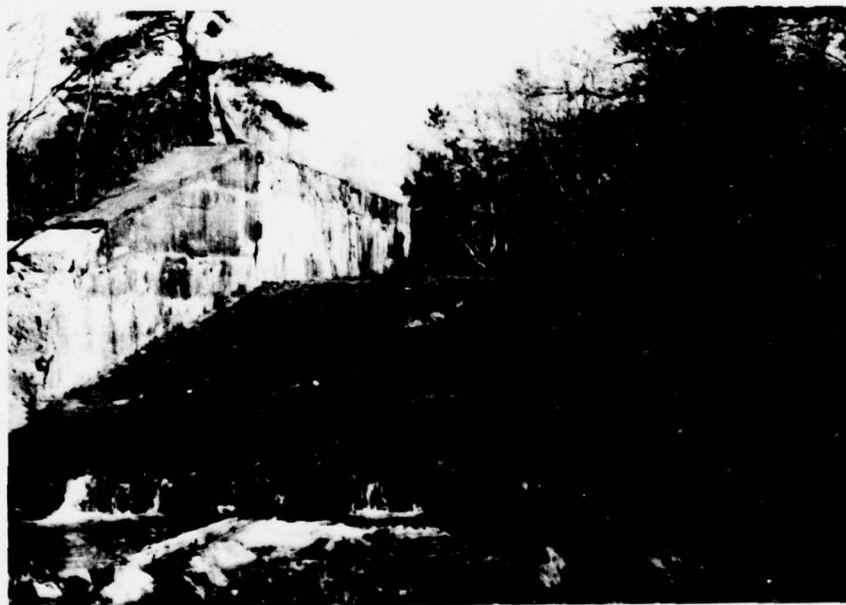
The abutment walls show signs of weathering and deterioration. The left wall has been patched and appears to be in good condition. The right wall shows more deterioration with the top of the wall severely spalled and broken at the downstream end. Bituminous material has been used in previous repairs.

The spillway outlet slab shows signs of the erosive deterioration due to the water overflow and is in fair condition. Undermining of the slab at its downstream edge was also observed. Some of the slab has broken away as a result of this support loss. This condition should be improved.

Spillway Chute

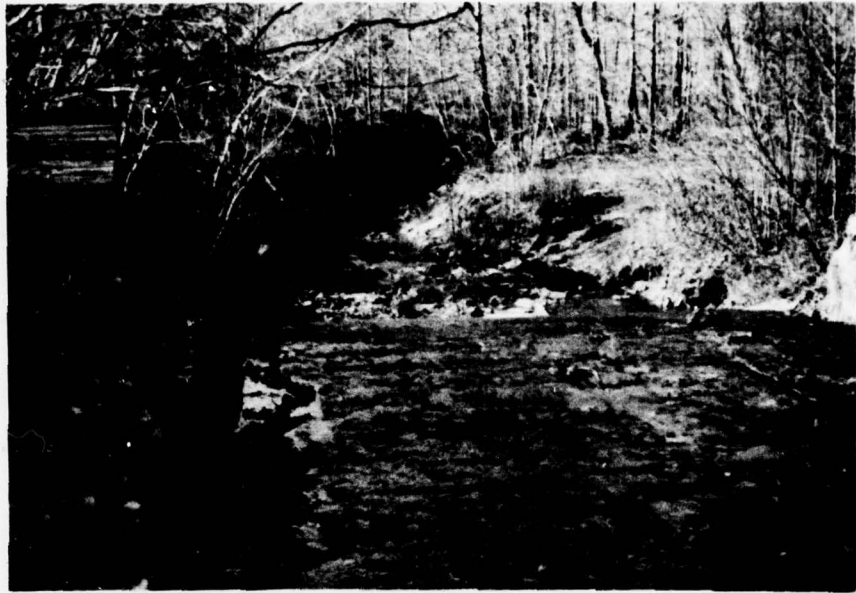
C. DISCHARGE CHANNEL: Lining Cracks Stilling Basin	Rocks ranging from 6" to 3' and red clay bottom. 1 to 2 feet of clay washed out from under toe of spillway apron, some chunks of concrete have broken off toe, spillway weathered, 1 horizontal crack across spillway at downstream end of abutments.

Spillway Outlet Channel

The spillway is in need of repairs to both the slab and the abutment walls and the channel just downstream from the end of the slab could be dressed and graded. The end of the slab also needs some support repair.

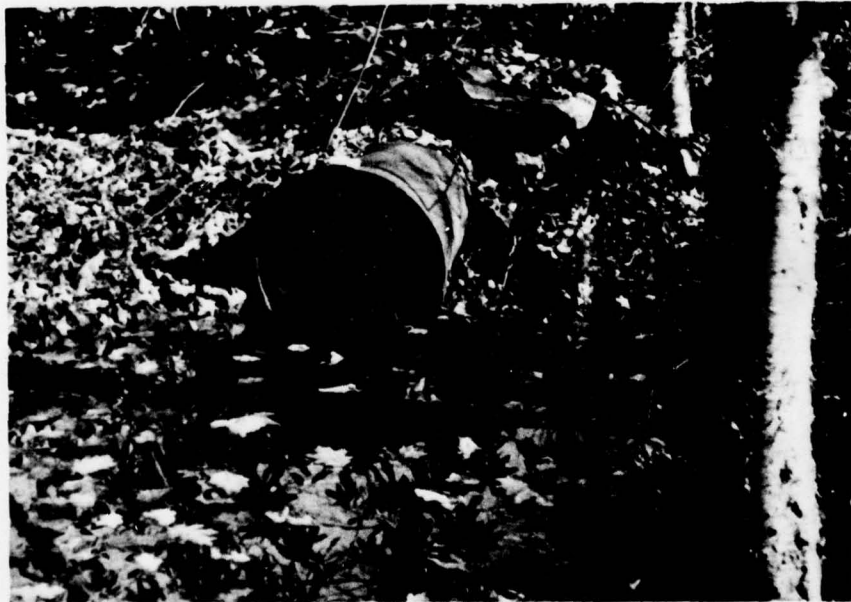
The outlet pipe for this dam has not been used over the past twelve years. The pipe, as observed at the downstream end appears to be in fair condition. The control valve, which is exposed, sitting on the ground surface, is rusty and in poor condition.

The condition of the blowoff pipe could only be observed at its outlet below the toe of the downstream slope of the embankment. It appears to be in fair condition. Its control, however, is rusty and in poor condition and should be scheduled for maintenance. There is no upstream control of this pipe.

Blowoff - Outlet

The outlet control valve is in the closed position and appears to be in poor operating condition, if it can actually be operated. It is doubtful that this control could be used in an emergency condition. This control should be made operable.
