MUD RUN DAM

NDI NO. PA-00690

PHASE I INSPECTION REPORT NATIONAL DAM INSPECTION PROGRAM

Name of Dam: MUD RUN DAM, NDS NO. PA-00690
State & State No. PENNSYLVANIA, 54-27
County: SCHUYLKILL
Stream: MUD RUN
Date of Inspection: NOVEMBER 1, 1978

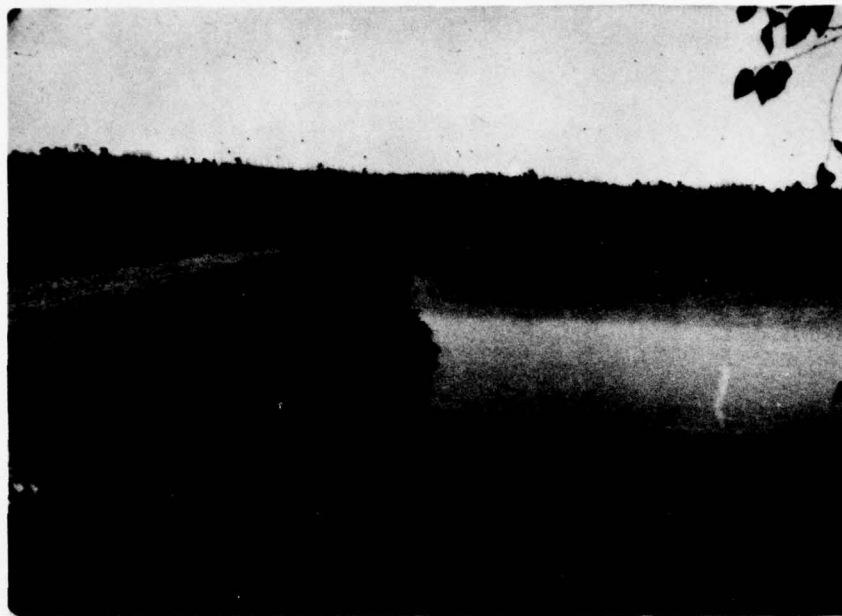
Inspection of the downstream slope surface did not reveal any symptoms of distress. The slope surface is composed of cobbles and is weed covered for the most part. There was no evidence of slope seepage observed. The upstream slope surface is also composed of cobbles and stone with some light weed growth near the top of the slope. The downstream slope was measured at 2.3H to 1V. The upstream slope is too short to measure an average slope angle; however, the available plans indicate a slope ratio of 2H to 1V (Appendix A, Plate A-I).

Upstream
Embankment Slope

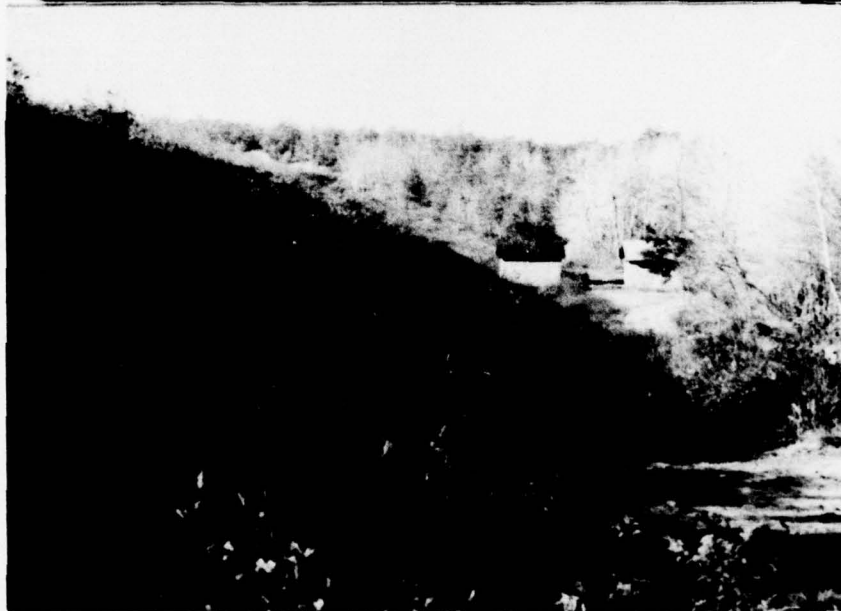
Seepage water was observed along most of the length of the downstream toe. Flow of seepage water was barely detectible. A valve on the blowoff line is not properly closed and permits water to leak from the reservoir.

Downstream
Embankment Slope

4. That the spillway outlet channel be cleared of all debris and obstructions.
5. That the seepage along the toe of the embankment be monitored on a regular schedule. Volume and clarity shall be recorded for comparison and analysis. Such records should include the elevation of the water level in the reservoir at the time of the observation. If significant increase in flow is noted or if the seepage discharge becomes turbid, immediate steps should be taken to correct the condition.

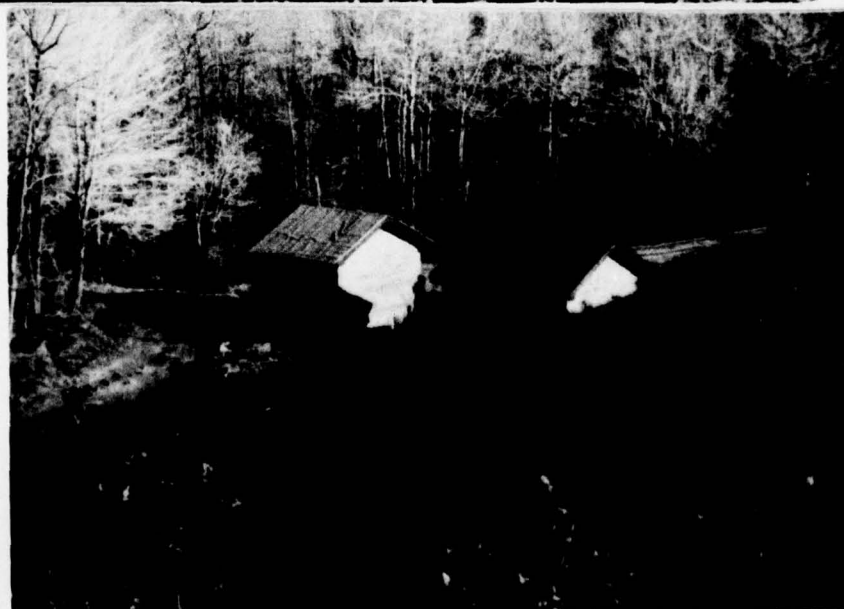
As indicated above, the valves which control the outflow from this dam are in poor condition. The stem yokes will probably need replacement as they are nearly rusted through. One of the valves is leaking, permitting considerable flow in the outlet ditch below the valve house. This condition should be corrected.

Valve Houses

1. That all control valves for this dam be put into good repair and made operable and that a regular program of maintenance and service be developed and put into action. The valves should be operated at least once each year.

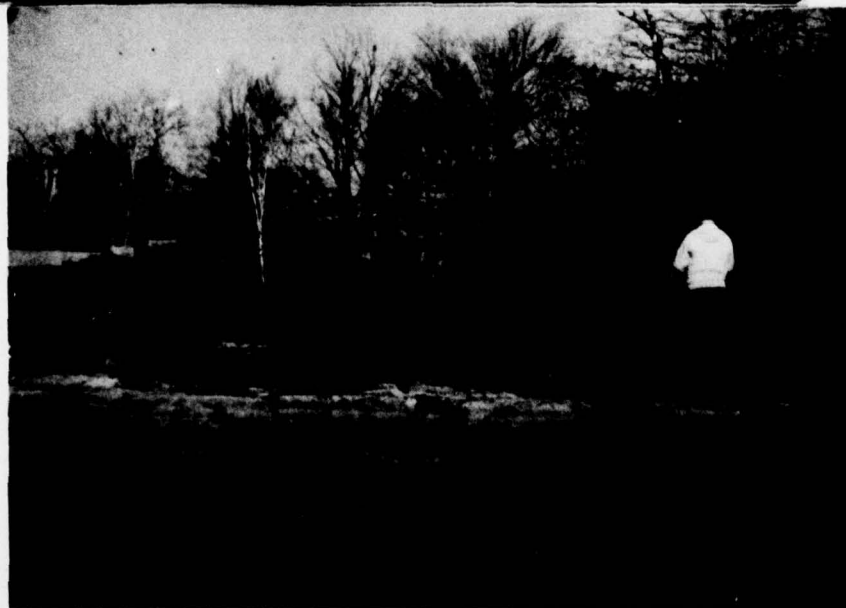
Spillway Crest

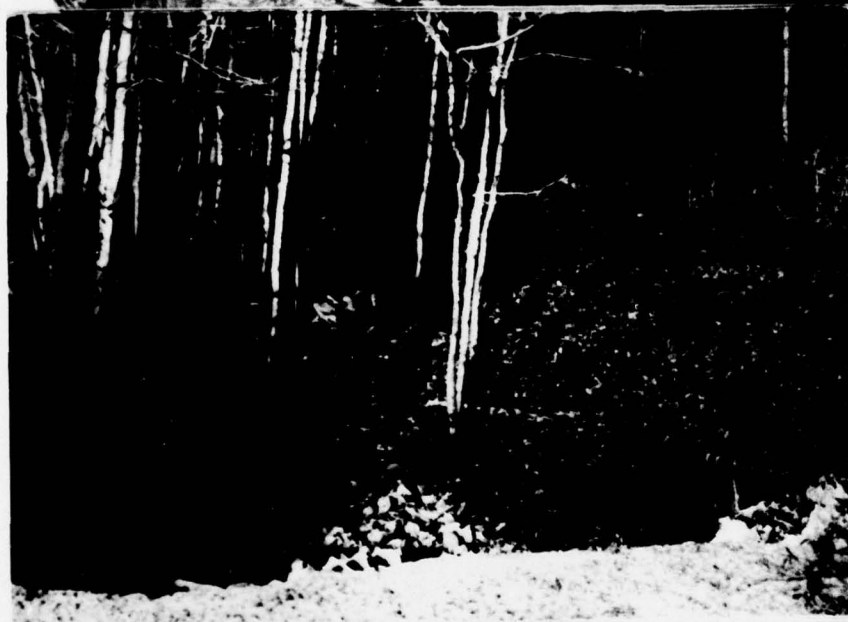
C. DISCHARGE CHANNEL: Lining Cracks Stilling Basin	abutment, right side of spillway embankment covered with small trees and brush - 20° slope. No flow over the spillway. 6" to 18" riprap. Steep banks, narrow trees in channel - seepage into channel about 150 feet downstream of spillway toe.

Spillway Outlet
Channel

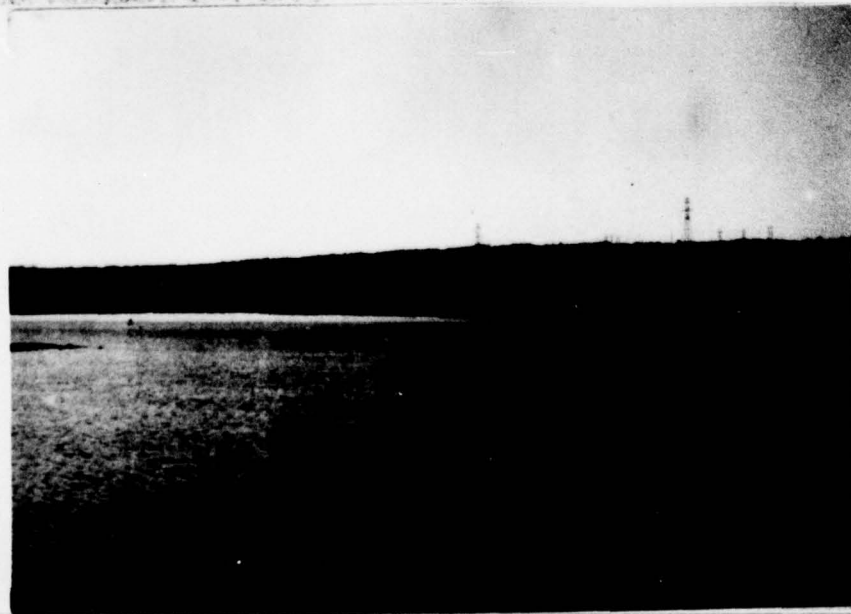
Reservoir Area
