DUTCH FORK DAM

NDI I.D. NO: PA-490

PHASE I INSPECTION REPORT
NATIONAL DAM INSPECTION PROGRAM

D'APPOLONIA CONSULTING ENGINEERS
10 DUFF ROAD
PITTSBURGH, PA. 15235
JANUARY 1979

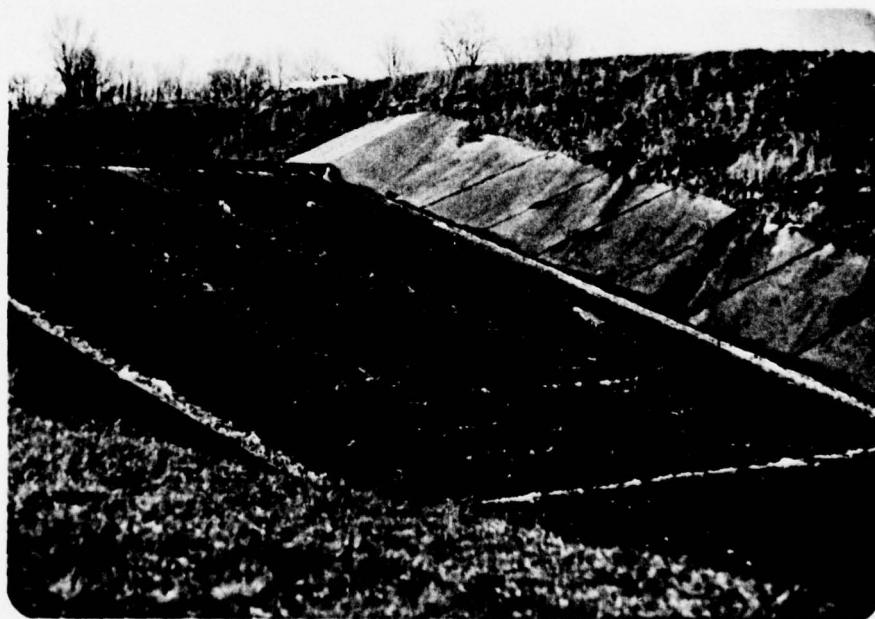
c. Appurtenant Structures. The spillway and outlet works were examined for deterioration or other signs of distress and obstructions that would limit flow. In general, the structures were found to be in good condition. Several structural cracks were observed in the lower half of the spillway discharge channel. However, due to the flow in

the spillway, these cracks could not be closely examined. The visible portions of the control tower and the outlet conduit were found to be in good condition.

Photograph No. 2
Spillway discharge channel.

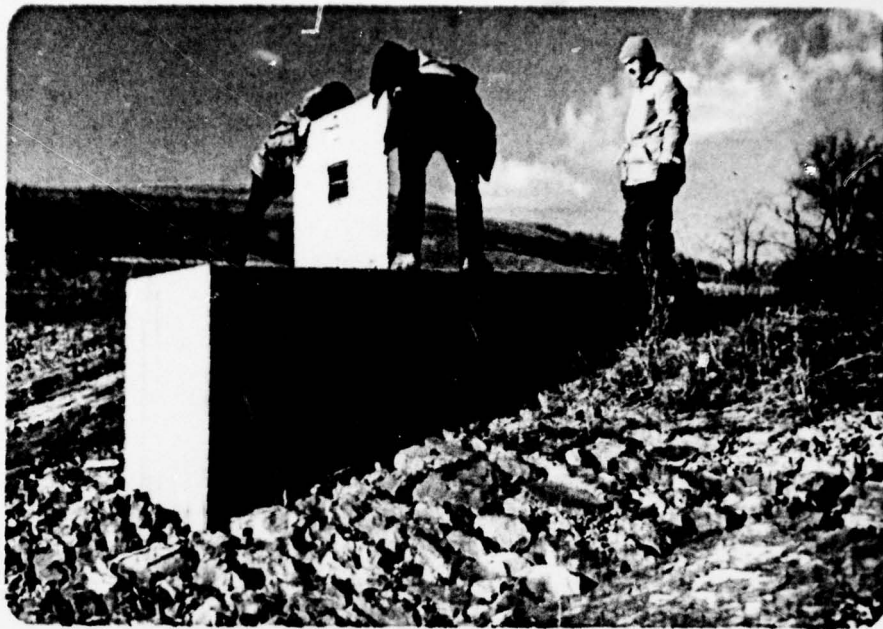
Photograph No. 3
Outlet works control tower.

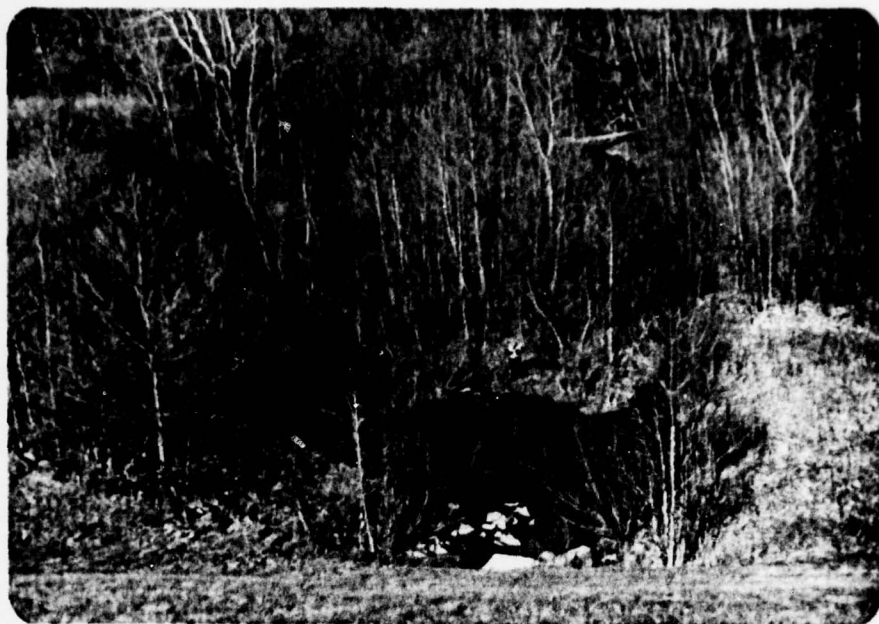
Photograph No. 5
Outlet works plunge pool.
