6 National Dam Inspection Program, Old Dam (NDI ID Number PA-499), Ohio River Basin, St. Patrick's Run, Washington County, Pennsylvania, Phase I Inspection Report.

PHASE I REPORT
NATIONAL DAM INSPECTION PROGRAM

NAME OF DAM: Old Dam
STATE LOCATED: Pennsylvania
COUNTY LOCATED: Washington
STREAM: St. Patrick's Run, a tributary of Raccoon Creek
DATE OF INSPECTION: November 29 and December 20, 1978

PHASE I REPORT
NATIONAL DAM INSPECTION PROGRAM
OLD DAM
NDI I.D. NO. PA-499
DER I.D. NO. 63-1

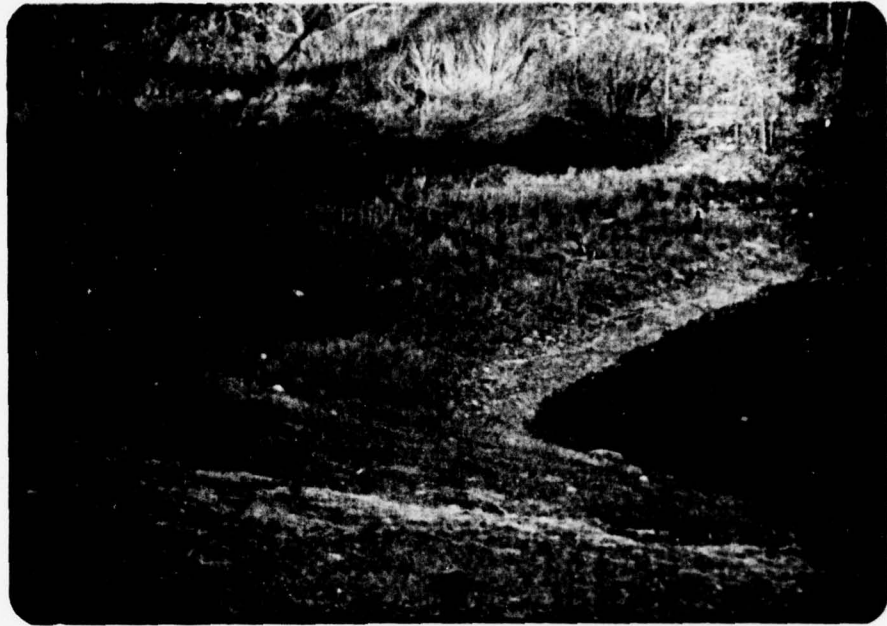
Upstream Face
