RYERSON STATION STATE PARK DAM

NDI I.D. NO: PA-193

**PHASE I INSPECTION REPORT
NATIONAL DAM INSPECTION PROGRAM**

D'APPOLONIA CONSULTING ENGINEERS
10 DUFF ROAD
PITTSBURGH, PA. 15235
MARCH 1979

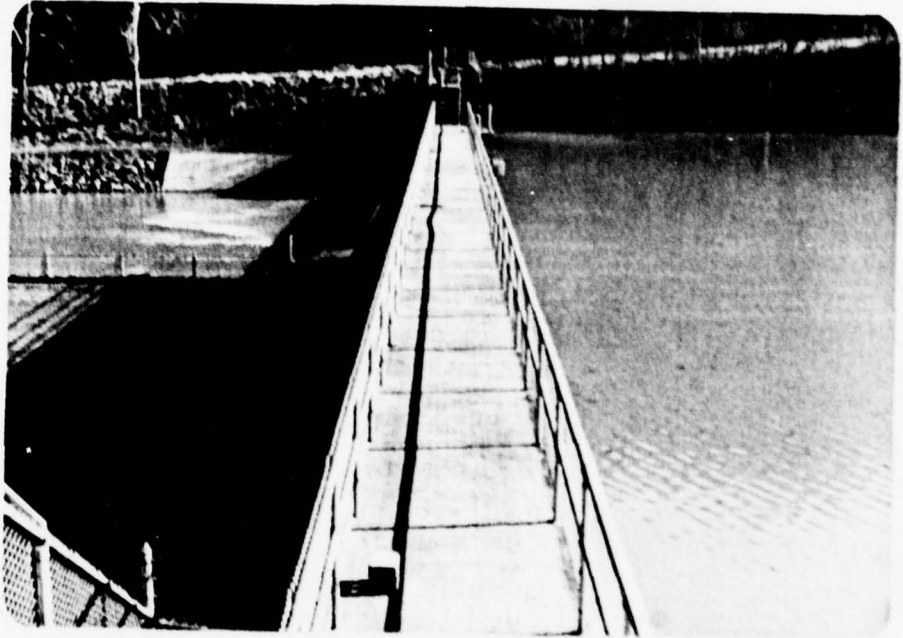
Photograph No. 1
Crest (looking east).

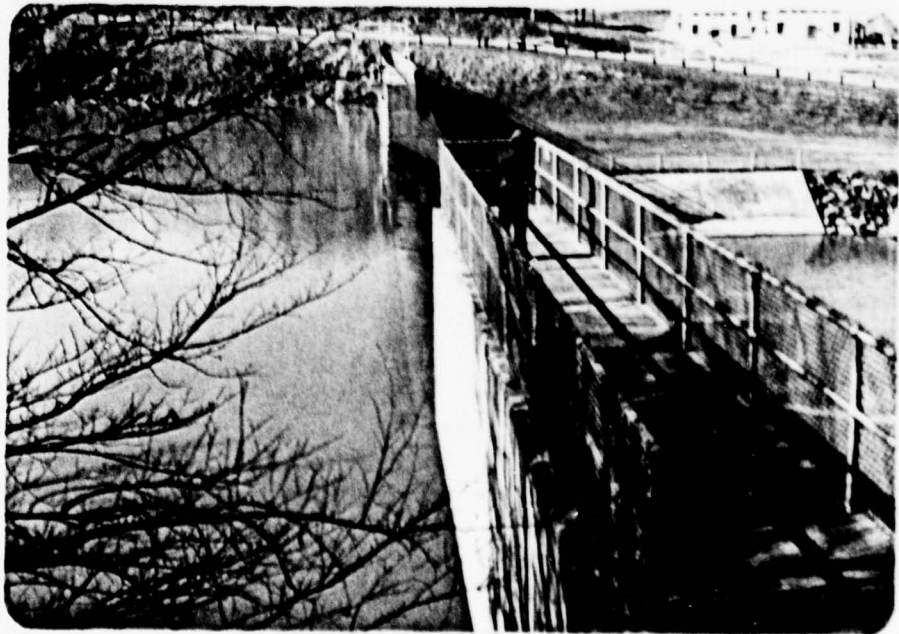
Photograph No. 2
Crest (looking west).

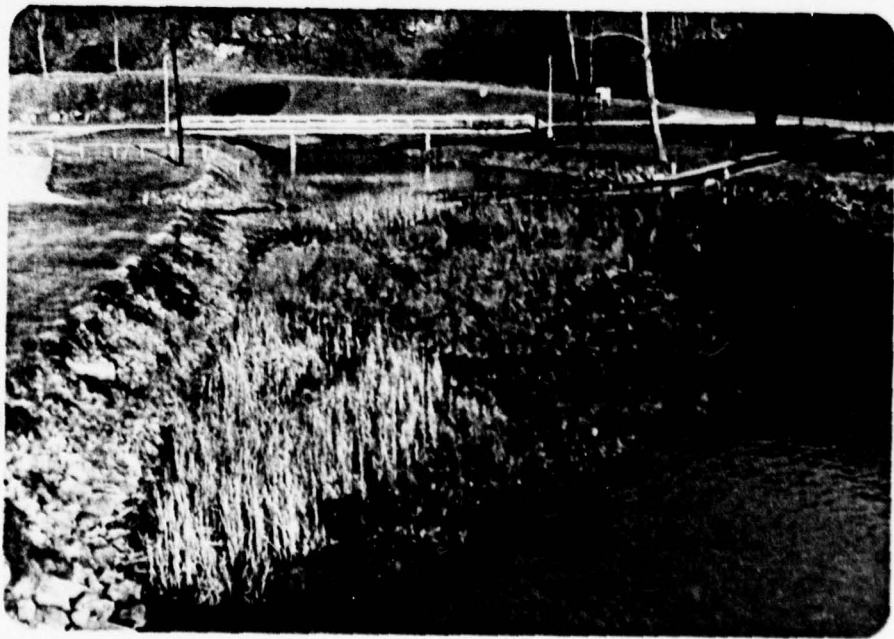
Photograph No. 4
Spillway discharge channel.

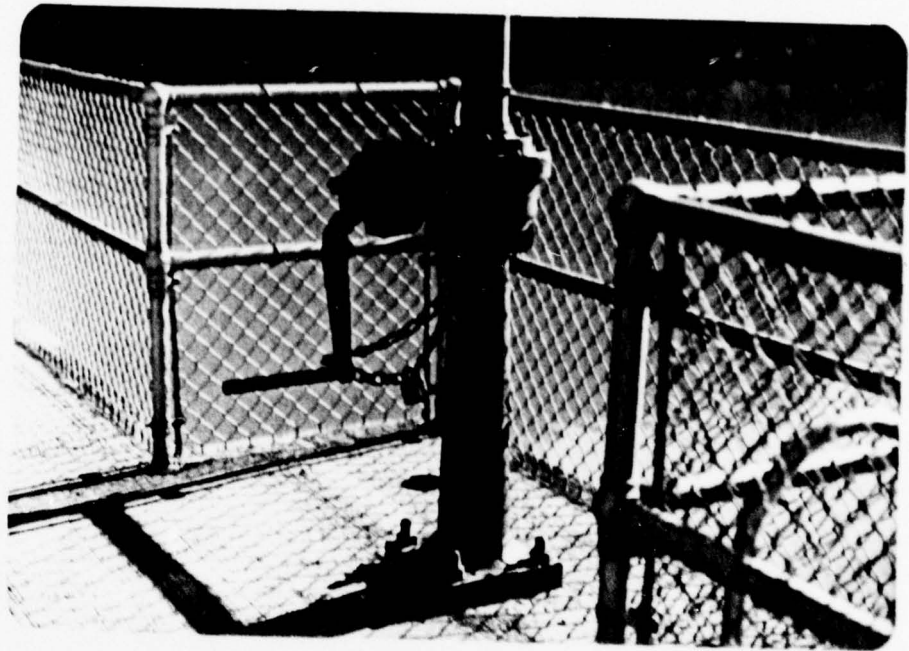
4.3 Maintenance of Operating Facilities. The only operational feature of the dam is the outlet conduit sluice gate. The sluice gate was operated by state park personnel and was observed to be functional. The maintenance condition of the operating equipment is considered to be satisfactory.

Photograph No. 5
Outlet valve hoist.

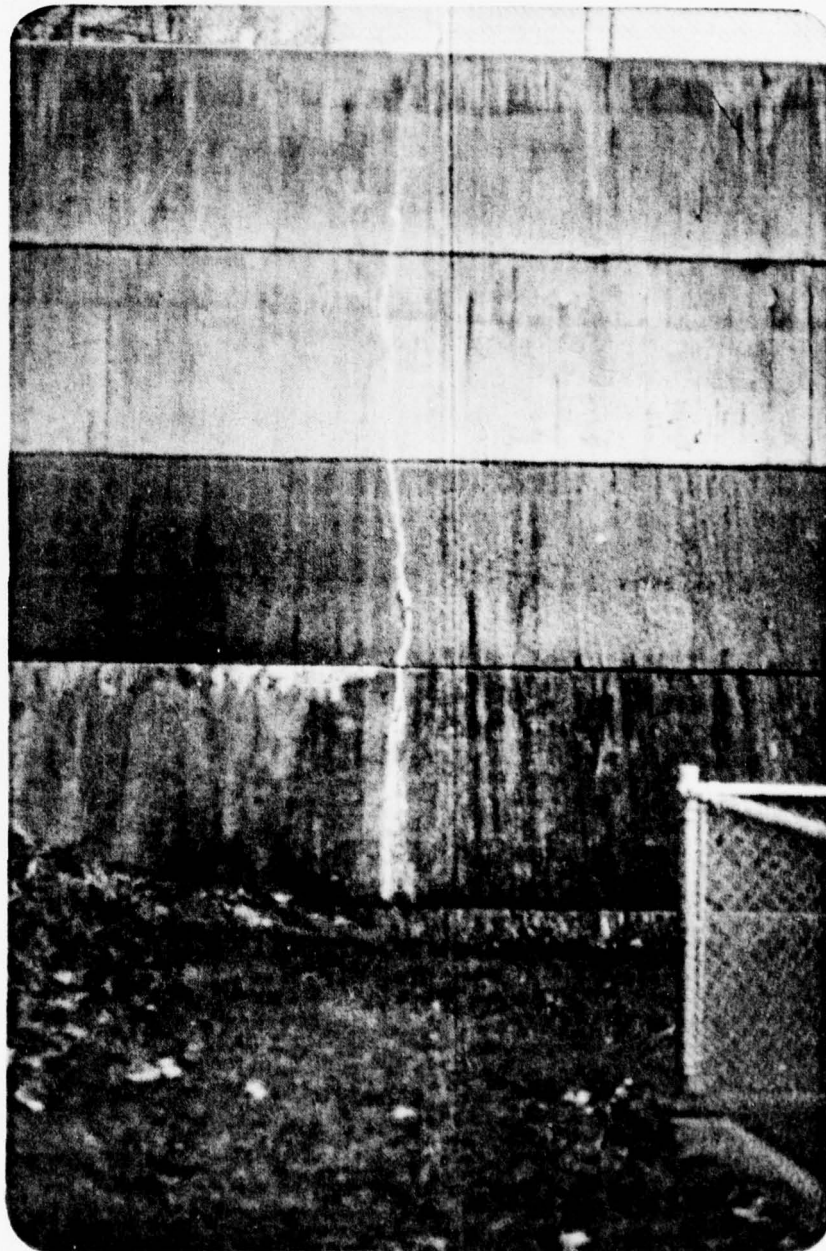
Photograph No. 7
Structural crack near right
abutment.

A structural crack was observed on the downstream face of the dam near the right abutment and extending across the crest. Only minor seepage was associated with this crack, indicating that the crack does not extend through the whole section. This condition is not considered to be serious relative to the overall stability of the dam at this time. However, it should be regularly inspected and monitored to document if further structural distress occurs, and necessary remedial work should be performed if such conditions are observed.

The overall condition of the dam is considered to be good. One structural crack was observed near the left abutment, extending across the crest and on the downstream face of the dam. Only minor seepage was associated with this crack, indicating that it is not extending throughout the entire cross section. The seepage flow was estimated to be on the order of one to two gallons per minute.

VISUAL EXAMINATION OF	OBSERVATIONS	REMARKS OR RECOMMENDATIONS
SURFACE CRACKS CONCRETE SURFACES	None significant.	
STRUCTURAL CRACKING	Near right abutment. Extends across the crest and through downstream face. Minor associated seepage (approximately one gallon per minute).	This crack should be periodically inspected and monitored.
VERTICAL AND HORIZONTAL ALIGNMENT	No measurable misalignment.	
MOROLITH JOINTS	No significant signs of distress.	
CONSTRUCTION JOINTS	No significant signs of distress.

1. The structural crack observed near the right abutment should be regularly inspected and monitored for signs of further structural distress, such as displacements and increased quantity of seepage through the crack. Necessary remedial measures should be performed if such conditions are observed.
2. An around-the-clock surveillance should be provided during unusually heavy runoff and a formal warning system developed to alert the downstream residents in the event of emergencies.

1. The structural crack observed near the right abutment should be regularly inspected and monitored for signs of further structural distress, such as displacements and increased quantity of seepage through the crack. Necessary remedial measures should be performed if such conditions are observed.
2. An around-the-clock surveillance should be provided during unusually heavy runoff and a formal warning system developed to alert the downstream residents in the event of emergencies.
3. The dam and appurtenant structures should be inspected regularly and necessary maintenance performed.

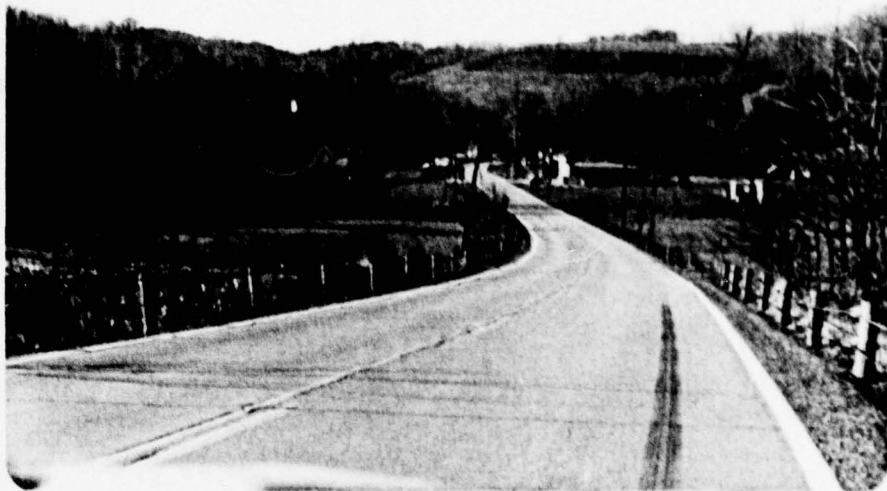
Photograph No. 8

Community of Ryerson Station 1-1/2 miles
downstream (looking downstream).

4.5 Evaluation. The maintenance condition of the dam and operating facilities is considered to be satisfactory. It is recommended that a formal warning system be developed to alert the downstream residents in the event of emergencies.

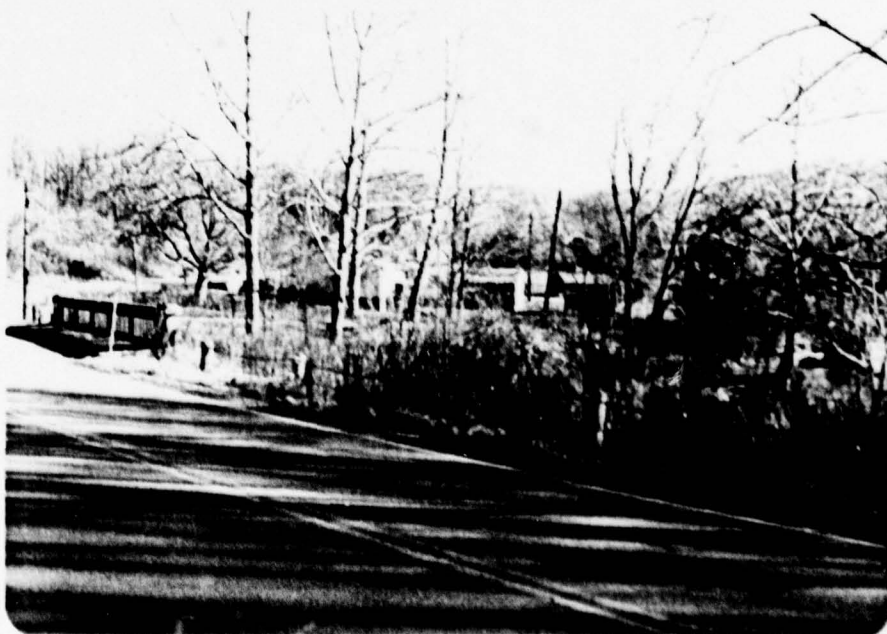
Photograph No. 9

Community of Ryerson Station (looking upstream).
