CABIN CREEK DAM

NDS ID NO. PA-00336

RED LION MUNICIPAL AUTHORITY
PHASE I INSPECTION REPORT
NATIONAL DAM INSPECTION PROGRAM

PHASE I INSPECTION REPORT

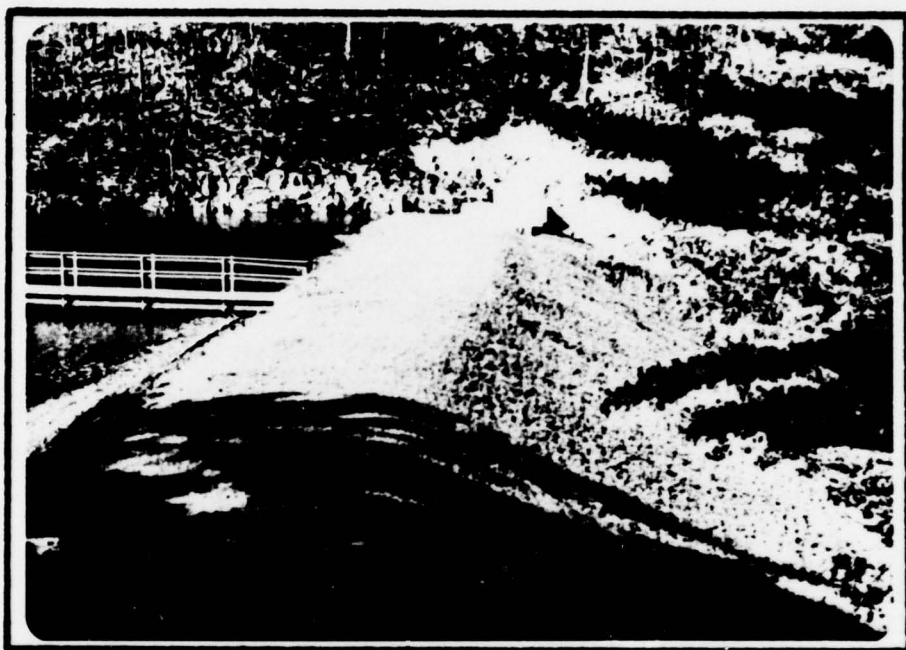
Overview of crest from right abutment.

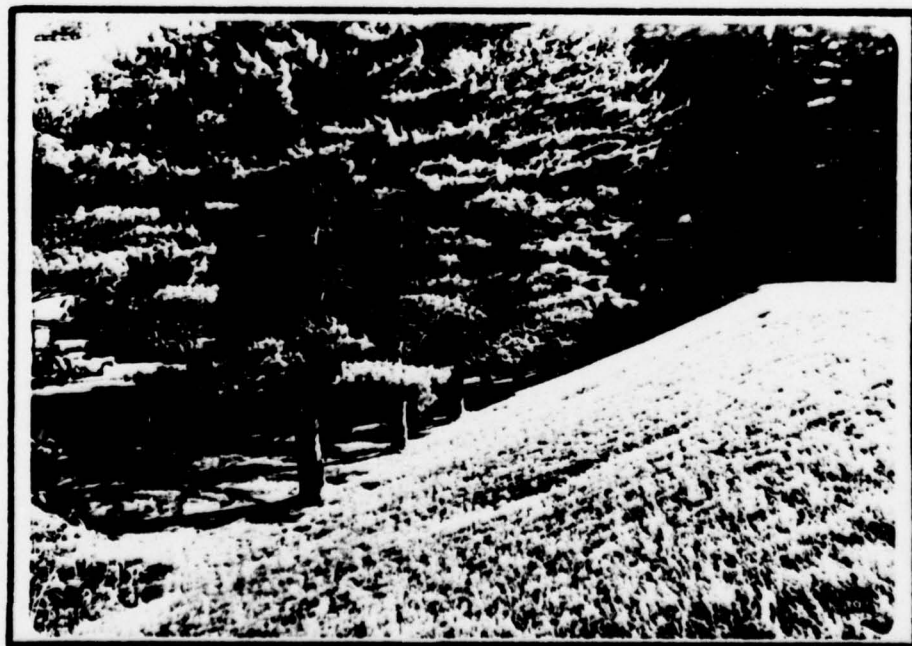
Downstream slope from left abutment.

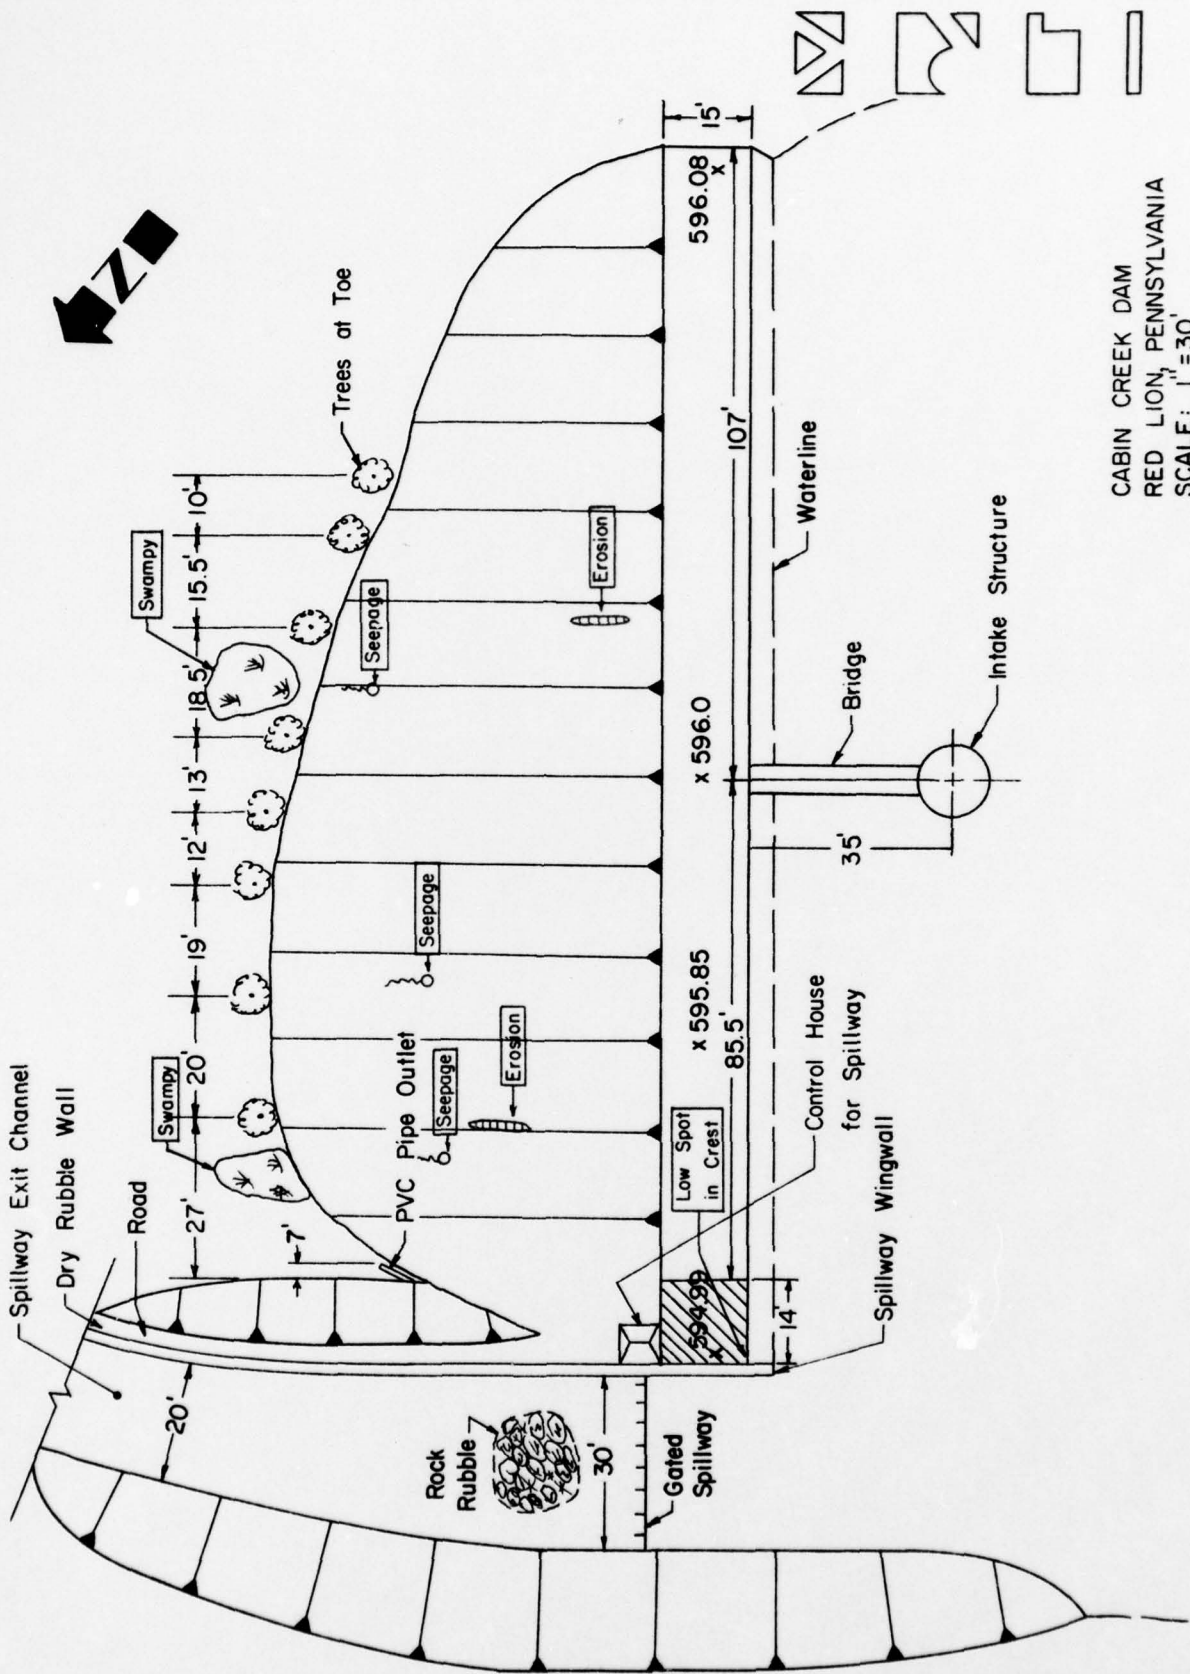
CABIN CREEK DAM
 RED LION, PENNSYLVANIA
 SCALE: 1" = 30'

b. Dam. The dam appears to conform closely to the construction drawings. From a brief survey conducted during the inspection it was determined that several low spots are present on the crest toward the left abutment. One area adjacent to the emergency spillway wingwall is approximately one (1) foot low. Several erosion gullies were noted on the downstream slope. These gullies may have resulted from the 1972 overtopping. Several seepage zones were noted on the downstream slope. The seepage zones were small (2' x 2') and minimal flow was noted. Two (2) wet areas (6' x 6') were noted at the toe of the embankment. Approximately seven (7) large trees are growing at the toe of the embankment. See drawing on pages 7 and 8 for location of seepage and wet areas.

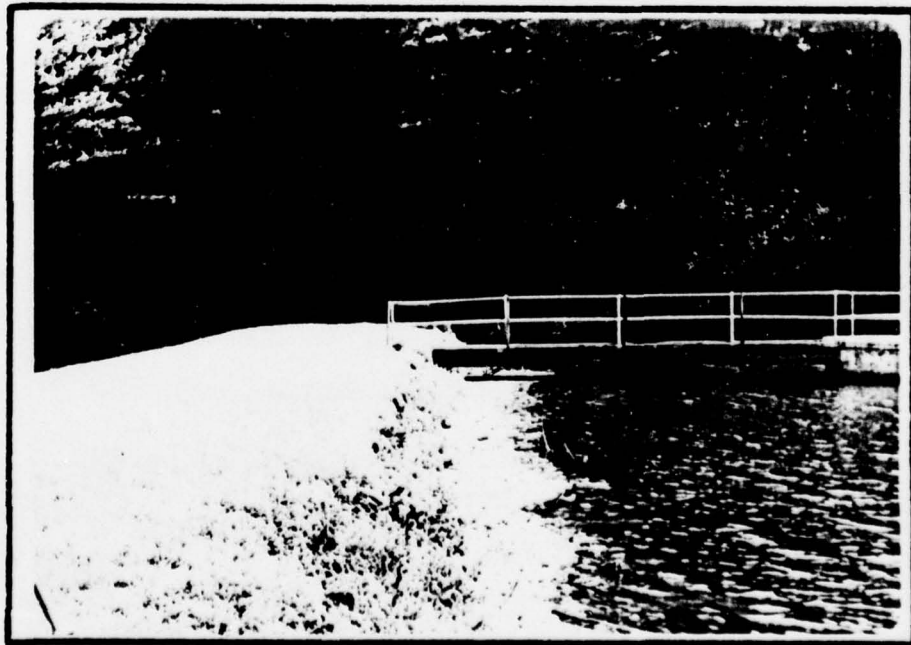
Photograph No. 2

View of upstream slope.

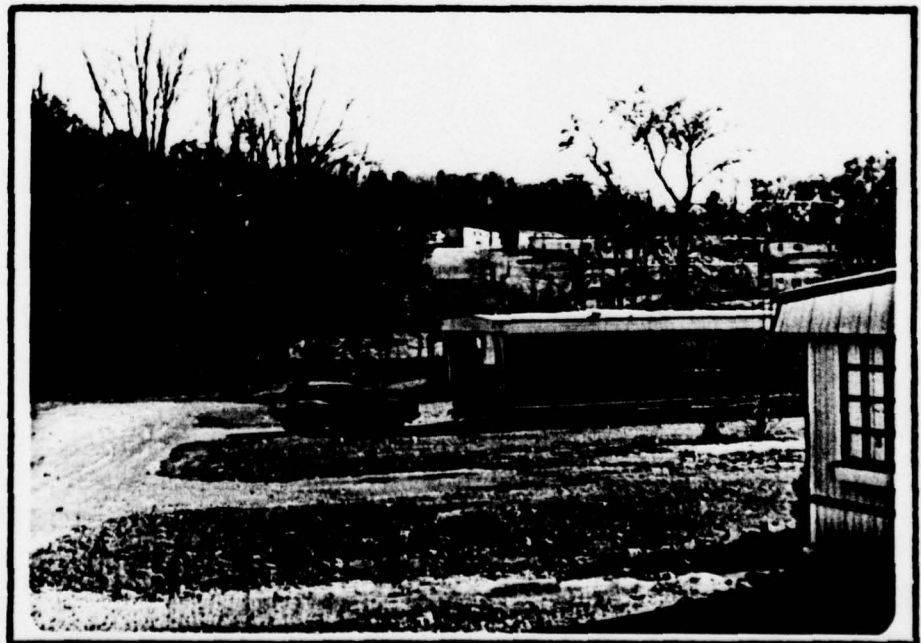
Photograph No. 6

Mobil home park at Margareta Furnace.
