LAUREL DAM

NDS ID NO. PA-00586

PHASE I INSPECTION REPORT

NATIONAL DAM INSPECTION PROGRAM

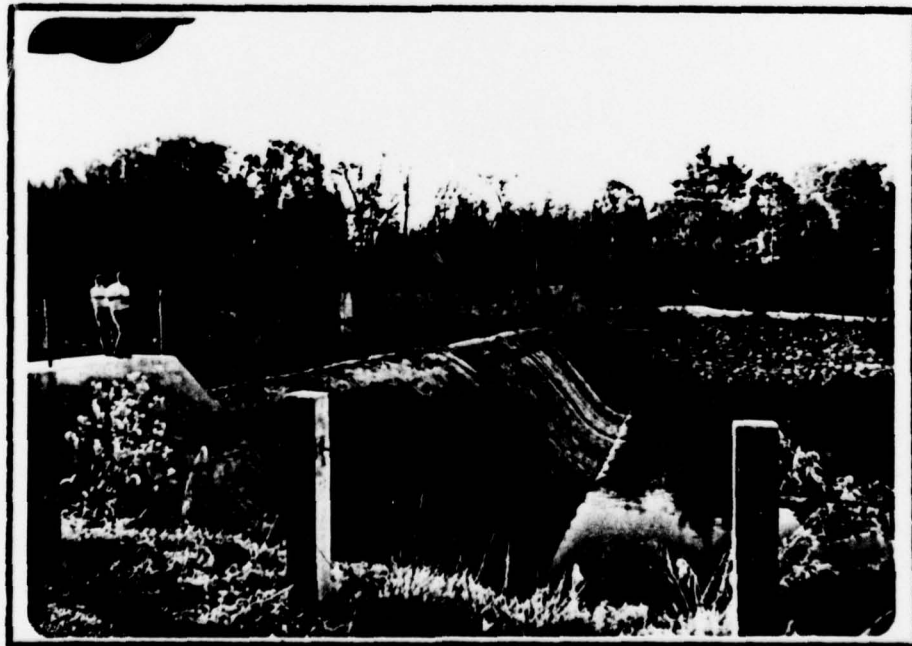
Overview of dam from right abutment.

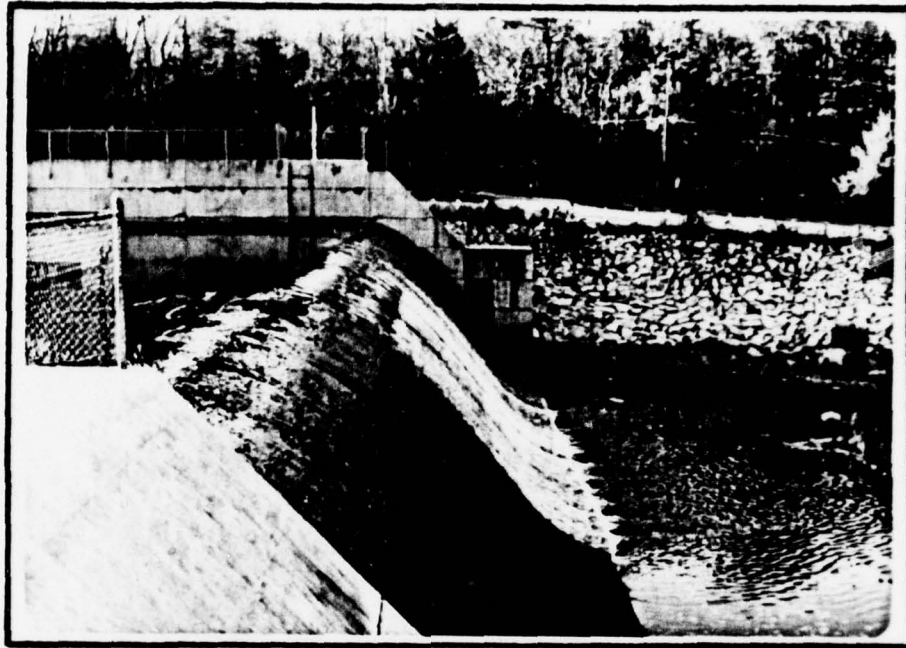
Photograph No. 1

The side channel banks downstream of the dam have grouted riprap for erosion protection. This riprap is in excellent condition.

Looking at left abutment, downstream riprap and reservoir drawdown outlet.

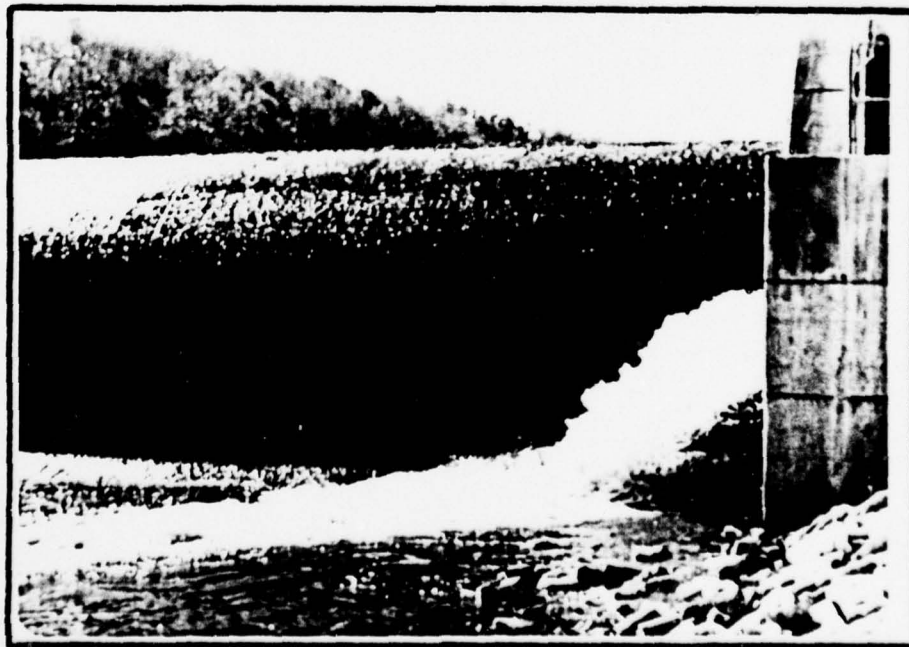
Photograph No. 2

c. Appurtenant Structures. The sluice gate on the drawdown conduit was operated by the operating personnel during the inspection. The sluice gate appears to be in good condition. The gate has to be operated manually. The controls are kept chained and locked.

Reservoir drawdown outlet discharging.

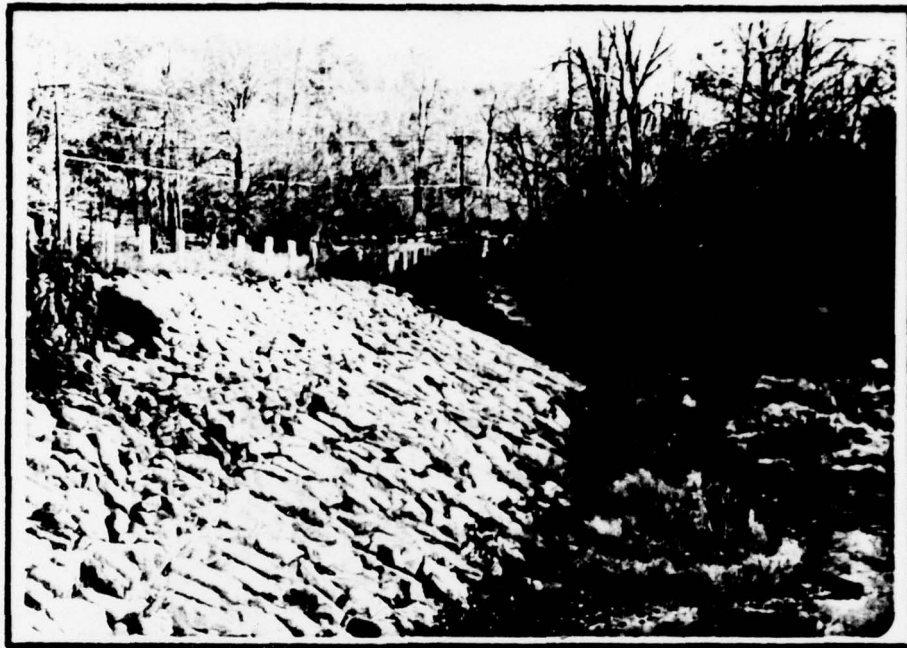
Photograph No. 3

Immediate downstream channel.

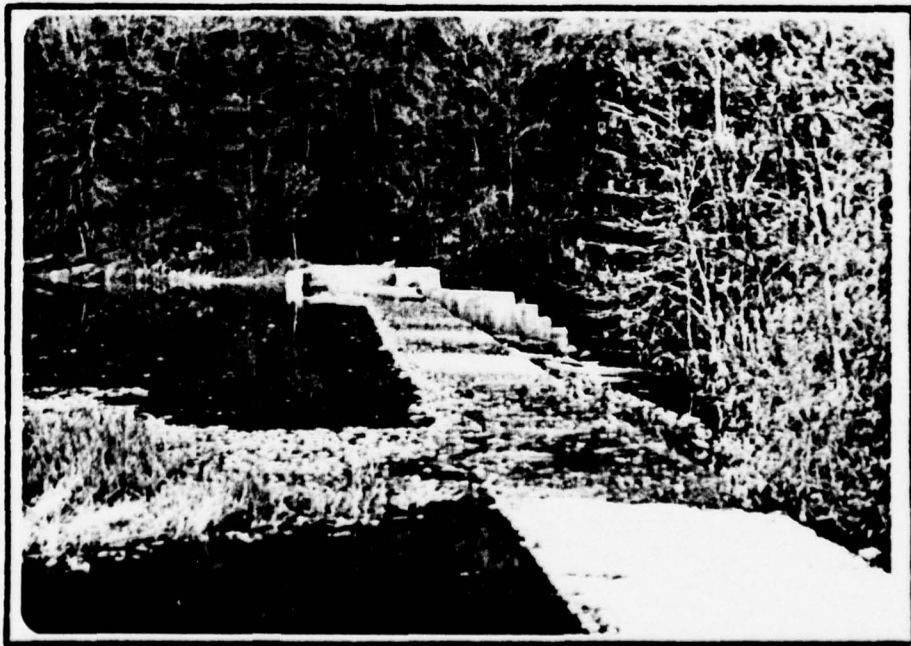
Photograph No. 6

Upper Mount Holly reservoir.

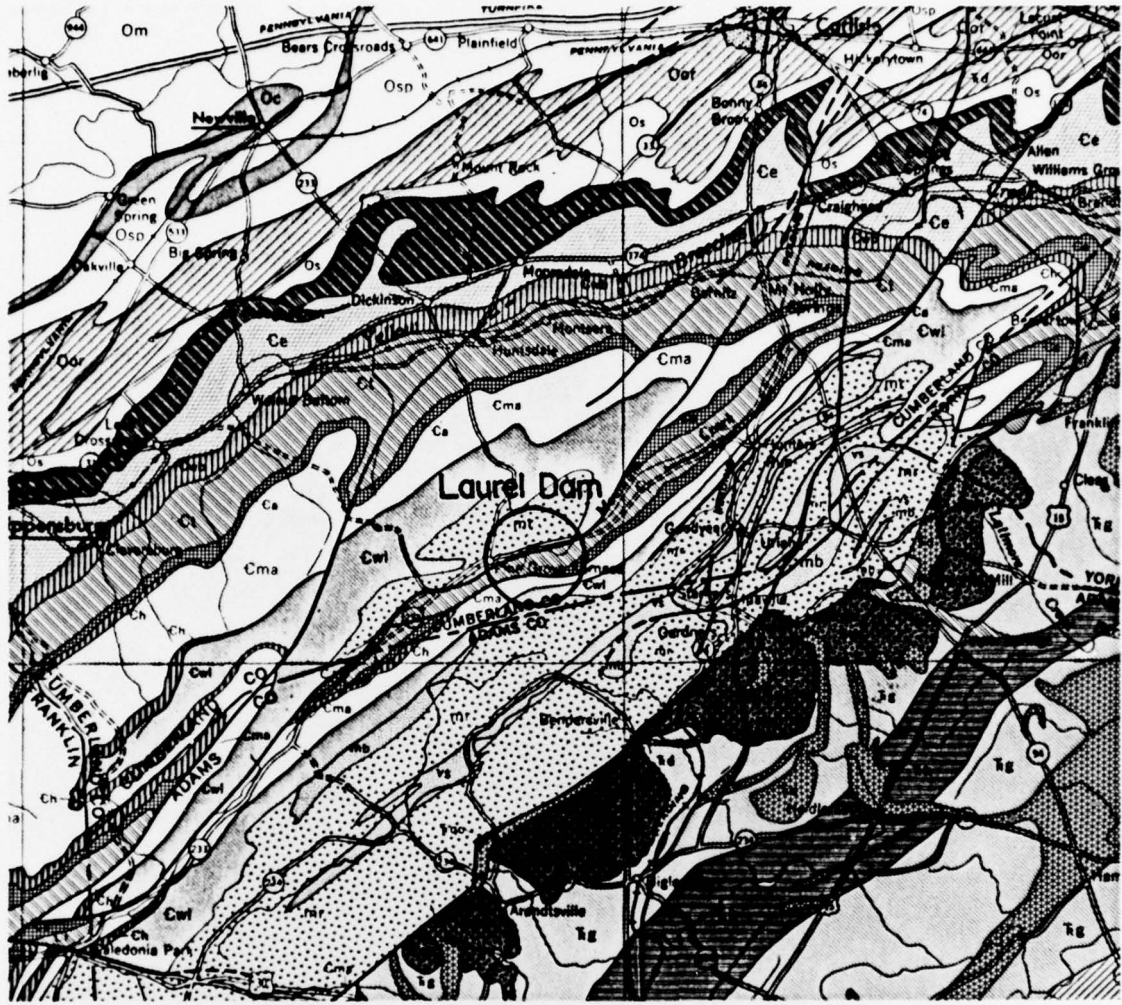
Geologic Map of Laurel Dam Area

The lake and dam lie astride a fault separating a Pre Cambrian aged metarhyolite (mr) from the Cambrian aged Tomstown Formation (Ct). No specific information is available on the metarhyolite, but they are usually fine-grained, red, gray and blue, and have phenocrysts of both quartz and feldspar. There is no bedding, but there may be joints. These may be abundant and closely spaced, but are usually only moderately developed with an irregular pattern. It is highly resistant to weathering, but a thin weathered rind may sometimes have to be removed before it can be utilized as a foundation material for heavy structures. It has good surface drainage and a low magnitude secondary porosity.

Little is known of the fault separating the dolomite from the metarhyolite. There is also a second fault paralleling the first at a distance of about one mile to the south.

A geologic study should be conducted to determine the potential for movement of faults in the area.
