6 National Dam Inspection Program. Cherry Valley Dam (NDI-PA-508, DER-63-56), Ohio River Basin, Raccoon Creek, Washington County, Pennsylvania. Phase I Inspection Report.

PHASE I REPORT
NATIONAL DAM INSPECTION PROGRAM

NAME OF DAM: Cherry Valley Dam
STATE LOCATED: Pennsylvania
COUNTY LOCATED: Washington
STREAM: Raccoon Creek, a tributary of the Ohio River
DATE OF INSPECTION: December 4 and 21, 1978

PHASE I REPORT
NATIONAL DAM INSPECTION PROGRAM
CHERRY VALLEY DAM
NDI I.D. NO. PA-508
DER I.D. NO. 63-56

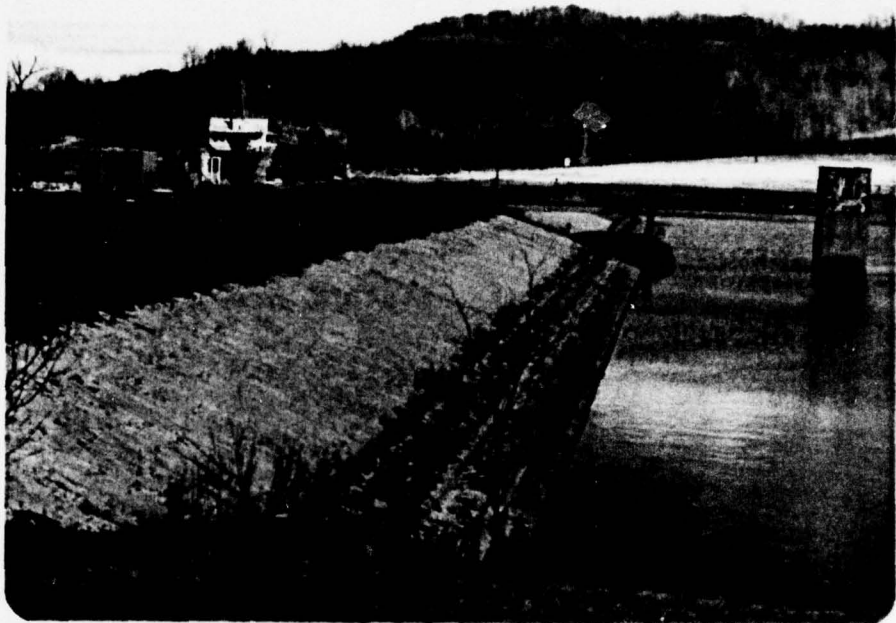
Upstream Face

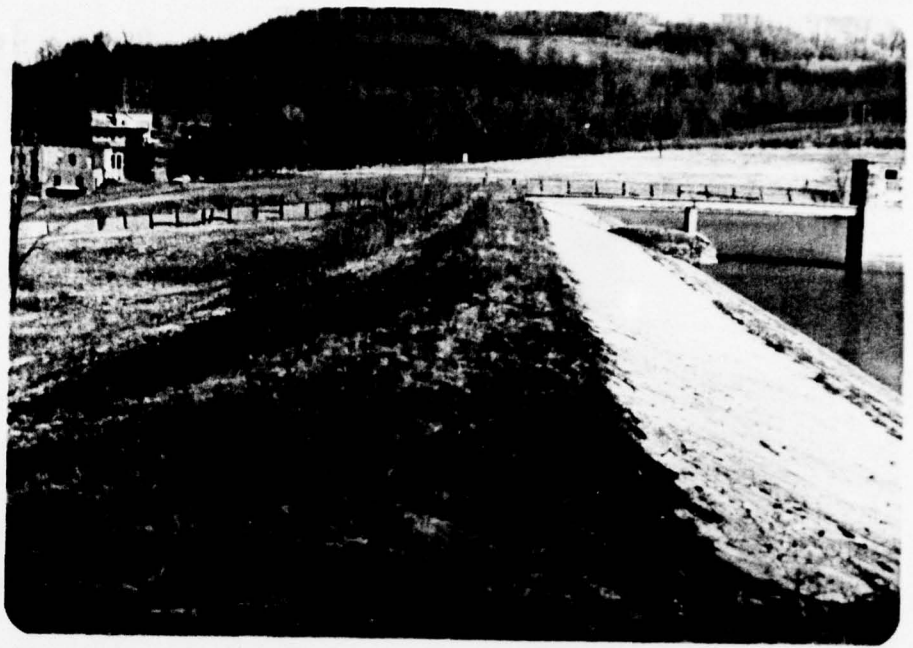
The top of the dam was surveyed relative to the spillway crest elevation and was found to have some vertical irregularities. While the design freeboard of the dam was 7.5 feet, the survey indicated freeboards ranging from 7.2 feet to 7.6 feet. The lowest area occurred approximately 150 feet from the left abutment.

Photograph No. 1
Crest (looking west).

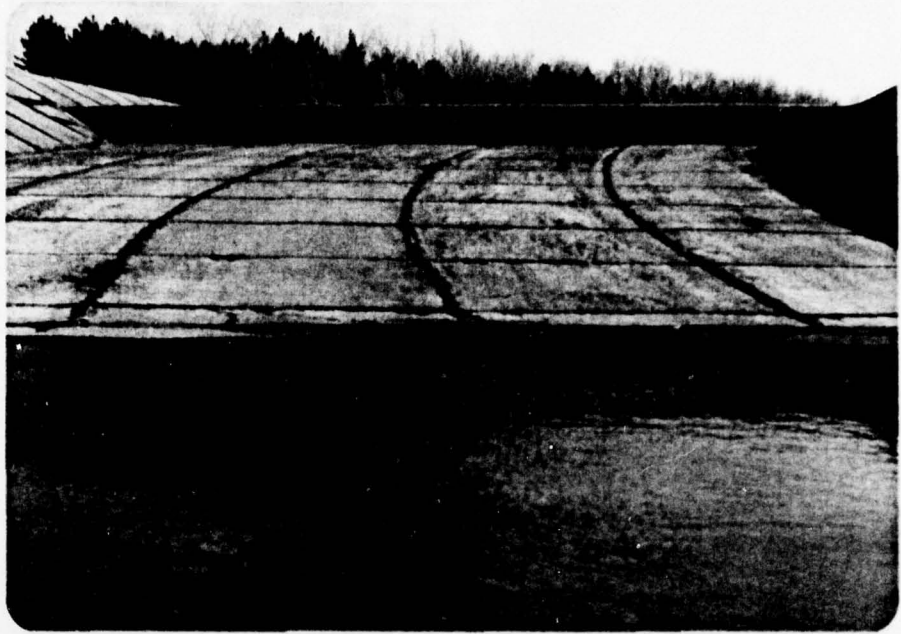
The concrete and spillway structures were found to be in good condition. Two seeps were observed on the side of the spillway discharge channel discharging approximately one to two gallons per minute through the construction joints.

Photograph No. 3
Spillway discharge channel.

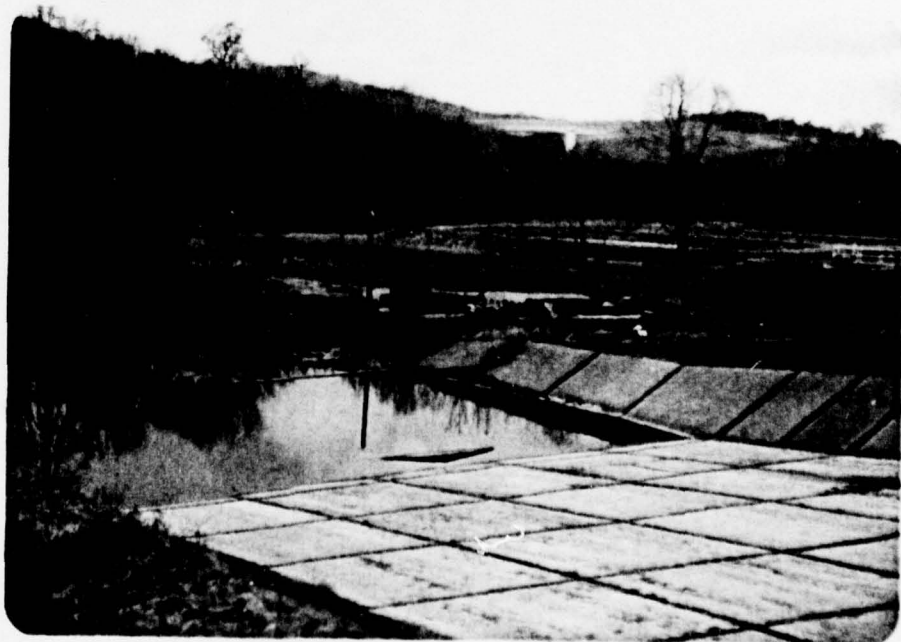
Photograph No. 4
Spillway stilling basin.

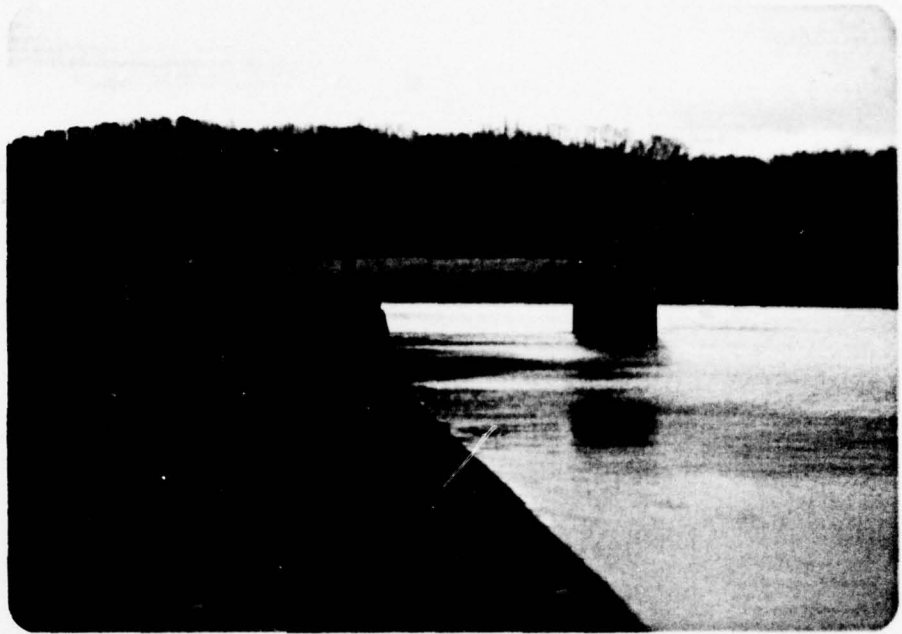
Photograph No. 5
Intake tower.

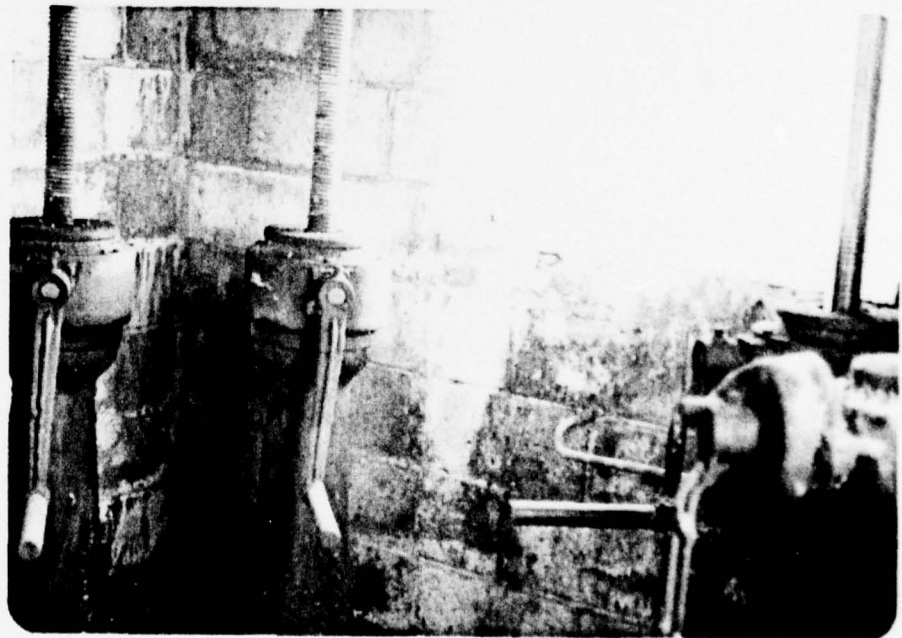
Photograph No. 6
Gate controls at intake tower.

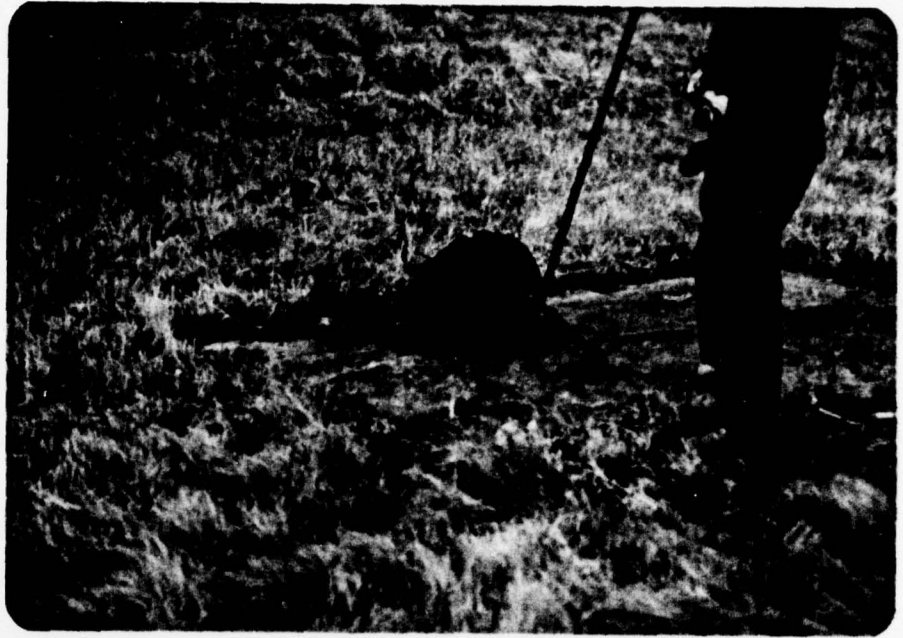
Photograph No. 7

The outlet valve chamber was inspected and found to be full of water. The downstream end of the outlet pipe was below the surface of a pond formed by a dike across the outlet channel and was not visible.

4.3 Maintenance of Operating Facilities. The maintenance of the operating facilities is considered to be poor. Reportedly, the outlet valve has never been operated since construction of the dam. The operation of the outlet valve was not observed during this inspection.

Blow-off pipe valve chamber (at downstream toe of dam).

1. The operational condition of the outlet valve should be evaluated and necessary maintenance performed, if necessary.
2. Adequate drainage should be provided to drain the pond in the outlet works discharge channel. The water in the valve chamber should also be drained and these areas should be inspected for signs of seepage.
3. Brush and trees on the downstream face of the dam should be removed.
4. The crest of the dam should be surveyed and low spots should be filled to design elevation.
5. Around-the-clock surveillance should be provided during unusually heavy runoff and a formal warning system should be developed to
