H. B. NORTON DAM
(PA NO NAME No. 42)
NDI No. PA 00385
PennDER No. 24-35

PHASE I INSPECTION REPORT
NATIONAL DAM INSPECTION PROGRAM

February 1979

H. B. Norton Dam (Pa. No Name No. 42), Elk County, Pennsylvania
NDI No. PA 00385, PennDER No. 24-35
Big Mill Creek
Inspected 13 and 14 November 1978

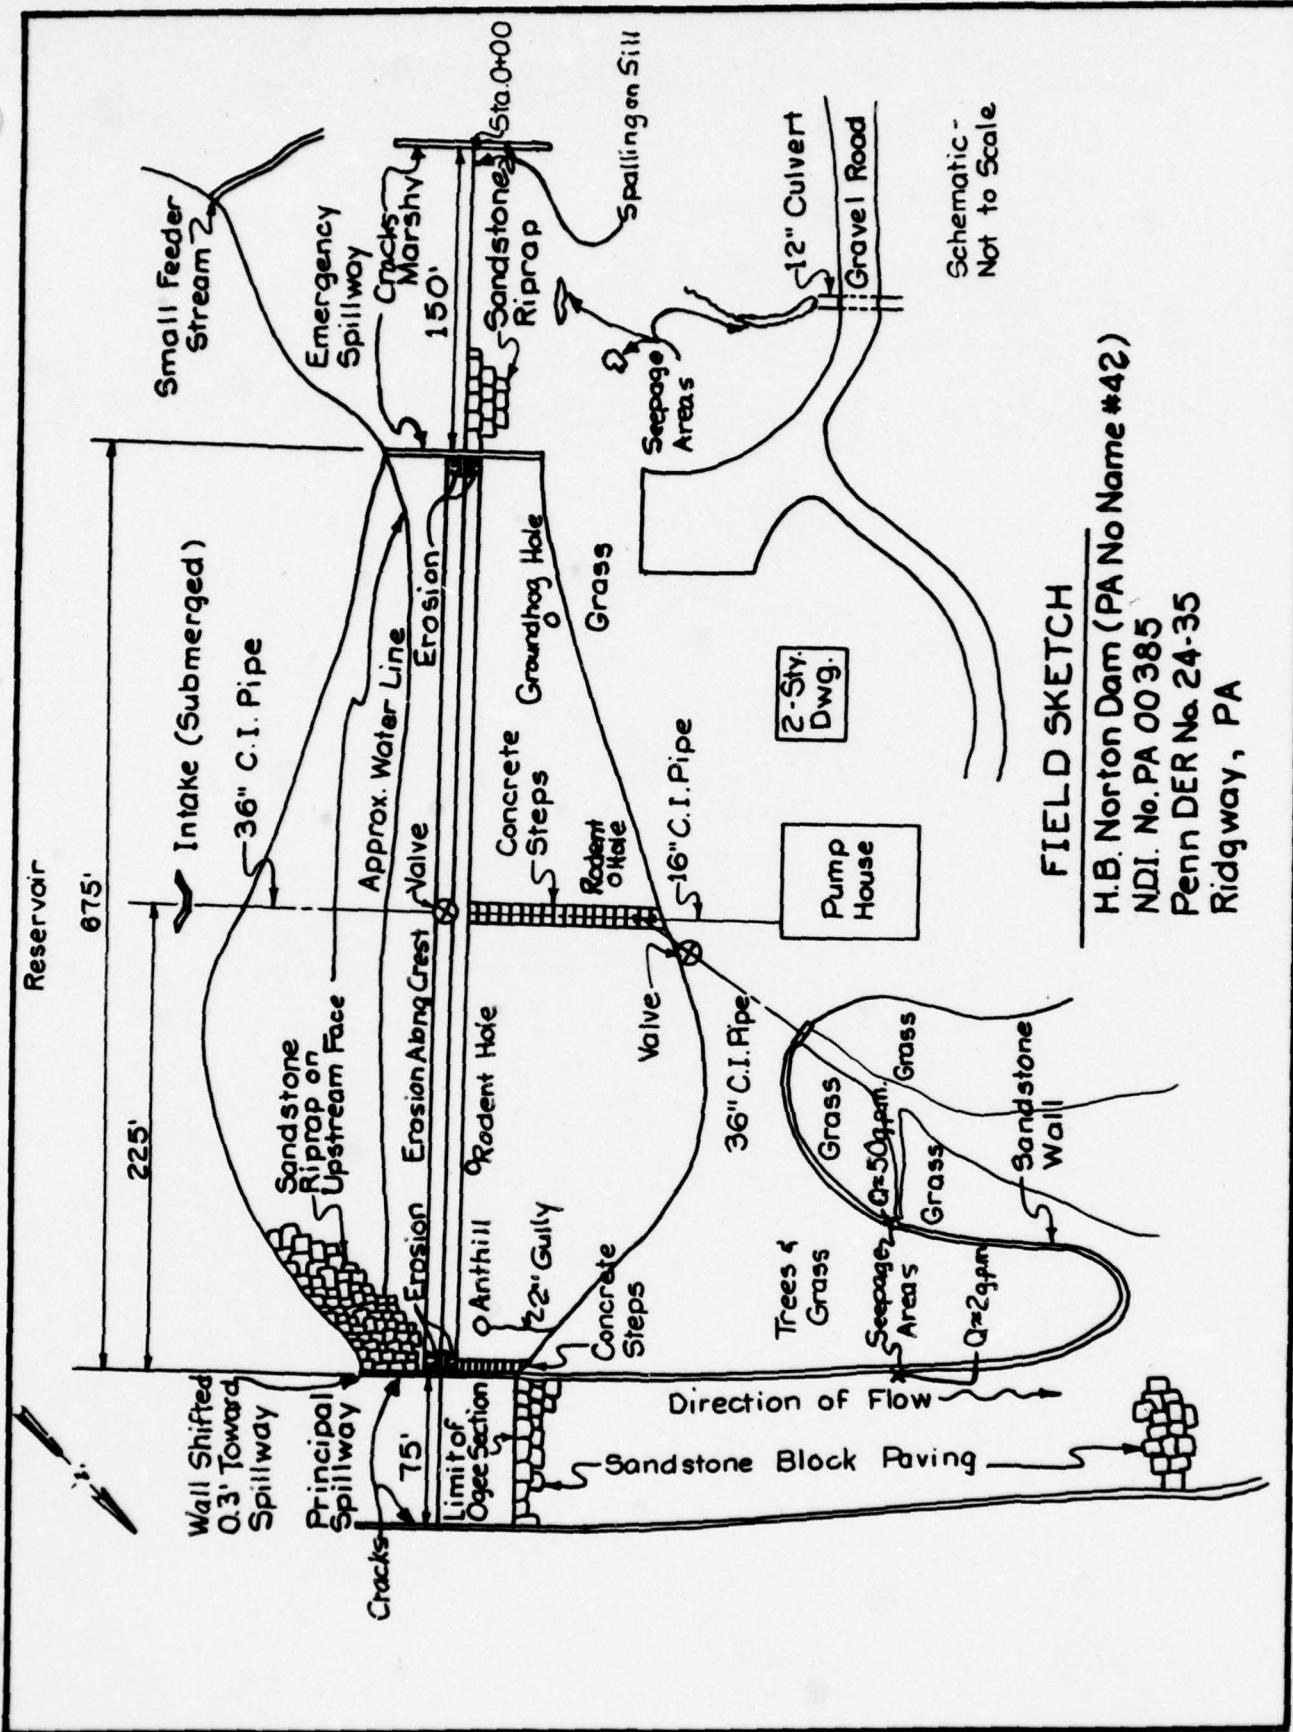
FIELD SKETCH
 H.B. Norton Dam (PA No Name #42)
 NDI. No. PA 00 385
 Penn DER No 24-35
 Ridgway, PA

- b. Dam - The riprap on the upstream face, from the water level to 4 feet above the water level, has settled due to erosion of the material between and under the sandstone boulders. The crest has eroded from 6 to 12 inches on the upstream face, and erosion has exposed the transition buttresses at both ends of the embankment. On the downstream face just right of the principal spillway, a 2-inch deep gully has developed from approximately mid-height of the dam to the toe. The downstream slope has numerous bush-like plants growing from the crest to the toe. Also, several rodent holes were found on the downstream face (see field sketch for location). No outlets were found for the tile drains.

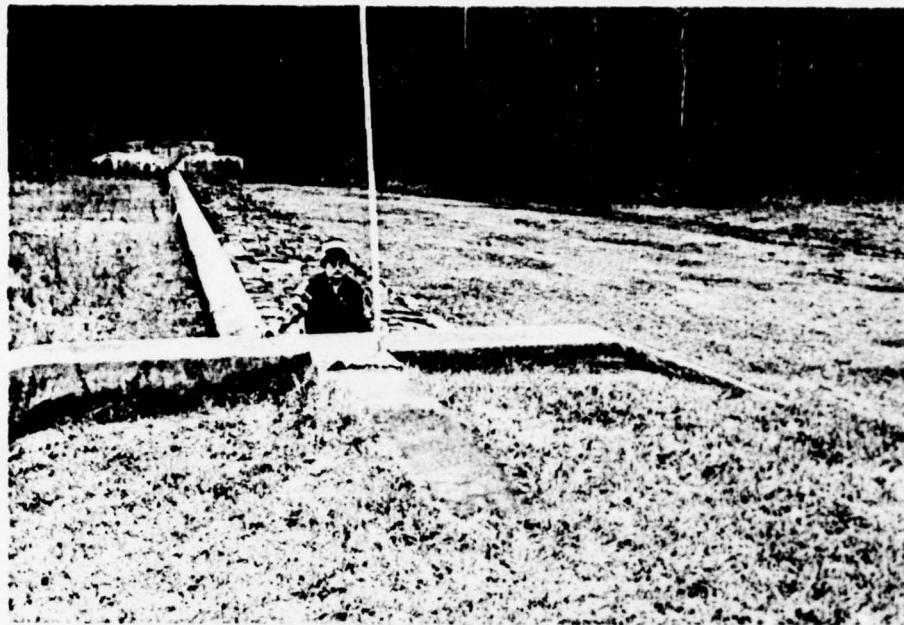
- c. Appurtenant Structures - The emergency spillway concrete has deteriorated and spalled along the sill, and a large crack was observed in the right abutment retaining wall. Cracks were also found in the principal spillway abutments. There was also a crack at the joint of the right abutment and the transition buttress of the emergency spillway. The concrete on the outer surfaces of the screen chamber access located on the crest of the dam showed signs of cracking and spalling. The intakes for the 36-inch and 16-inch cast-iron pipes were inaccessible. However, the outlet structure for the 36-inch pipe encased in concrete appears to be in fair condition and showed no signs of excessive deterioration. The 16-inch outlet to the pump house was also inaccessible and therefore no evaluation could be made of its condition.

Photo 1 - View of Emergency Spillway Looking Left to Right
from Crest of Dam
(Note cracking of concrete and erosion of crest
along wing wall.)

**PHOTO 1. View of Emergency Spillway Looking Left to Right
from Crest of Dam**

- 4) The trees along the top of the wall of the downstream principal spillway (right side) should be removed or trimmed to facilitate future inspection of the wall.
- 5) The bush-like vegetation that is on the downstream slope should be removed, and the slope should be treated and seeded with an appropriate mixture to prevent erosion.
- 6) The concrete wing walls, transition buttresses, and spillways should be repaired where cracking and spalling has occurred.

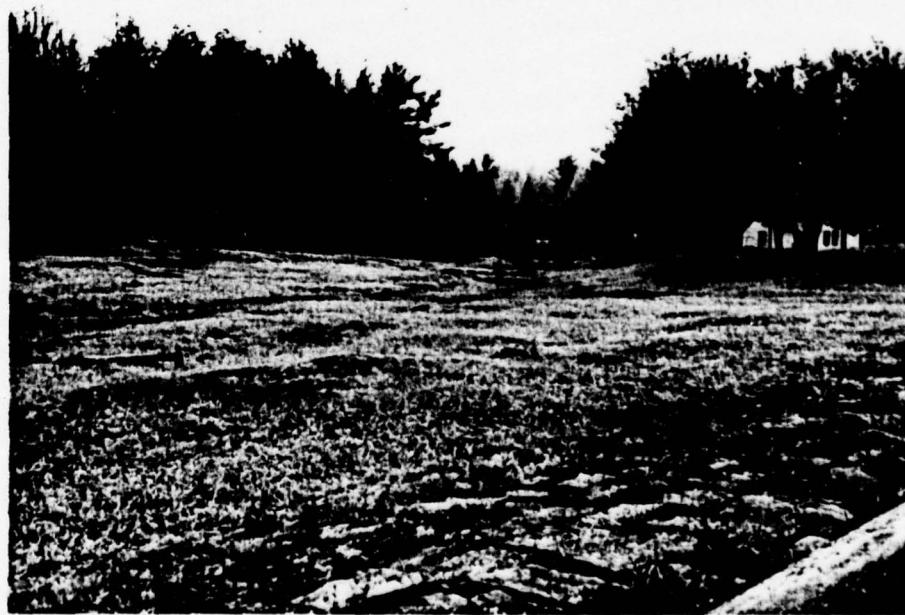
PHOTO 2. View of Emergency Spillway Outlet Channel

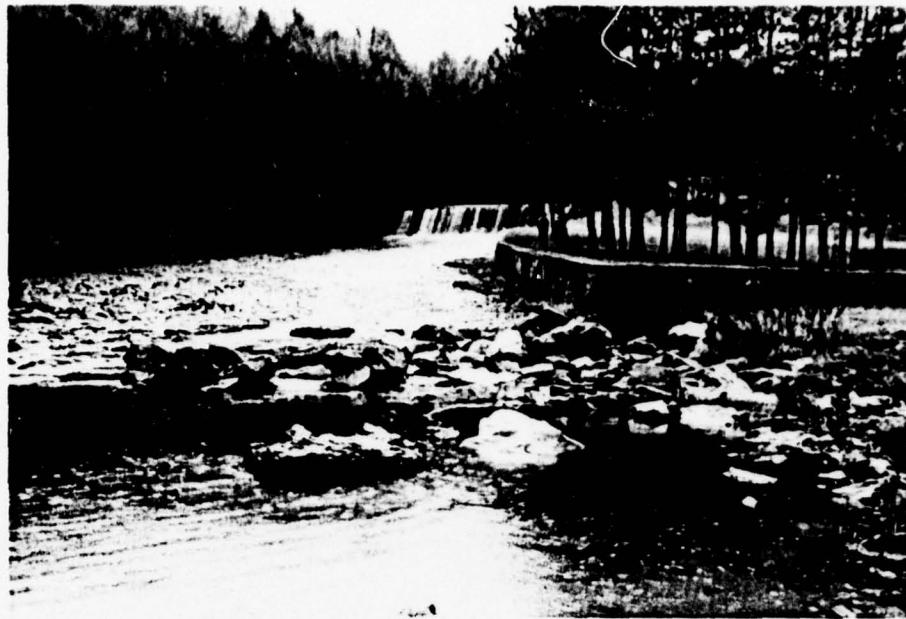
PHOTO 3. View of Principal Spillway Looking Upstream

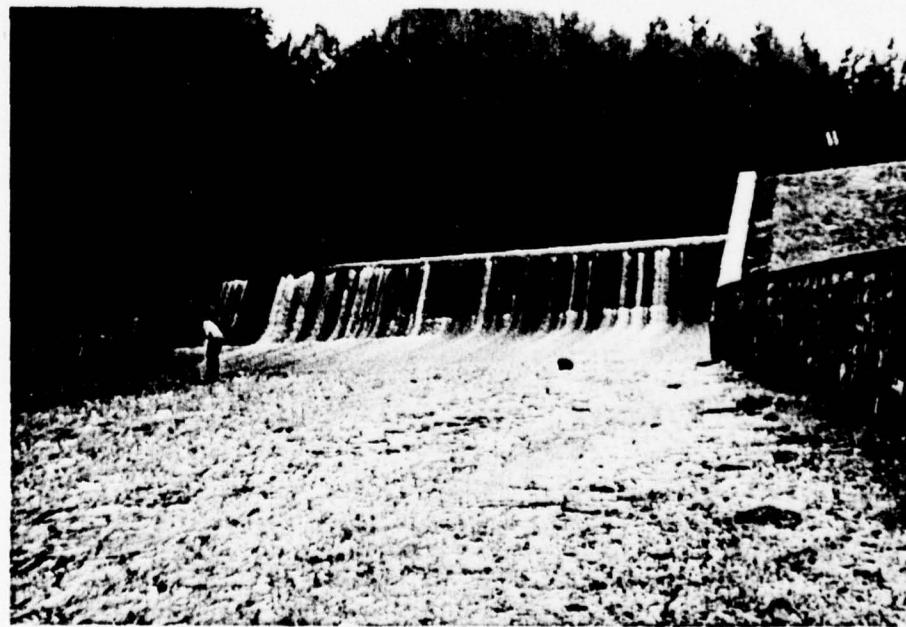
VISUAL EXAMINATION OF		OBSERVATIONS	REMARKS OR RECOMMENDATIONS
CONCRETE WEIR		Principal spillway consists of a 75-ft. wide concrete ogee-section. The spillway abutments are cracked in several locations. There is also a crack at the joint of the right abutment and training wall. The 2-ft. wide, 150-ft. long concrete sill at the emergency spillway shows signs of cracking and spalling at several locations. There is a 10-ft. wide strip of cut stone riprap on the downstream side of the sill which is in fairly good condition.	The concrete on both spillways should be repaired.
APPROACH CHANNEL		The approach channel to the principal spillway is free of debris, erosion and obstructions. The approach to the emergency spillway consists of earth and low grasses. No obstruction or serious erosion was noted.	
DISCHARGE CHANNEL		The principal spillway channel is stone-lined, approximately 230 ft. long, and 75 ft. wide. Some differential settlement of the stone was observed. This channel exits into a natural stilling pool. Both the stilling pool and channel are relatively free of debris and other obstructions. The emergency spillway discharge channel consists of an earth channel covered with low grasses, having an average slope of about 5%. This channel joins Big Mill Creek several hundred feet downstream. No debris or obstructions were located in the channel.	The differential settlement of the stone does not appear to be a serious problem.

Photo 4 - View Showing Ogee Weir Spillway
(Note cracks along wing wall.)

PHOTO 4. View Showing Ogee Weir Spillway

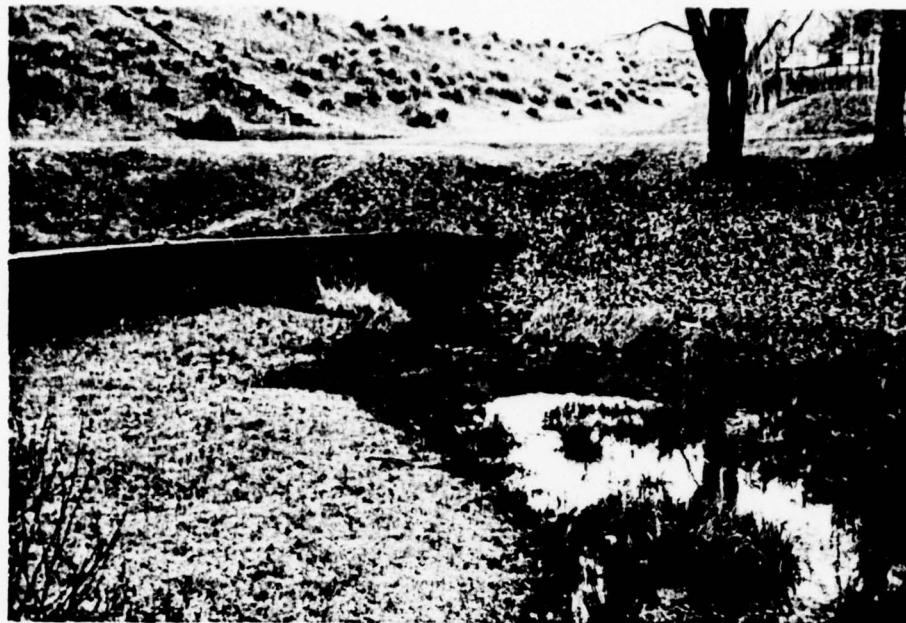
PHOTO 5. View of Head Wall of 36-Inch Blow-Off Pipe

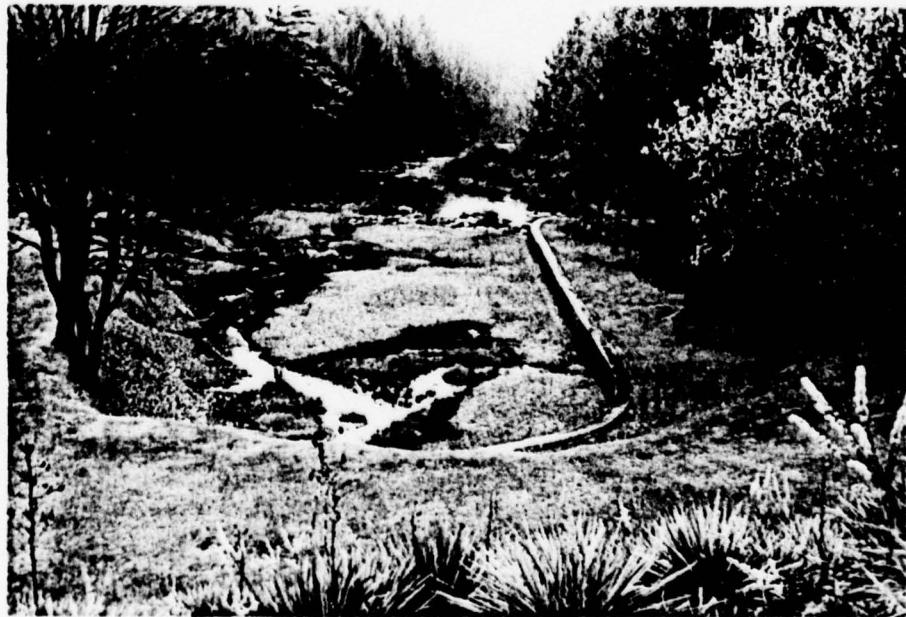
PHOTO 6. View Looking Downstream Along Outlet Pipe Discharge Channel

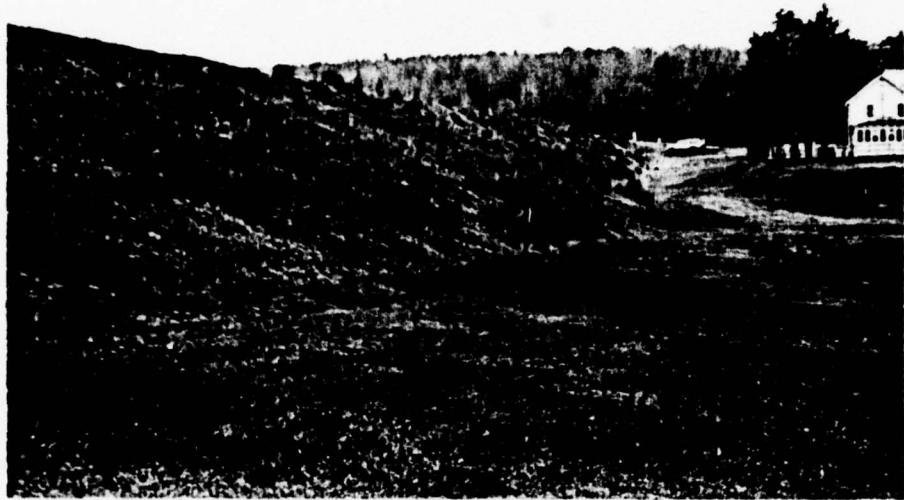
PHOTO 7. View of Downstream Embankment Showing Vegetation

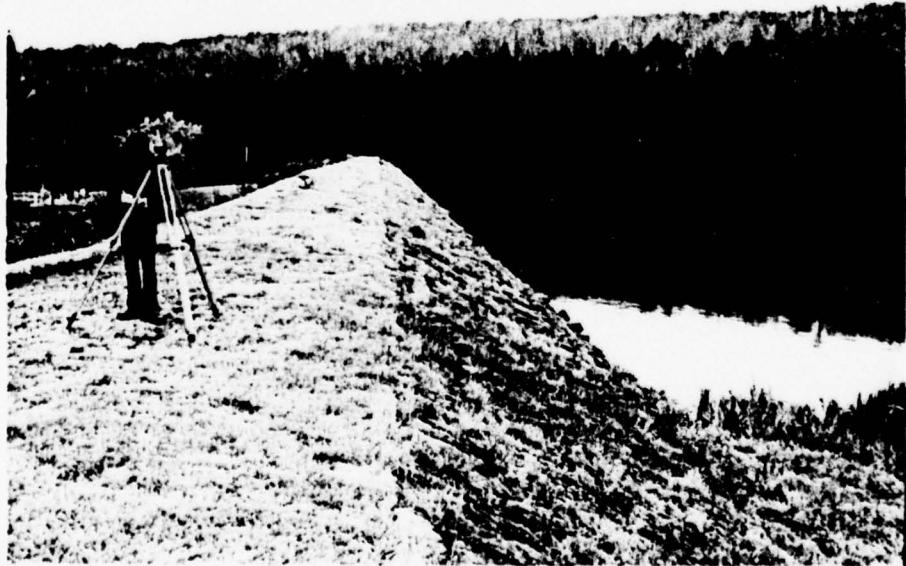
RIPRAP FAILURES	The crest on the upstream side is eroded from 6 to 12 in.	The crest area should be graded, treated and seeded with an appropriate seeding mixture to prevent erosion.
	Several locations of the riprap on the upstream face at the water level to 4 ft. above it have settled due to erosion of the material between and under the boulders.	The riprap should be restored to its original position with a granular cushion/filter under the riprap.

PHOTO 8. View Looking at Crest and Upstream Slope

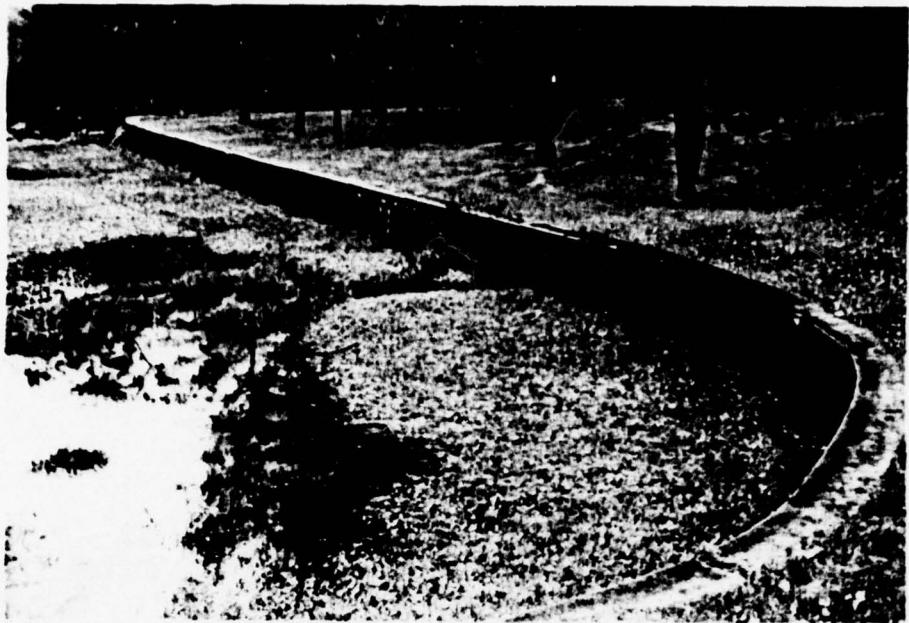
- a. Visual Observations - No structural inadequacies were noted during the visual inspection of the dam. The seepage areas indicated in paragraph 3.1.e. are not considered detrimental to the stability of the dam according to the conditions present at the time of inspection. The seepage from the sandstone wall may be from the area behind the sandstone wall or possibly from the tile drains under the dam that were not outletted properly. The wet areas below the emergency spillway may be a result of natural springs or seeps in the area.

PHOTO 9. View Looking Downstream at Seepage Area

- 2) The drain outlets for the tile drain, located in the area behind the steel sheet core wall, should be located and extended to an outlet channel. The quantity and turbidity of all seepage should be monitored and recorded. If conditions indicate the necessity, remedial measures should be taken.
