PENNSYLVANIA
LEVEL
TAMARACK LAKE DAM "A"

NDI No. PA 00181
PenDER No. 20-47A
SCS No. PA 461A

PHASE I INSPECTION REPORT
NATIONAL DAM INSPECTION PROGRAM

TAMARACK LAKE DAM "A"
CRAWFORD COUNTY, COMMONWEALTH OF PENNSYLVANIA
NDI No. PA 00181
PennDER No. 20-47A
SCS No. PA 461A

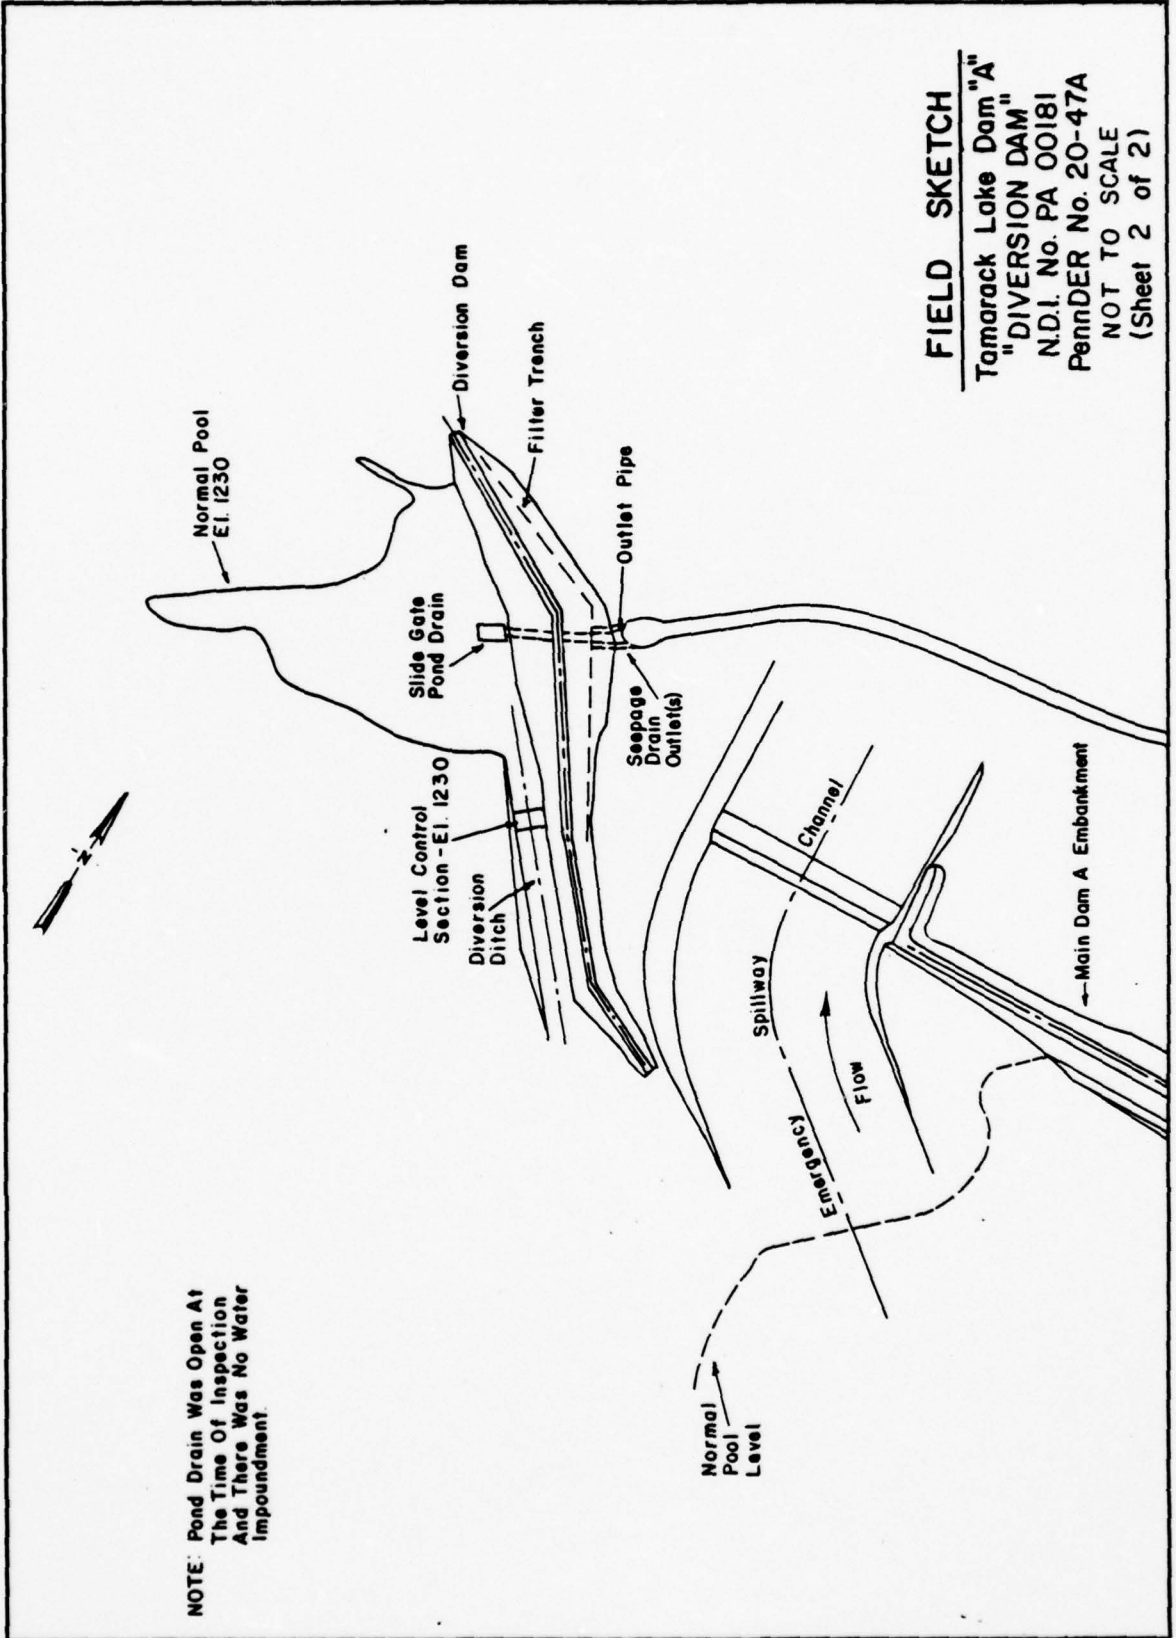
FIELD SKETCH
 Tamarack Lake Dam "A"
 "DIVERSION DAM"
 N.D.I. No. PA 00181
 PENNDR No. 20-47A
 NOT TO SCALE
 (Sheet 2 of 2)

NOTE: Pond Drain Was Open At
The Time Of Inspection
And There Was No Water
Impoundment

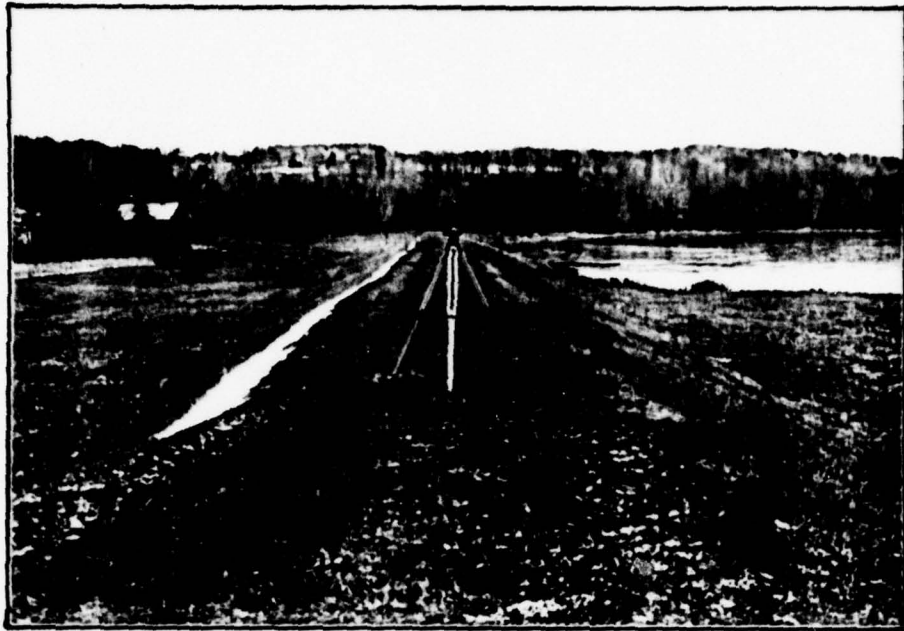
**PHOTO 1. View of Dam from Junction of Embankment and
Emergency Spillway**

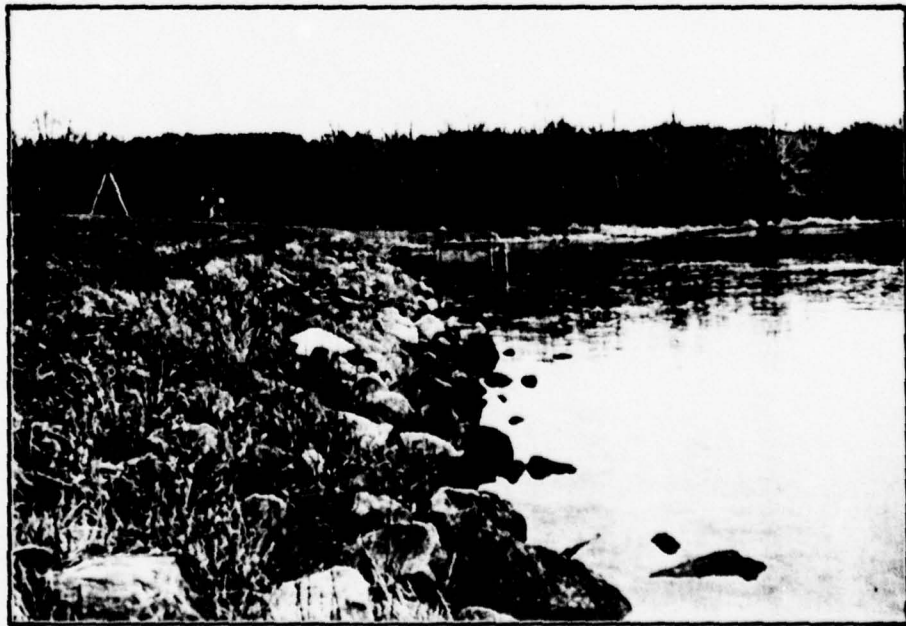
**PHOTO 2. View of Principal Spillway Intake, Upstream Slope,
and Riprap Protection**

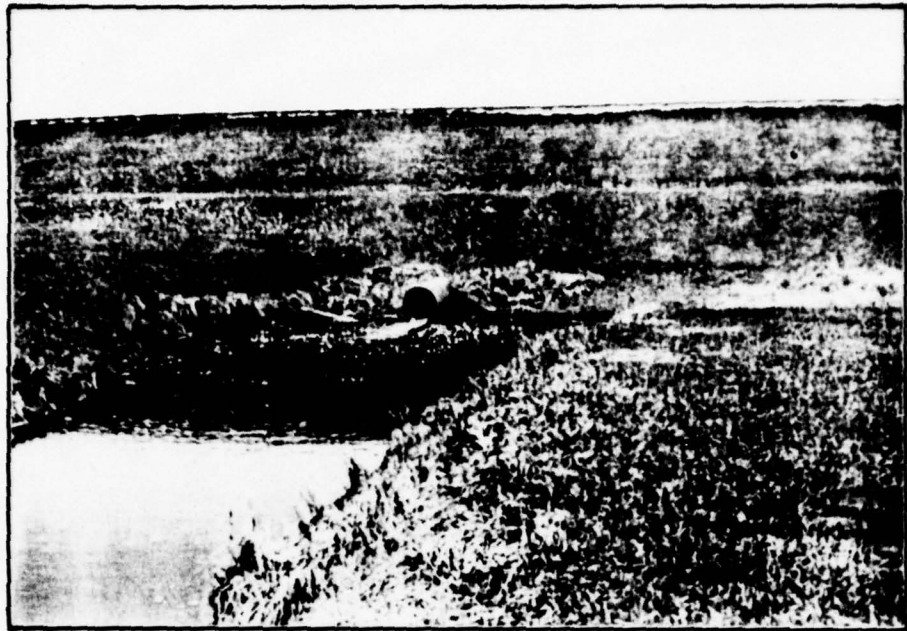
- d. Appurtenant Structures - The concrete in the intake and outlet structures of the principal spillway system is in good condition. According to the owner's personnel, the plunge pool is enlarging.

**PHOTO 3. View of Principal Spillway Outlet Conduit and Plunge Pool
[Drain Outlet at Left (in Photo) of Conduit and Seepage Area to Right of Conduit]**

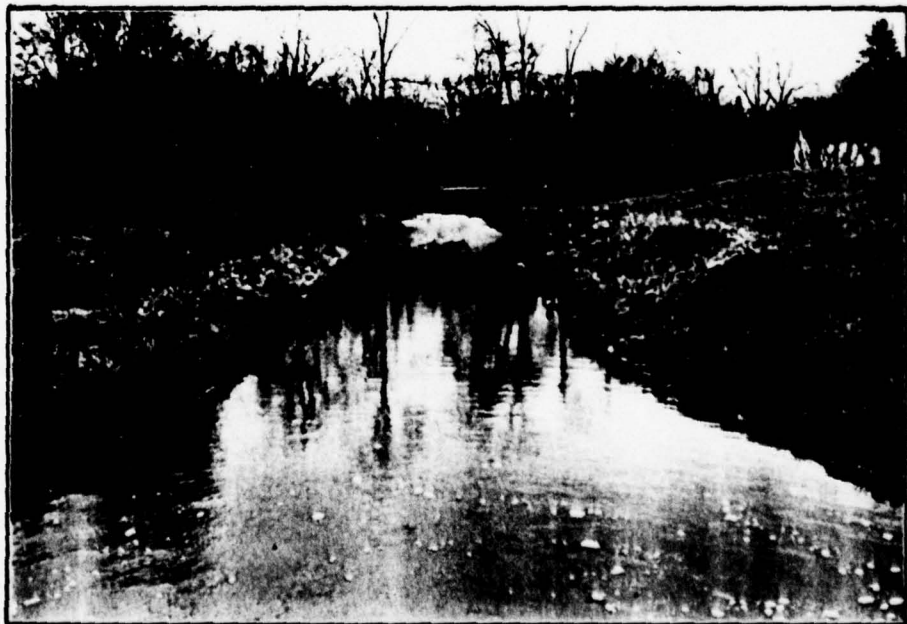
PHOTO 4. View of Outlet Channel and Downstream Roadway Culvert

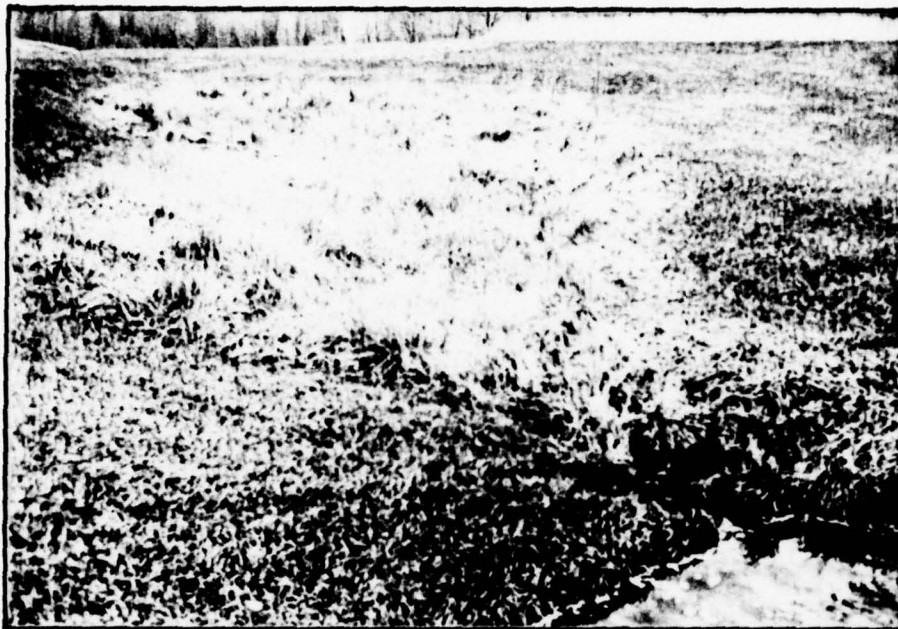
- a. General - The dam and its appurtenant structures were found to be in good overall condition at the time of the inspection, with the exception of the seepage area noted at the downstream toe of the embankment left of the outlet conduit. Noteworthy deficiencies observed are described briefly in the following paragraphs. The complete visual inspection check list and field sketches are given in Appendix A.

- a. Visual Observations - The marshy area and seepage observed during the visual inspection is not considered detrimental to the stability of the dam according to the conditions present at the time of inspection.
- b. Design and Construction Data - Calculations of embankment slope and foundation stability were not available for review. However, a summary report from the SCS Soil Mechanics Laboratory at Lincoln, Nebraska dated 14 April 1961 contained the following information:

PHOTO 5. View of Seepage Area Located to Left of Outlet Conduit

- 1) Install a weir to monitor the seepage.
- 2) Provide proper inspection access to the vertical drain on the left side of the outlet conduit.
- 3) After access has been provided, a qualified professional engineer should inspect the vertical drain and provide recommendations as necessary.
- 4) Periodically inspect and maintain the vertical drains in the future as necessary.
- 5) Repair minor erosion areas on the dams. Efforts to prevent use of motorcycles and other vehicles on the dams and in the spillway should be increased.
- 6) Install properly designed riprap or other measures to prevent erosion around the plunge pool.

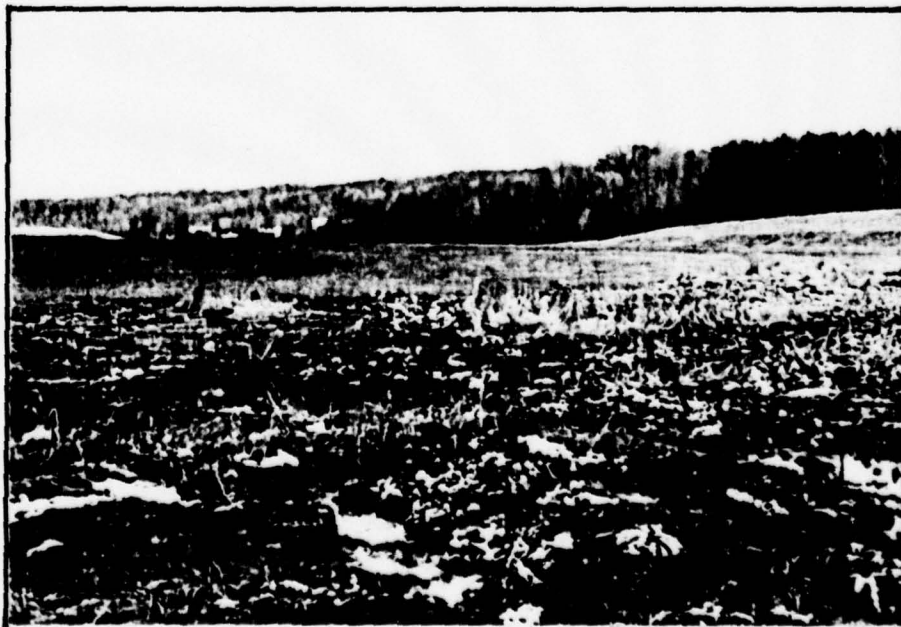
Vehicles tracks were observed on the dam, diversion dam, and emergency spillway. No other problems were observed. Areas should be reseeded.

**PHOTO 6. View Looking Upstream at Emergency Spillway Channel
(Diversion Dam Forms Left Abutment of Emergency
Spillway Channel Located in Right Portion of Photo)**

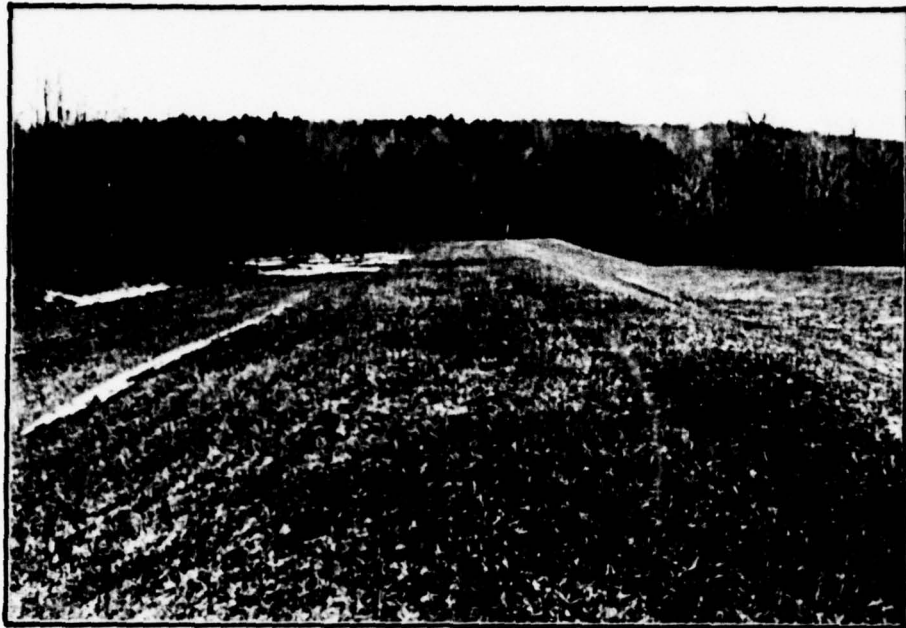
- c. Diversion Dam - Some minor erosion was observed on the crest of the dam. No other significant deficiencies were noted. The pond drain was open at the time of inspection and no water was impounded behind the dam.

**PHOTO 7. View Looking Downstream from Reservoir at Diversion Dam
(Emergency Spillway Channel in Right Portion of Photo, Diversion Ditch in Left
Portion of Photo, Drained Diversion Pond in Upper-Left Center Portion of Photo)**

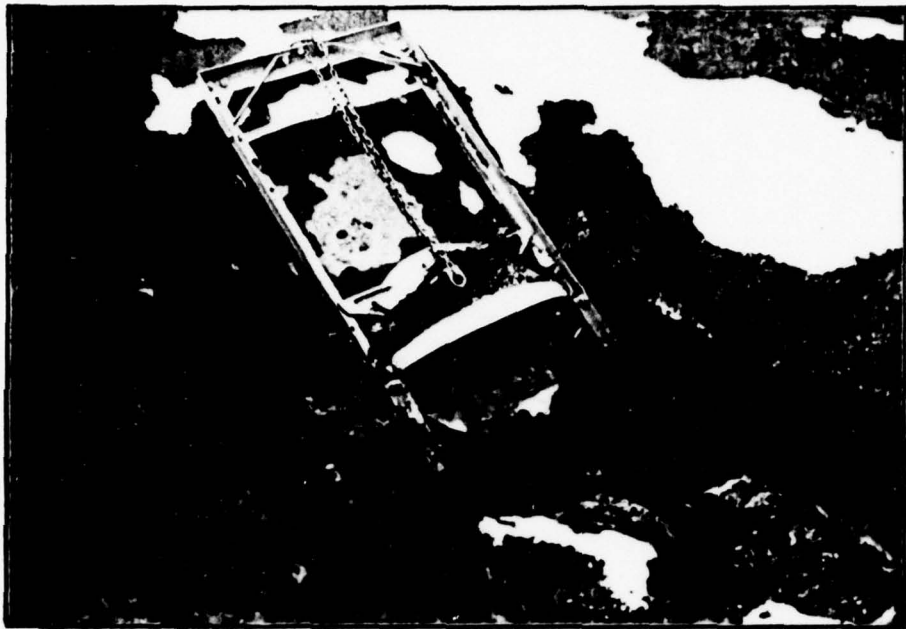
PHOTO 9. View of Slide Gate Pond Drain Inlet for Diversion Dam Pond

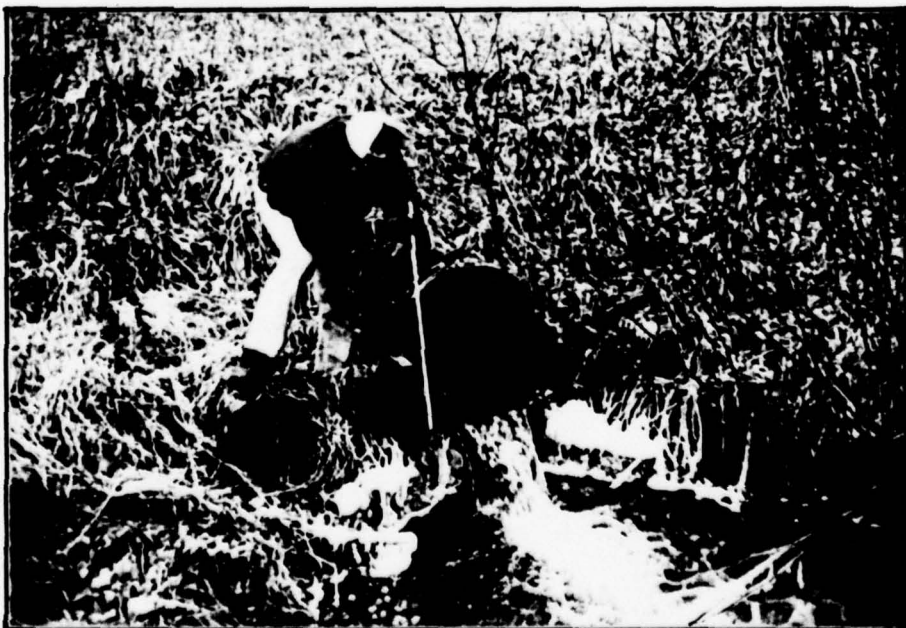
PHOTO 10. View of Pond Drain Outlet Conduit and Drain Outlets
