NATIONAL DAM INSPECTION PROGRAM. PA-484 DAM (NDI-ID-PA-489) (DE--ETC(U)

PA-484 DAM  
NDI I.D. NO: PA-489  
DER I.D. NO: 63-72

PHASE I INSPECTION REPORT  
NATIONAL DAM INSPECTION PROGRAM

MARCH 1979

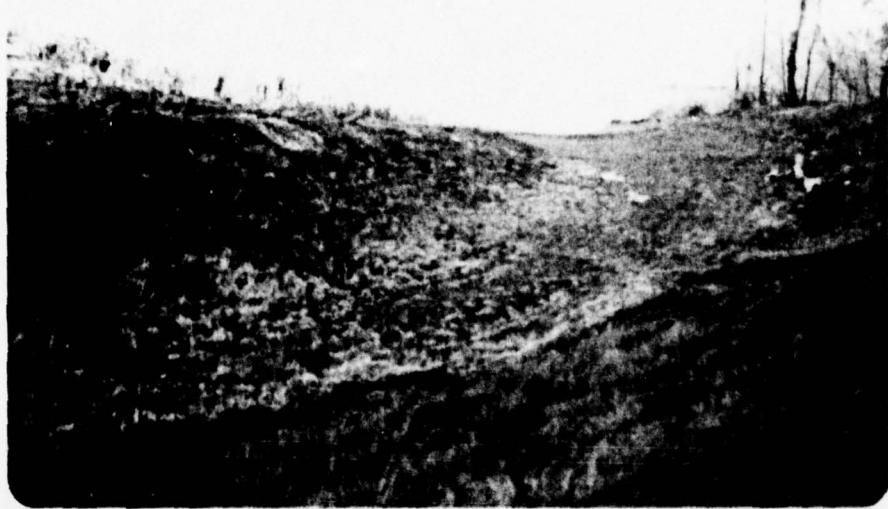
Photograph No. 1  
Emergency spillway approach channel.

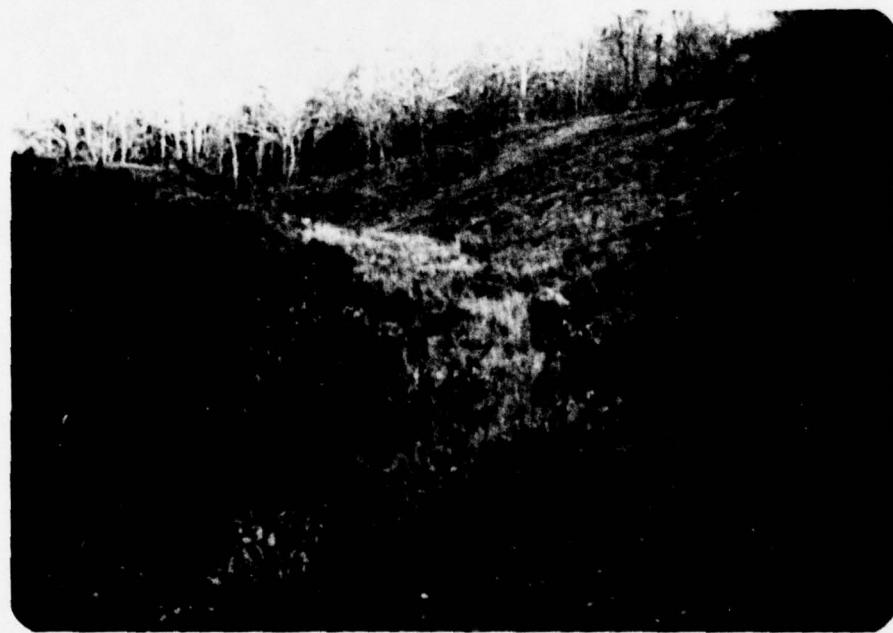
Photograph No. 2  
Emergency spillway discharge channel.

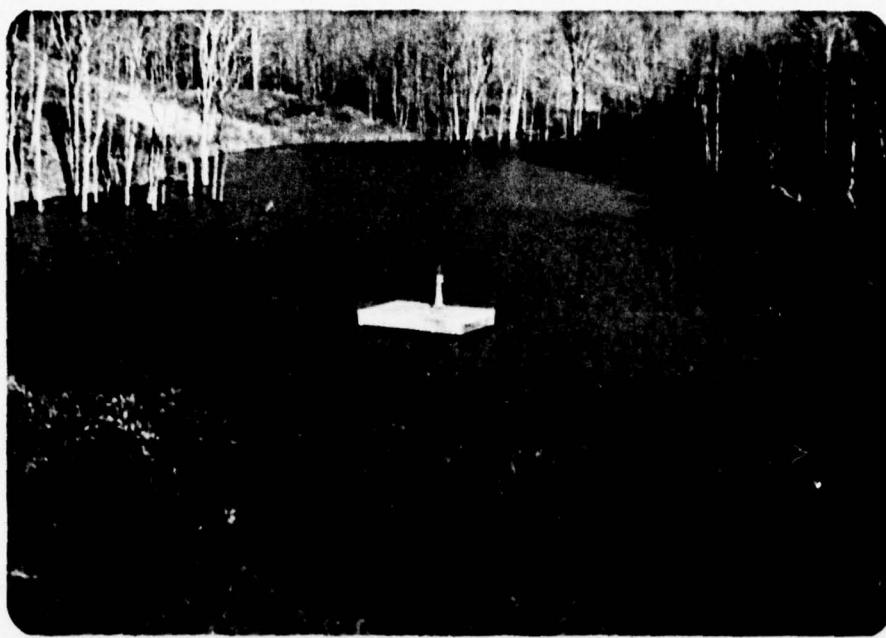
c. Appurtenant Structures. The appurtenant structures were examined for deterioration or other signs of distress or obstructions that would limit flow. On the date of inspection, the pool was approximately at the crest level of the primary spillway (Elevation 938.25),

indicating that the orifice of the drop inlet structure is obstructed. Other than this problem, the structures were found to be in good condition. No other deficiencies were noted at this time.

Photograph No. 3  
Primary spillway drop inlet structure.

4.5 Evaluation. The maintenance condition of the dam is considered to be satisfactory. However, the orifice in the drop inlet structure should be cleaned to permit lowering the reservoir to its normal elevation. The erosion rills in the truck tracks on the downstream slope of the dam should be filled and vegetated to prevent future erosion problems.

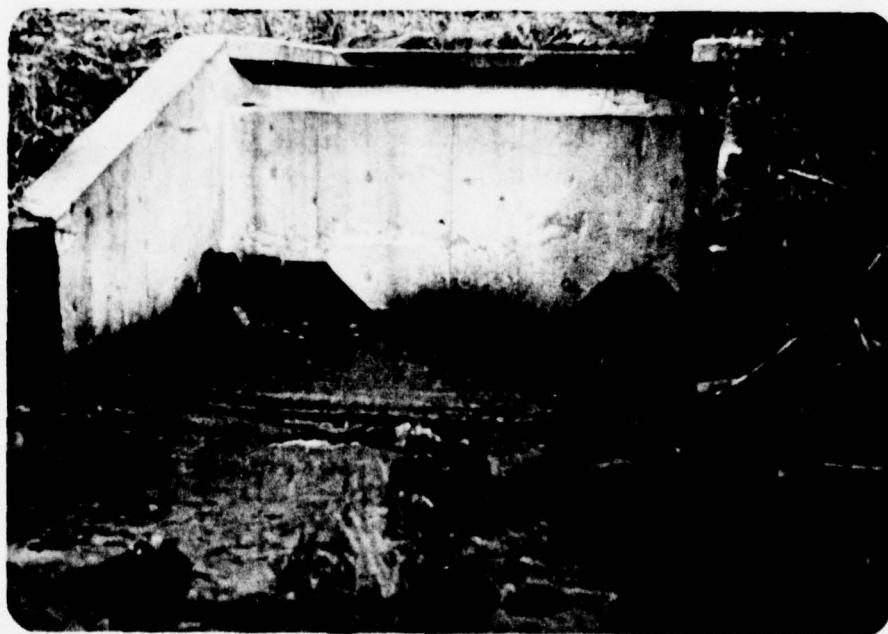
Photograph No. 4  
Outlet pipe impact basin.
