BRADFORD CITY No. 3 DAM

NDI No. PA 00025
PennDER No. 42-10

PHASE I INSPECTION REPORT
NATIONAL DAM INSPECTION PROGRAM

February 1979

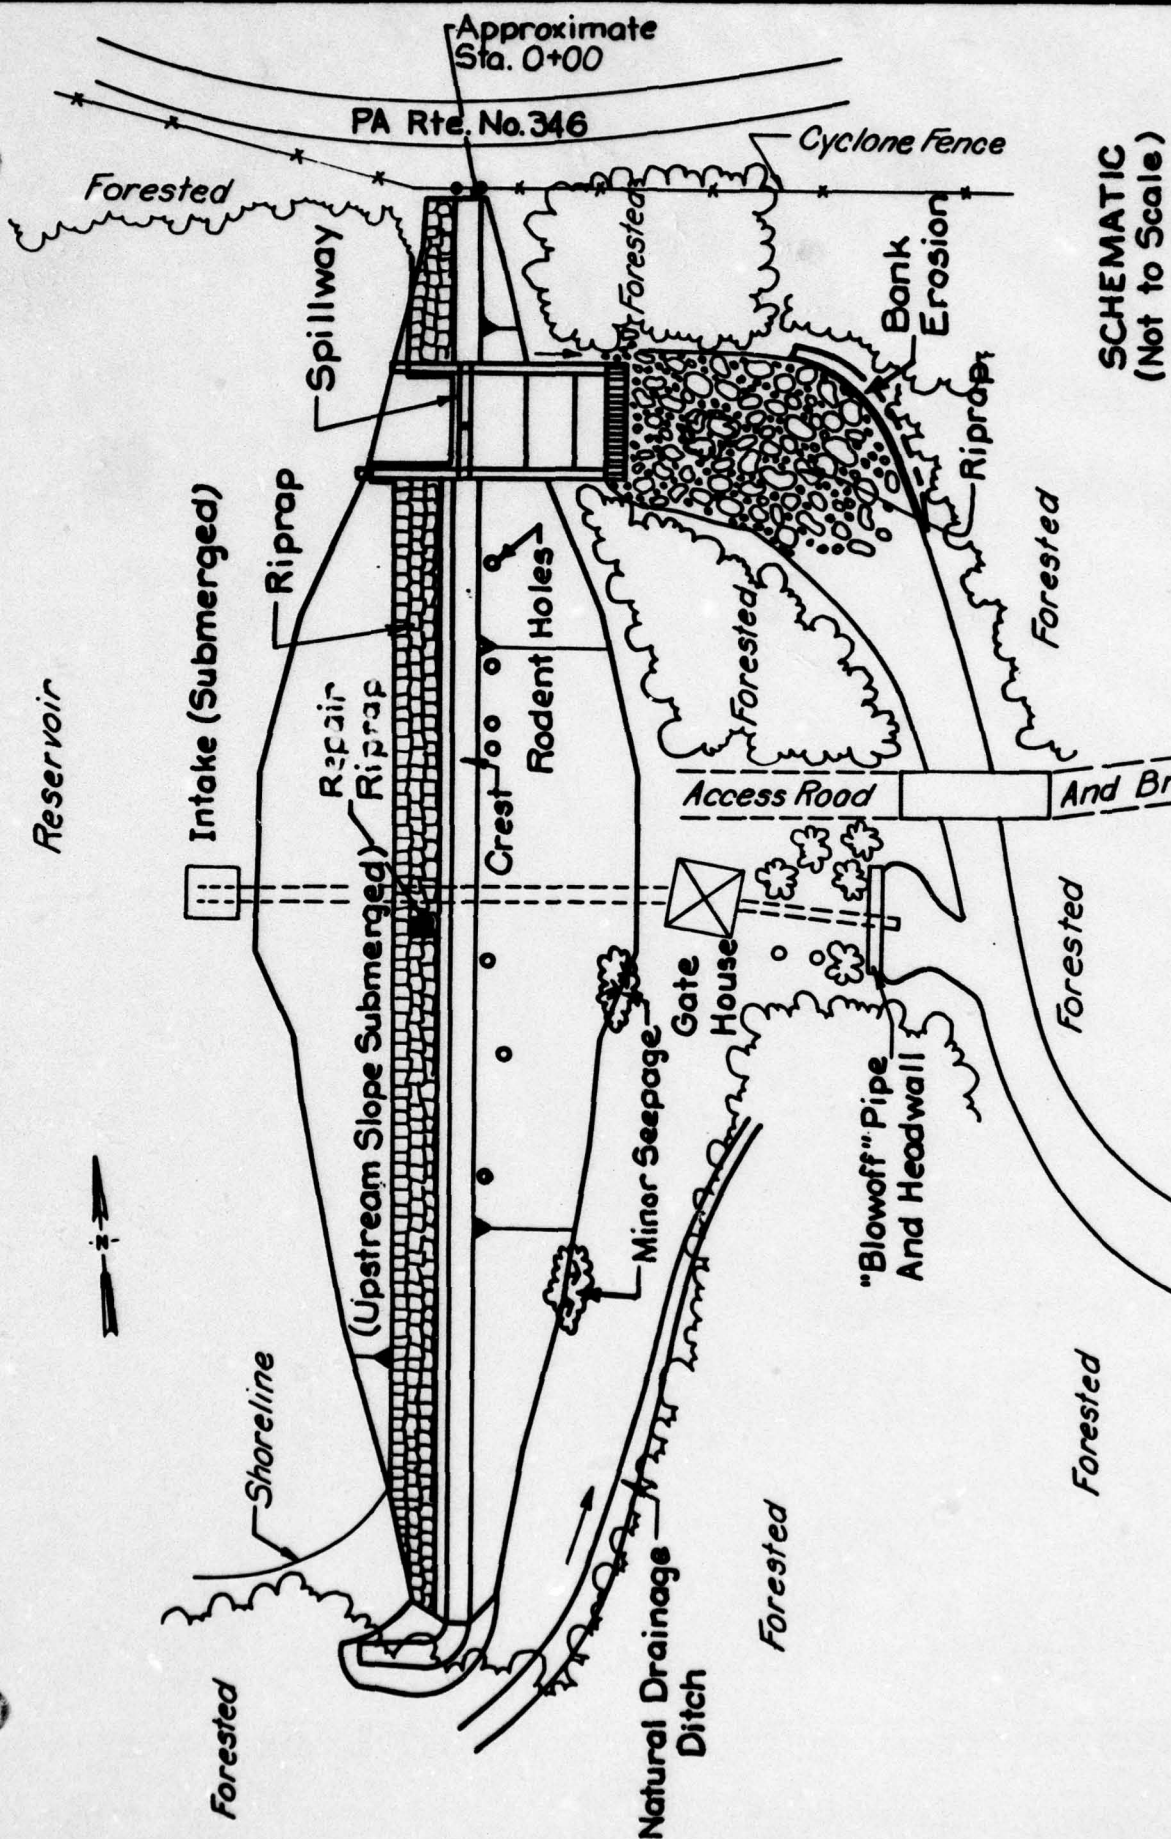
FIELD SKETCH

Several rodent/groundhog/animal burrows were observed in the downstream slope of the embankment. The locations of these holes are shown on the field sketch in Appendix A.

VISUAL EXAMINATION OF	OBSERVATIONS	REMARKS OR RECOMMENDATIONS
RODENT/ANIMAL BURROWS	Several rodent/animal burrows were observed. The approximate locations of these holes are shown on the field sketch.	These burrows should be repaired. A groundhog/rodent/animal control program should be implemented.

- 1) Repair of the animal burrows in the embankment and establishment of a rodent control program.
- 2) Repointing of the joints of the sandstone block spillway structure.
- 3) Repair of the riprap on the upstream face.
- 4) Placement of riprap protection along the left bank of the downstream channel where erosion is occurring.
- 5) The periodic inspection of the seepage areas to identify a change in quantity or the exiting of muddy water from these areas and, if necessary, to assess the stability and piping potential of the dam in connection with the seepage conditions.
