TAMARACK LAKE DAM "B"

NDI No. PA 00746

PHASE I INSPECTION REPORT  
NATIONAL DAM INSPECTION PROGRAM

Tamarack Lake Dam "B", Crawford County, Pennsylvania  
NDI No. PA 00746, PennDER No. 20-47B, SCS No. 461B  
Mud Run  
Inspected 29 November 1978

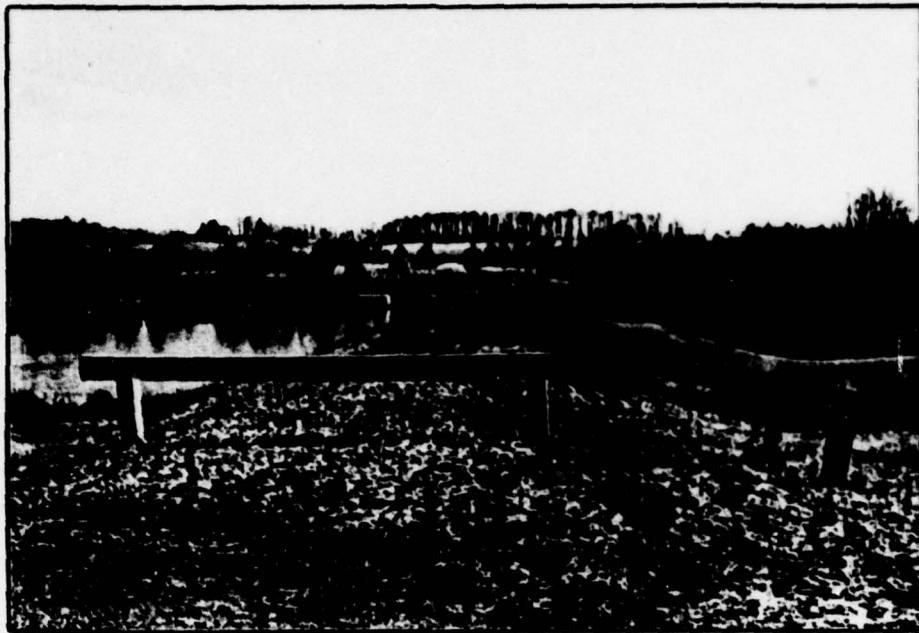
**Overall View of Dam from Right Abutment  
(Emergency Spillway Channel Located behind Trees in Left-Center of Photo)**

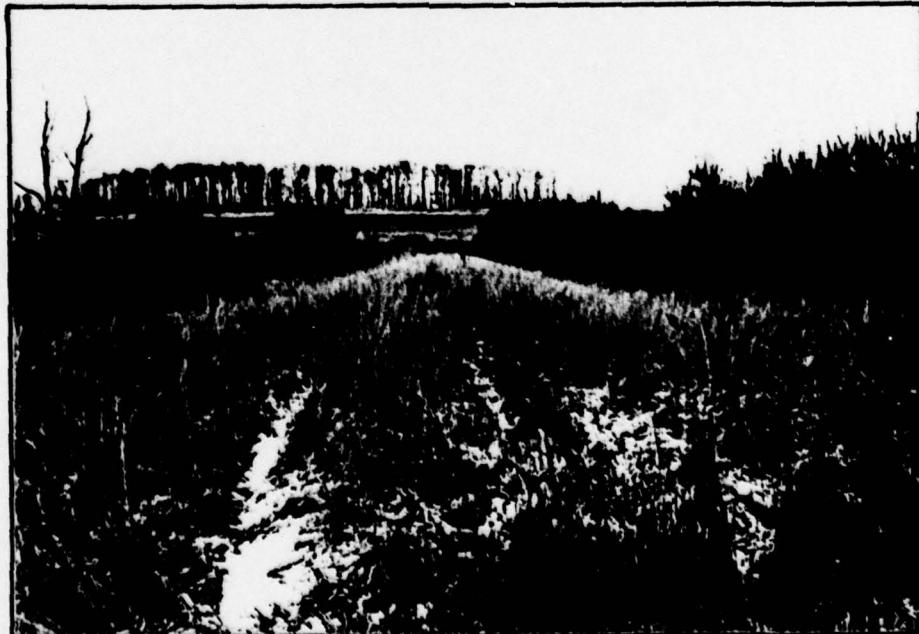
**Overall View of Dike from Right Abutment of Dike**

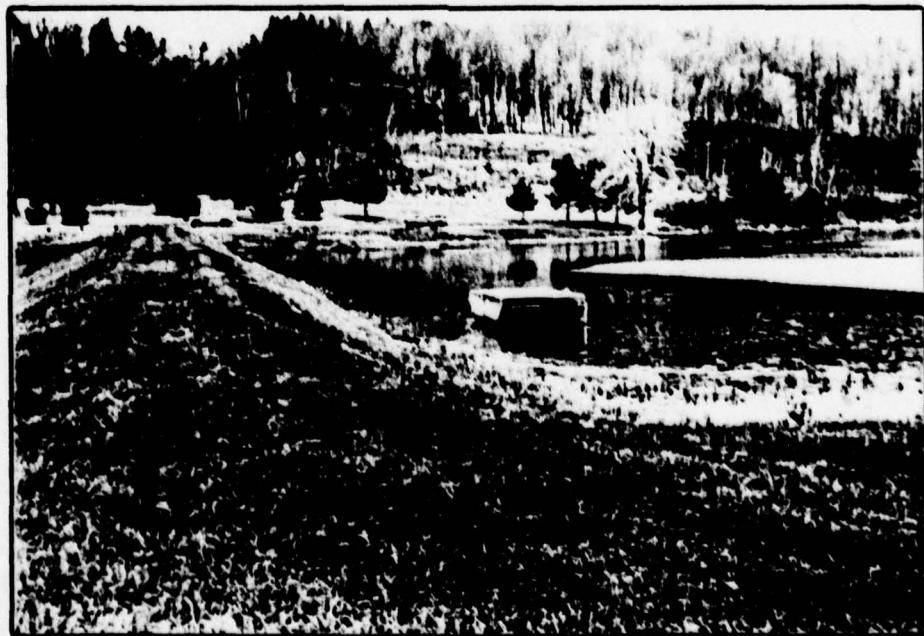
**PHOTO 2. View from Left Abutment of Dam**

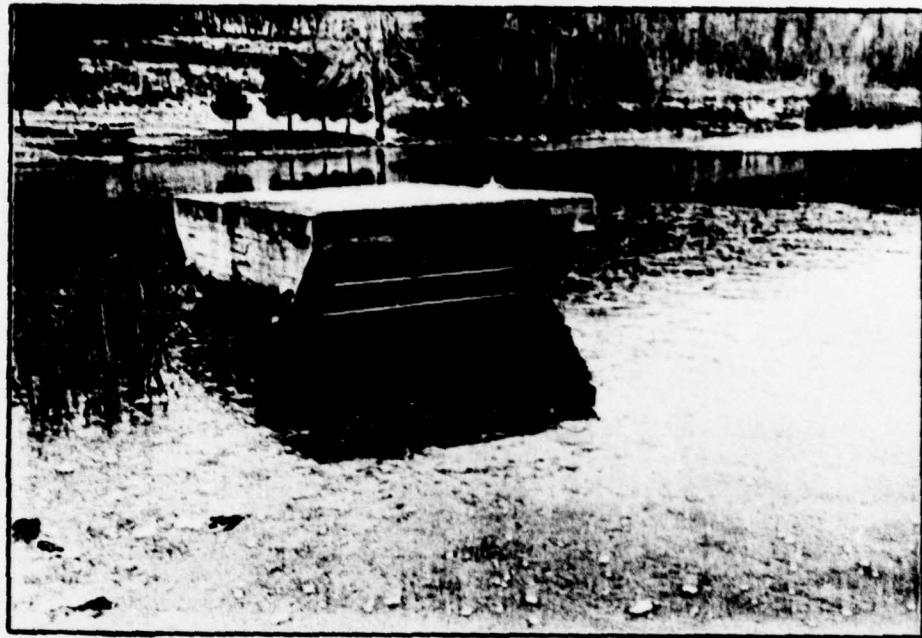
| VISUAL EXAMINATION OF | OBSERVATIONS | REMARKS OR RECOMMENDATIONS |
|--|---|---|
| INTAKE STRUCTURE | No deterioration of the structure was observed. | |

PHOTO 3. Close-up of Intake Riser

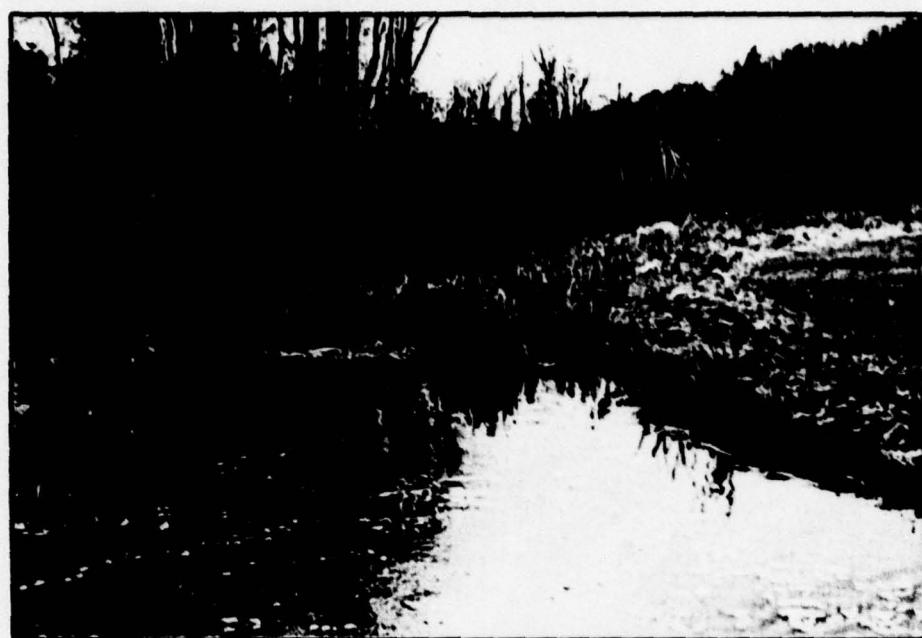
| DOWNSTREAM CHANNEL | | REMARKS OR RECOMMENDATIONS |
|---|--|---|
| CONDITION<br>(OBSTRUCTIONS,<br>DEBRIS, ETC.) | No serious erosion or debris was noted in the downstream channel. There is, however, some vegetation located in the channel just below the stilling basin. | The downstream channel should be checked periodically for debris or other obstructions. The vegetation should be removed from the channel immediately downstream of the outlet pipe to minimize restriction of flood flows. |

**PHOTO 5. View of Downstream Channel (Note Vegetation In Channel)**
