MINERSVILLE DAM NO. 4

**NDI NO. PA-00675
DER NO. 54-39**

SCHUYLKILL COUNTY, PENNSYLVANIA

**PHASE I INSPECTION REPORT
NATIONAL DAM INSPECTION PROGRAM**

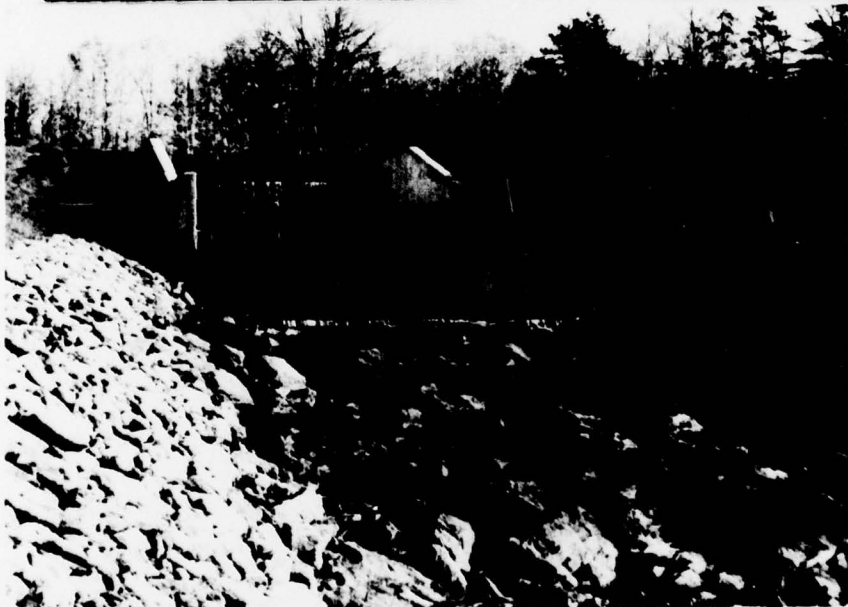
Drop Structure
Stilling Basin

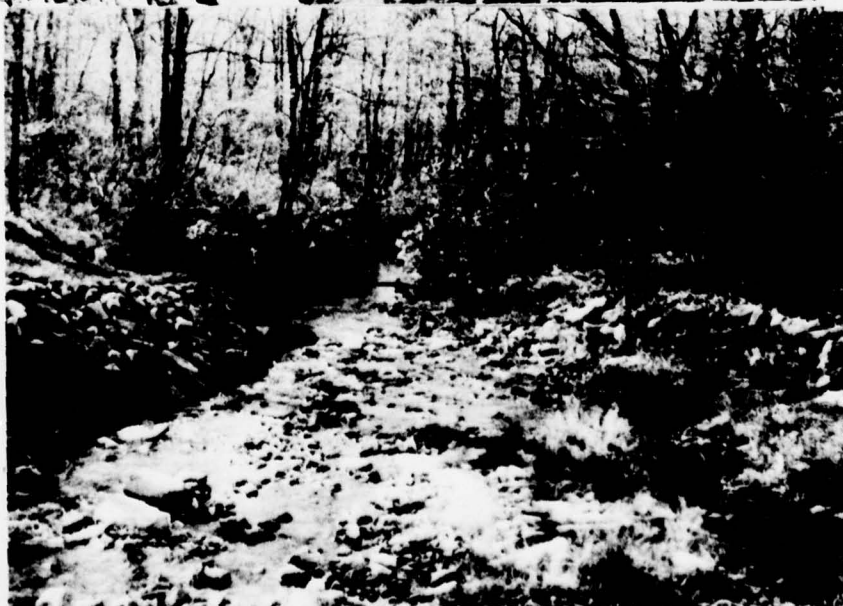
Spillway Outlet
Channel

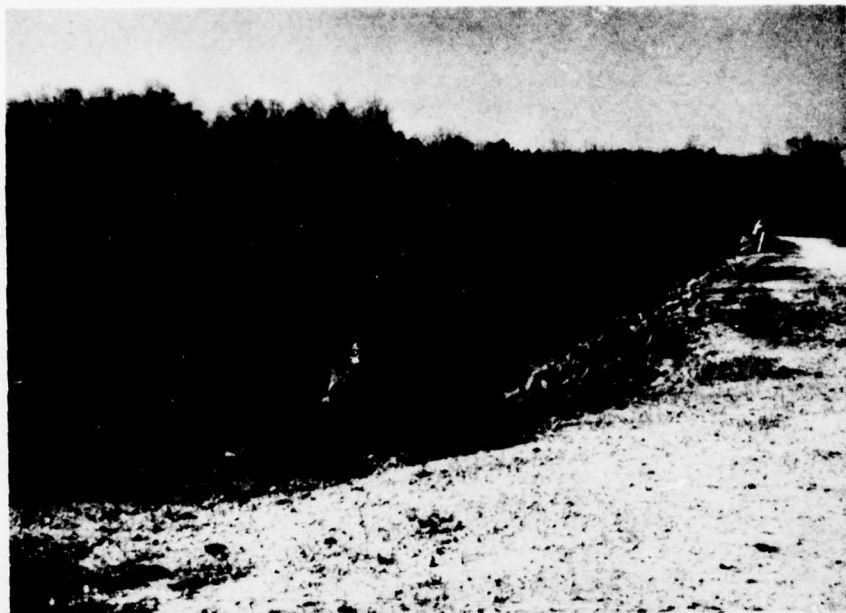
Downstream Slope
and
Valve House
