SPEEDWELL FORGE DAM

NDS No. PA-00345

**PHASE I INSPECTION REPORT
NATIONAL DAM INSPECTION PROGRAM**

FEBRUARY 1979

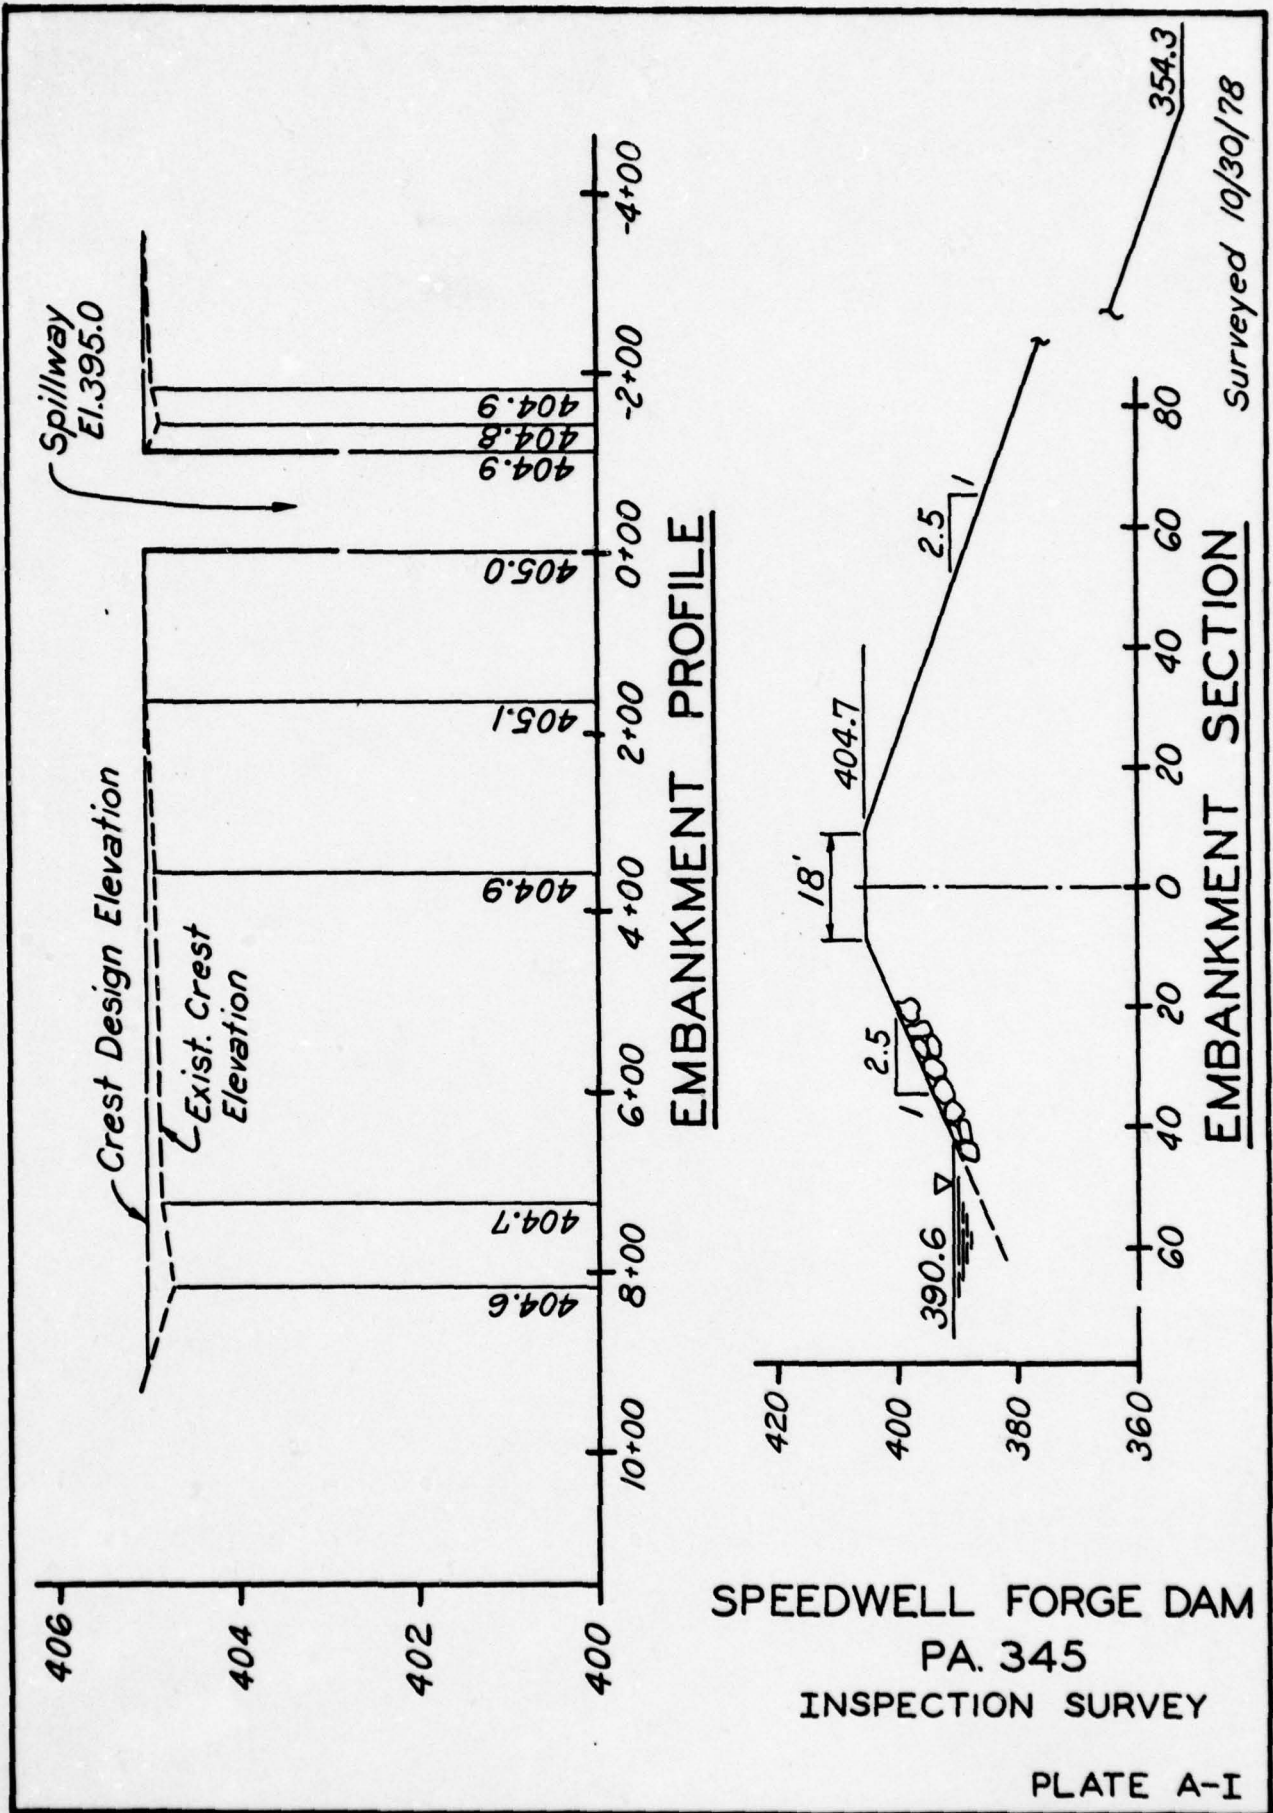
SPEEDWELL FORGE DAM
 PA. 345
 INSPECTION SURVEY

The results of the inspection survey show an uneven profile of the embankment crest. Refer to Plate A-II in Appendix A. While this condition does not affect the stability of the embankment, providing a uniform elevation at the design crest level would provide some improvement to the capacity of the facility.
