⑥ National Dam Inspection Program. Stovers Dam (NDS-PA-00600, DER-38-5), Susquehanna River Basin, Lebanon County, Pennsylvania. Phase I Inspection Report.

PHASE I REPORT  
NATIONAL DAM INSPECTION PROGRAM

Name of Dam: STOVERS LAKE DAM, NDS NO. PA-00600  
State & State No. PENNSYLVANIA, 38-5  
County: LEBANON  
Stream: A BRANCH OF BRANDYWINE CREEK  
Date of Inspection: November 15, 1978

STOVERS LAKE DAM

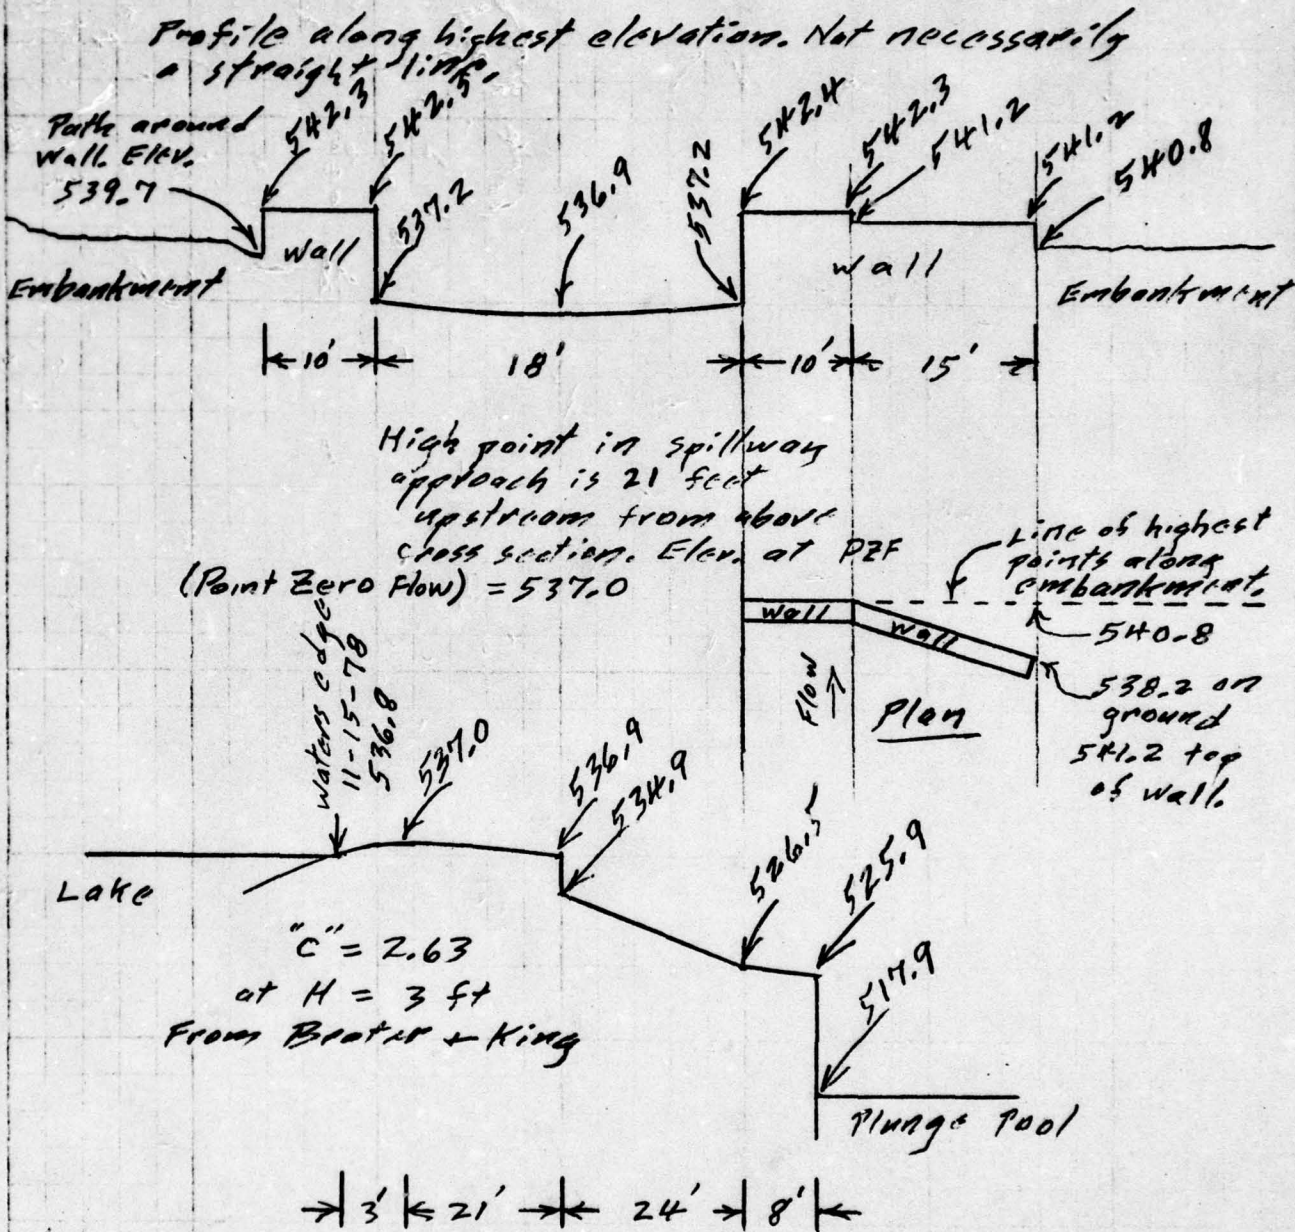
Spillway Rating

Top of embankment is uneven due to many paths  
 Lowest elev. 539.7 H = 2.7  
 Average elev. 541.4 H = 4.4  
 Highest elev. 542.3 H = 5.3

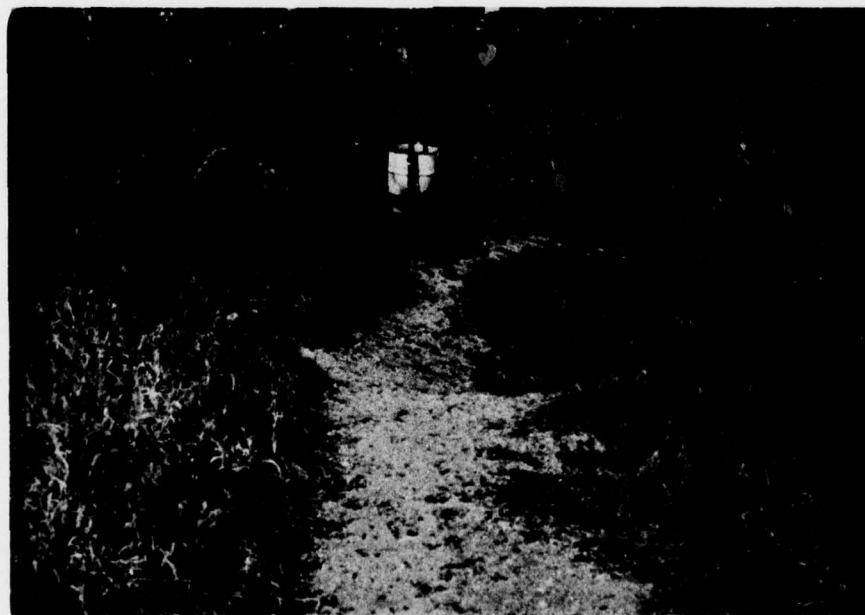
The embankment is in poor condition, due mainly to poor vertical alignment. The top of dam was designed to be three feet above the spillway. The actual average height is at present 4 feet with a low point of only about 2.7 feet above the spillway. Refer to Appendix A, Plates A-I and A-II, for the results of the survey. The dam breast has a very uneven cross section, with many gullies at the downstream and upstream edges. The top of the embankment is used by many fisherman and there is no cover. Pieces of concrete curbing are at several places. The upstream embankment slope has many bulges, probably caused by dumping riprap and cementing the surface against erosion. The lake was drawn down in 1972 and the city representative stated that the upstream slope is paved with brick over its full surface.

Dam Crest at Right Abutment

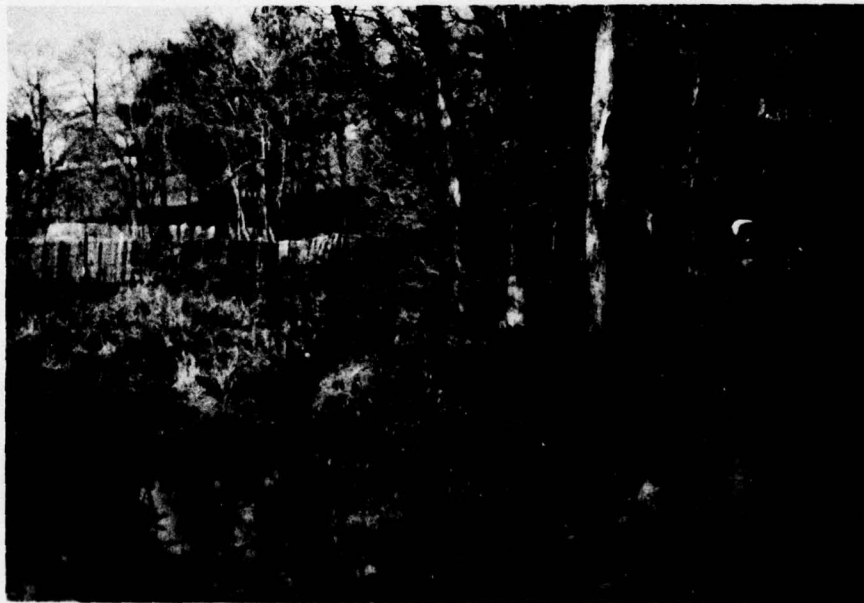
Downstream Channel & 12-Inch Pipe
