PIKE TOWNSHIP
MUNICIPAL AUTHORITY
DAM

NDS I. D. No. PA-00916
PENNDER I. D. No.17-111

PHASE I INSPECTION REPORT
NATIONAL DAM INSPECTION PROGRAM

GAI CONSULTANTS, INC.
570 BEATTY ROAD
MONROEVILLE, PENNSYLVANIA 15146
APRIL 1979

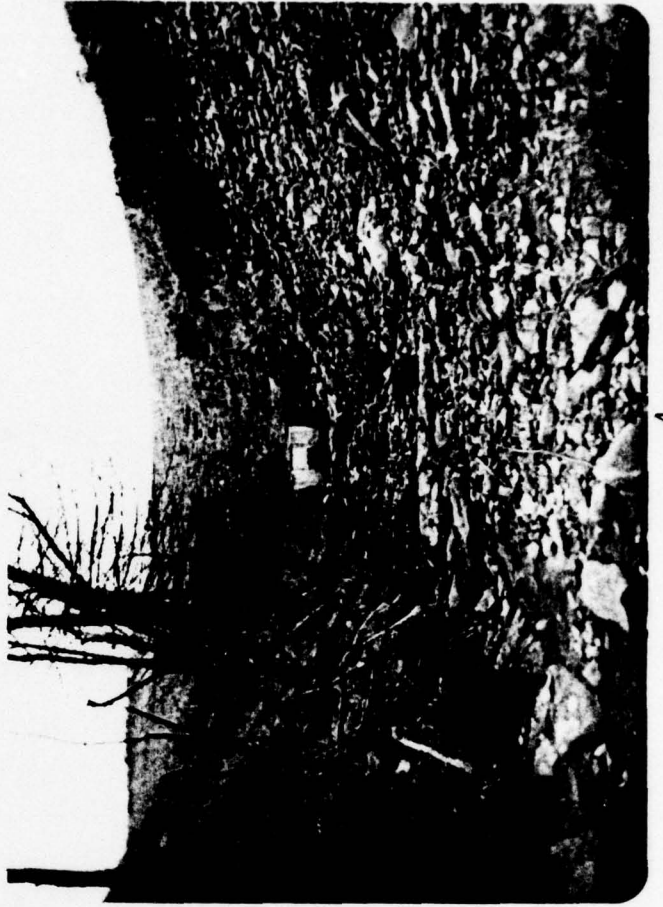
PHOTOGRAPH 4 View of the outlet structure.

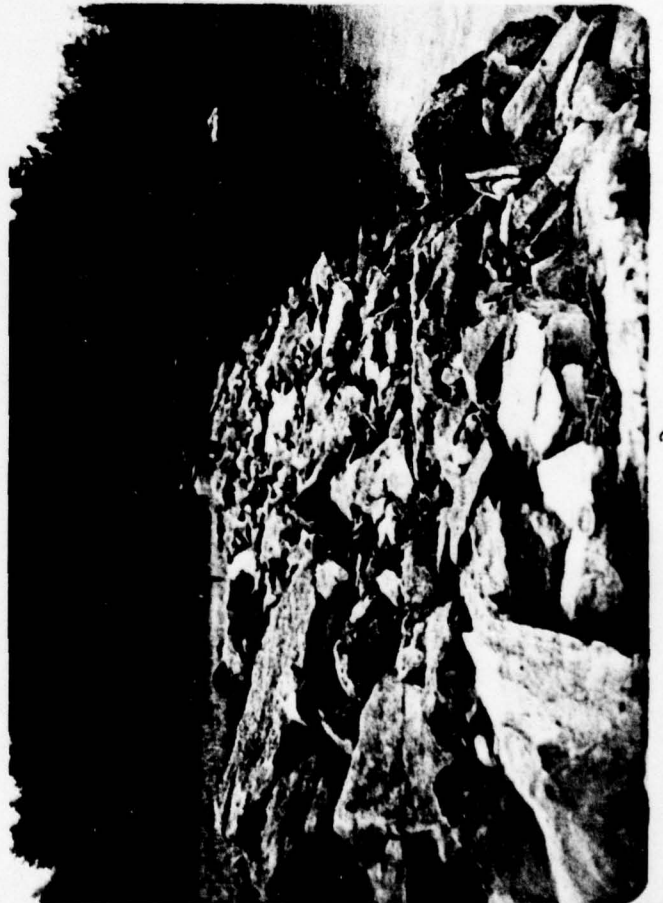
PHOTOGRAPH 3 View of the riprap and sluice gate operator located along upstream slope.

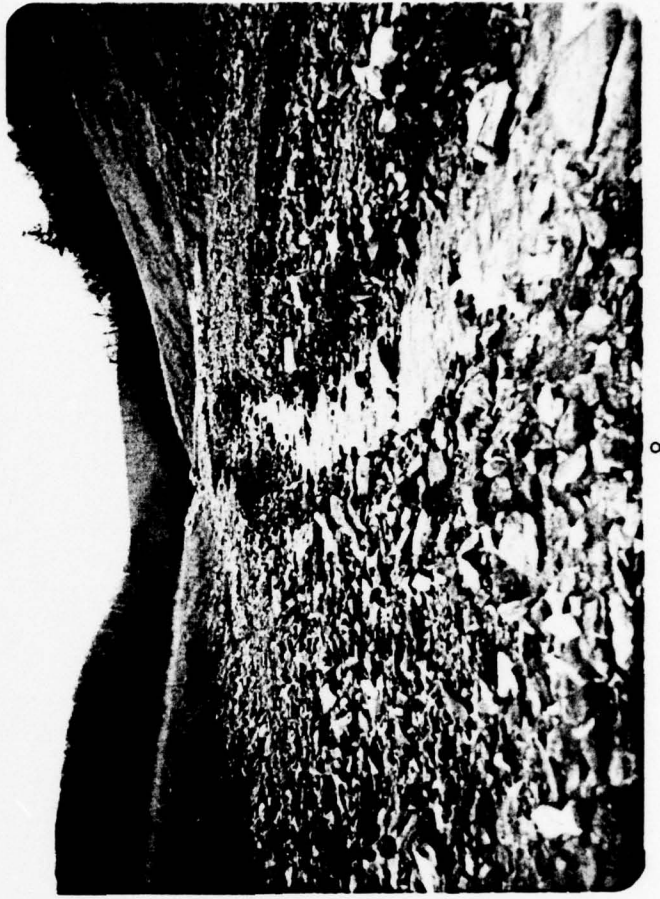
1. Spillway. A single structure has been provided for the facility which operates as both the service and emergency spillway. Visual inspection indicated that it is in poor condition having deep erosion gullies (8 feet deep) immediately downstream of the heavily riprapped segment (see Figures 1 and 3). Active sliding of the left channel wall is also evident and is possibly related to loss of toe support from spillway downcutting. The slide is shown in Photographs 7 and 8.

PHOTOGRAPH 8 View looking upstream through the spillway channel with the slide evident in the upper-right corner.

c. Monitor the movement of the slide on the left abutment. If movement becomes excessive, remedial measures are warranted for protection of the spillway channel.

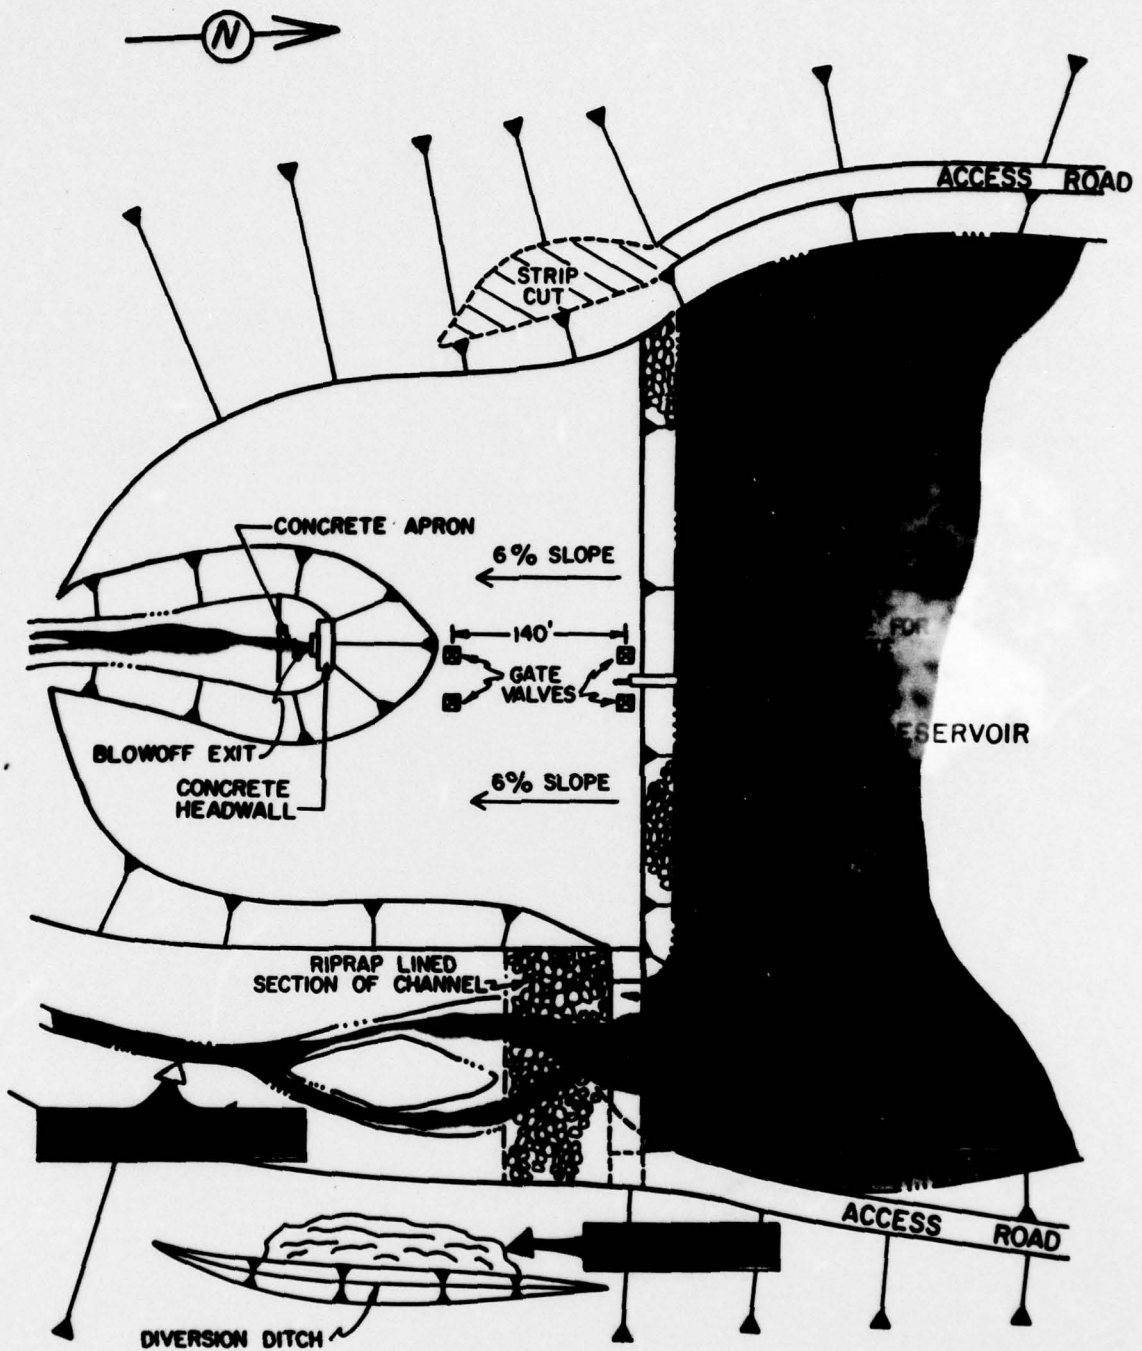
FIGURE 1 - PIKE TOWNSHIP MUNICIPAL AUTHORITY DAM
 GENERAL PLAN
 FIELD INSPECTION NOTES

2. Outlet System. Discharges through both the supply and blowoff conduits are controlled by a system of gate valves, all of which are manually operated from the crest (see Figure 1). There are two gate valves on each line located approximately 140 feet apart. In addition, the blowoff conduit is equipped with a sluice gate that is controlled by a manual operator, also accessible from the crest. The operator appeared to be in an open position and its condition appeared satisfactory. The outlet end of the discharge pipe is capped with a flap valve and is also in satisfactory condition. No deficiencies were noted that would indicate the system could not operate satisfactorily, if required.

b. Appurtenant Structures. The open channel spillway system has been troublesome since completion. At the time of inspection, severe erosion was evident in the spillway channel and instability of the slope forming the left channel wall was observed (see Figure 1).
