9  
I.D.  
National Dam Inspection Program, I.D.  
Jeannette Dam (NDS PA-00486),  
(Pennder 65-9), Ohio River Basin,  
Unnamed Tributary to Brush Creek,  
Westmoreland County, Pennsylvania.

PHASE I REPORT  
NATIONAL DAM INSPECTION PROGRAM

Jeannette Dam: NDS I.D. No. PA-00486

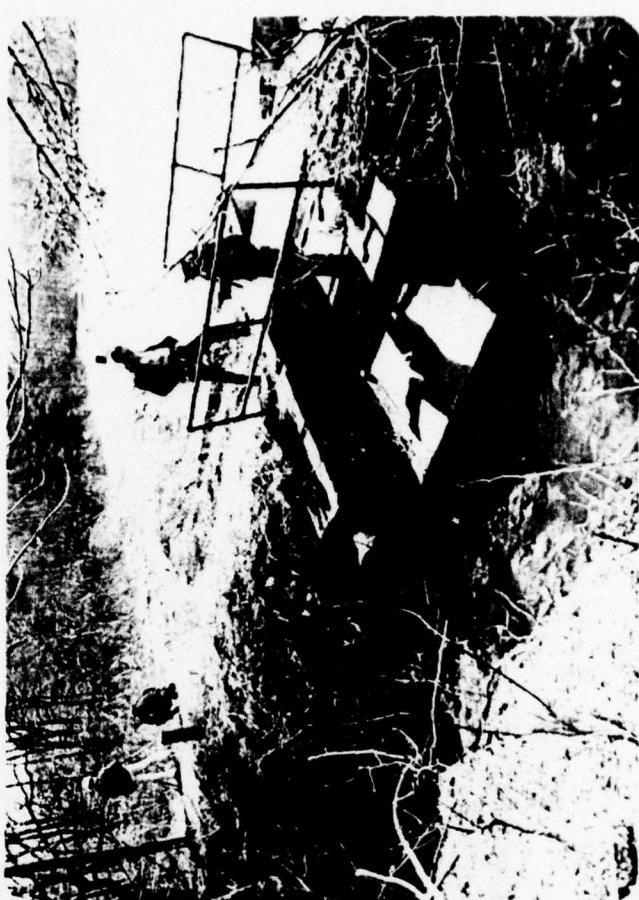
The small channel spillway located between the reservoir and diversion channel is shown in Photograph 4. As indicated, the end of the spillway adjacent to the diversion channel has settled and cracked apparently as a result of undercutting. Under low flow conditions, discharge actually passes under the structure and into the diversion channel, further undercutting the slab. The downstream masonry wall has cracked beneath the wood plank walkway and has also rotated several inches.

PHOTOGRAPH 4 View of the emergency spillway structure and diversion channel located along the west shore of the lake approximately 35 feet from the embankment crest.

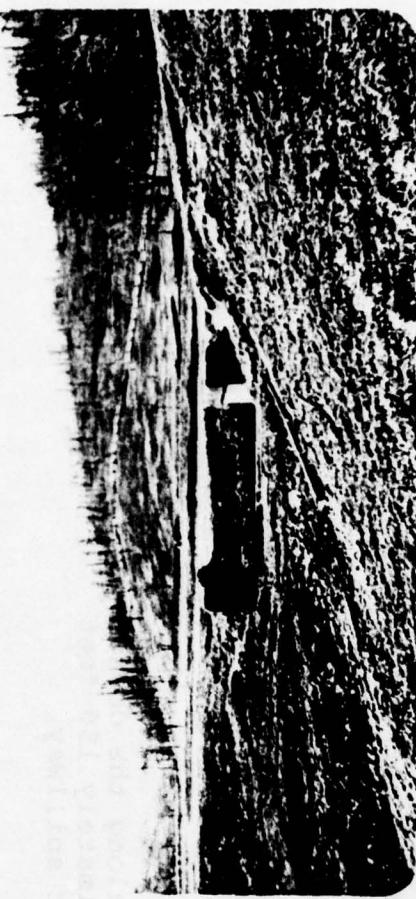
The condition of the original drop-inlet structure is shown in Photographs 7 and 8. The extent of erosion and deterioration is readily discernible when compared with Photograph 6 taken in 1915. Approximately 16 feet of soil has been eroded from all sides of the structure to the extent that the foundation is being undercut along its left corner, seriously endangering its stability. The erosion also threatens the stability of the embankment and its natural soil foundation in the area of the inlet structure and along the left abutment-embankment contact.
