**PENNSYLVANIA
LICKING CREEK DAM—
CLEARVIEW RESERVOIR**

NDS ID NO. PA-00581

PHASE I INSPECTION REPORT

NATIONAL DAM INSPECTION PROGRAM

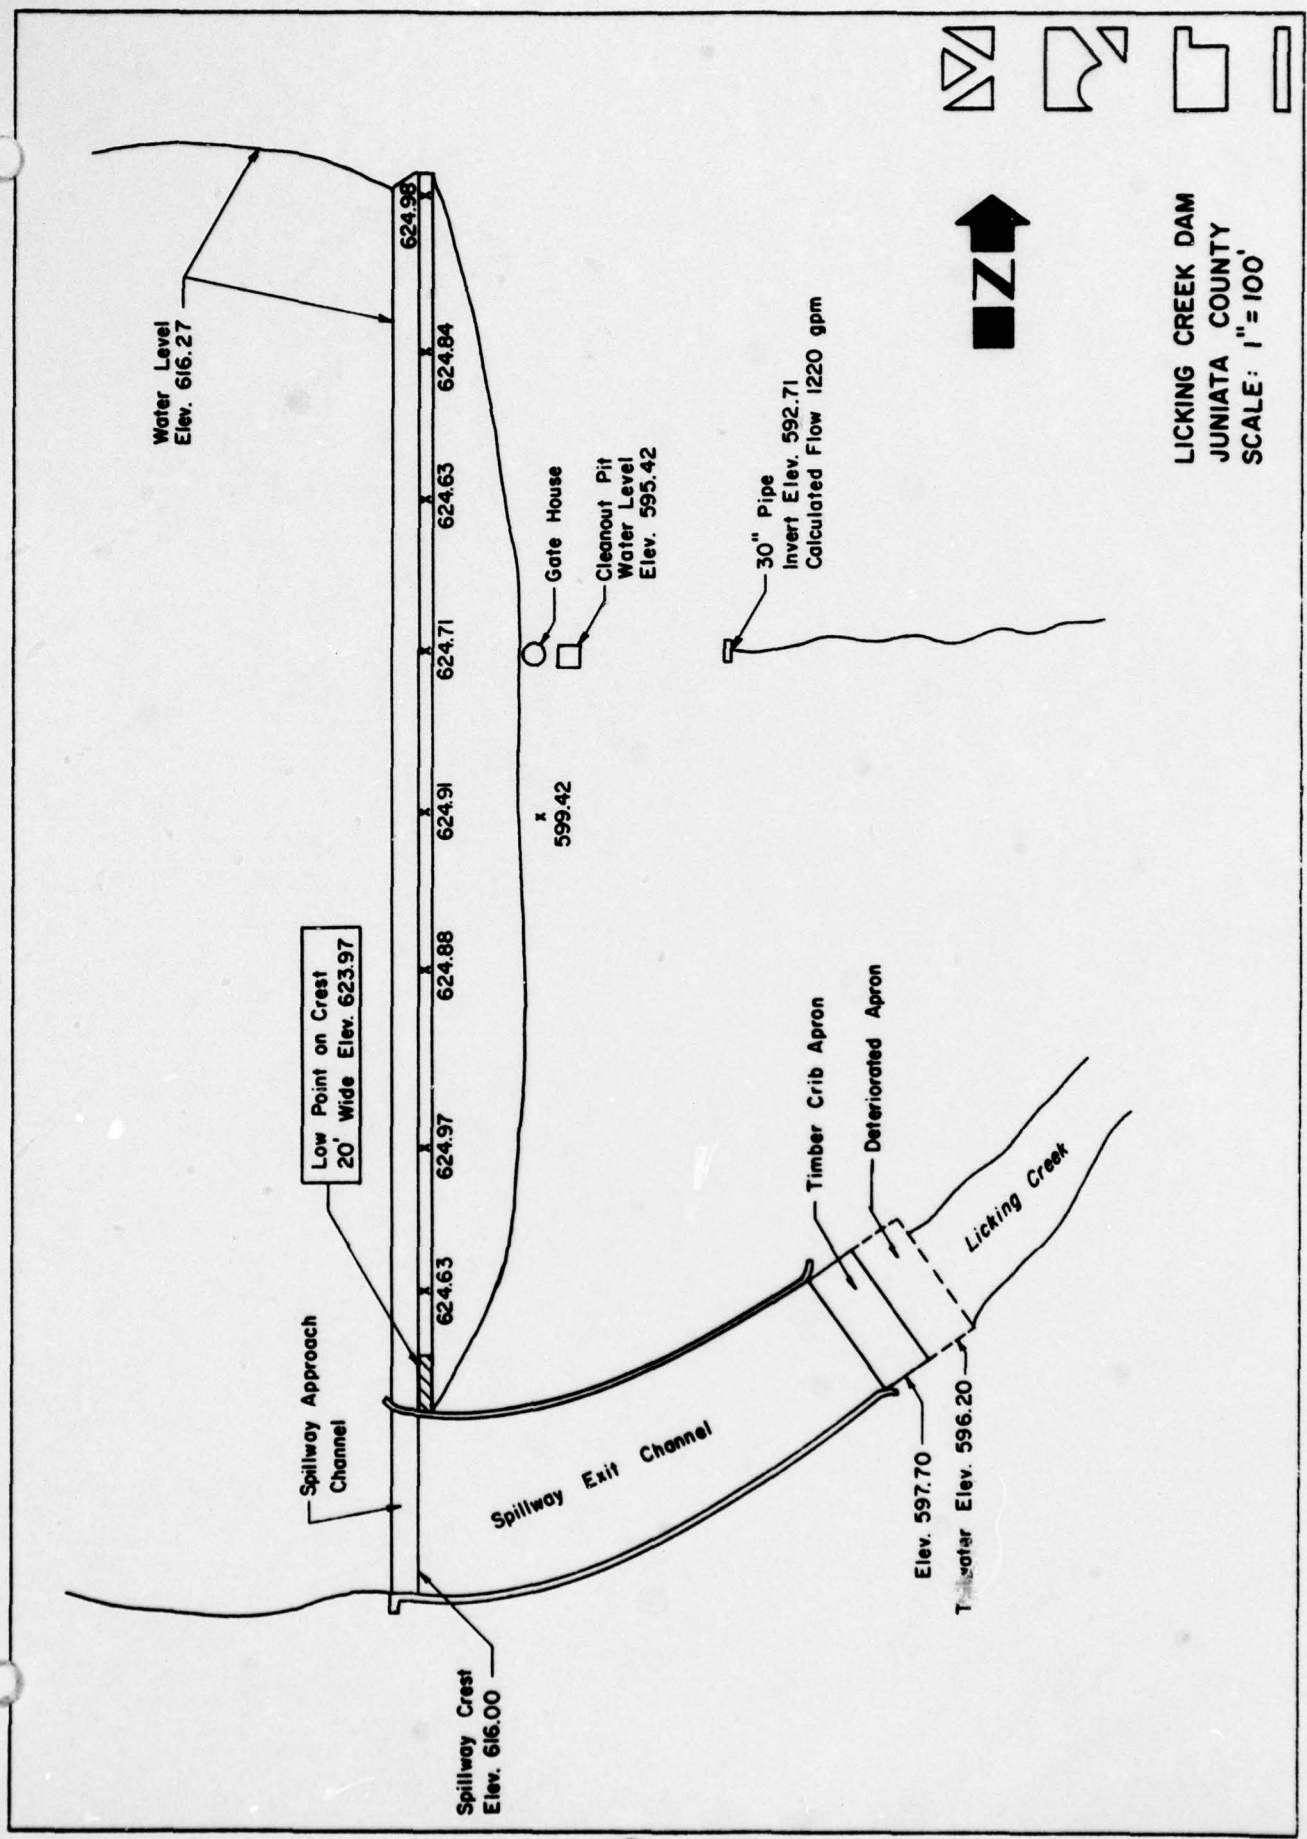
LICKING CREEK DAM
 JUNIATA COUNTY
 SCALE: 1" = 100'

b. Dam. The dam appears to closely conform to the few construction drawings available. From a brief survey conducted during the inspection it was noted that a low spot approximately 150 feet long exists on the right abutment adjacent to the spillway wingwall. This low spot gradually increases in depth toward the spillway. The lowest portion is 0.78 feet deep and extends for 20 feet in length (See drawing on page 7).

A low spot was noted on the dam embankment adjacent to the spillway approach wingwall. This area could easily be filled to the top of dam elevation.

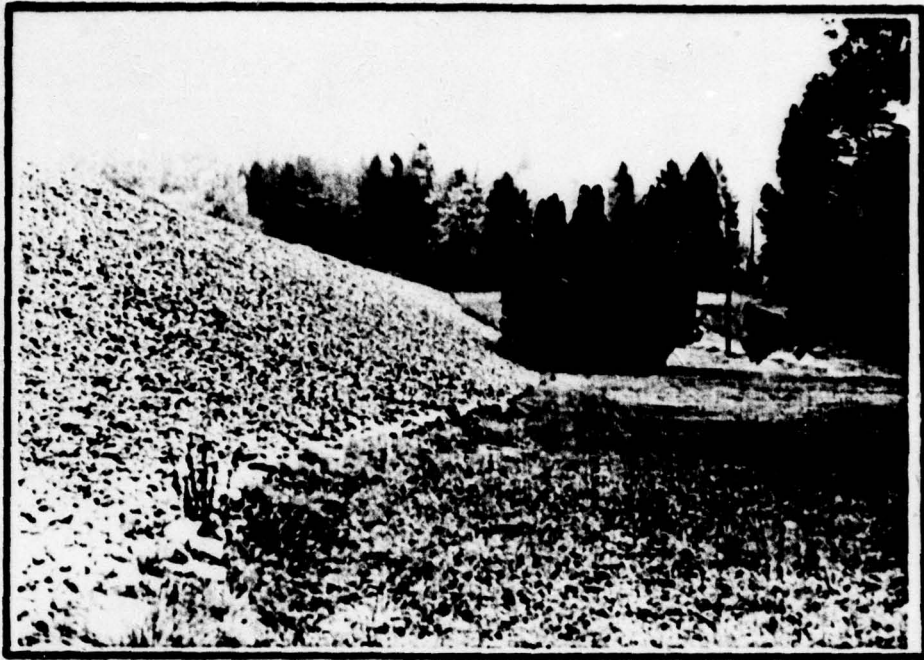
Photograph No. 1

Downstream slope from right abutment toe.

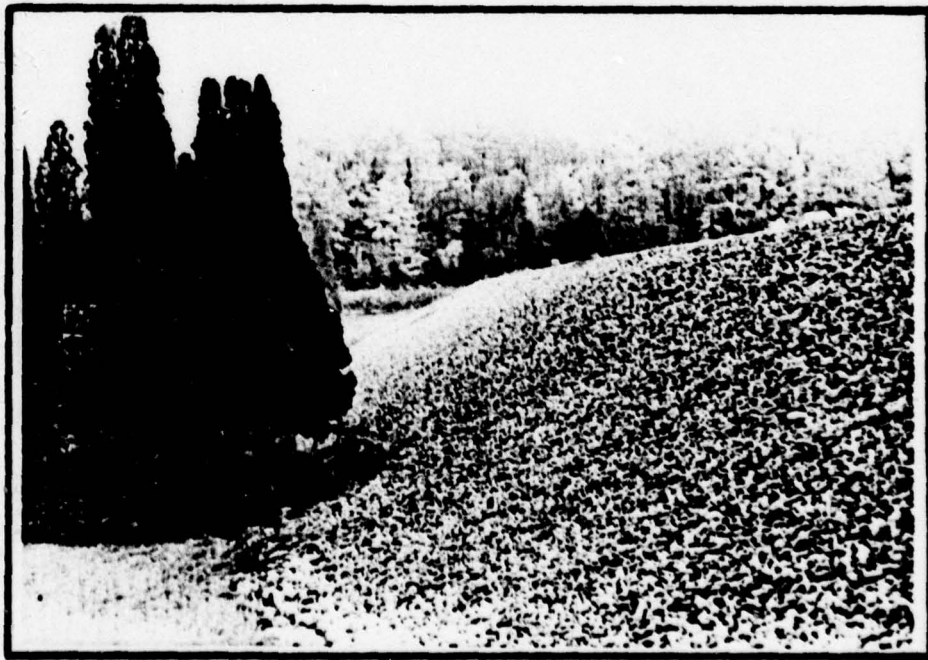
Photograph No. 2

Downstream slope from left abutment toe.

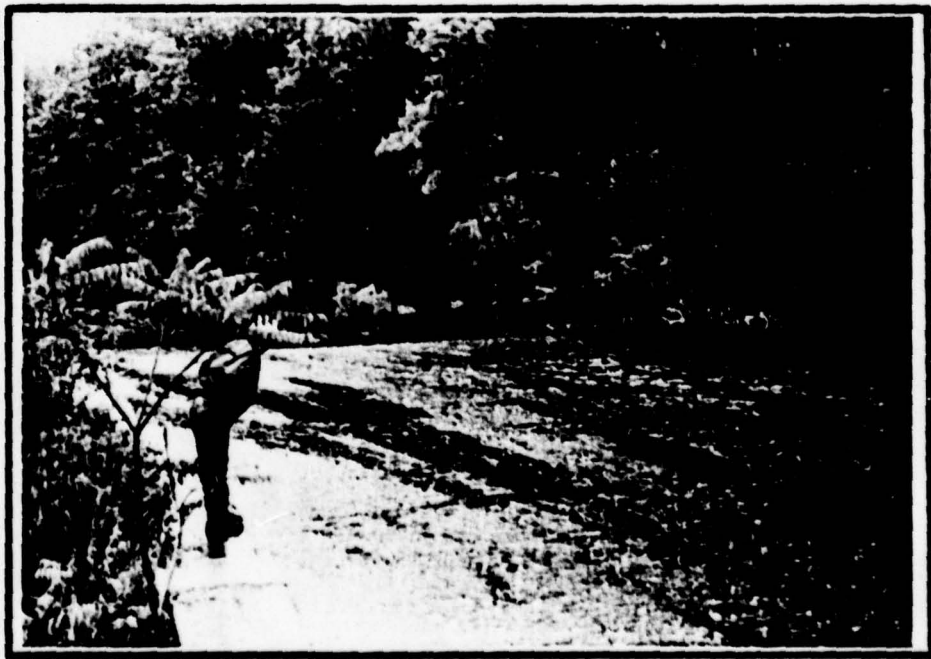
Photograph No. 4

Looking down spillway exit channel.

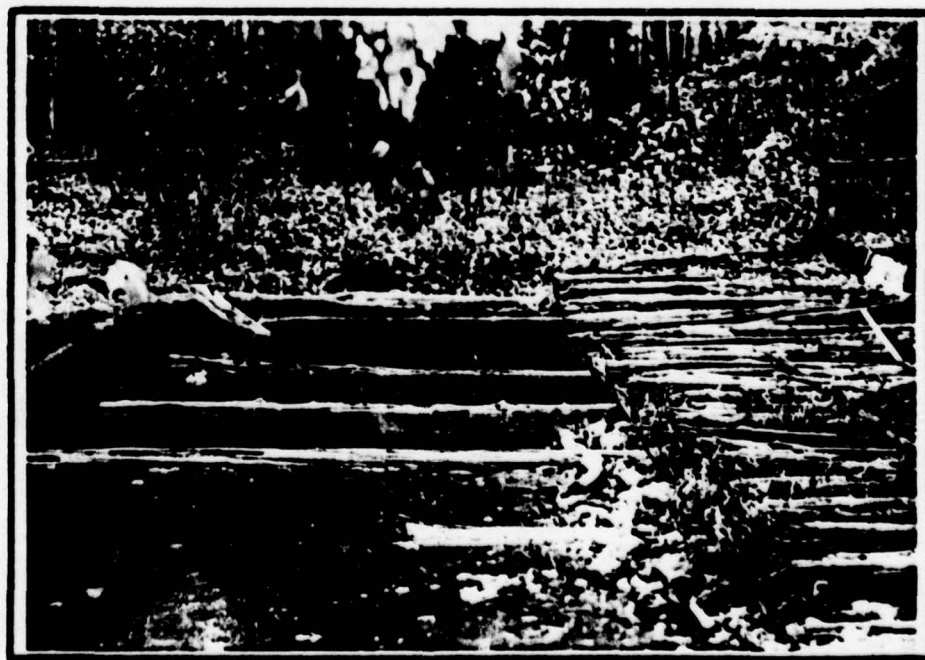
Photograph No. 6

c. Visual Observations. The spillway appeared to be in good condition and well maintained. The timber crib apron located at the spillway discharge is in need of repair.

Timber stilling basin.

5. The deteriorating crib apron at the spillway outlet should be repaired to prevent undercutting of the spillway due to large discharges.

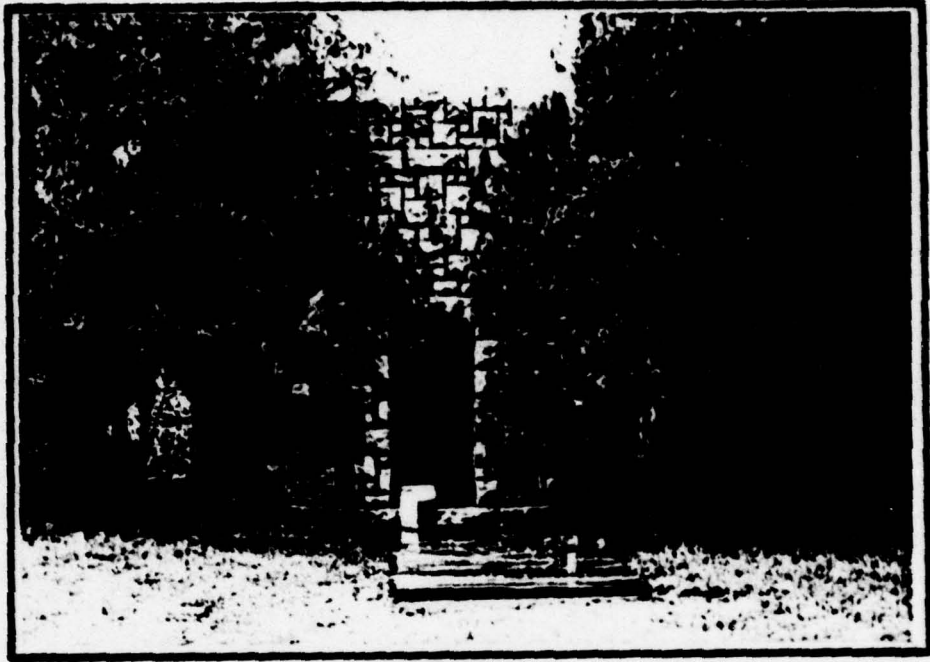
Photograph No. 7

Gatehouse structure at downstream toe.

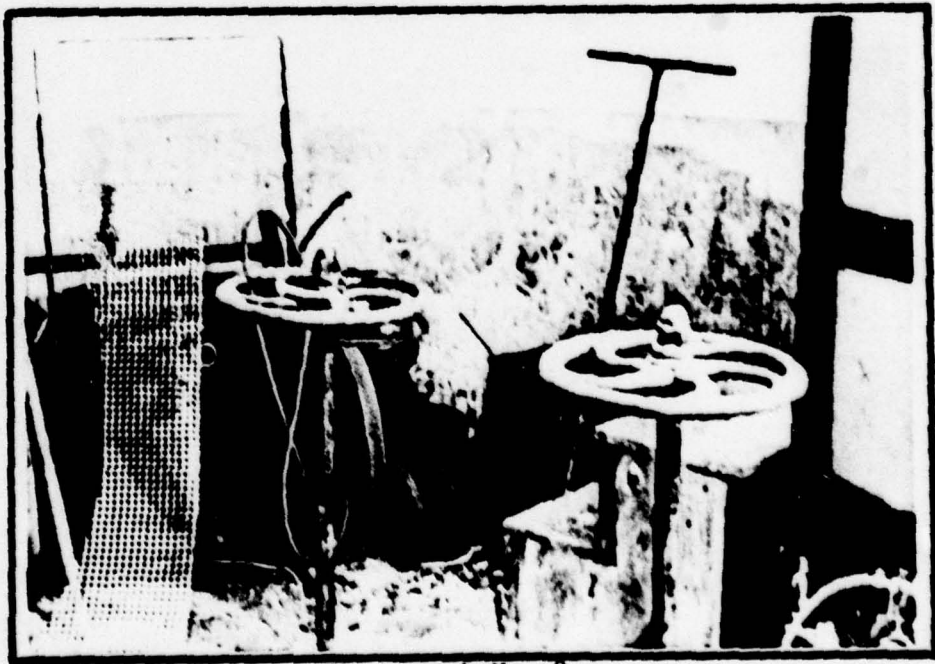
Photograph No. 8

Manual control valves in gatehouse.

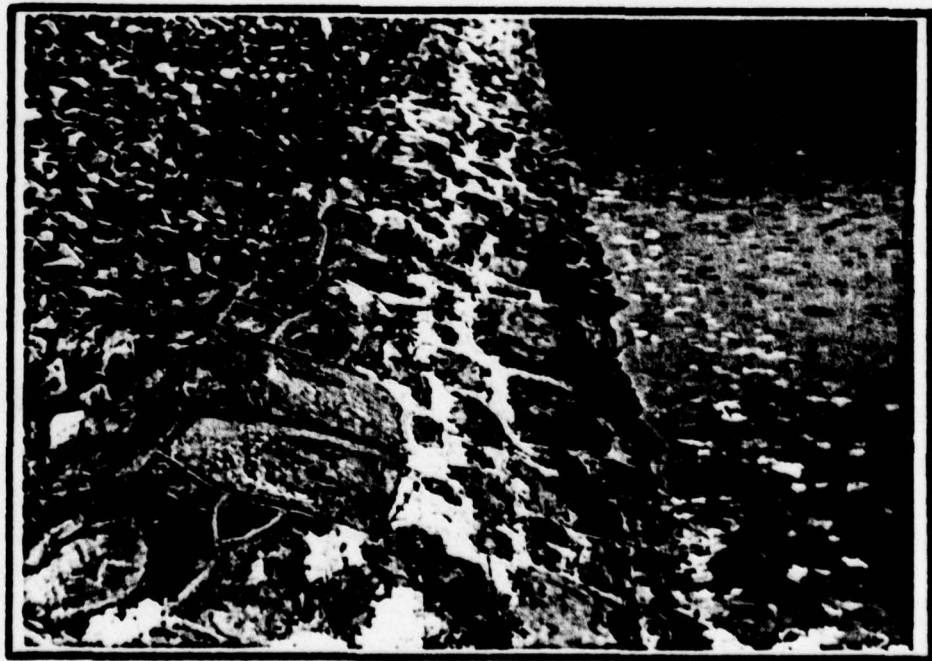
Photograph No. 10

Slope paving on upstream face.
