OLYPHANT NO. 3 DAM

NDI ID NO. PA-00381

PHASE I INSPECTION REPORT
NATIONAL DAM INSPECTION PROGRAM

JANUARY 1979

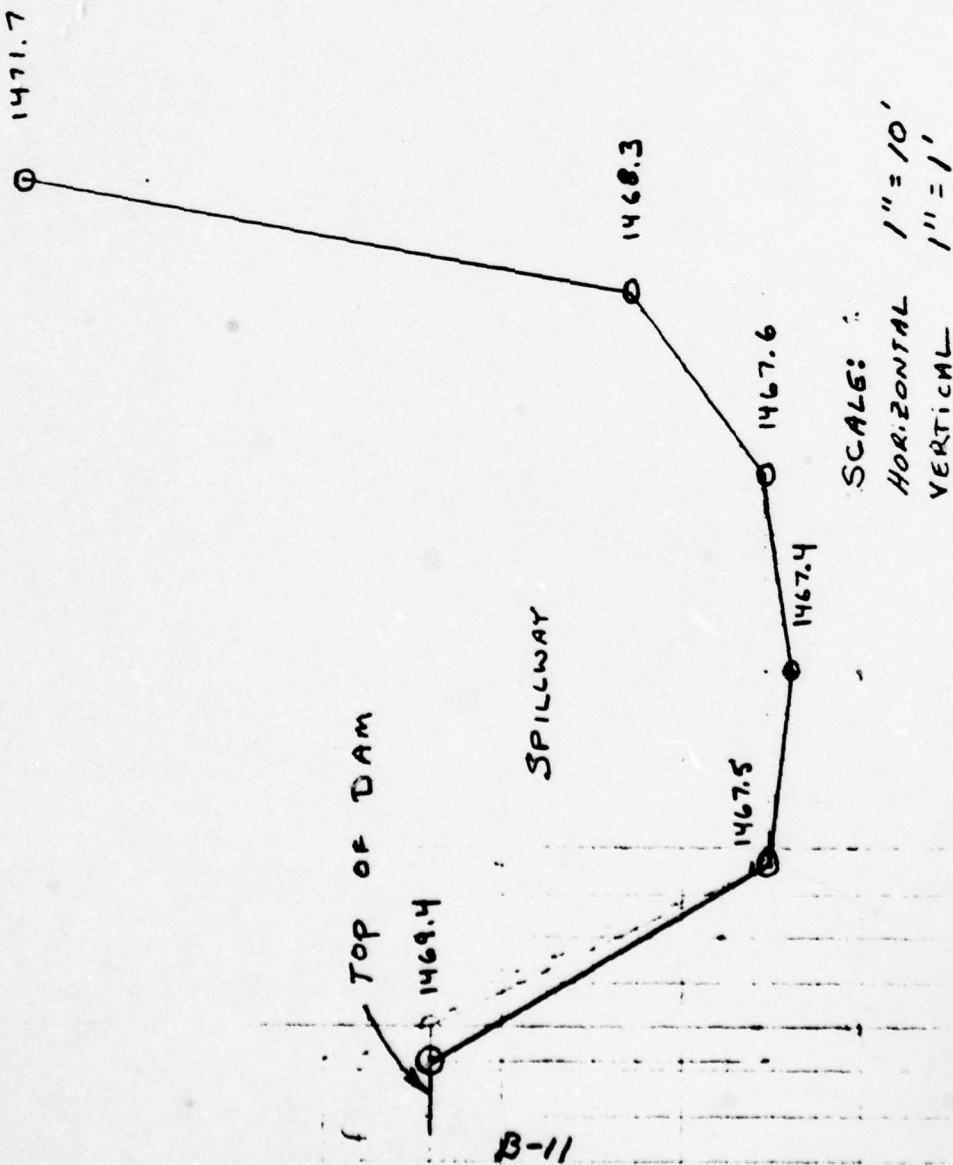
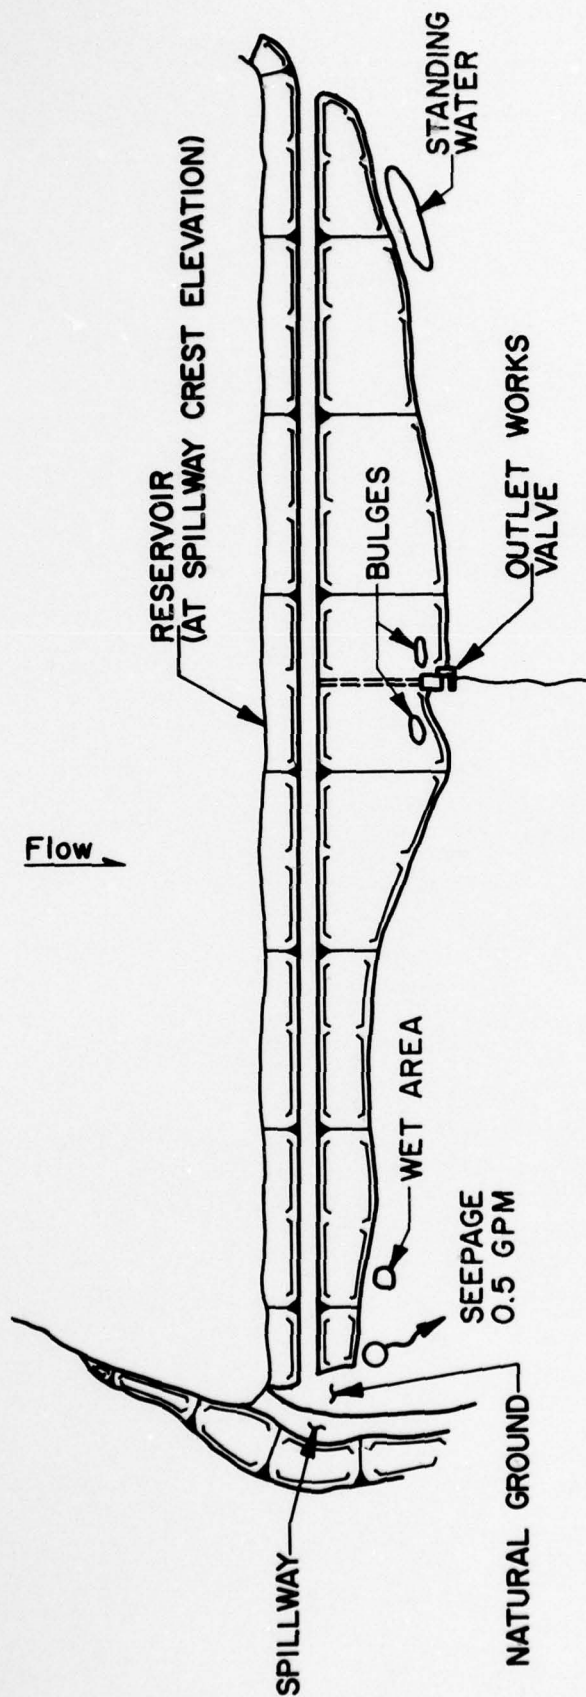
PHASE I INSPECTION REPORT
 NATIONAL DAM INSPECTION PROGRAM
 OLYPHANT NO. 3 DAM
 PENNSYLVANIA GAS AND WATER COMPANY
 RESULTS OF VISUAL INSPECTION
 JANUARY 1979 PLATE B-1

a. General. The overall appearance of the dam was fair, with some deficiencies as noted herein. The locations of some of these deficiencies are shown in Appendix B on Plate B-1. Survey data acquired during this inspection is presented in Appendix B. On the day of the inspection, the pool was at spillway crest elevation.
