LAKE CAREY DAM

NDI ID NO. PA-00887

PHASE I INSPECTION REPORT
NATIONAL DAM INSPECTION PROGRAM

JANUARY 1979

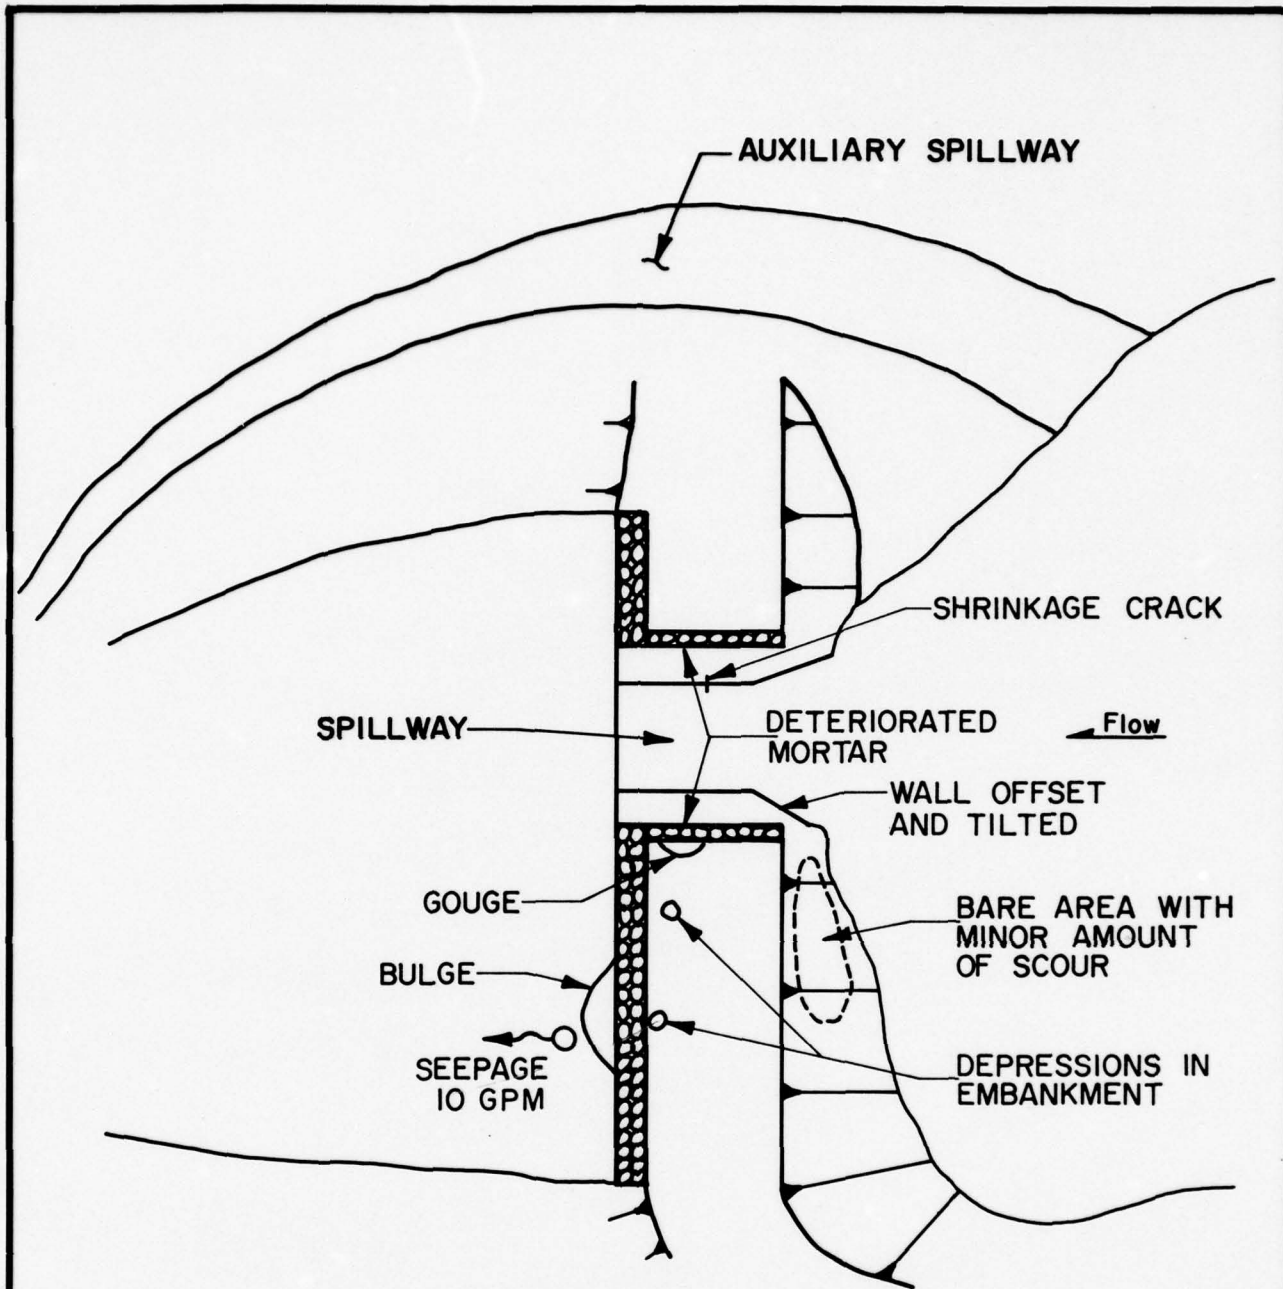
PHASE I INSPECTION REPORT
 NATIONAL DAM INSPECTION PROGRAM
 LAKE CAREY DAM
 LAKE CAREY WELFARE ASSOCIATION
 RESULTS OF VISUAL INSPECTION
 JANUARY 1979 PLATE B-1

A sketch of the dam with the location of some deficiencies is presented on Plate B-1. Survey information acquired for this inspection is summarized in Appendix B. On the day of the inspection, the pool was at spillway crest elevation.

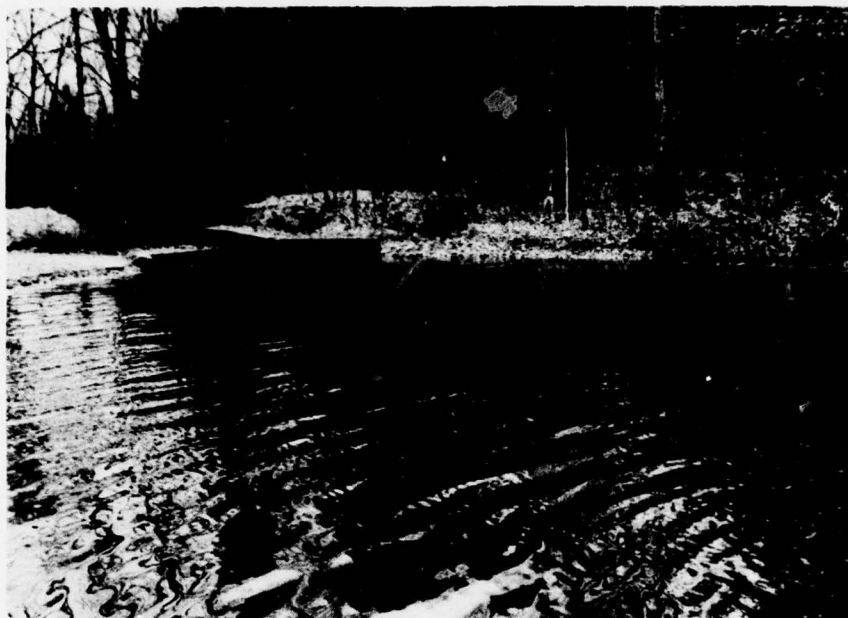
b. Dam. The embankment appears in fair condition. Much low brush and some trees, which are about 3 inches in diameter, are growing on the earthfill (Photographs C and E). The sod appears to be in good condition except on the upstream slope of the embankment to the left of the spillway, where bare soil is visible (Photograph D). There is no riprap on the upstream slope. There are two depressed areas, each about 1 foot square, on the top of the embankment. An eroded surface drainage path leads down the left abutment. The courses of the stone masonry are uneven and tilted. To the left of the spillway, the stone masonry is bulged (Photograph H). The bulge is apparently a long standing condition and from its appearance could have been present since original construction. The bulge makes a 5.1V on LH slope; the remainder of the stone masonry face is more vertical. Concrete, apparently wasted during previous construction, covers both an area to the right of the bulge and along the toe of the mortarless, stone masonry section (Photograph H). Clear seepage of about 10 gpm is flowing from beneath the wasted concrete. The Owner reports that this is the approximate location of the outfall of the old outlet works conduit. Although the lowest point on the top of the dam was at elevation 950.5 (Appendix B), the top elevation used in rating the dam was Elevation 950.7, which is the top of the spillway wall. No design information is available to ascertain the design elevation for the top of the dam.

C. Upstream Slope of Embankment,
Spillway Approach, and Auxiliary Spillway Approach.

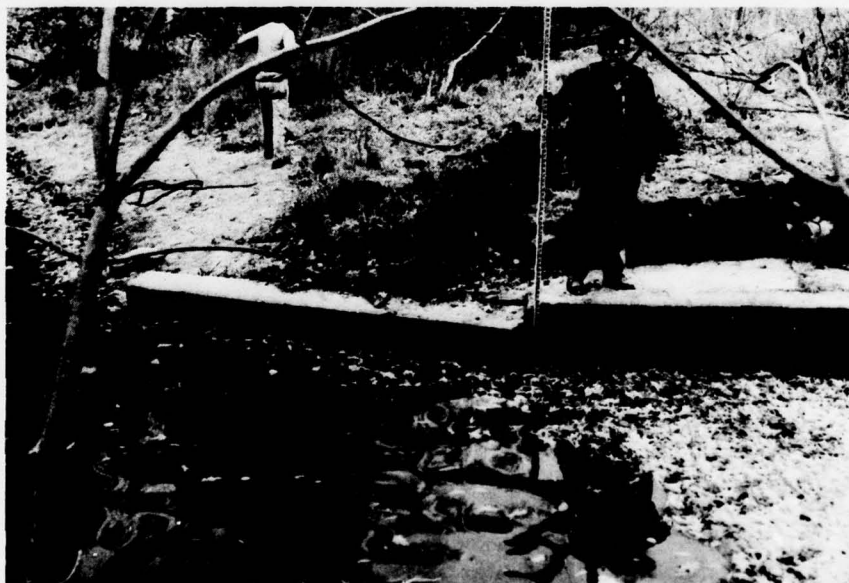
(1) Spillway. The spillway appeared to be in fair condition. The left approach wall is tilted and offset by 0.5 foot from the spillway walls (Photograph D). The mortar is missing or deteriorated in the stone masonry spillway walls. The right wall has a shrinkage crack. There is a gouge in the embankment near the left spillway wall (Photograph E). Stoplog slots were constructed in the spillway walls. The Owner reports that the stoplogs are no longer in use.

(3) Appurtenant Structures. The spillway left approach wall has evidence of relative movement, probably caused by ice pressure or frost heave. The shrinkage crack in the right wall is probably caused by improper joint locations. The deteriorated mortar prevents the spillway walls from acting as a watertight structure and can only increase the seepage potential. The gouge to the left of the spillway is probably caused by a stone from the masonry wall being removed. The conditions at the outlet works are of concern. In view of the uncertain plugging procedures for the old conduit a potential for collapsing of the conduit and settlement of the embankment might be present.

D. Spillway Left Approach Wall.

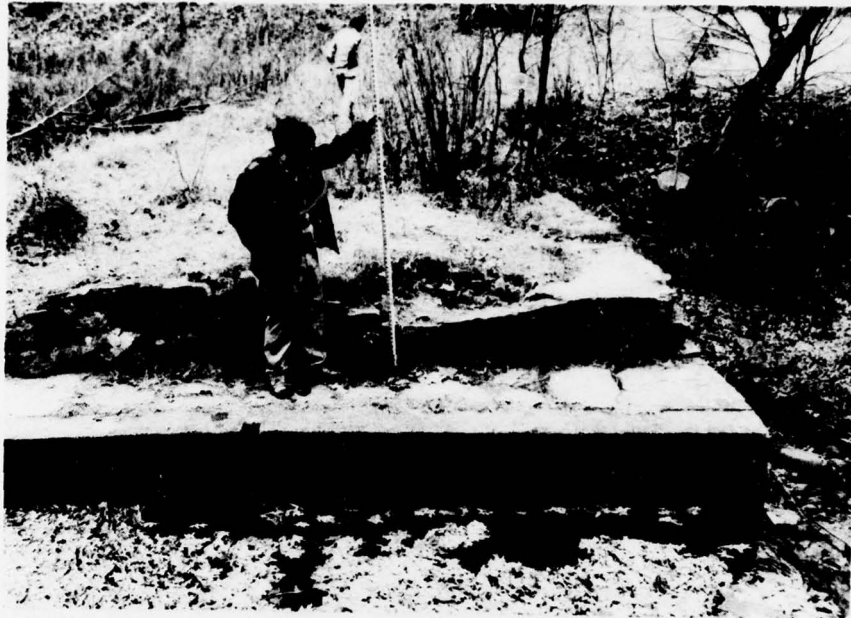
E. Spillway Left Wall.

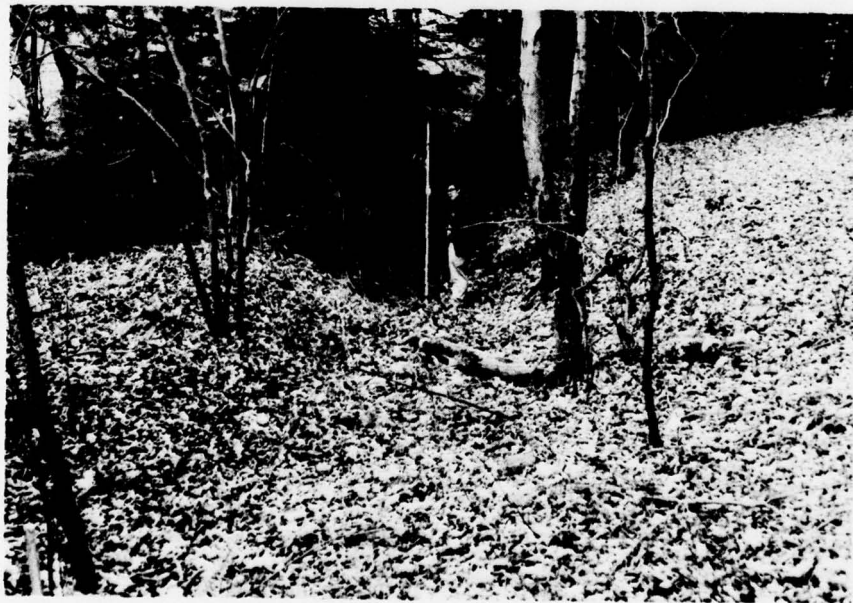
F. Auxiliary Spillway Channel.

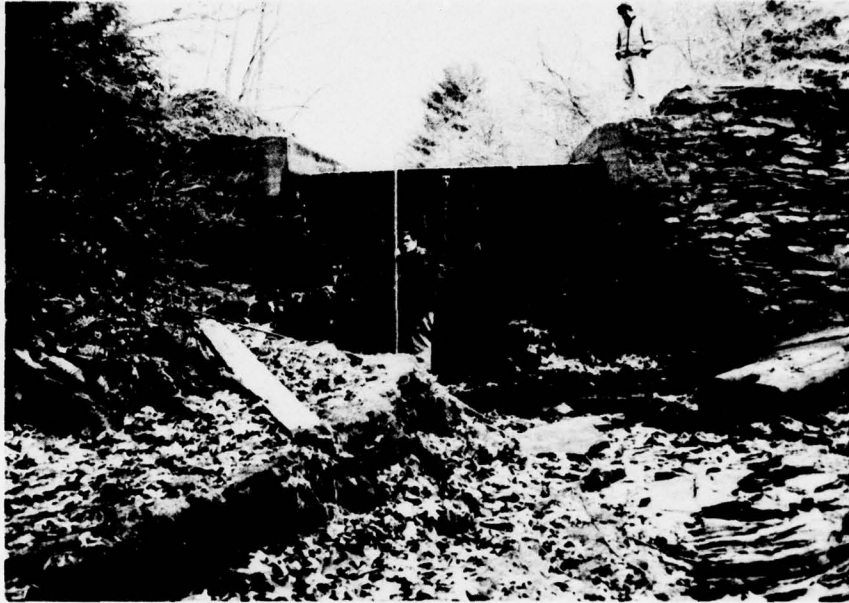
G. Downstream Face of Dam.

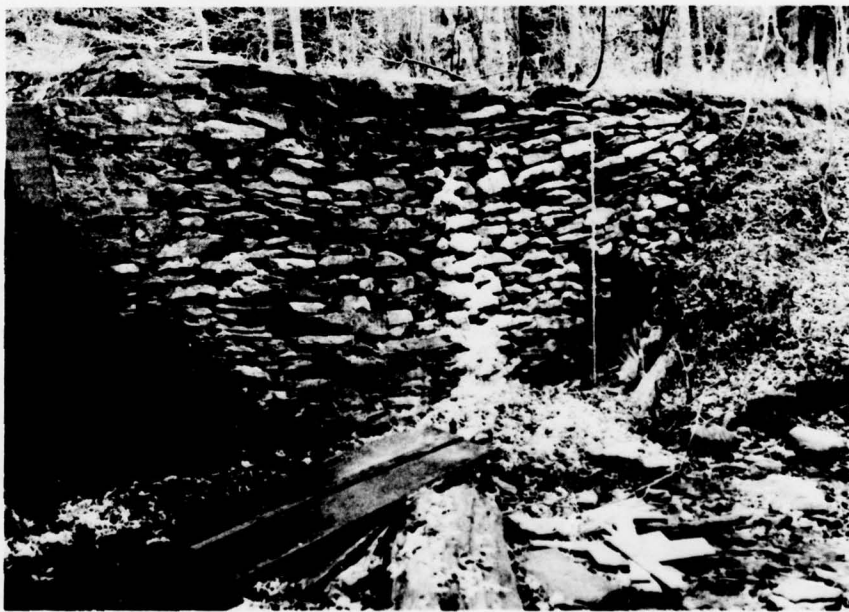
H. Downstream Face of Dam to Left of Spillway.
