NRL Memorandum Report 4003

Shock Performance of a Shipboard Electrical Switchgear

EDWARD W. CLEMENTS

June 15, 1979

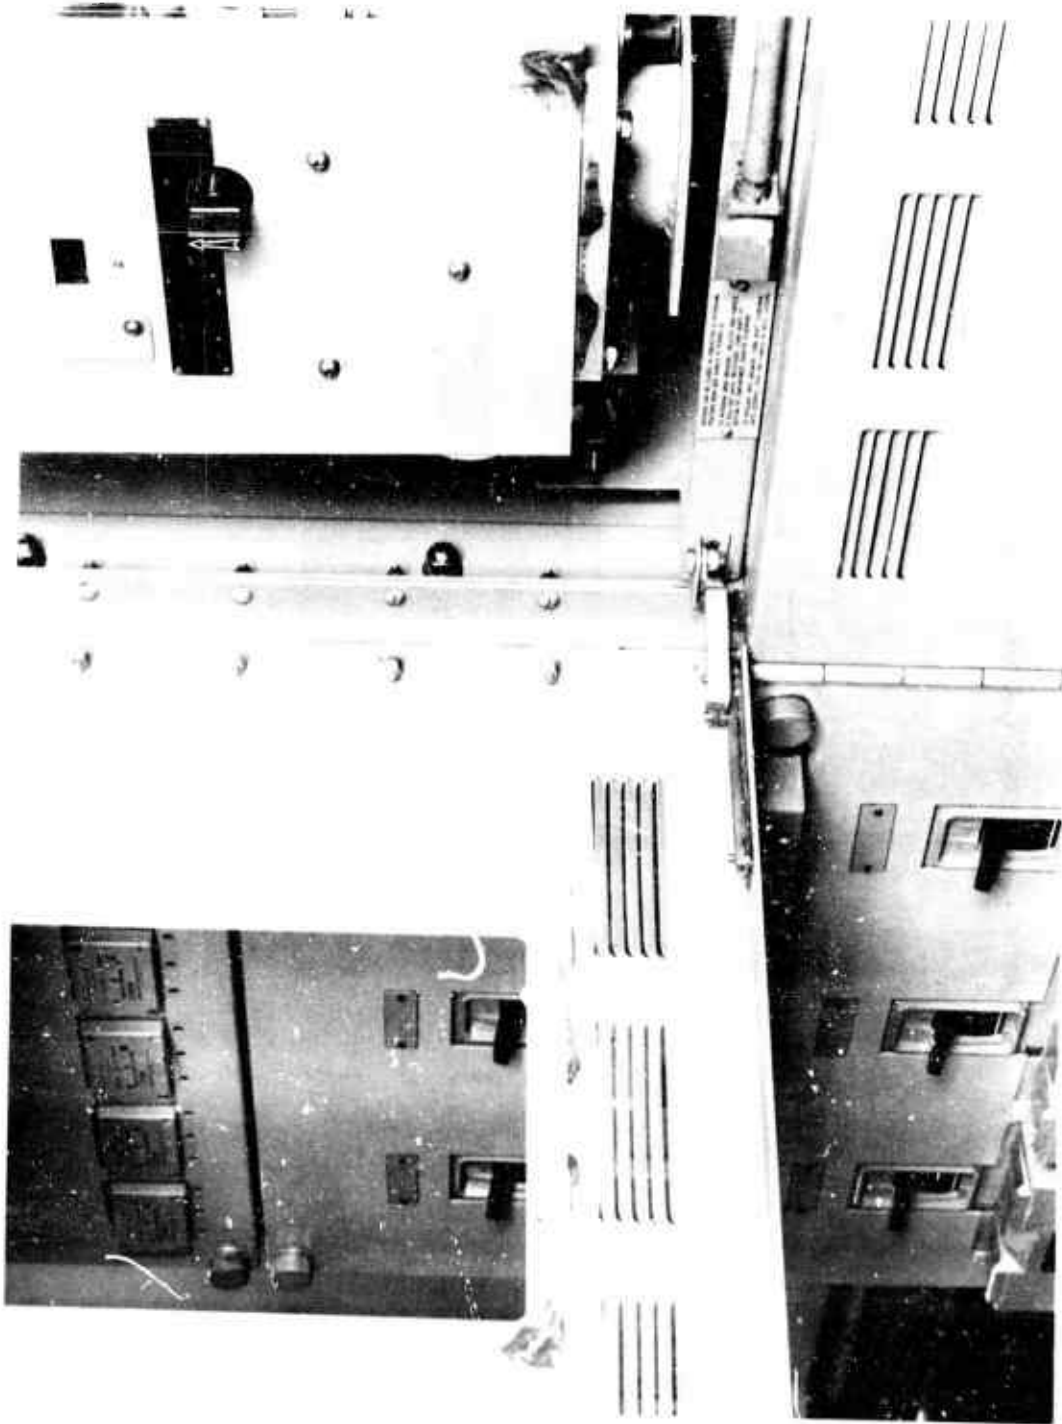
Damage was thus limited to the broken breaker ties referred to above, which were replaced with steel strips of similar dimensions, and wear and abrasion to the ACB breakers and their door panels, Figs. 16-18.

Fig. 16 - Damage from vibration test - upper ACR-1600. Note abrasion of breaker and door, and bending of louvers.

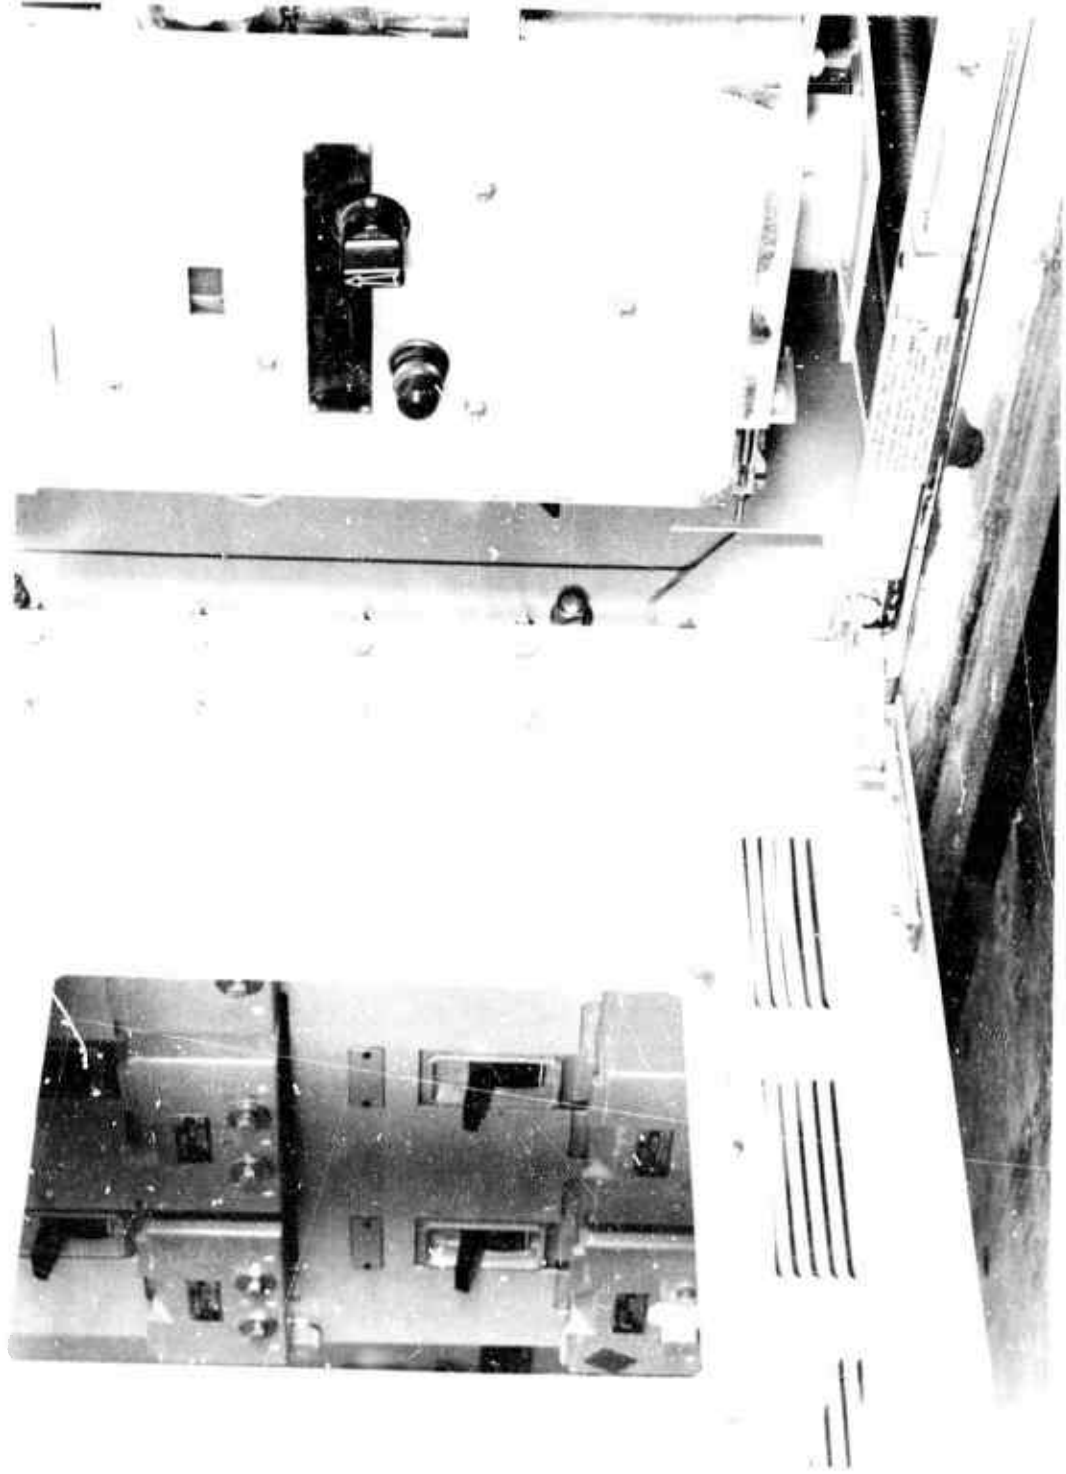
Fig. 17 - Damage from vibration test - lower ACB-1600. Note abrasion of breaker and door, and bending of louvers.

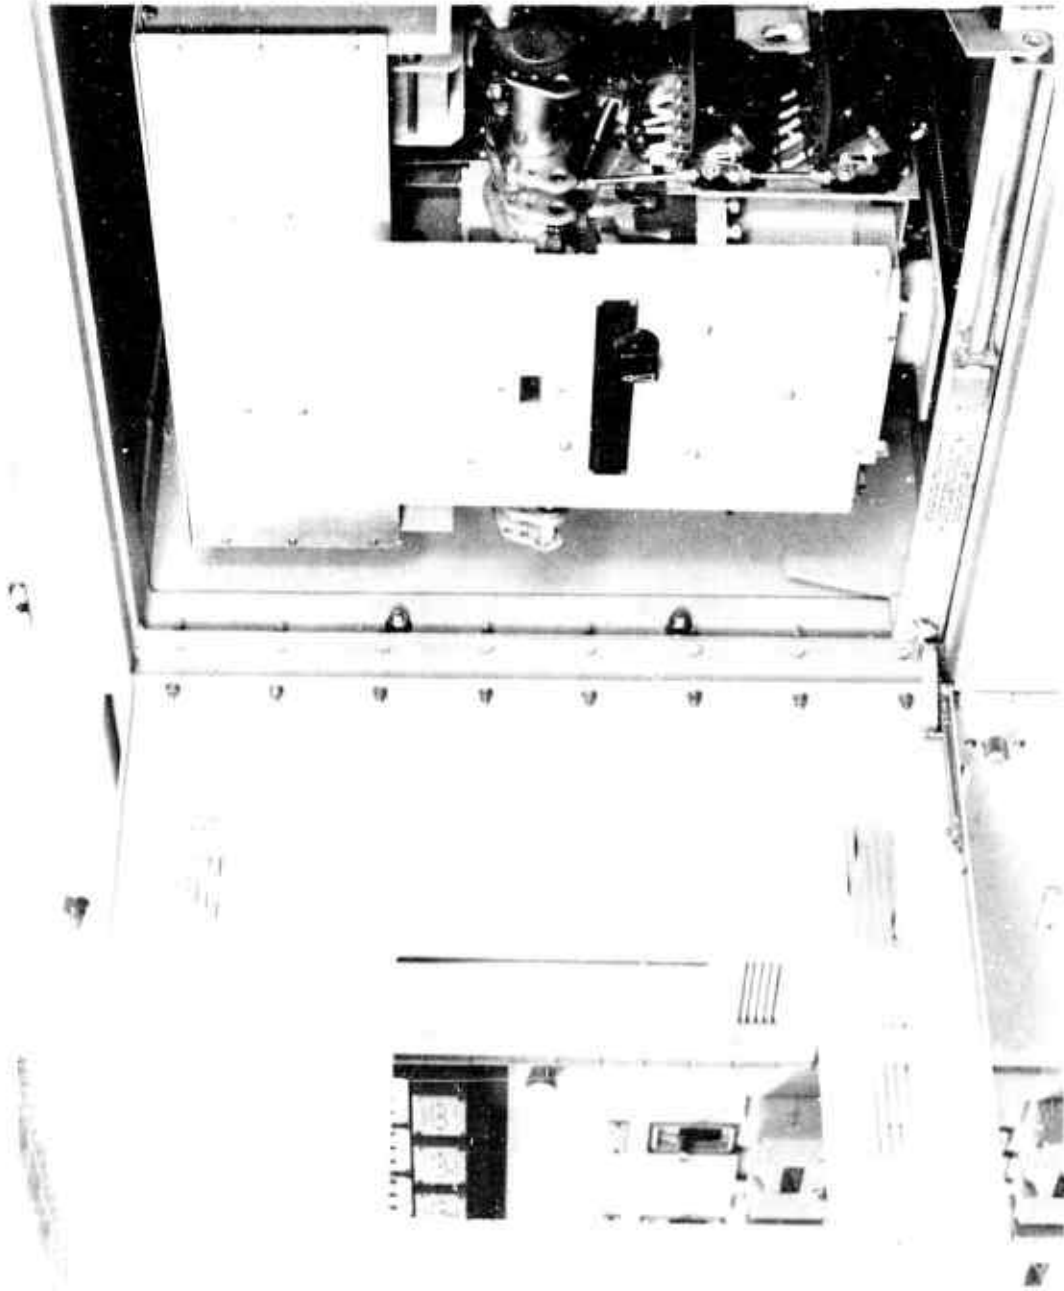
Fig. 18 - Damage from vibration test - ACB-2400. Note abrasion of breaker and door, and bending of louvers.

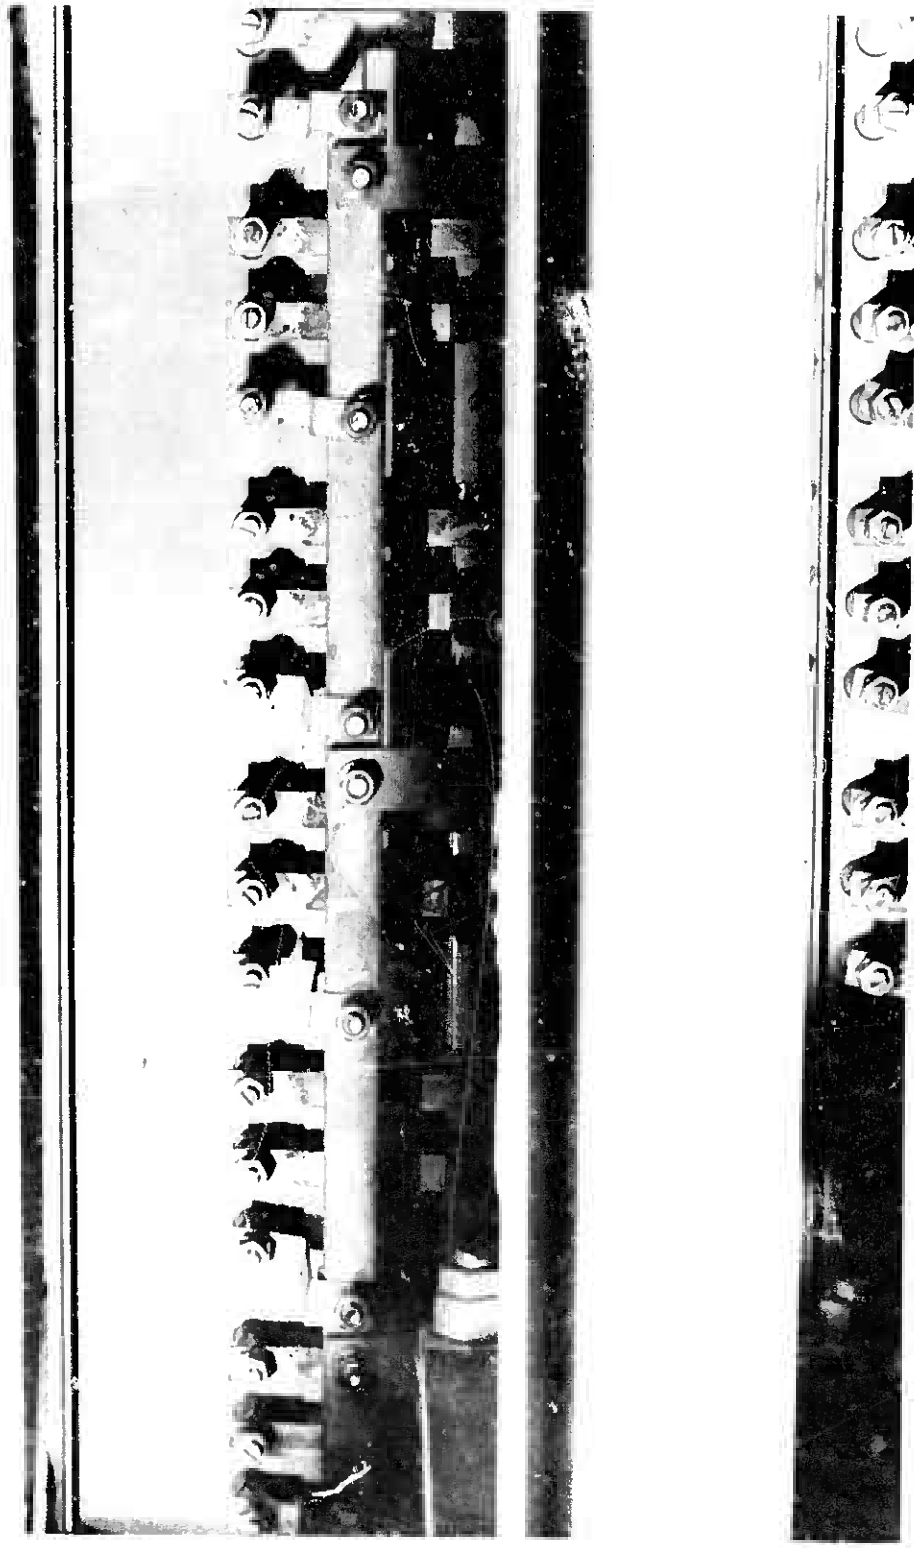
Fig. 19 - Damage from vibration test - upper horizontal bus (LF101). Note broken feeds from bus to breakers.

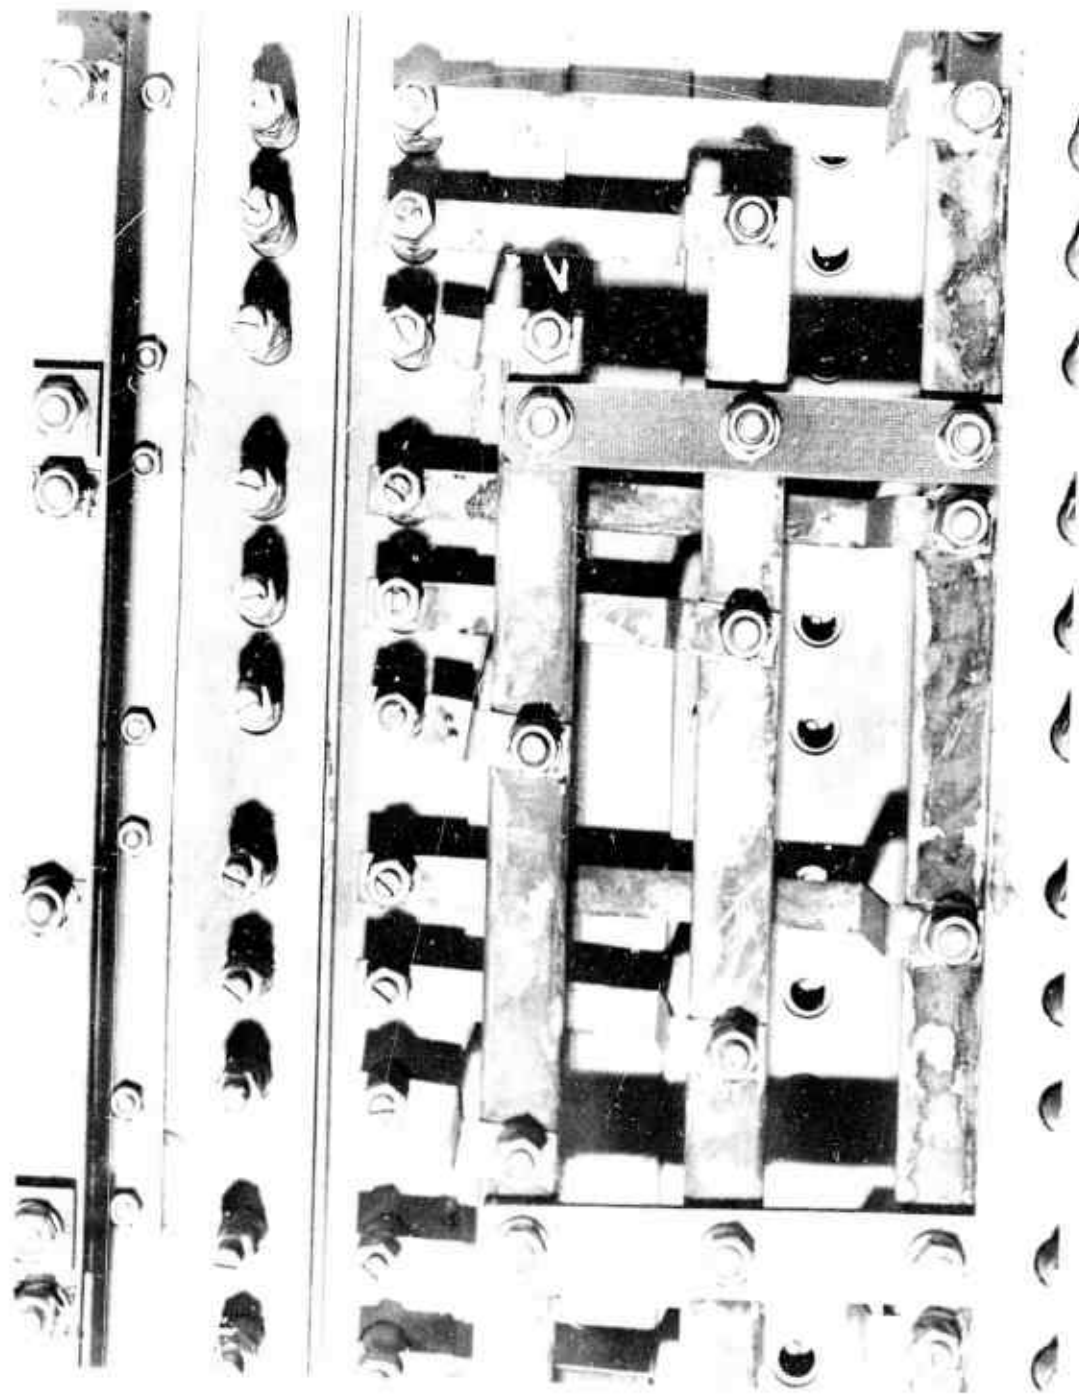
Fig. 21 - Damage from vibration test - Lower horizontal bus (LF101). Note broken feeds from bus to breakers.

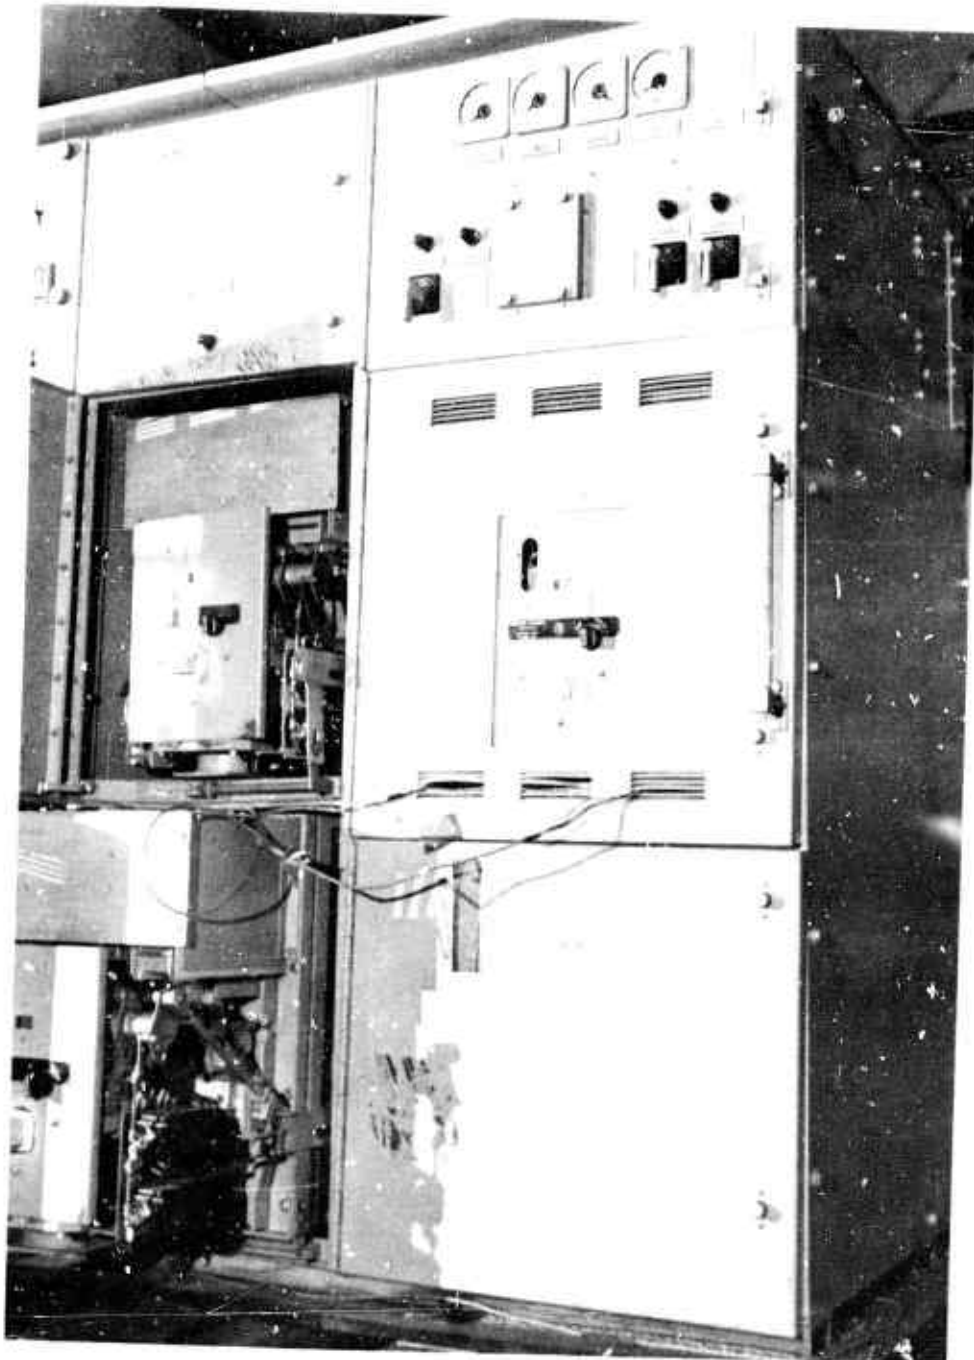
1. All six door-panels tilted downward because of slippage of the hinges, and louvers were torn (Figs. 26, 32 and 33).
2. The door panel of ACB-1600 No. 2 was jammed closed due to damage of the lower lock (Fig. 32).

3. The horizontal frame members below the ACB breakers were bent downward from impact by the breakers (Figs. 26, 27, 28, 30, 32, 33 and 35).
4. The interlock mechanisms of the ACB breakers were damaged, those of ACB 1600 No. 2 and the ACB 2400 having their actuator pins bent and that of ACB 1600 No. 1 being knocked out completely (Figs. 28, 29, 32, 34 and 36).

Fig. 26 - Damage from Vertical Shock. Note tilting of panel doors due to slippage of the hinges on the switchgear frame, and bending of the horizontal frame member below the upper 1600 A breaker. Photographed after Blow 3 (5-1/2 ft. Drop, 3 in 2 panel), but similar damage was noted for the preceding 3-1/4 ft. Drop blows.

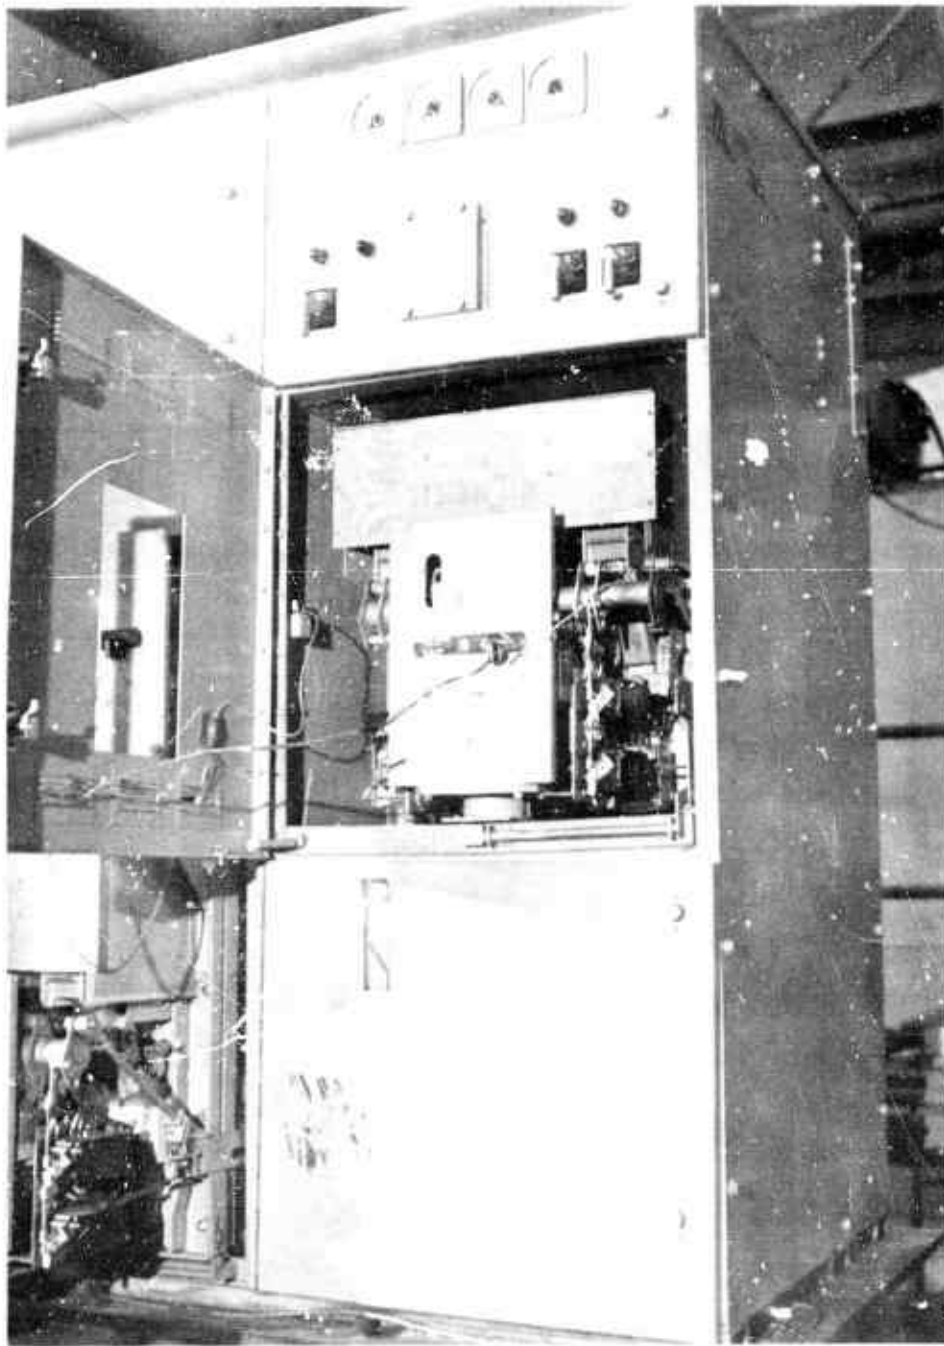
Fig. 27 - Damage from Vertical Shock. Note deformation of horizontal frame member below the 2400 A breaker, and misalignment of panel door hinge. (After Blow 3).

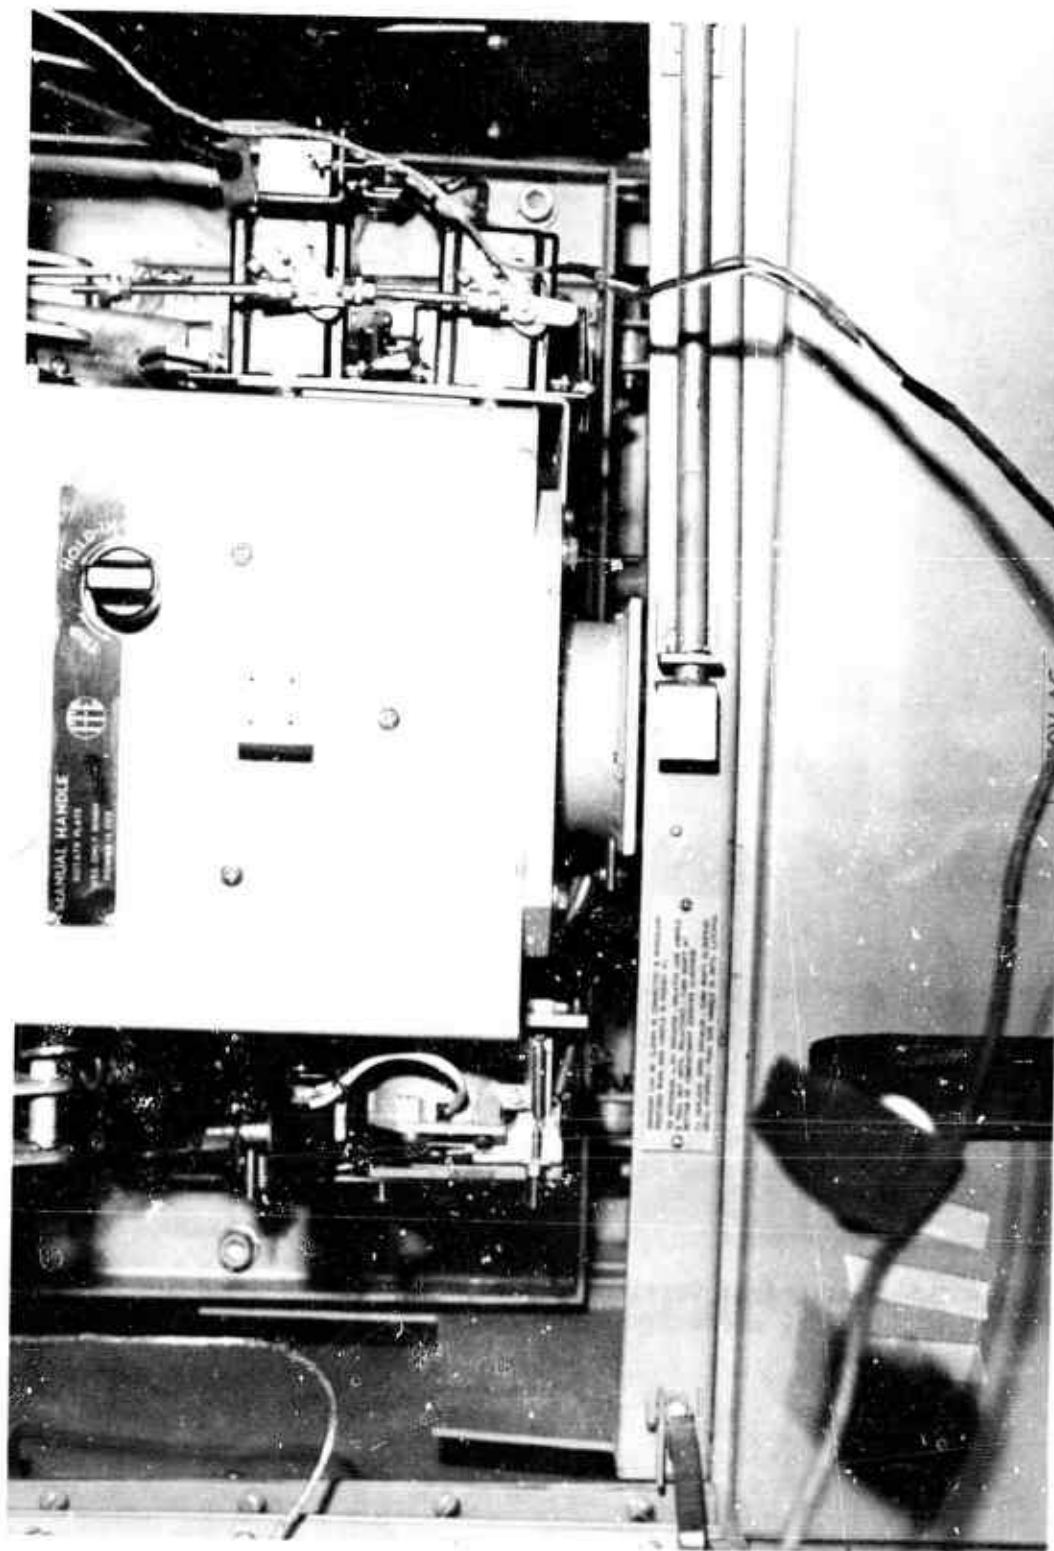
Fig. 28 - Damage from Vertical Shock - 2400 A Breaker Compartment. Note deformation of interlock mechanism (far right), breaker support, horizontal frame member; and slippage of panel-door hinge. (After Blow 3).

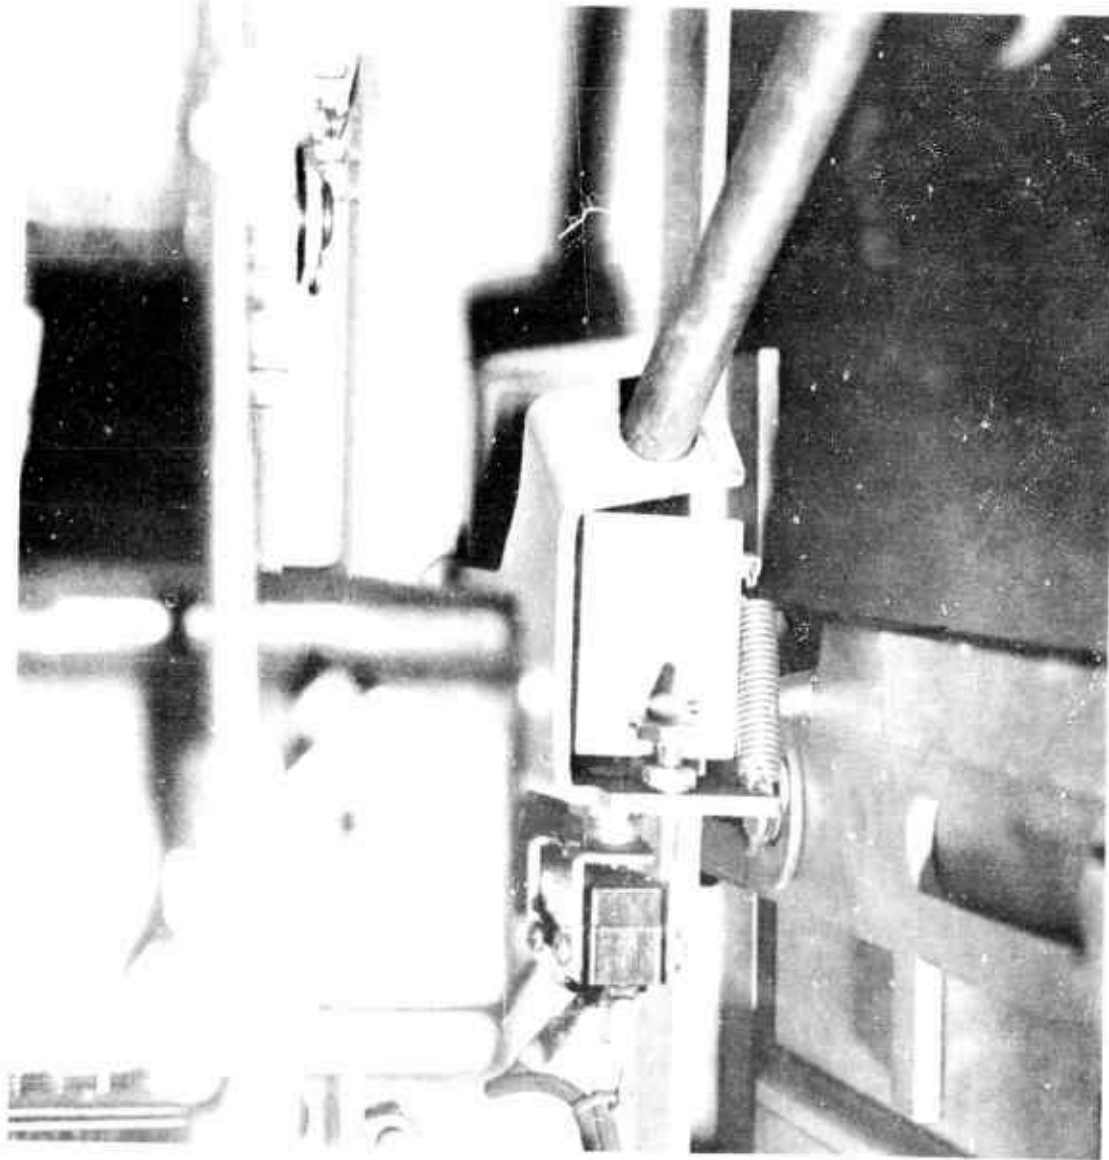
Fig. 29 - Damage from Vertical Shock. Detail of damage to 2400 A breaker interlock mechanism after Blow 3.

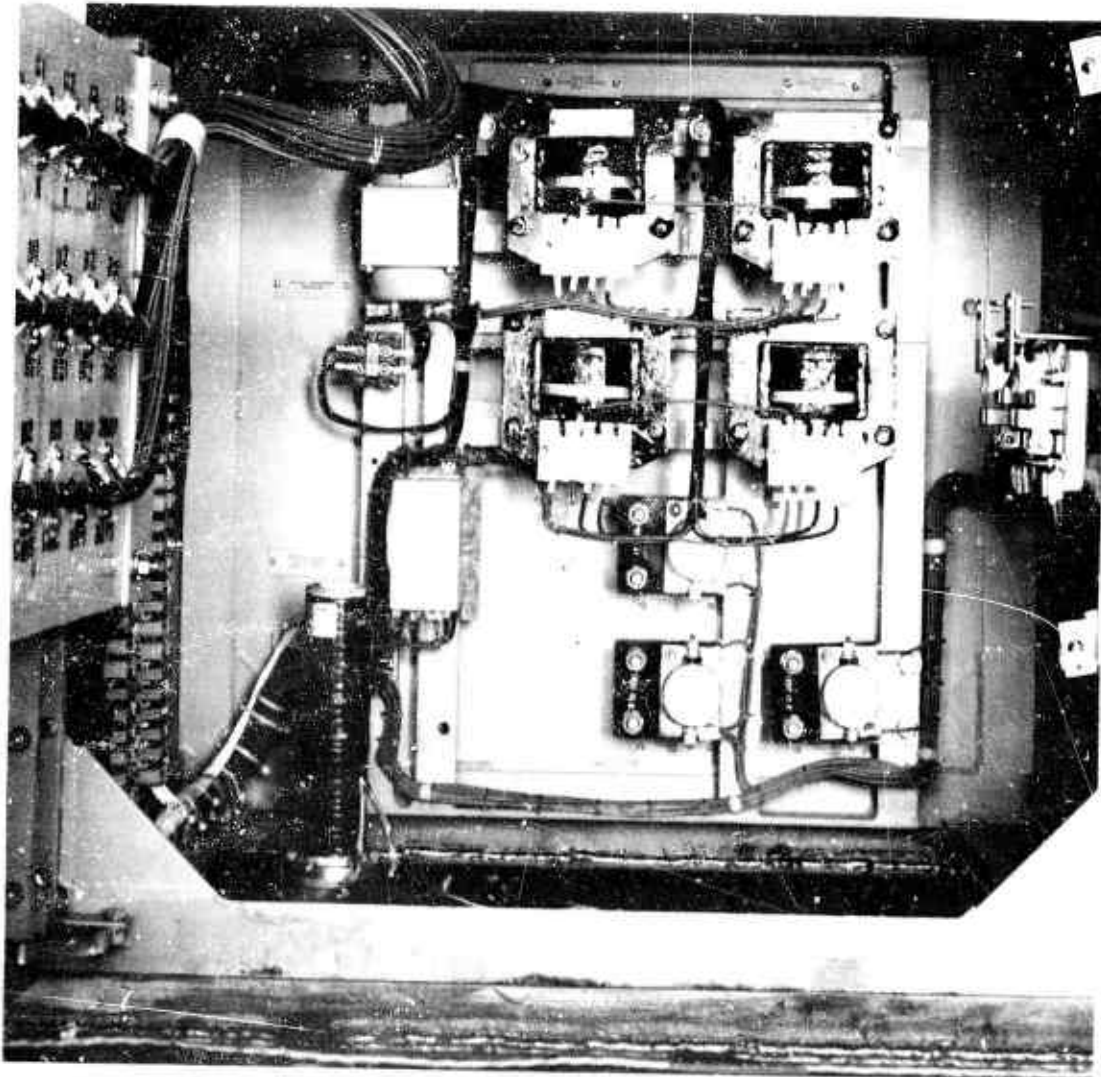
Fig. 31 - Damage from Vertical Shock - Fuse Compartment. Note slippage of fuse board hinge and damage of fuse board and fasteners. The vertical black cylinder at lower left is the velocity meter. (After Blow 3).

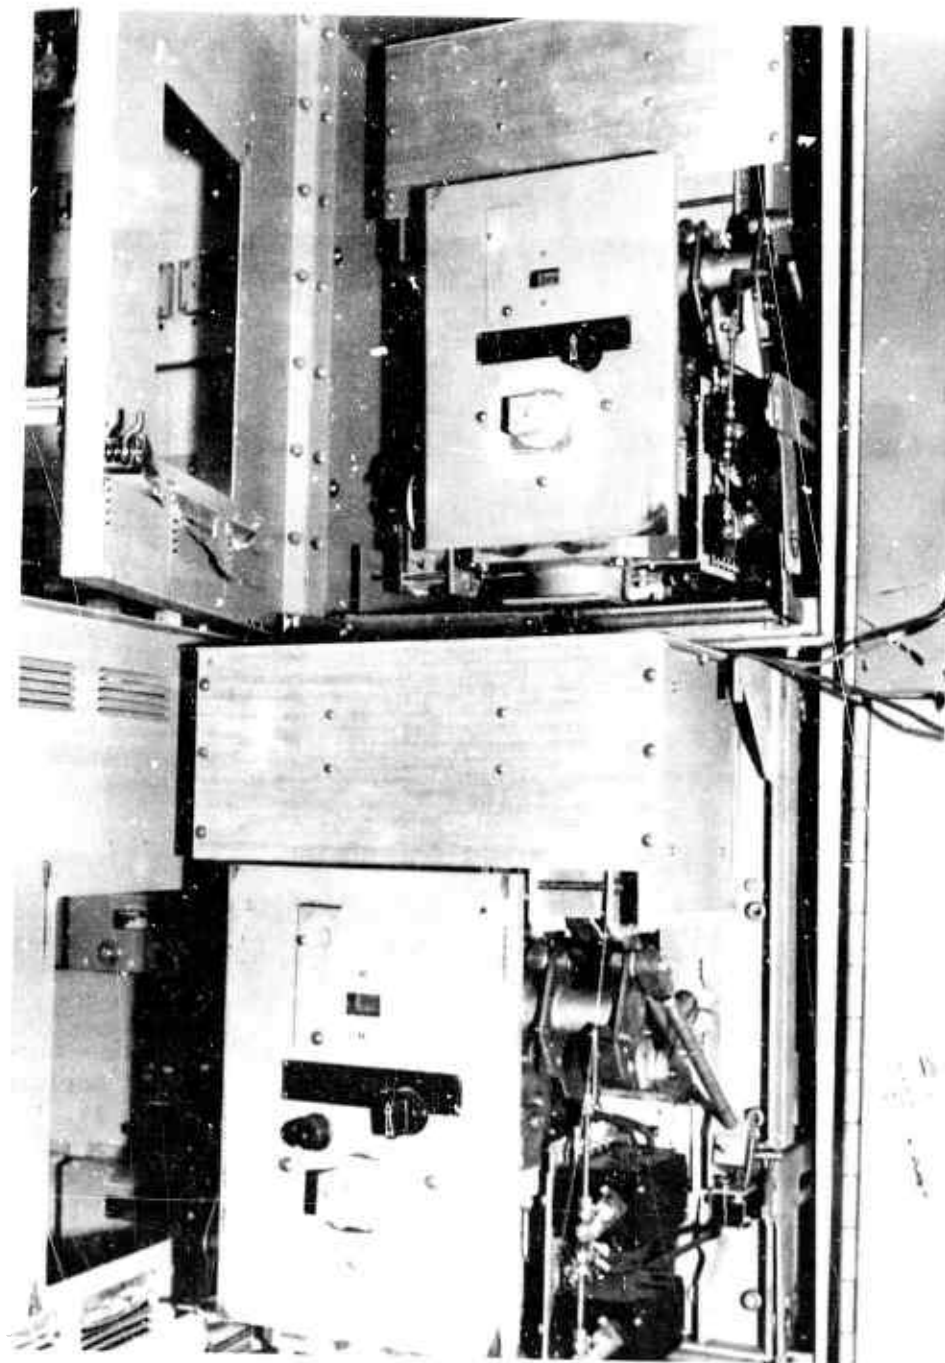
Fig. 32 - Damage from Vertical Shock - 1600 A Breaker Compartments.
Note damage to panel door louvers and locks. (After Blow 3).

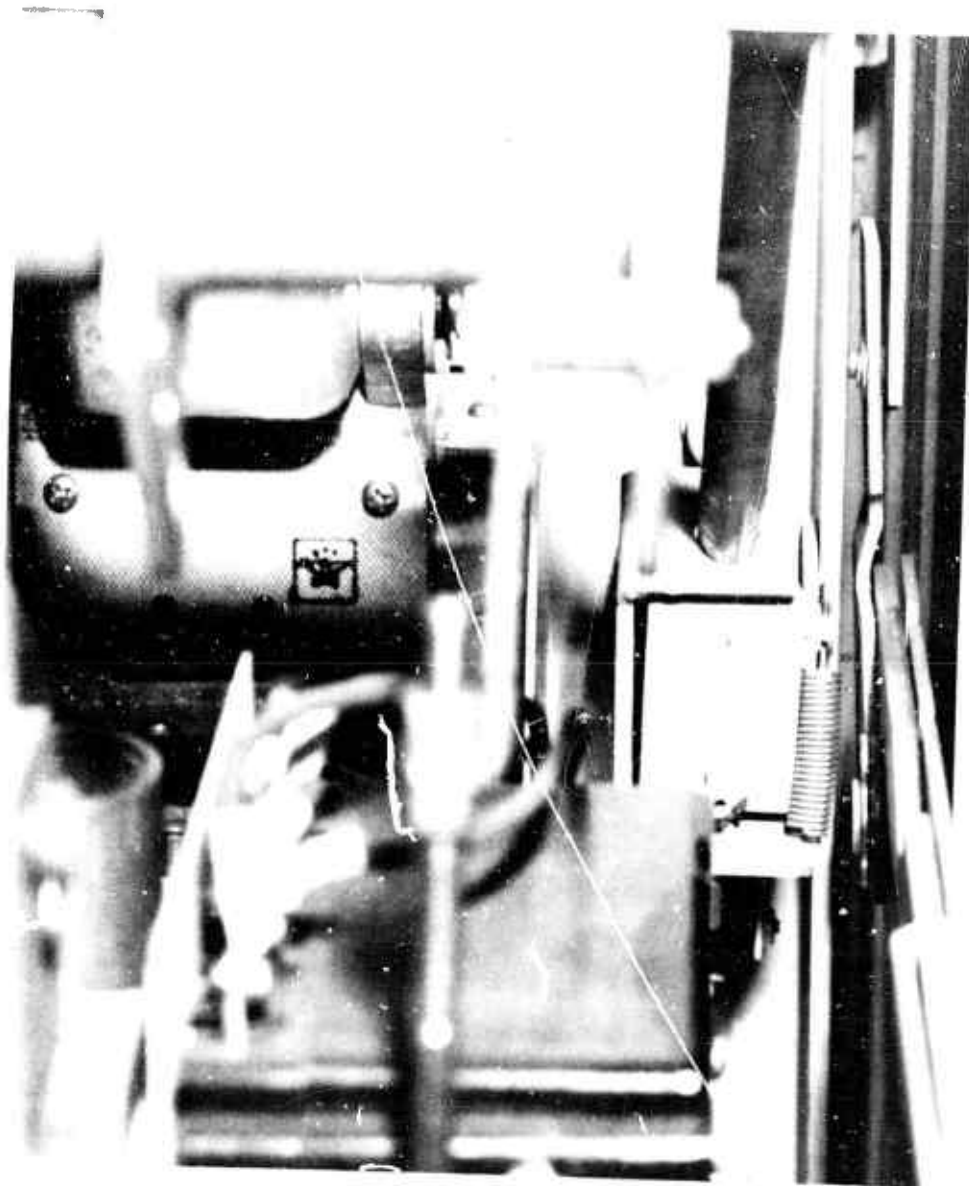
Fig. 34 - Damage from Vertical Shock - upper 1600 A Breaker Compartment. Detail of damage to interlock mechanism. (After blow 3).

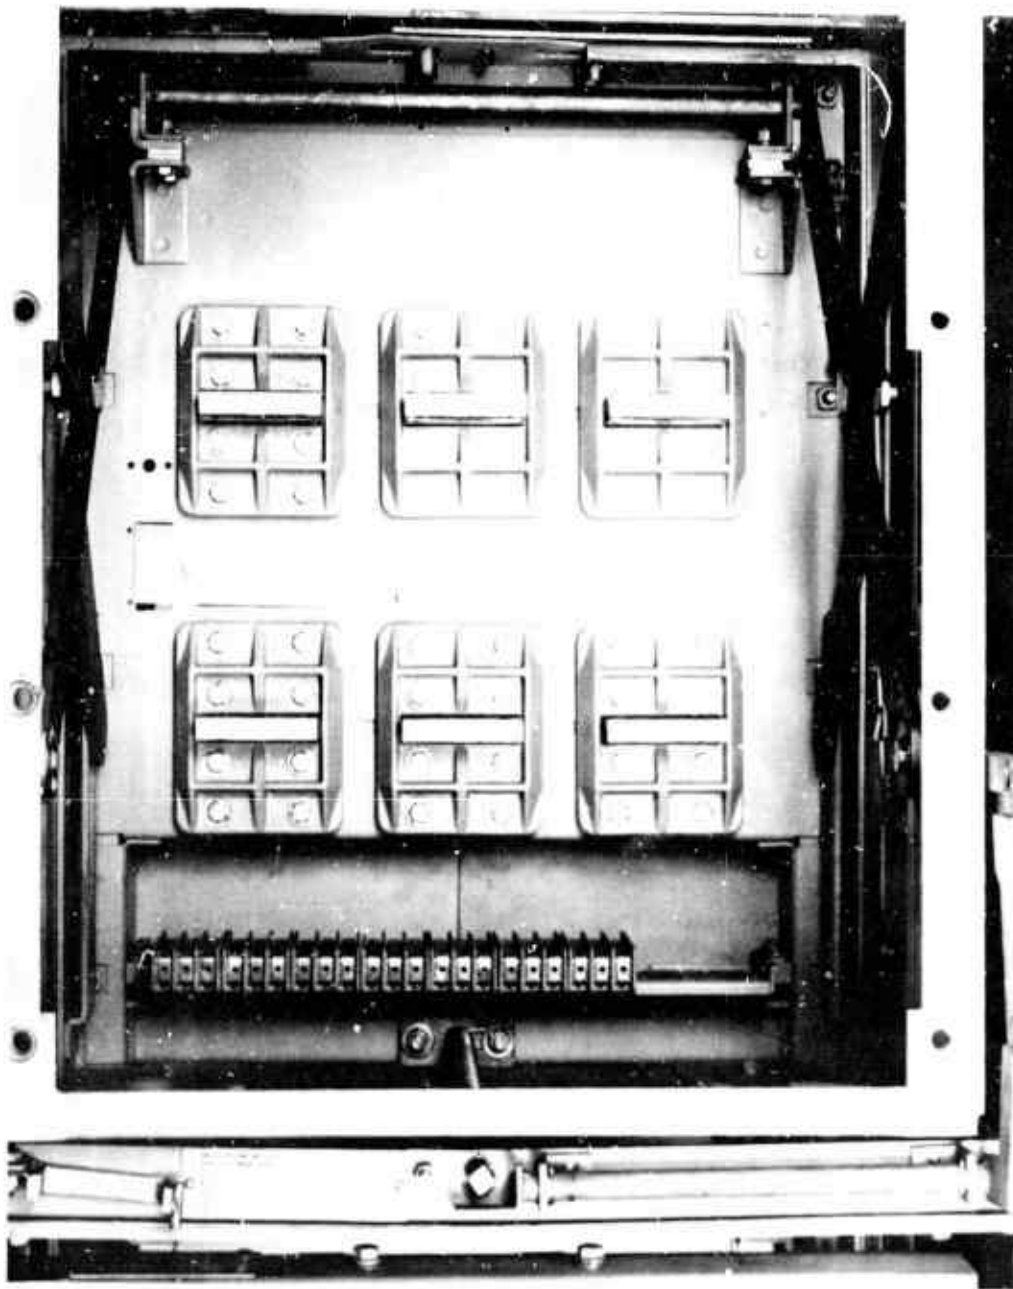
Fig. 35 - Damage from Vertical Shock - upper 1600 A Breaker Compartment. Note deformation of breaker support frame, particularly at top. (After Blow 3).

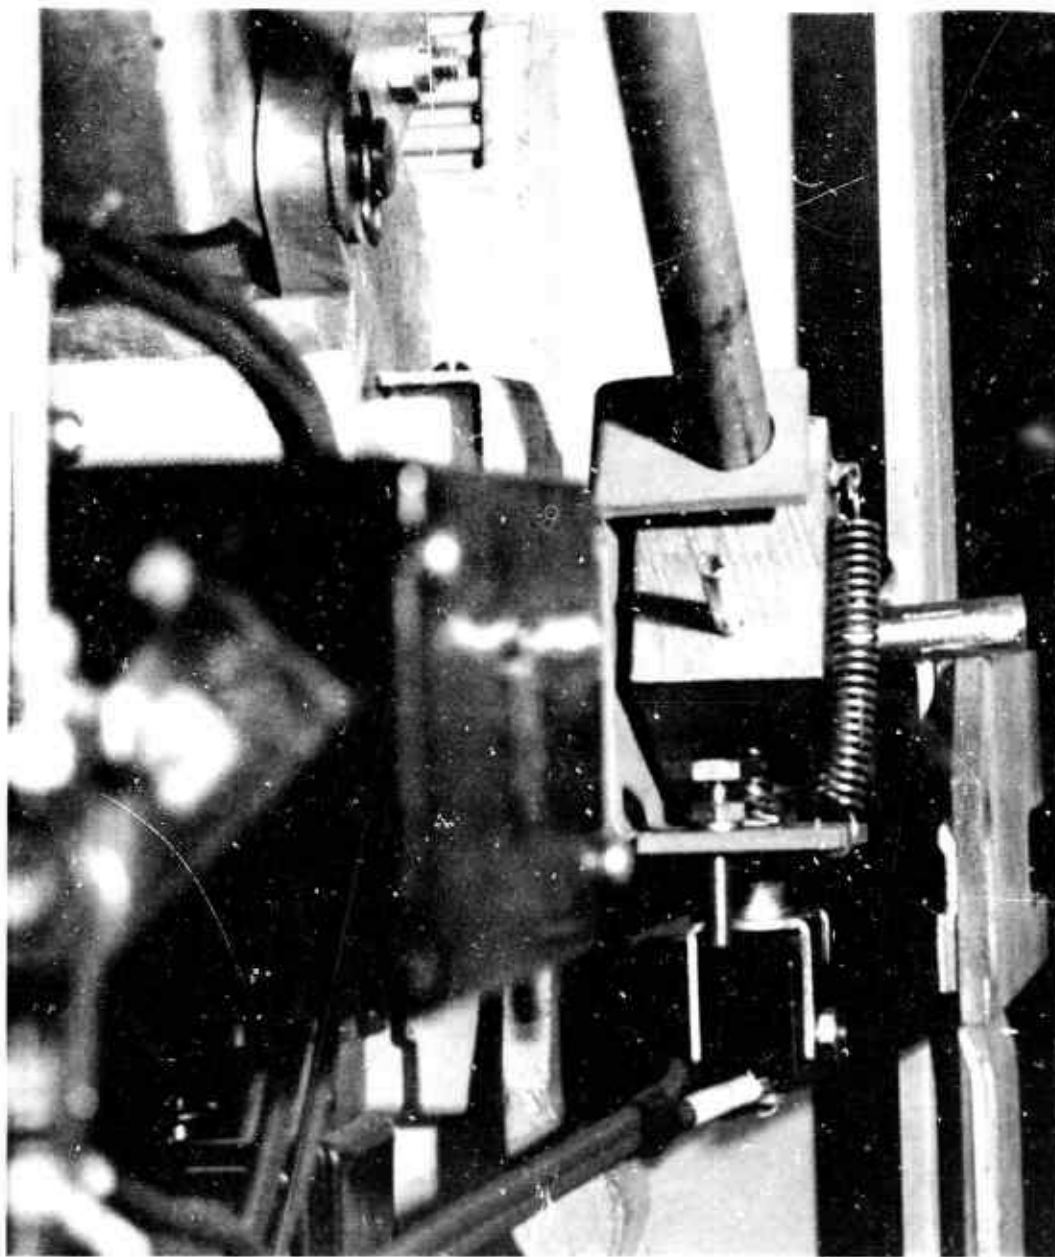
Fig. 36 - Damage from Vertical Shock - lower 1600 A Breaker Com-
partment. Detail of damage to breaker inlock mechanism. (After
blow 3).

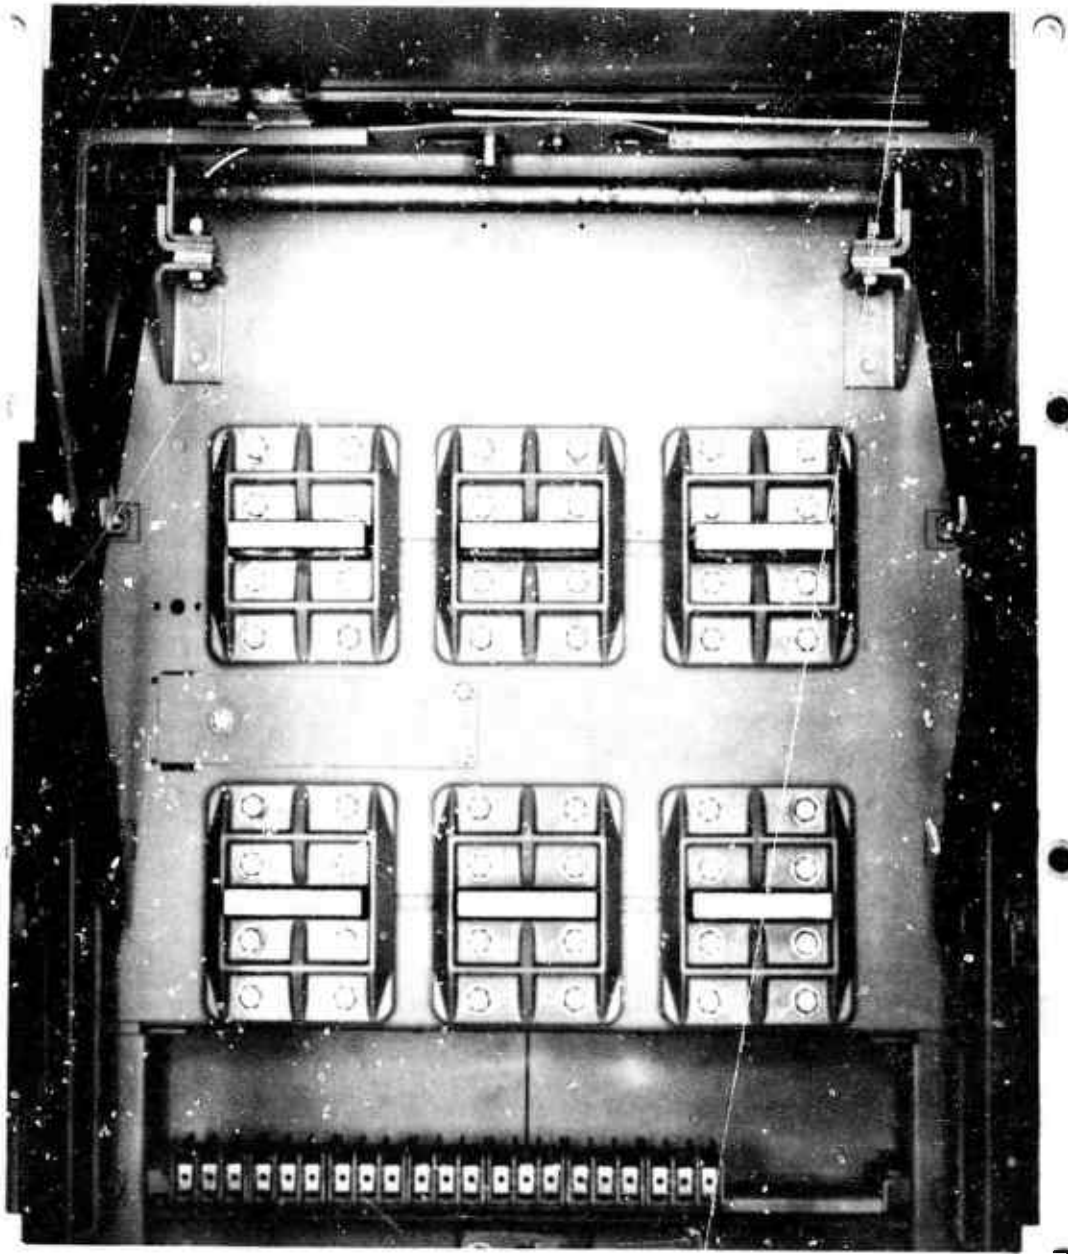
6. One of the brackets holding the frame for the ACB 2400 breaker was broken off, and the upper guide and lock plate was bent. The bolts holding the melamine connector panel sheared, allowing the panel to slip down (Figs. 30, 37, 38, 39 and 40).

Fig. 37 - Damage from Vertical Shock - lower 1600 A Breaker Compartment. Note deformation of breaker support frame. (After Blow 3).

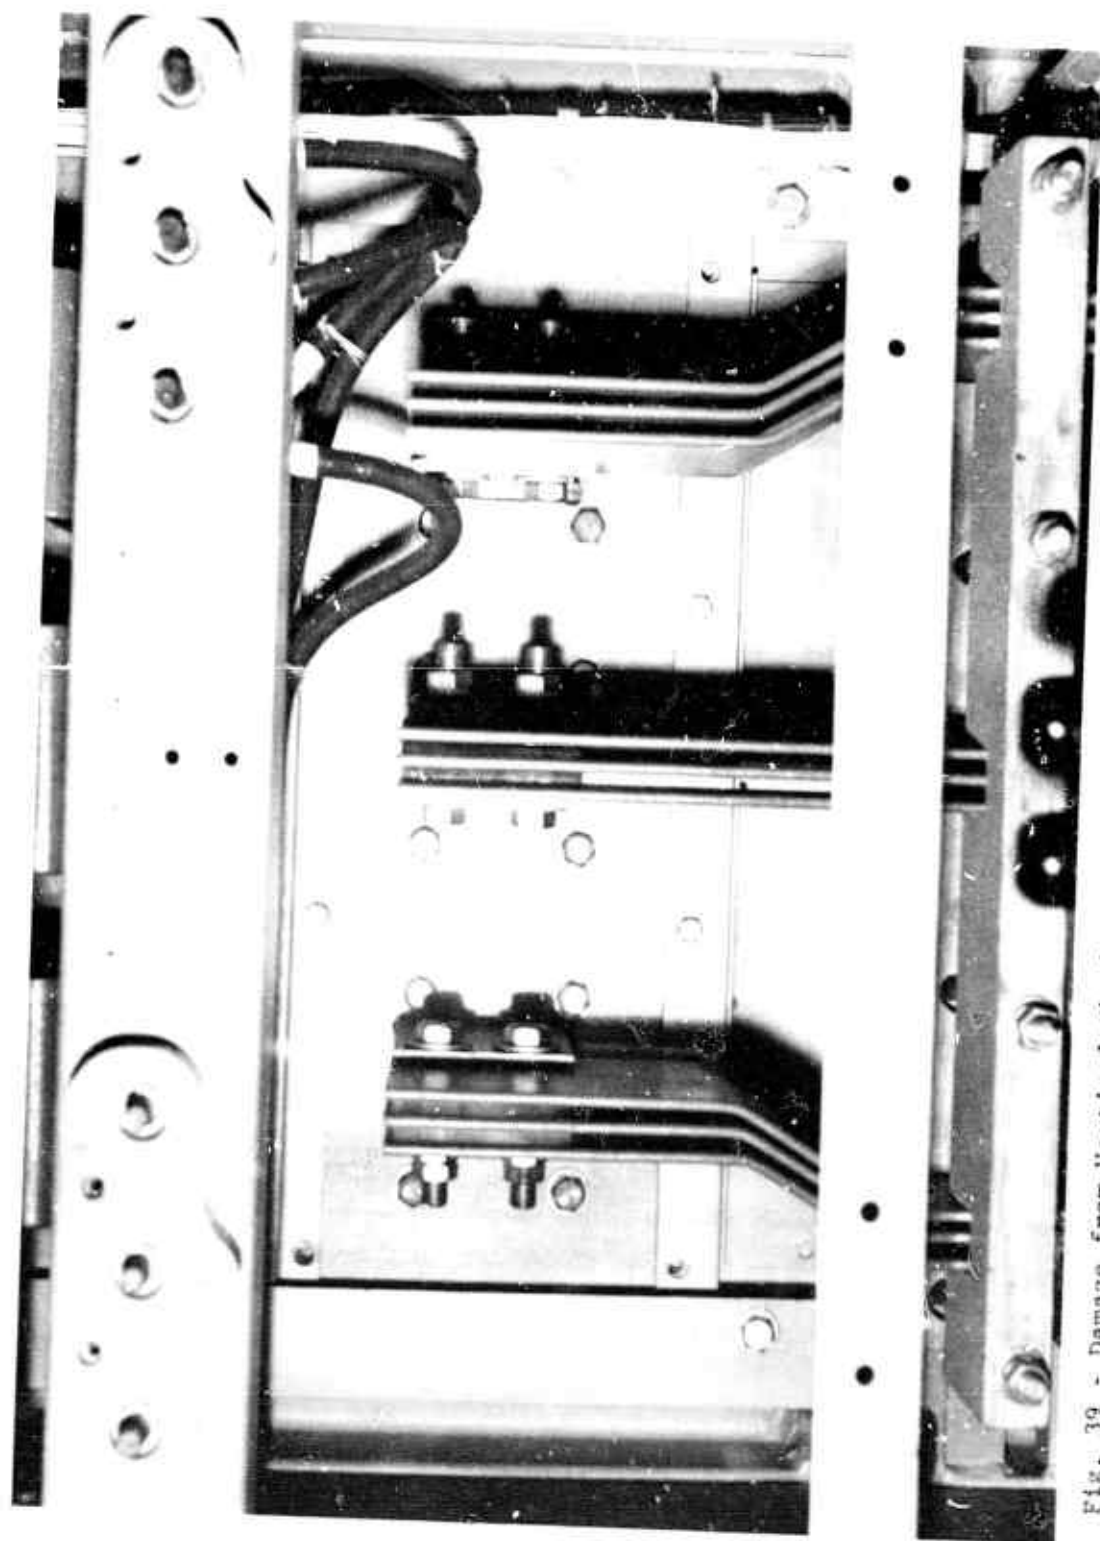
Fig. 39 - Damage from Vertical Shock - 2400 A Breaker Bay (Rear). Sheared bolts in lower half of melamine board. (After Blow 3).

Only the major damage was repaired - broken welds were gouged out and rewelded, broken bolts drilled out and replaced with high-strength bolts. The damage louvers on the ACB door-panels were stripped off entirely as they were a hazard to accelerometer cables. Bent frame members, slipped hinges, etc. were not repaired since similar damage could be predicted on the next blow with high confidence. When the test was
