NRL Memorandum Report 4003

Shock Performance of a Shipboard Electrical Switchgear

EDWARD W. CLEMENTS

June 15, 1979

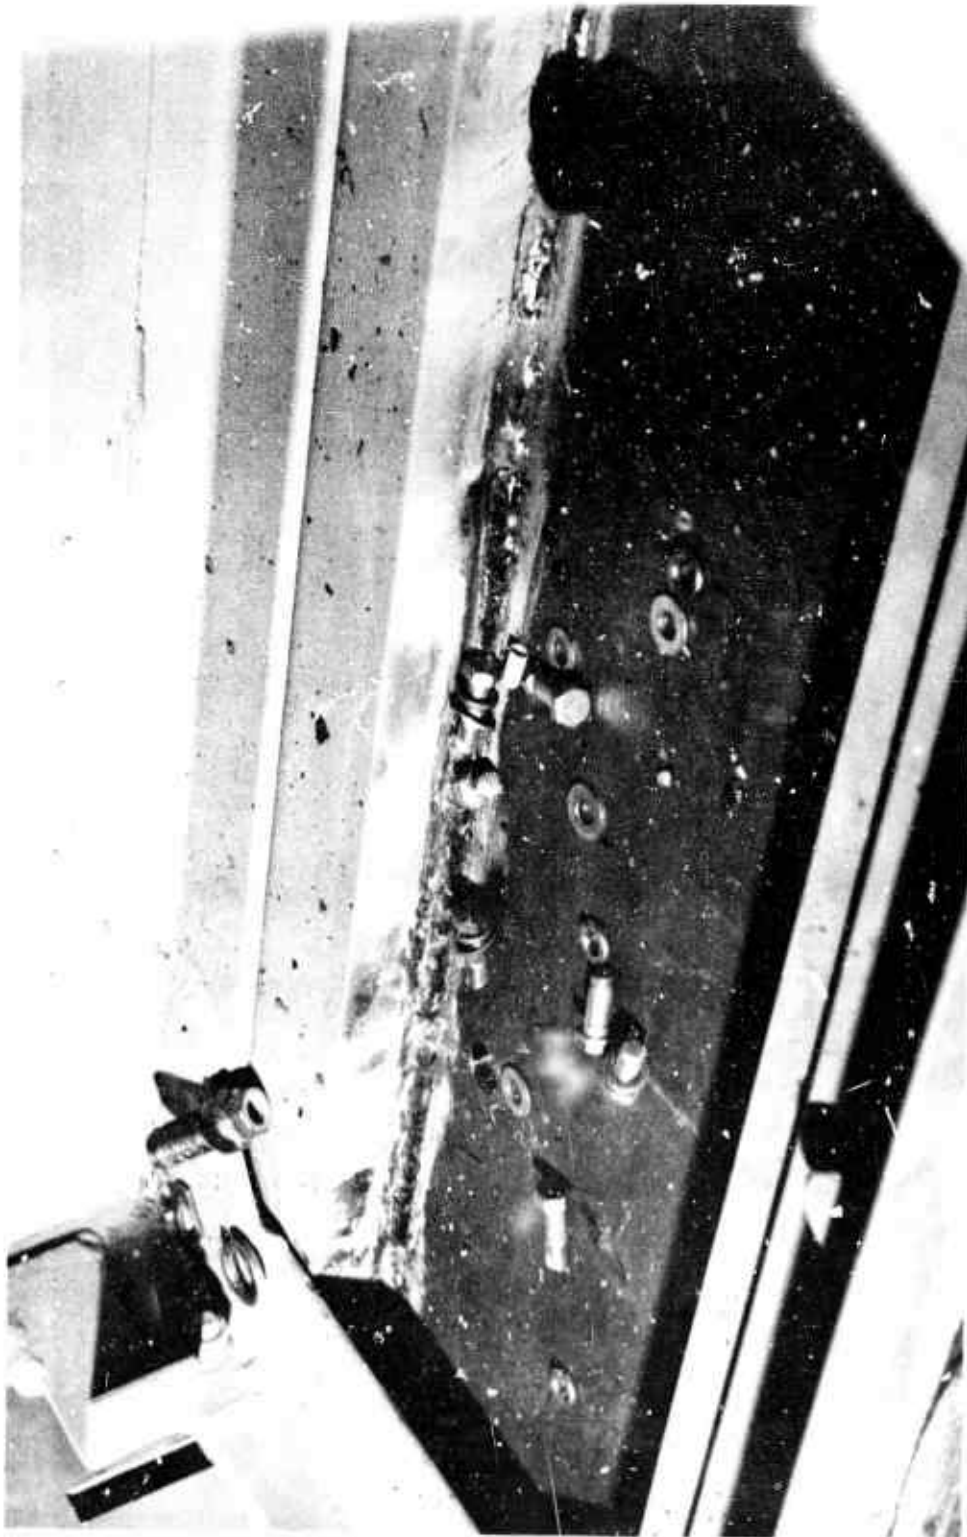
6. One of the brackets holding the frame for the ACB 2400 breaker was broken off, and the upper guide and lock plate was bent. The bolts holding the melamine connector panel sheared, allowing the panel to slip down (Figs. 30, 37, 38, 39 and 40).

FIG. 40 - Damage from Vertical Shock - 2400 A Breaker Bay (Rear). The smaller bolts were the support bolts for the melamine board. The large bolt at upper left was a switchgear hold-down bolt which was stripped out of the hole in the corner.

Only the major damage was repaired - broken welds were gouged out and rewelded, broken bolts drilled out and replaced with high-strength bolts. The damage louvers on the ACB door-panels were stripped off entirely as they were a hazard to accelerometer cables. Bent frame members, slipped hinges, etc. were not repaired since similar damage could be predicted on the next blow with high confidence. When the test was

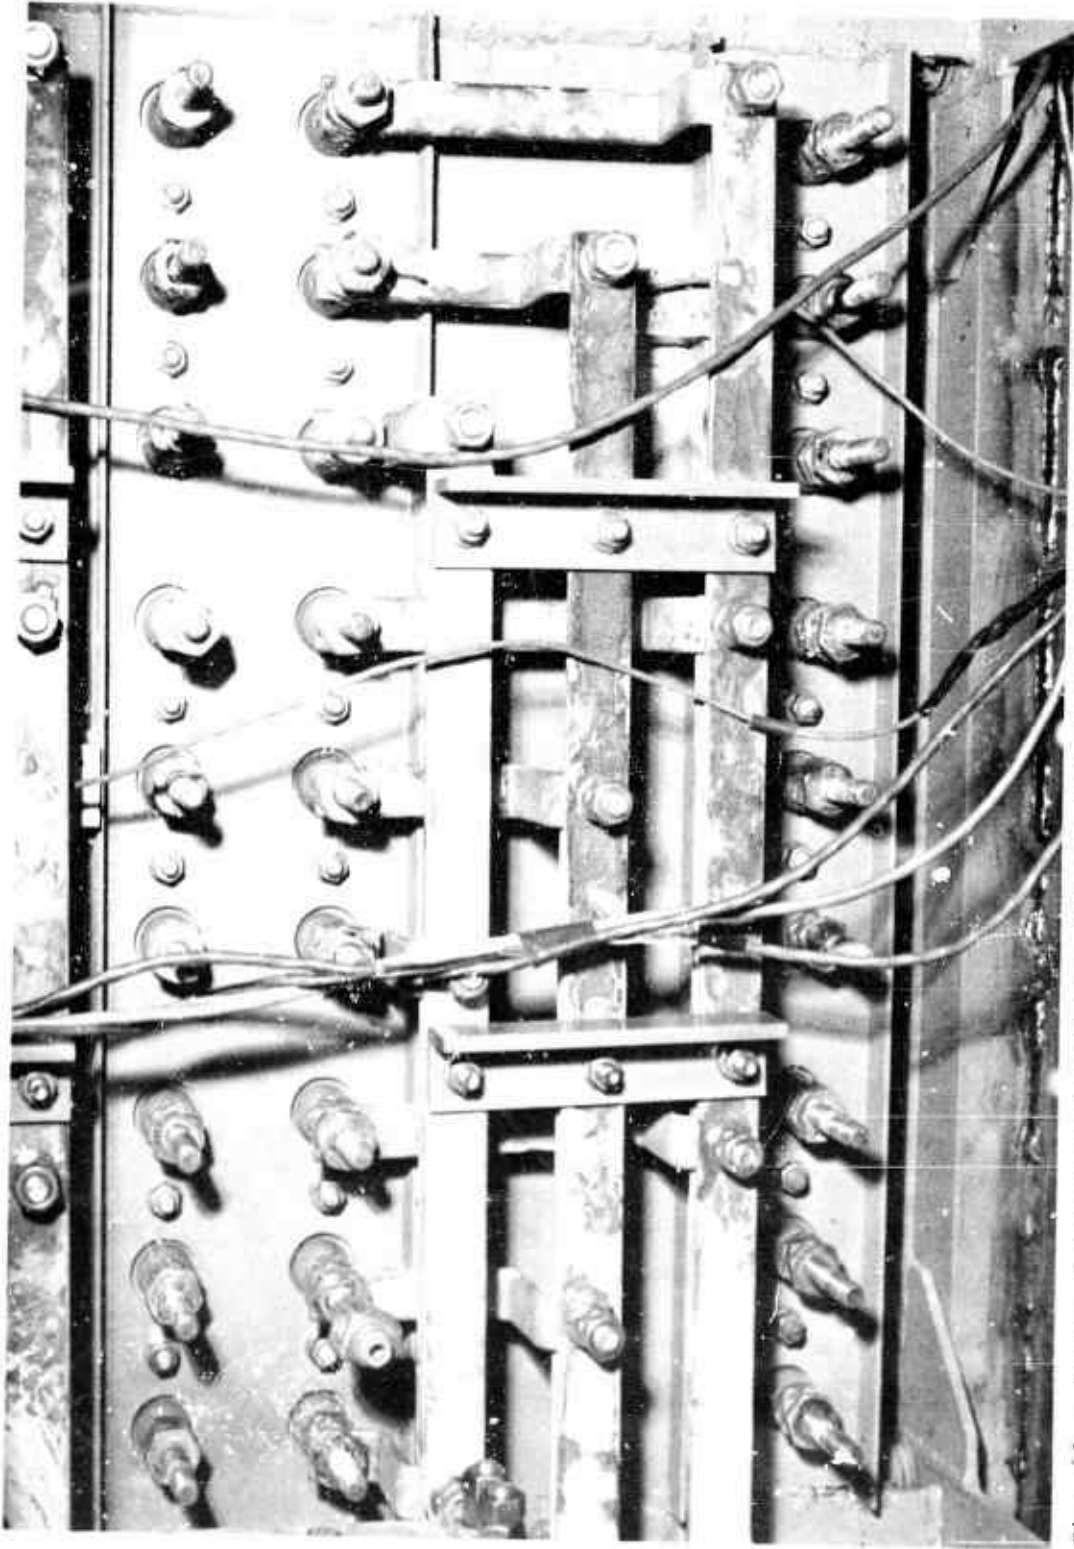
10. The welds attaching the bottom of the AQB mounting panel to the frame of the bay were broken (Fig. 41). Welds were of poor quality, with little penetration. Member edges had apparently been simply butted together without grooving.

Fig. 41 - Damage from Vertical Shock - AQB Breaker Bay (Rear). Note cracked welds at each end of the lower frame member. (After Blow 3).

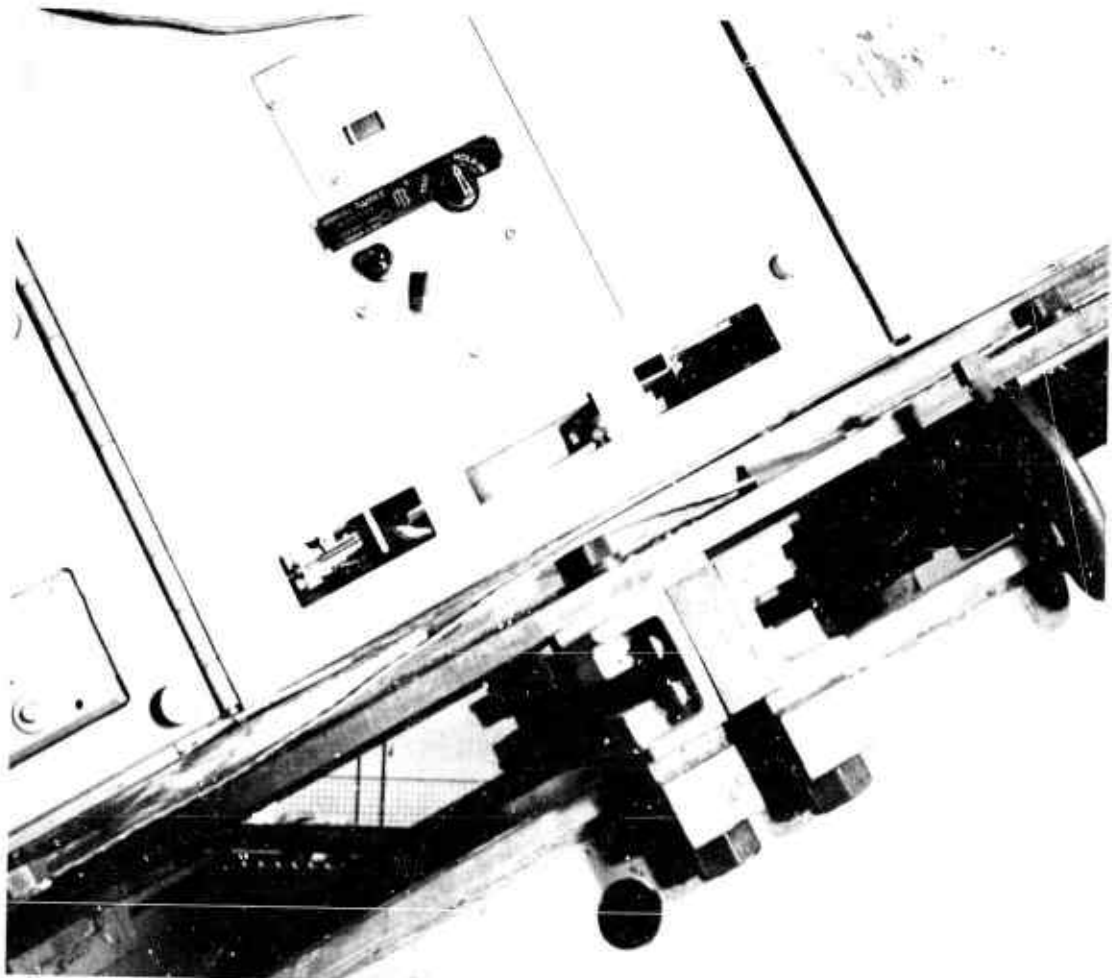
Only minor damage such as slipping of door-panels and the fuse panel was noted as the test progressed. However, inspection after Blow 6 located fractures and deformation in the front bottom frame members at the bay junctions (Fig. 42) accompanied by loosening of the hold-down bolts in the vicinity. One hold-down bolt, in the corner of the ACB-1600 bay adjacent to the junction with the ACB-2400 bay, was stripped out. Replacing this bolt and tightening the loose ones drew the frame back down in contact with the channels. No other repairs were made.

Fig. 42 - Damage from Vertical Shock. Note breakage and deformation of switchgear base frame member below bay junctions. Switchgear is oriented for Inclined Shock. (After Blow 6).

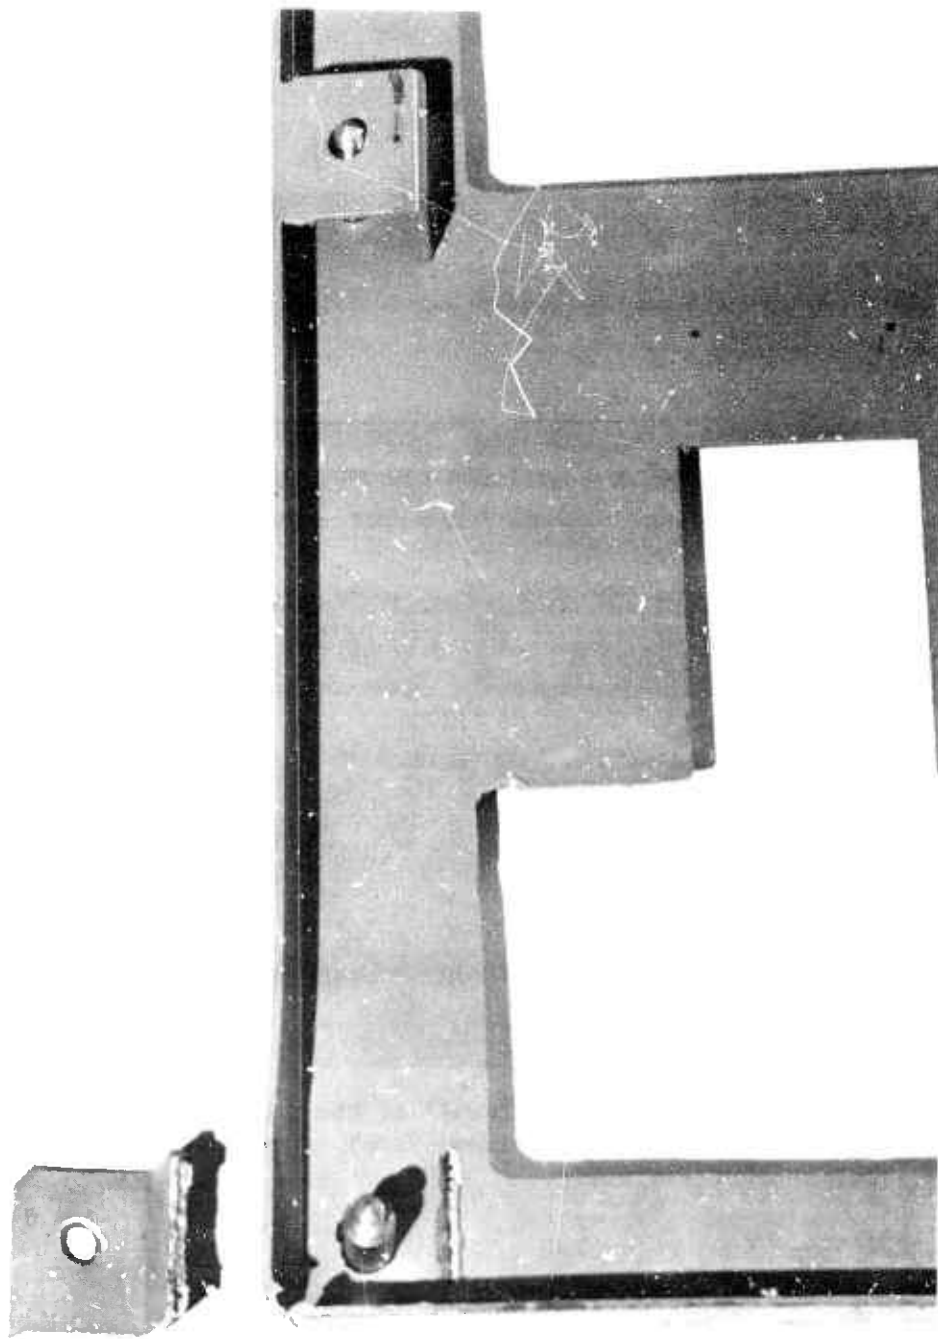
Fig. 45 - Damage from Shock Test. Broken corner and support of LF250 cover panel.

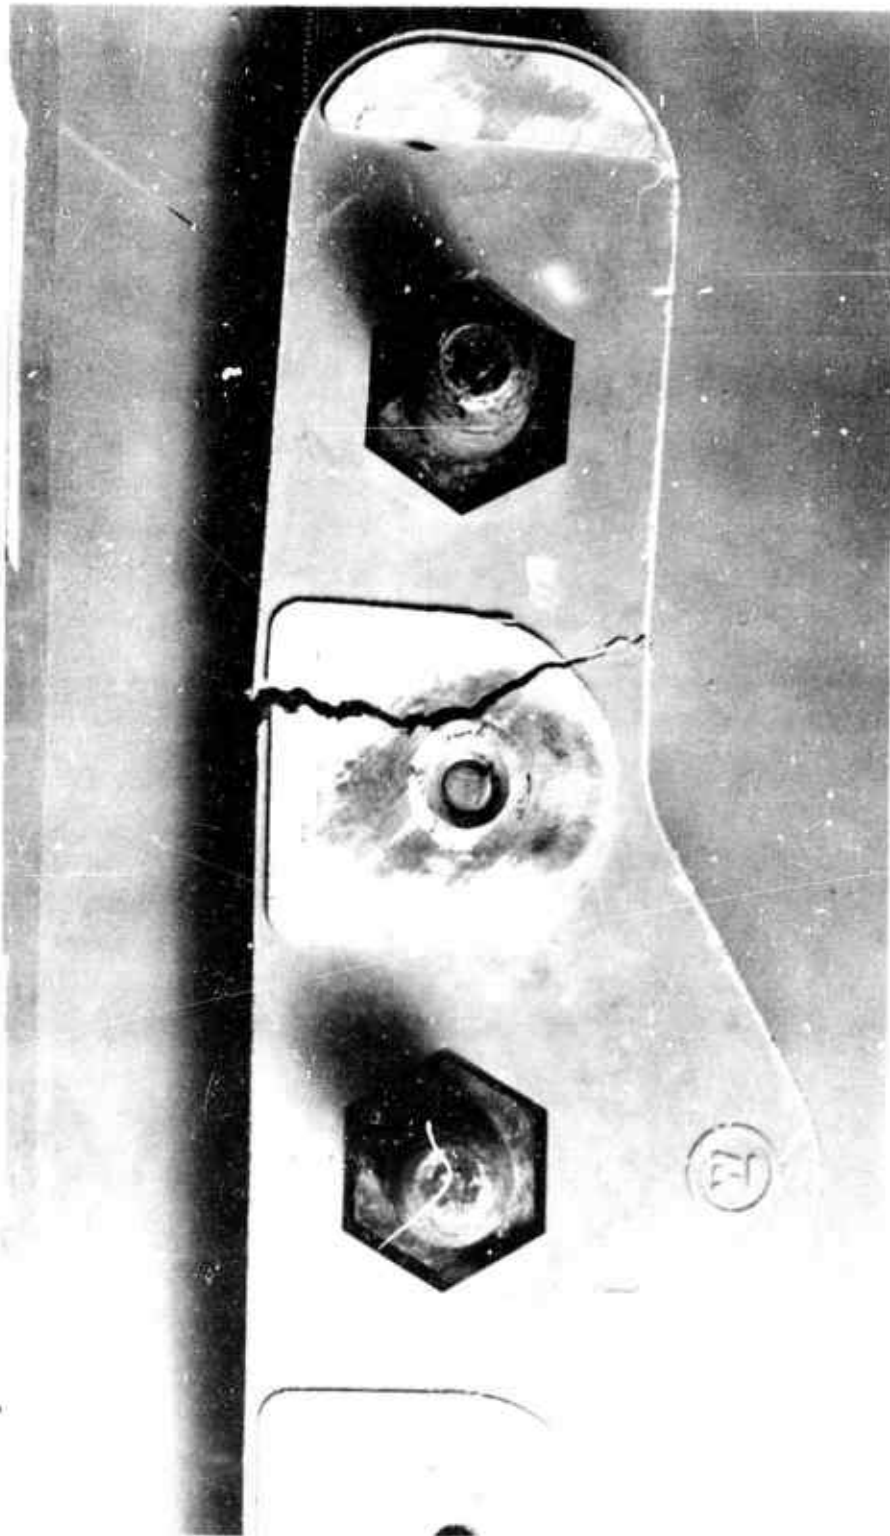
Fig. 46 - Damage from Shock Test. Broken upper mount and sheared breaker hold-down bolt for LF250 No. 9.

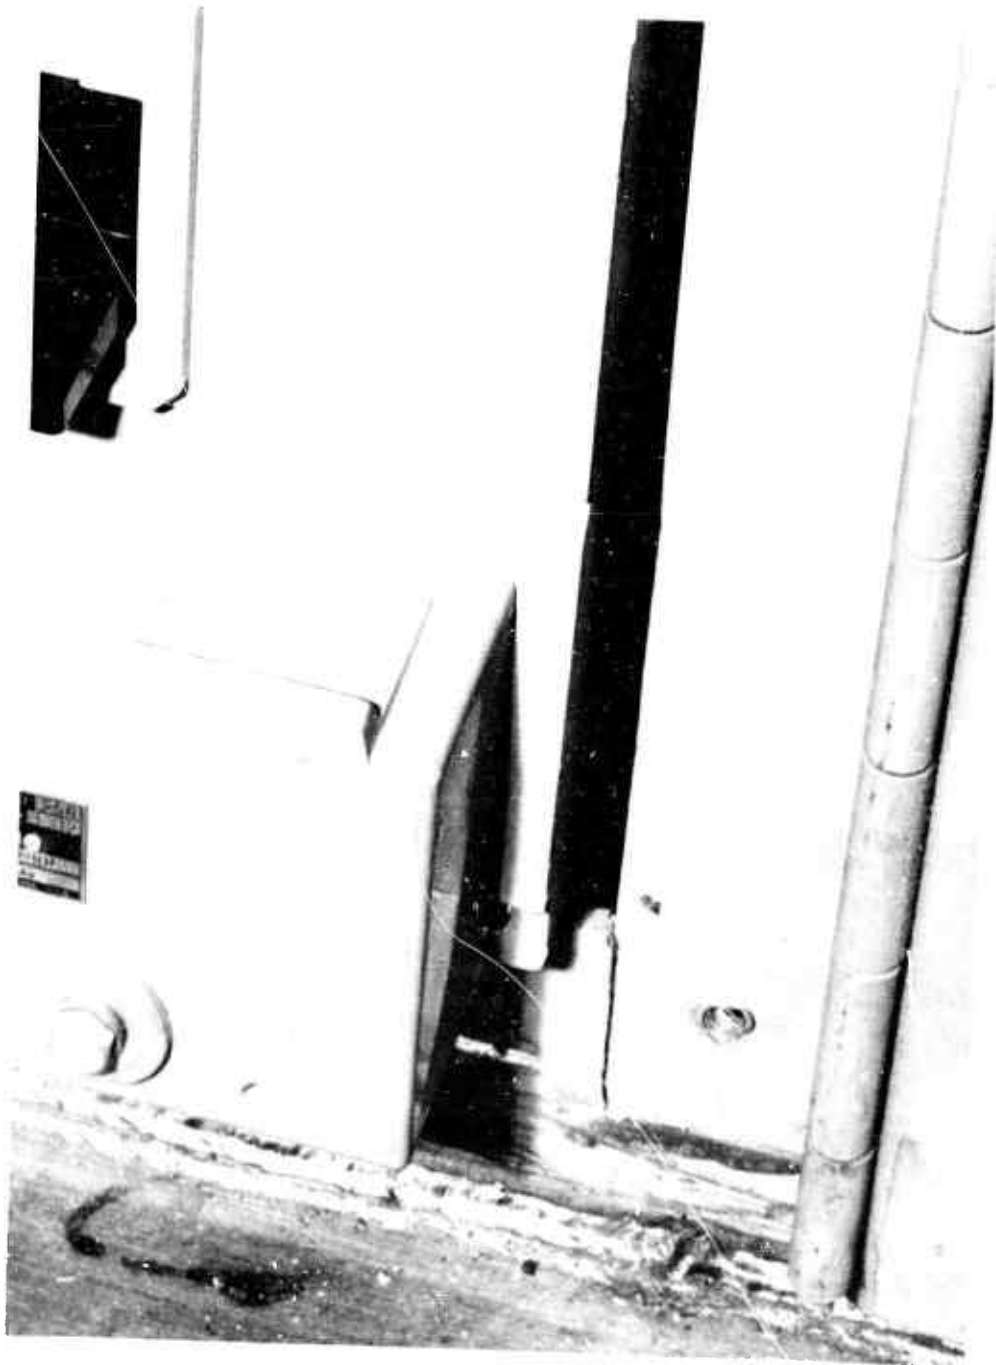
Fig. 49 - Damage from Shock Test - AQB Breaker Bay. Inner vertical frame member broken loose at base, and horizontal bottom member shifted over.

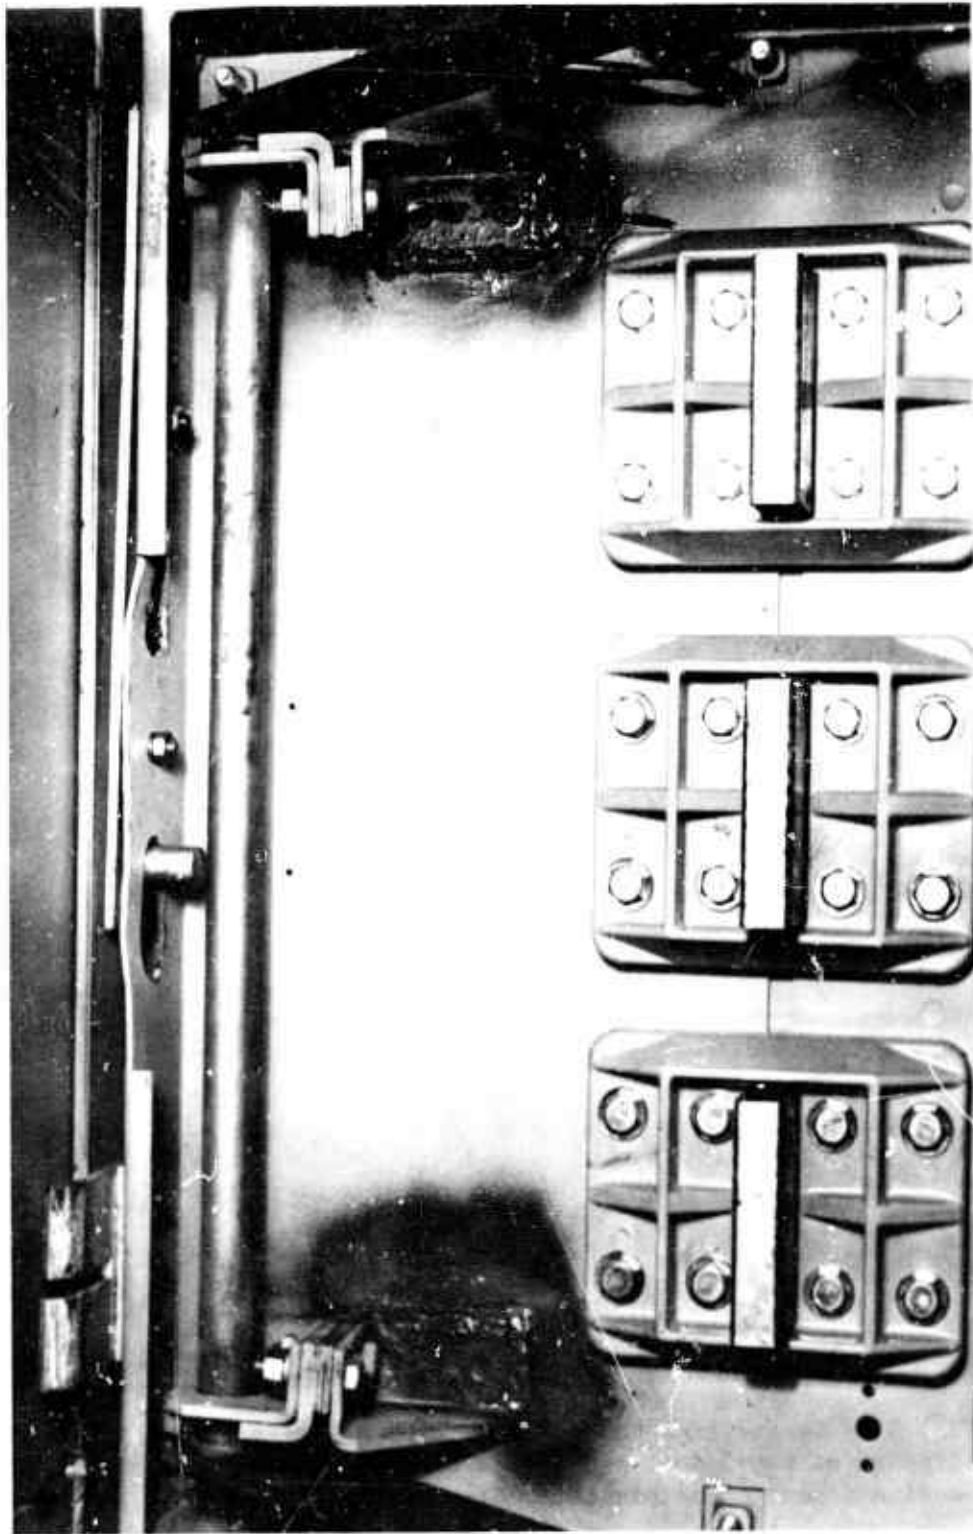
Fig. 50 - Damage from Shock Test - upper 1600 A Breaker Compartment. Damage to breaker support frame.

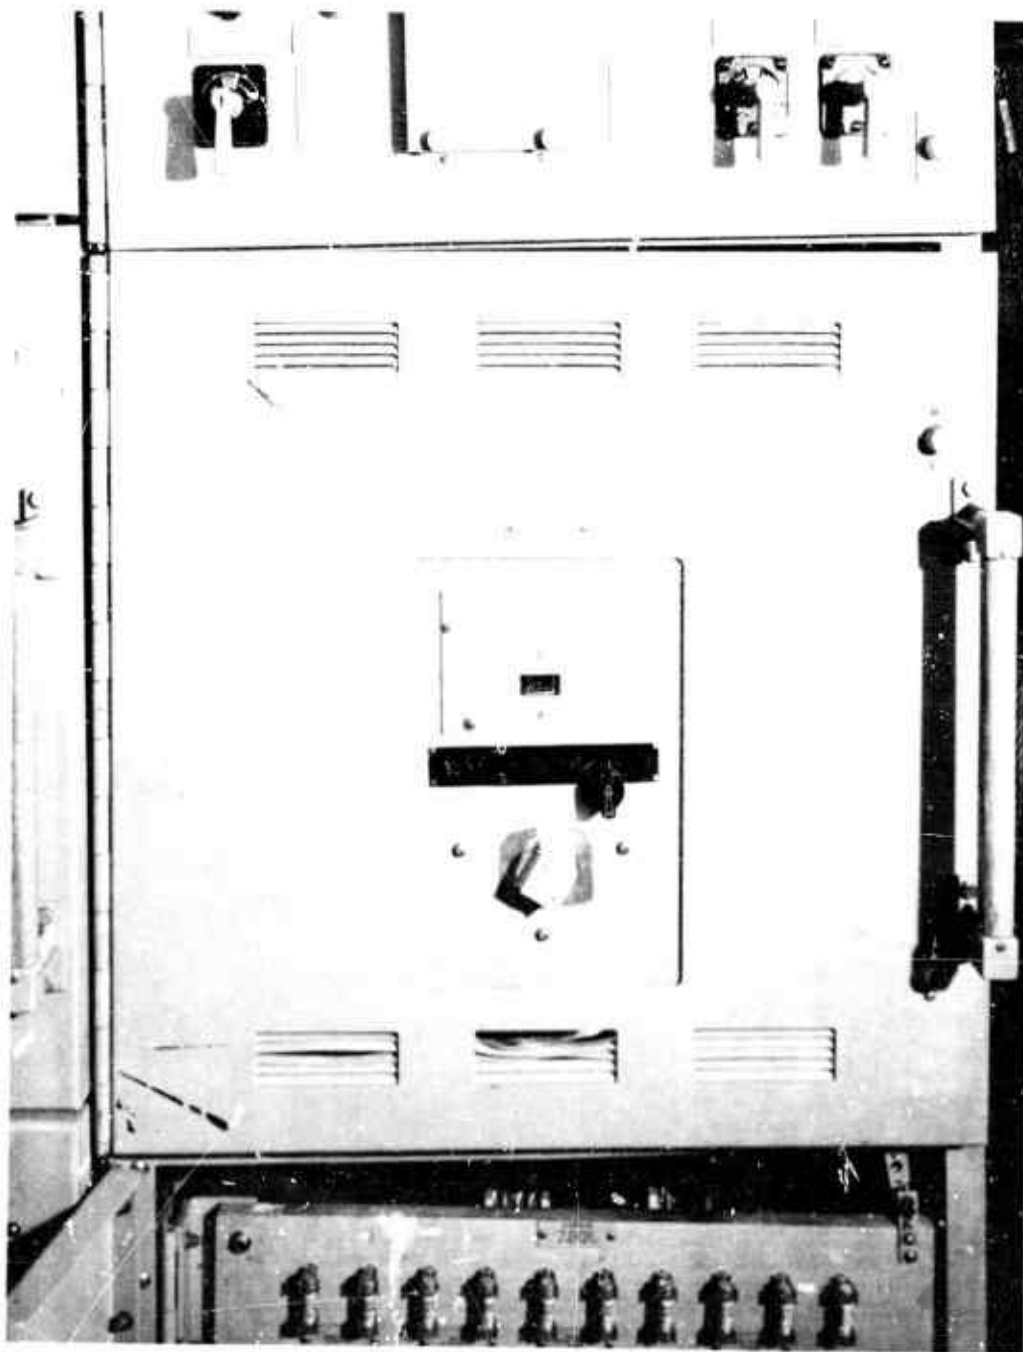
Fig. 51 - Damage from Shock Test - 2400 A Breaker Bay. Note slippage of panel door and damage to louvers, slippage of fuse panel and damage and panel and fasteners.

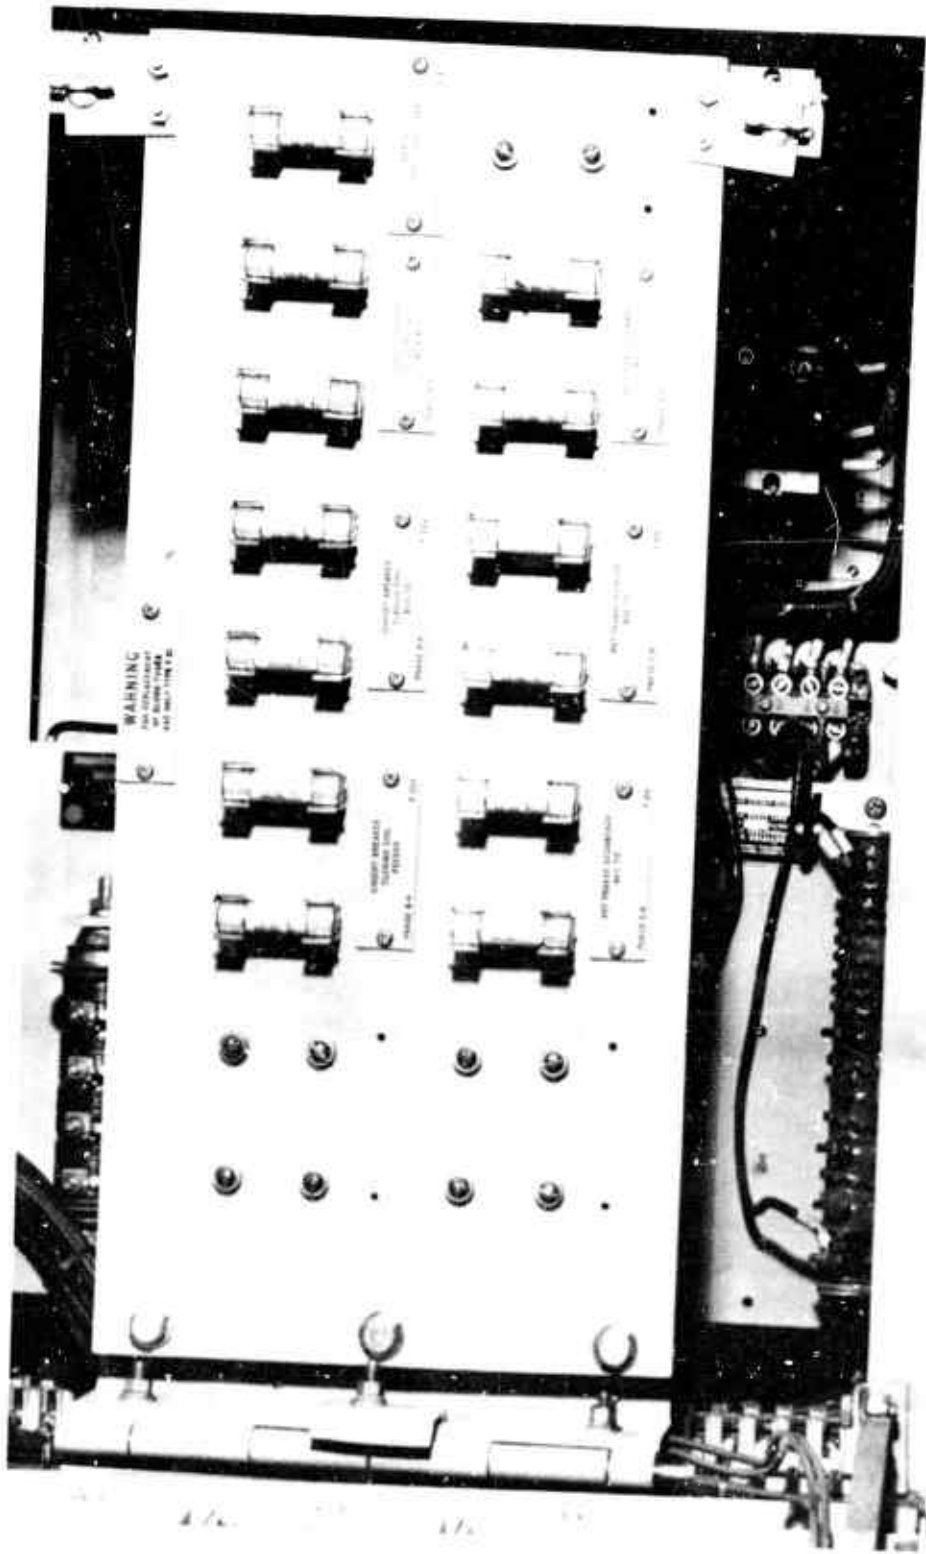
Fig. 52 - Damage from Shock Test - Fuse Compartment. Note slippage of fuse panel hinge and travel of hinge pin.

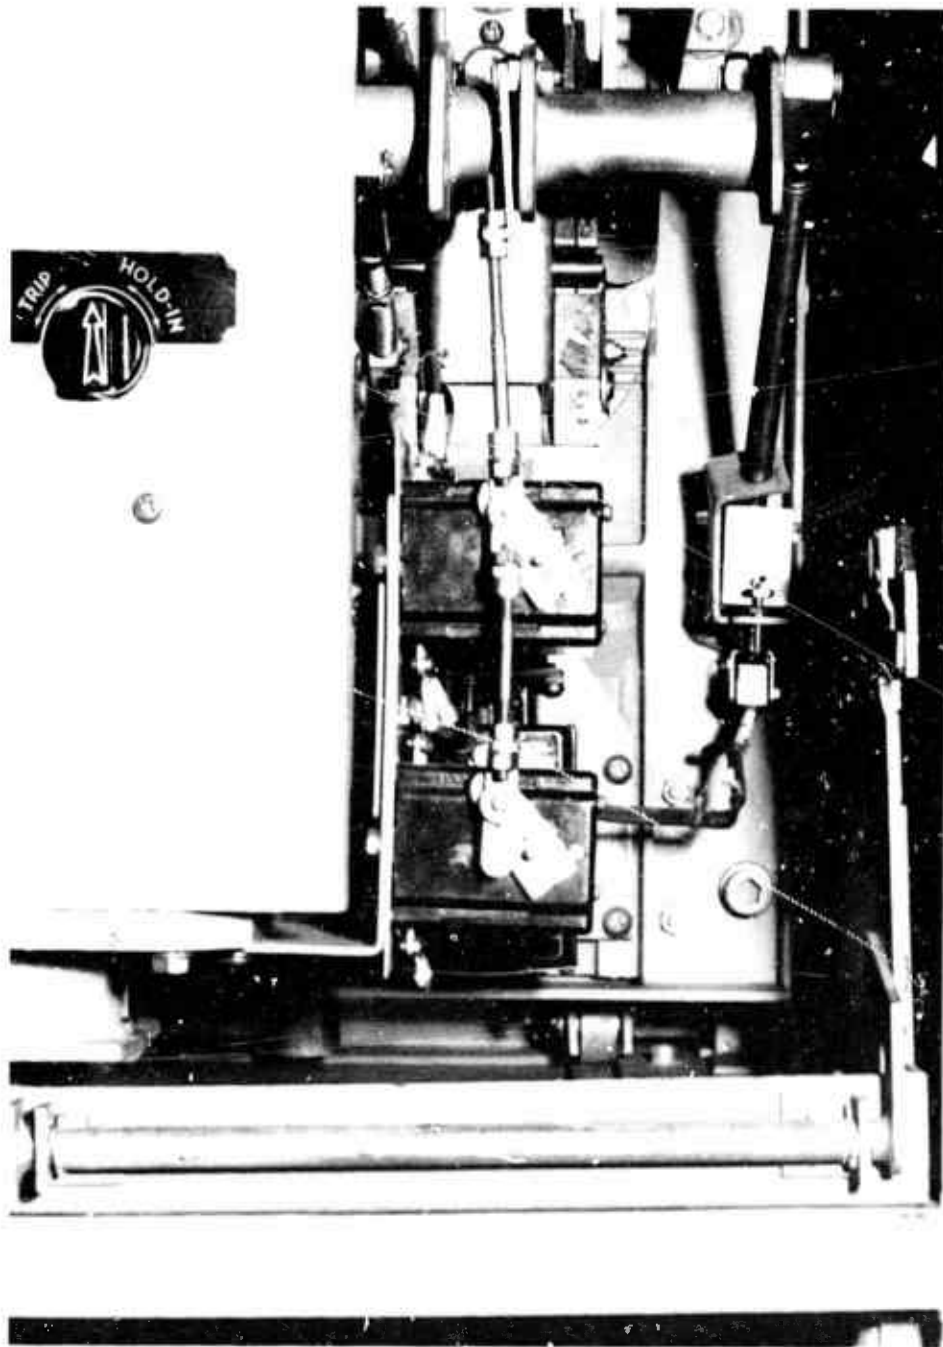
Fig. 53 - Damage from Shock Test - 2400 A Breaker Compartment.
Note damage to interlock mechanism and deformation of accessory
bracket and linkage.

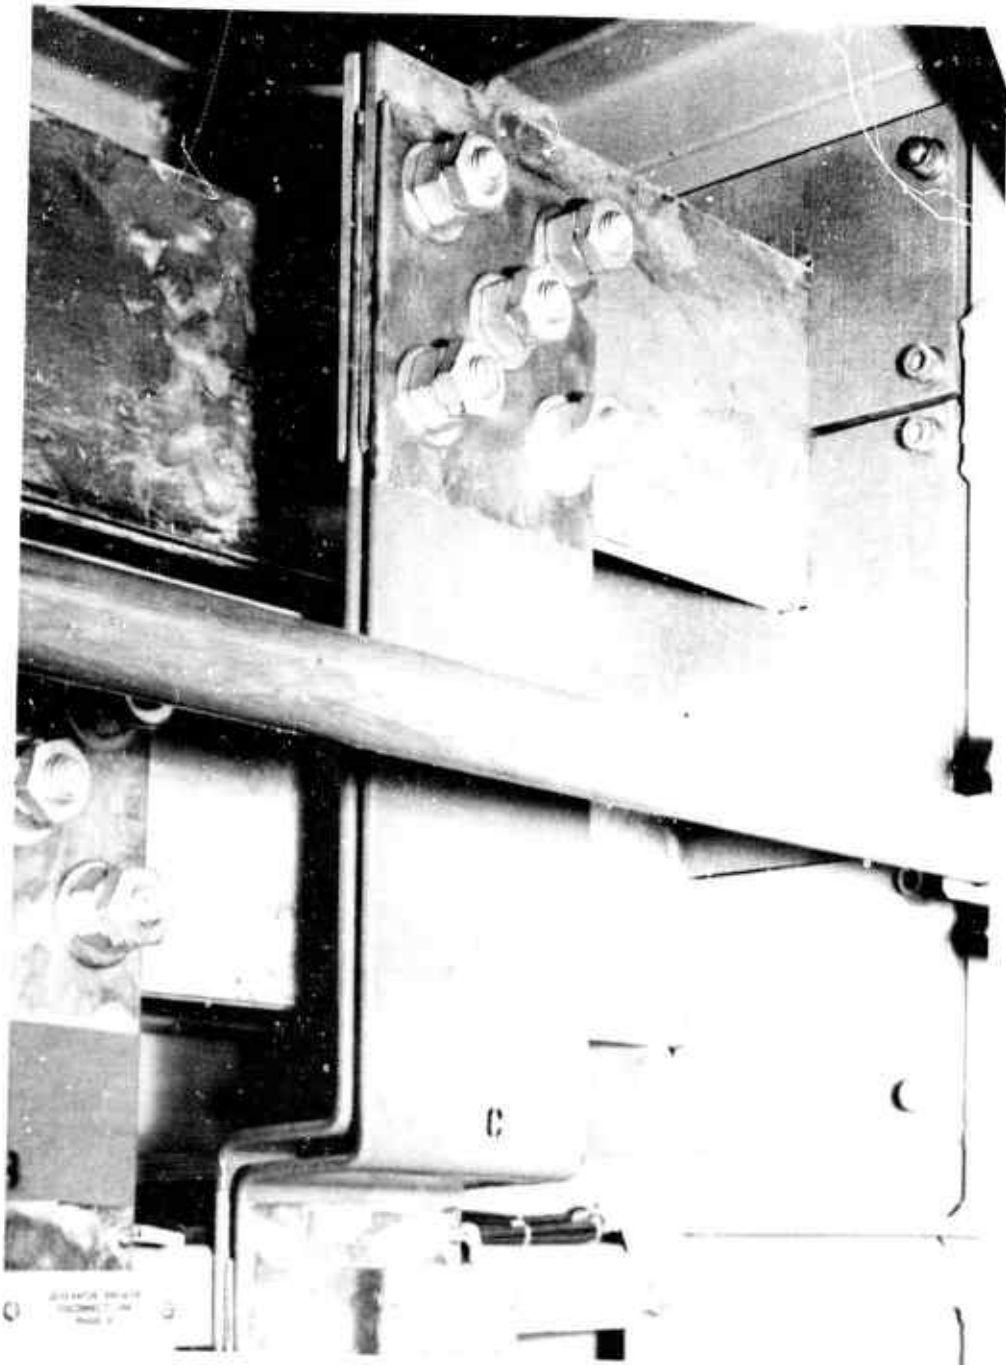
Fig. 54 - Damage from Shock Test - 2400 A Breaker Bay (Rea-).
Note cracking and abrasion of melamine support for main horizontal
bus between 2400 A and 1600 A Breaker Bays.

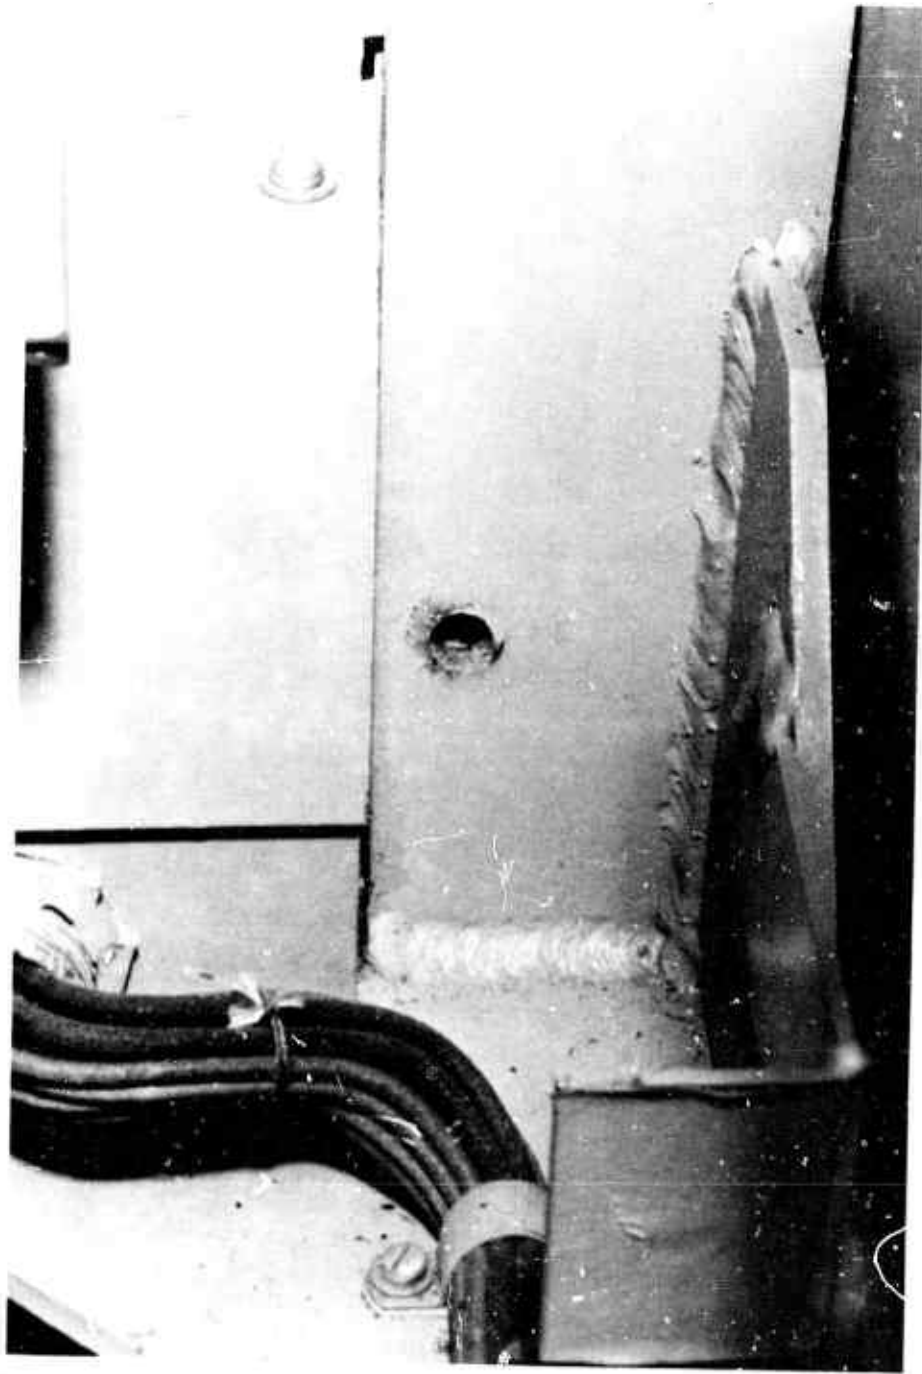
Fig. 58 - Damage from Shock Test - 1600 A Breaker Bay (Rear).
Sheared bolt supports lower base frame for the lower 1600 A
Breaker.

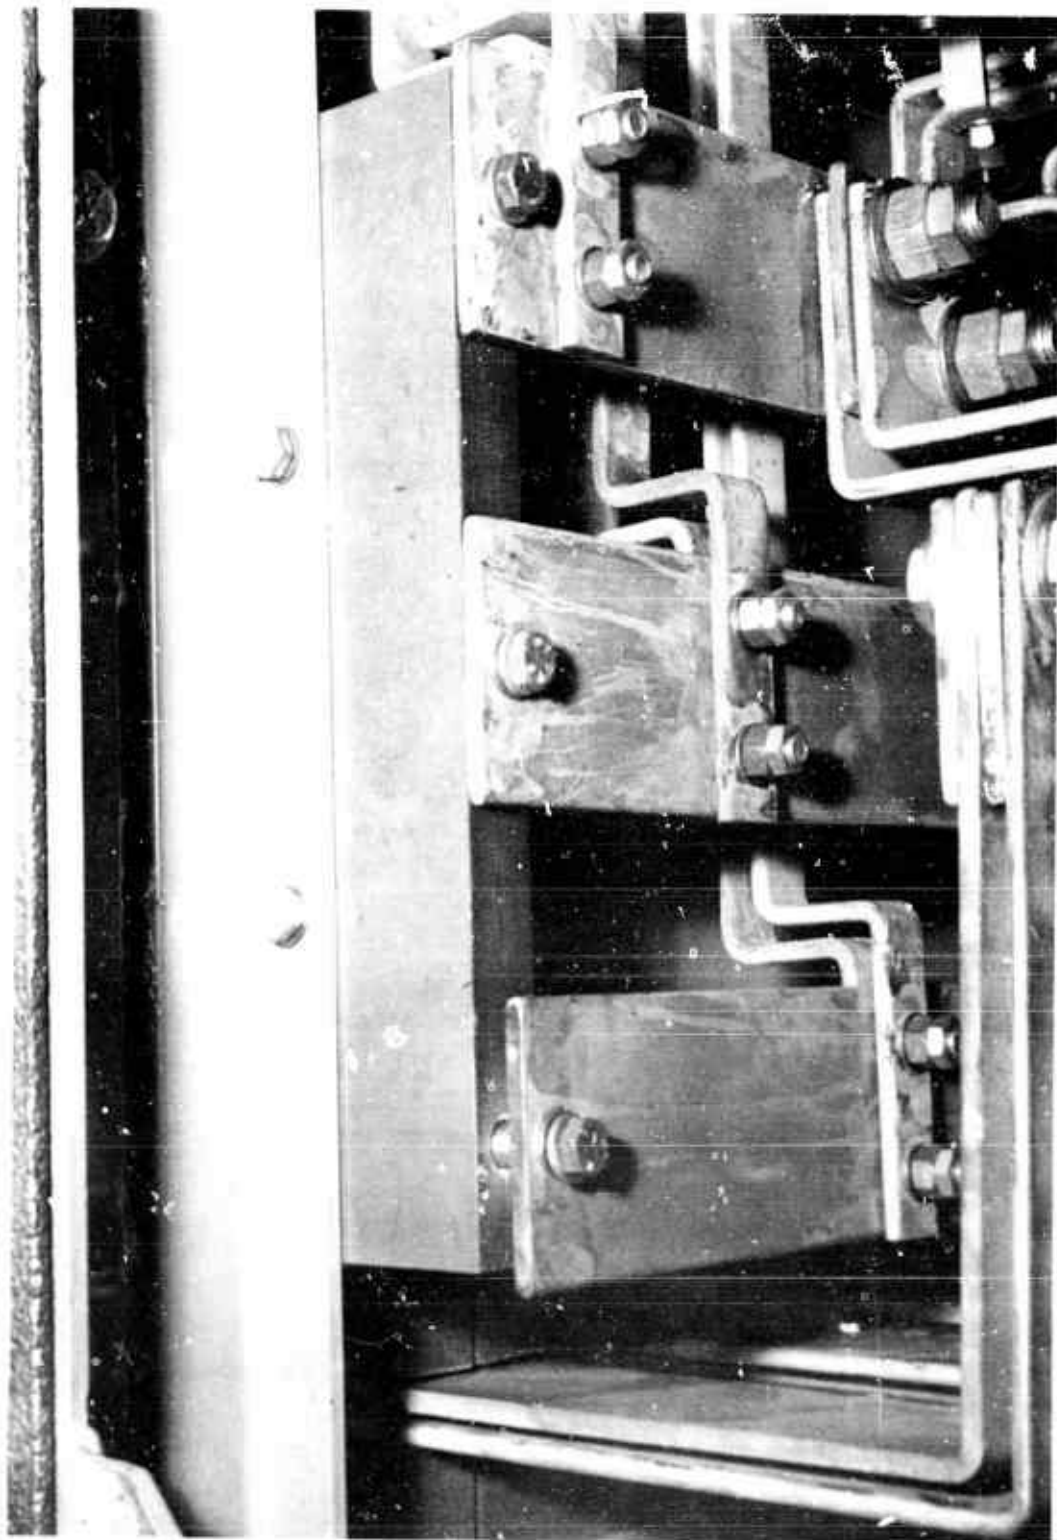
Fig. 59 - Damage from Shock Test - AQB Breaker Bay (Rear). Stripped helicoil in the melamine support at upper end of main vertical bus.

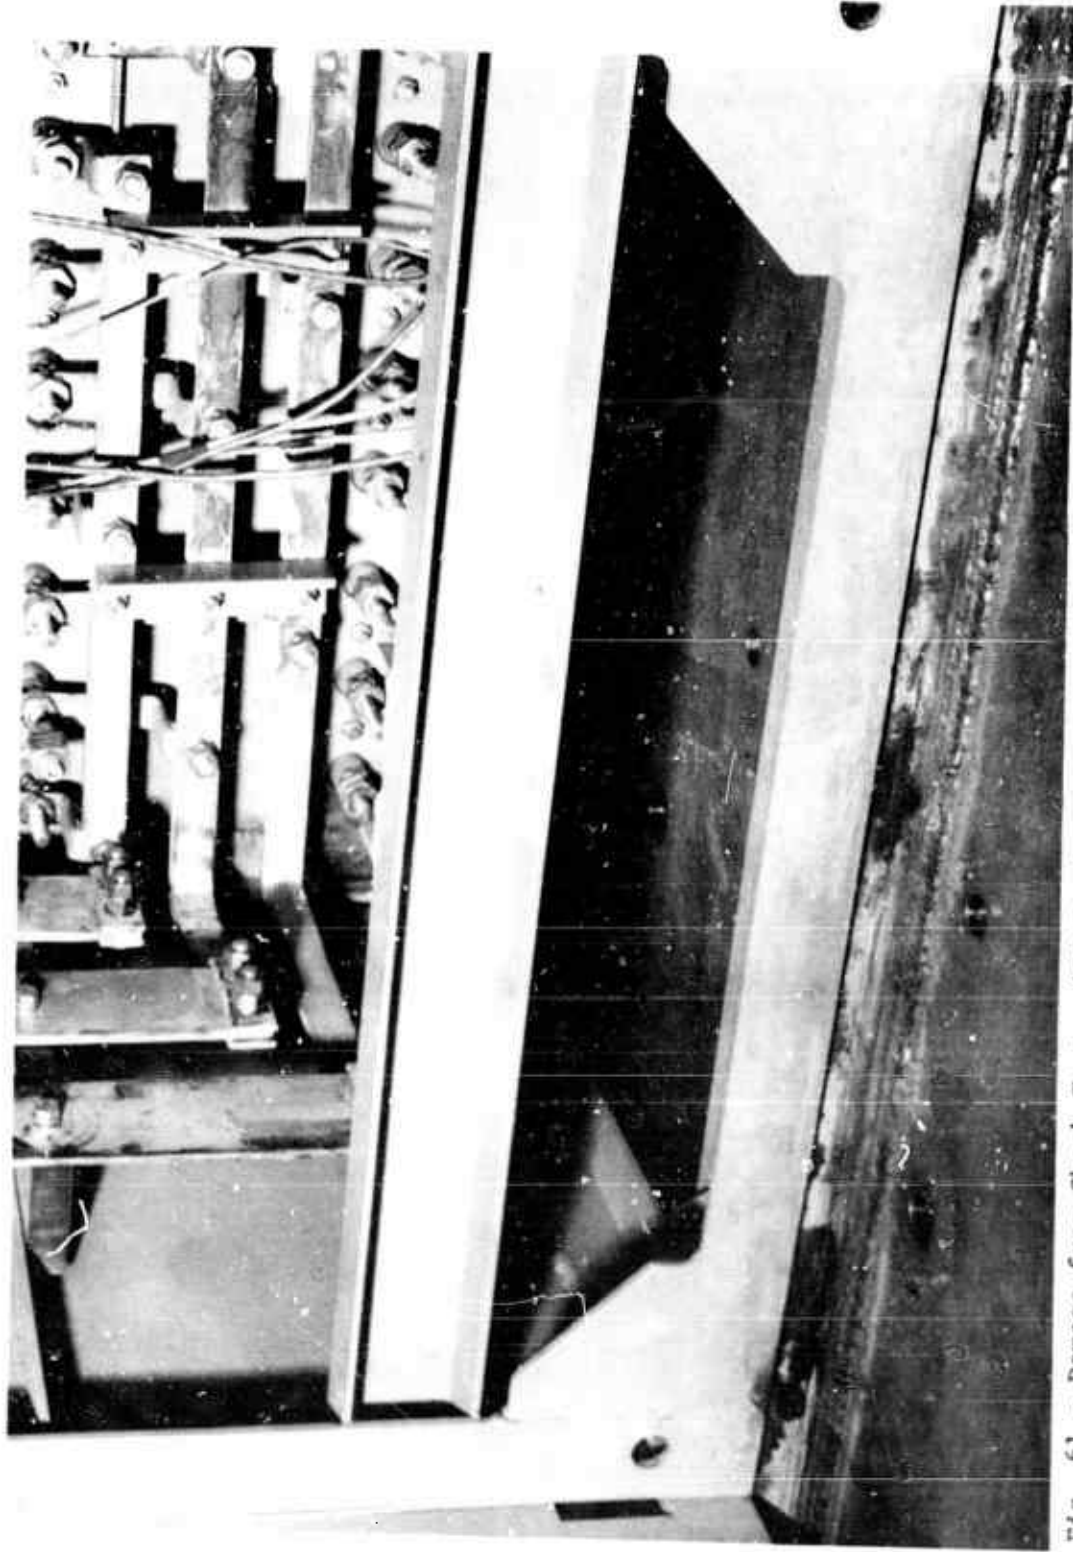
Fig. 61 - Damage from Shock Test - AQB Breaker Bay (Rear). Cracked welds in gussets at base of frame.

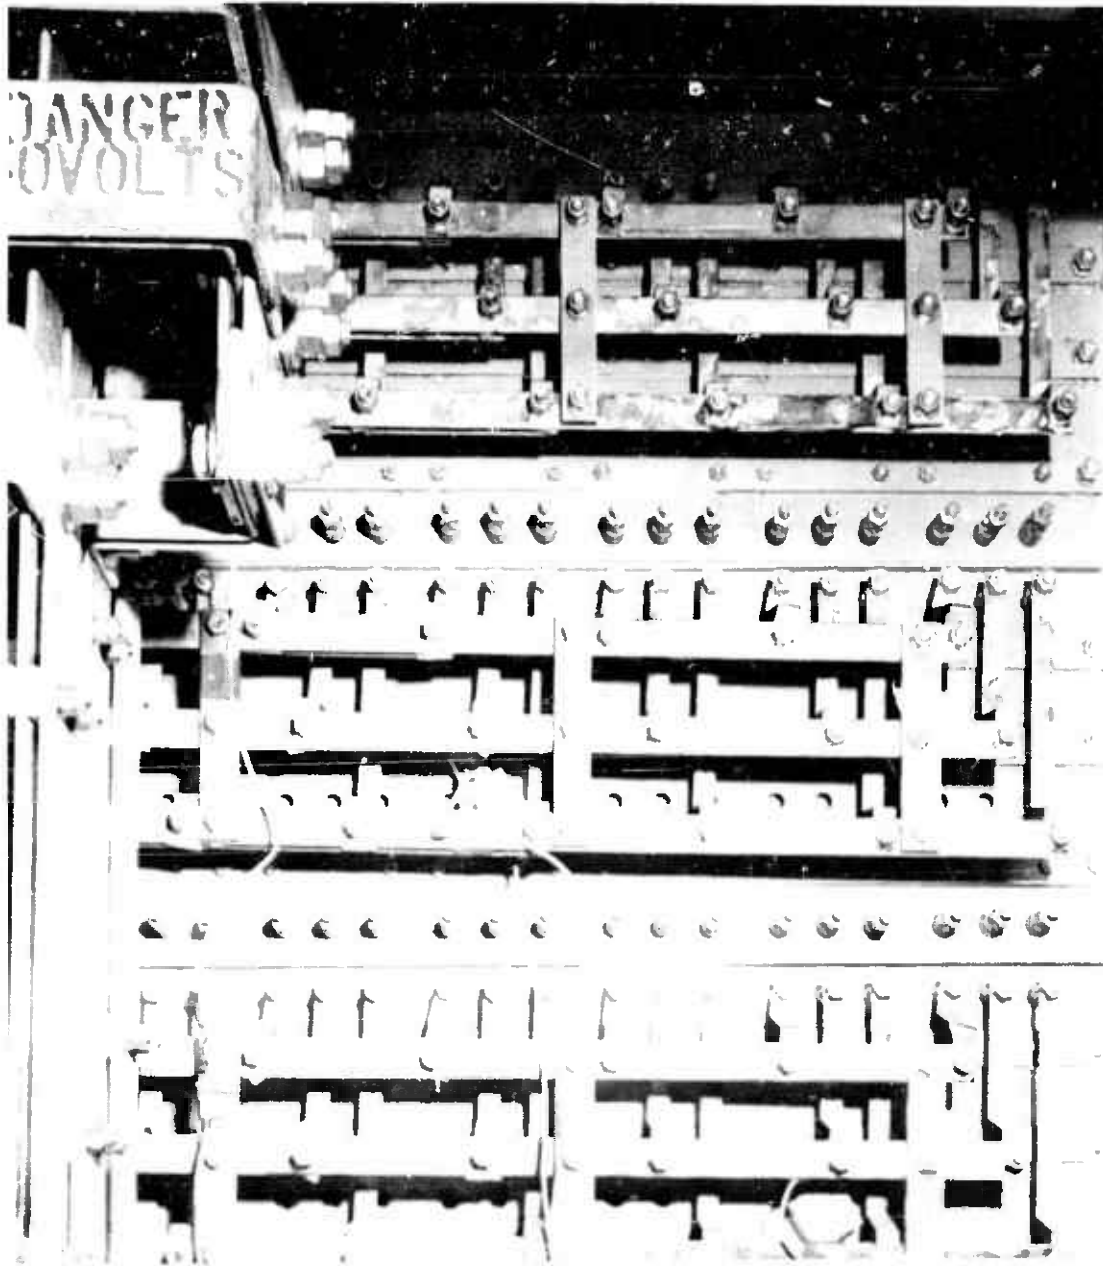
Fig. 62 - Damage from Shock Test - AQB Breaker Bay (Rear). Downward tilt of LF100 horizontal buses and deformation of breaker pickoffs.
