NRL Memorandum Report 4003

Shock Performance of a Shipboard Electrical Switchgear

EDWARD W. CLEMENTS

June 15, 1979

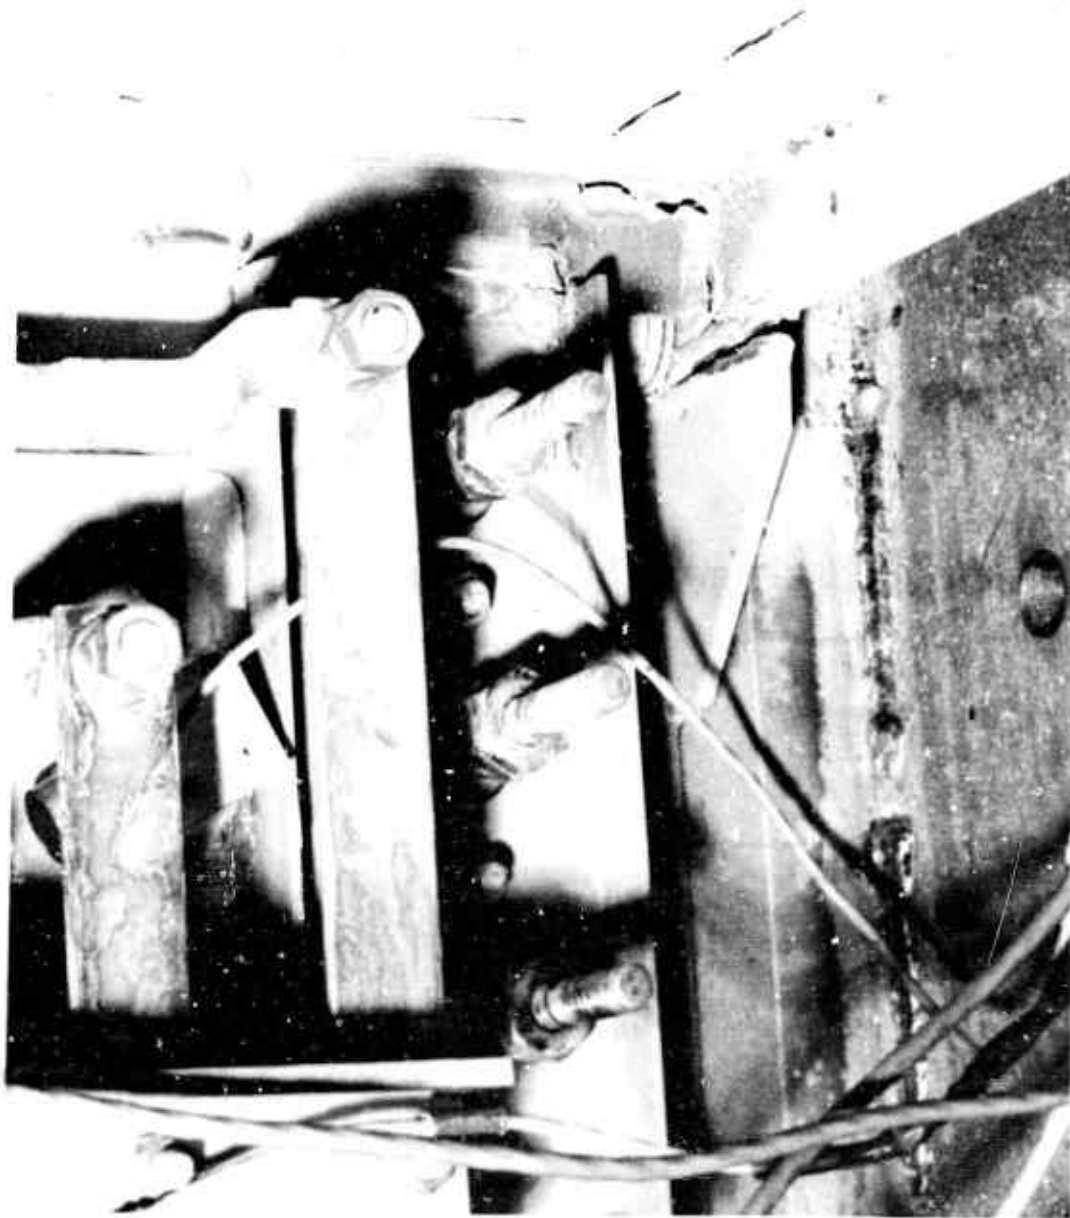
Fig. 64 - Damage from Shock Test - AQB Breaker Bay (Rear). Broken welds in frame base structure, outboard end.
