OHIO RIVER BASIN  
CALVIN CLARK RUN, MERCER COUNTY  
PENNSYLVANIA

**LITTLE SHENANGO DAM**

NDI No. PA 00246

**PHASE I INSPECTION REPORT**  
**NATIONAL DAM INSPECTION PROGRAM**

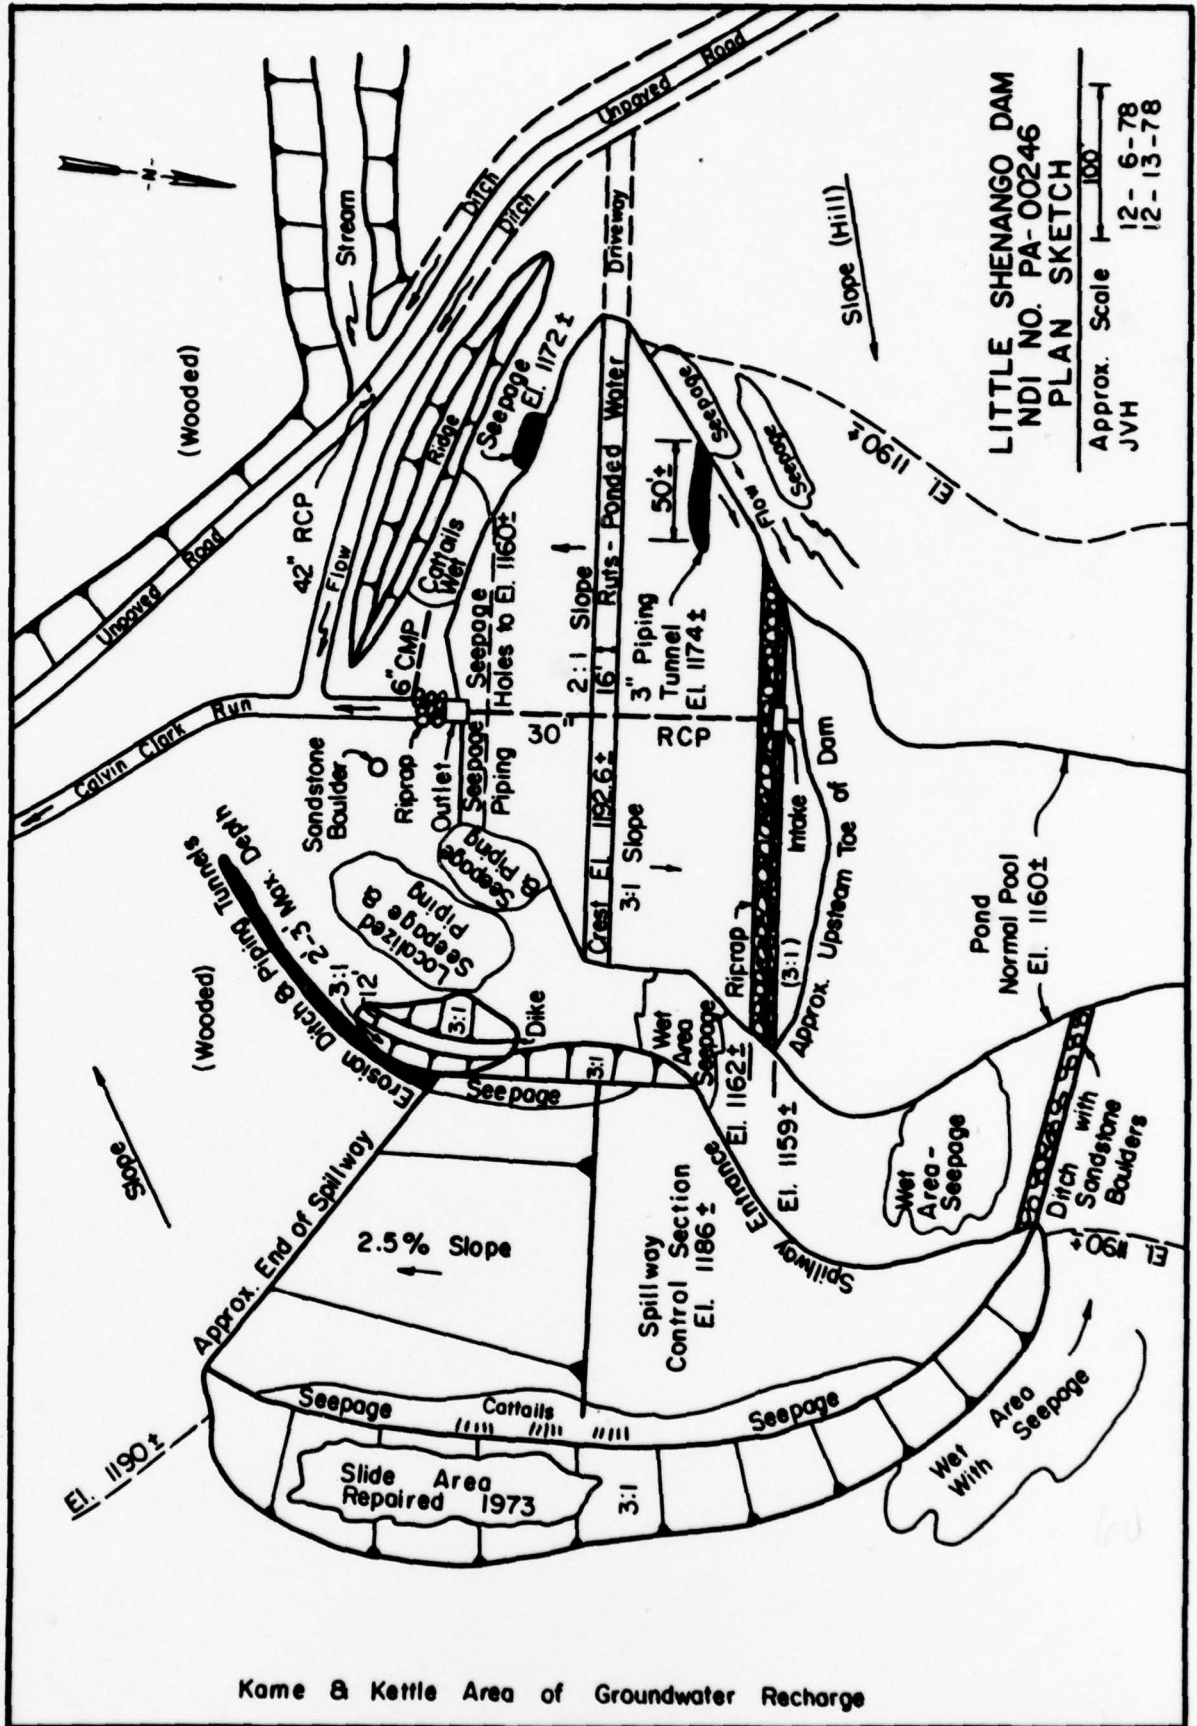
- b. Dam - Seepage and evidence of piping (internal erosion of fine soil particles) was observed at several locations in the dam embankment and its abutments. These seepage and piping areas are shown in the field sketch (Appendix A), and they are described briefly below and in detail in the Seepage and Piping Supplement.

LITTLE SHENANGO DAM  
 NDI NO. PA-00246  
 PLAN SKETCH  
 Approx. Scale 1" = 100'  
 12-6-78  
 12-13-78  
 JVH

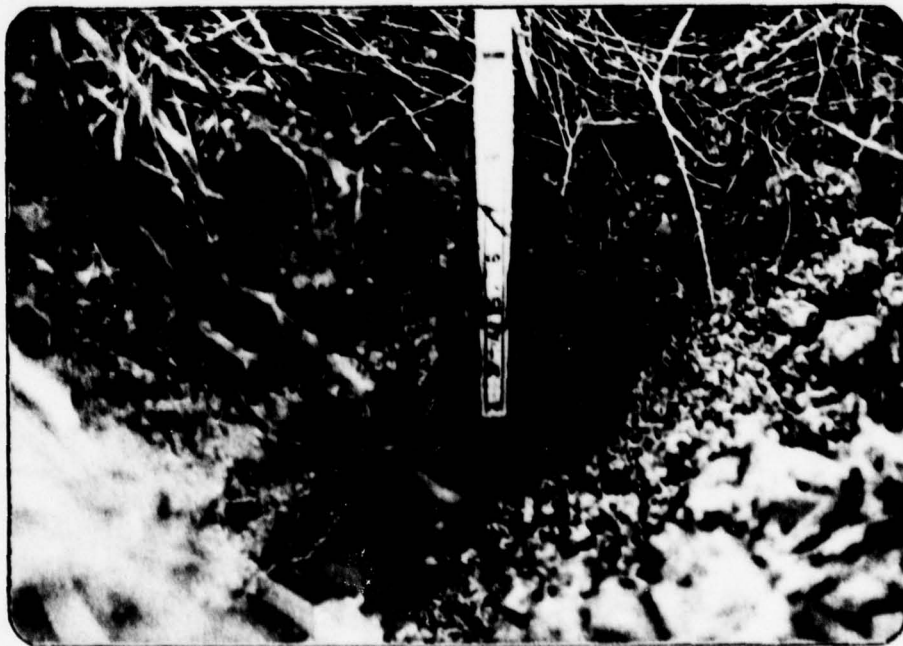
A 3-inch diameter piping tunnel was noted at a depth of about 1 foot in silty fill on the right (west) side of the upstream slope of the dam at El. 1174+ feet. This tunnel appeared to extend horizontally some 50 feet left from the right abutment contact before turning into the embankment in an area where the fill is denser and well graded. It seems likely that this tunnel was produced by piping due to flow from springs in the right abutment as normal pool level is El. 1160 feet.

**PHOTO 8. Close-up of Piping Tunnels in Upstream Slope**

The inspection has revealed the existence of seepage and piping features at several locations in the dam embankment and abutments. It is recommended that the owner retain the services of a registered professional engineer experienced in the design and construction of dams; especially in regards to seepage, piping, and stability aspects of earth dams; to immediately conduct a detailed investigation of the following items.
