NATIONAL DAM INSPECTION PROGRAM. RECREATION DAM (NDS ID NUMBER --ETC(U)  
MAR 79

PHASE I REPORT  
National Dam Inspection Program  
Abstract

Recreation Dam (Cold Stream Dam): NDS I.D. No. PA-00446

Owner: Borough of Philipsburg  
State Located: Pennsylvania (PennDER I.D. No. 14-26)  
County Located: Centre  
Stream: Cold Stream  
Inspection Date: 14 and 22 November 1978  
Inspection Team: GAI Consultants, Inc.  
570 Beatty Road  
Monroeville, Pennsylvania 15146

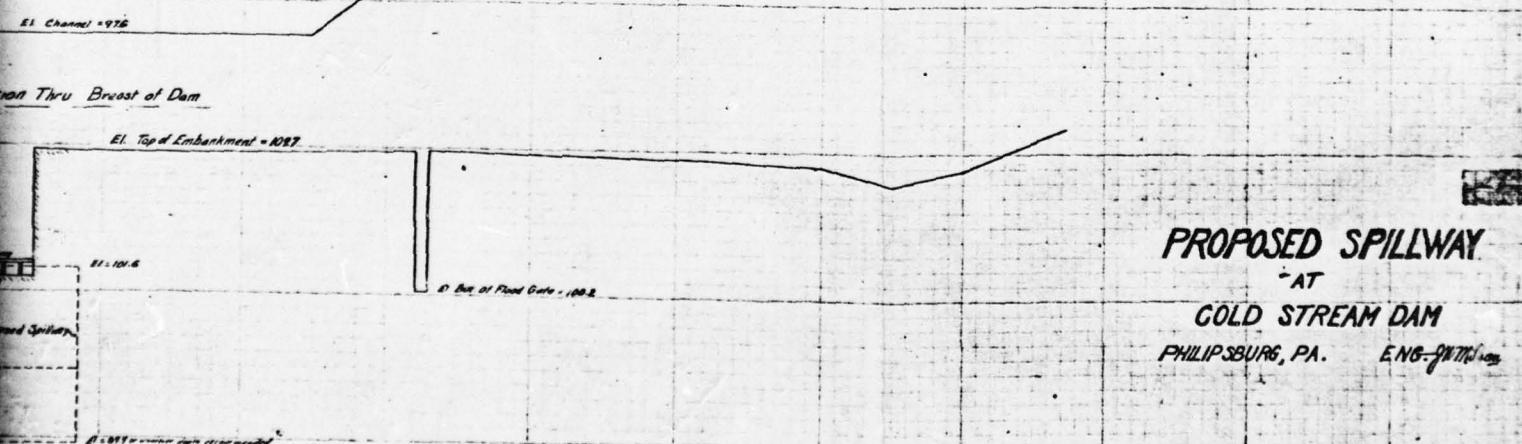
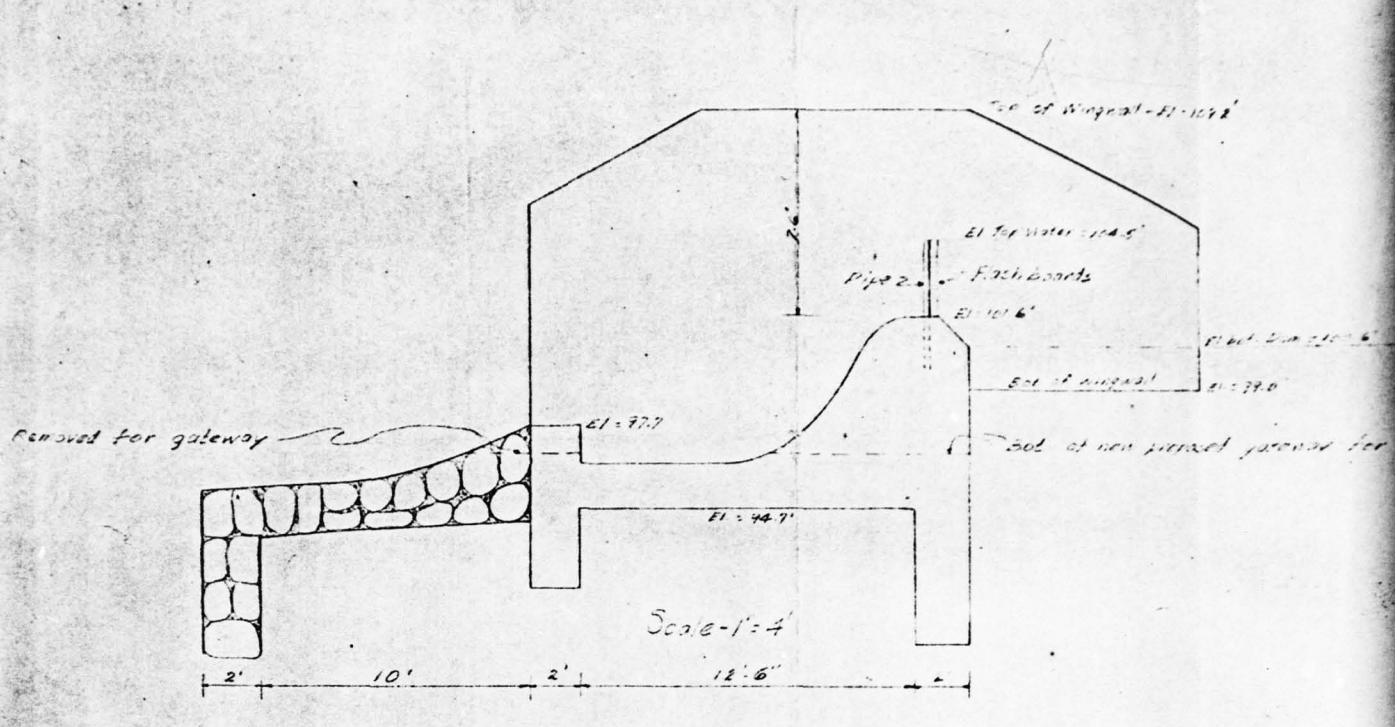
FIGURE 2

pool level so that it can be used for swimming. Originally, the flashboards were designed to be 35 inches high and to fail under various heads, depending on the spacing of the support pipes (see Figure 2). At the time of inspection, 2 of the 4 spillway bays contained flashboards. Field measurements indicated that the average flashboard height was actually 4 feet.
