**LEVEL**  
DELAWARE RIVER BASIN  
WRIGHT CREEK, LUZERNE COUNTY

**PENN LAKE DAM**

NDI-PA 00542  
PA DER 40-28

ADA070835  
**PHASE I INSPECTION REPORT**  
**NATIONAL DAM INSPECTION PROGRAM**

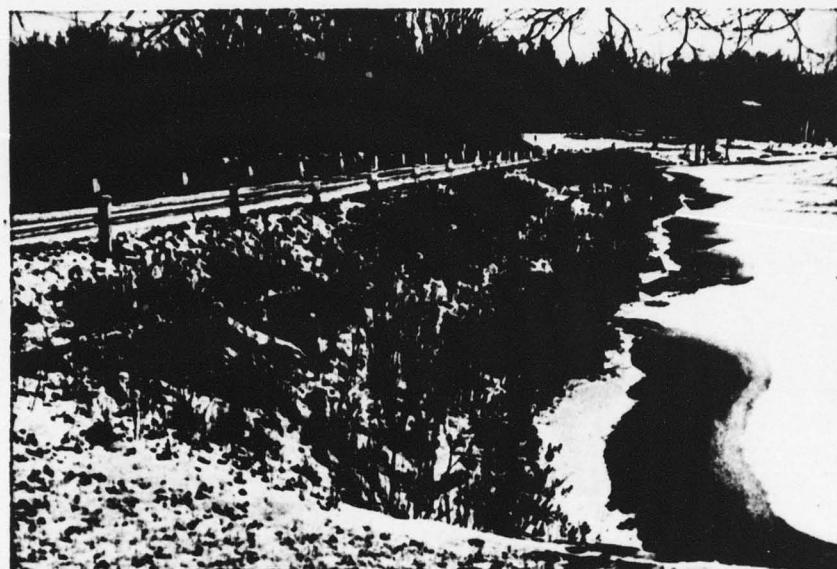
UPSTREAM VIEW OF THE DAM

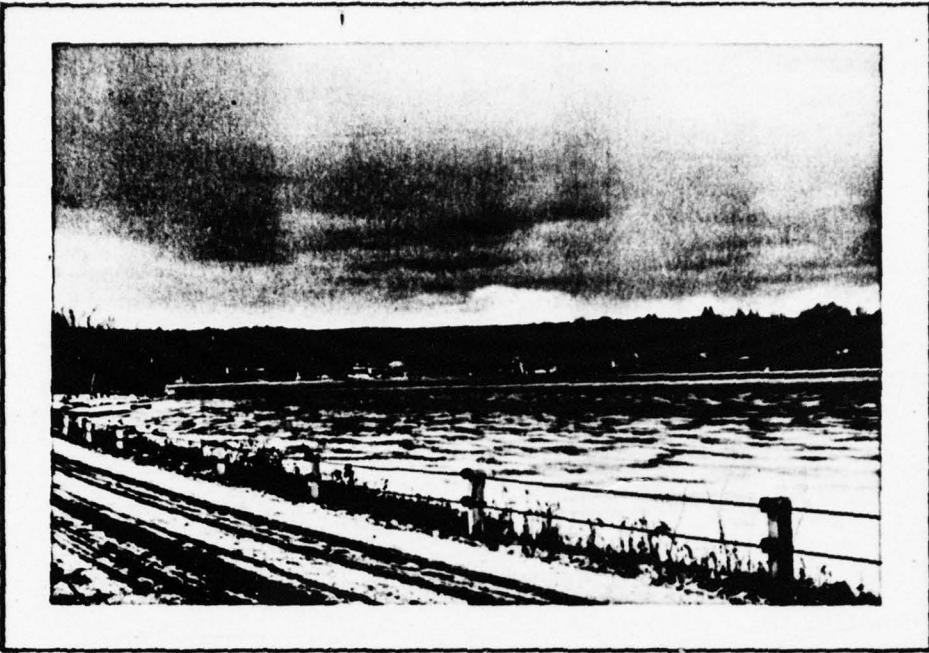
VIEW OF THE RESERVOIR  
FROM THE TOP OF THE DAM

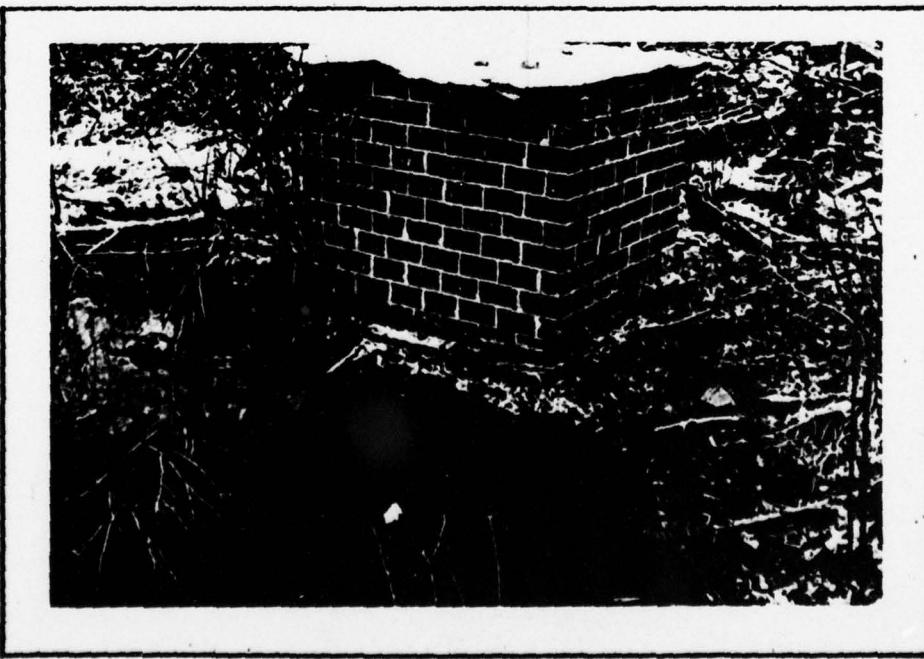
VISUAL EXAMINATION OF	OBSERVATIONS	REMARKS OR RECOMMENDATIONS
CRACKING AND SPALLING OF CONCRETE SURFACES IN OUTLET CONDUIT	Outlet conduit cannot be observed.	Draw down impoundment so that outlet reservoir drain system can be examined.
INTAKE STRUCTURE	Intake structures could not be observed because of was major winter.	"
OUTLET STRUCTURE	Outlet of reservoir drain system could not be observed because it was made of below grade block structure.	"
OUTLET CHANNEL	Flow around through the works for about 200 feet before it joins the channel for the supply of discharge.	Should be realigned to flow directly away from the dam.
EMERGENCY GATE	It is observed the sluice valve is in permanent lift open position jacking down the dam part of water flowing in the vicinity of the concrete block structure which houses the gate.	Sluice valve should be examined and repaired as needed.

THE GATE VALVE SHELTER. DISCHARGE IS FROM  
THE RESERVOIR DRAIN PIPE AND SEEPAGE

4. The area at the downstream end of the reservoir drain system should be cleared of silt and debris. The drain system should then be appraised and repaired as needed. A means of positive closure at the upstream end of the reservoir drain system should be developed.

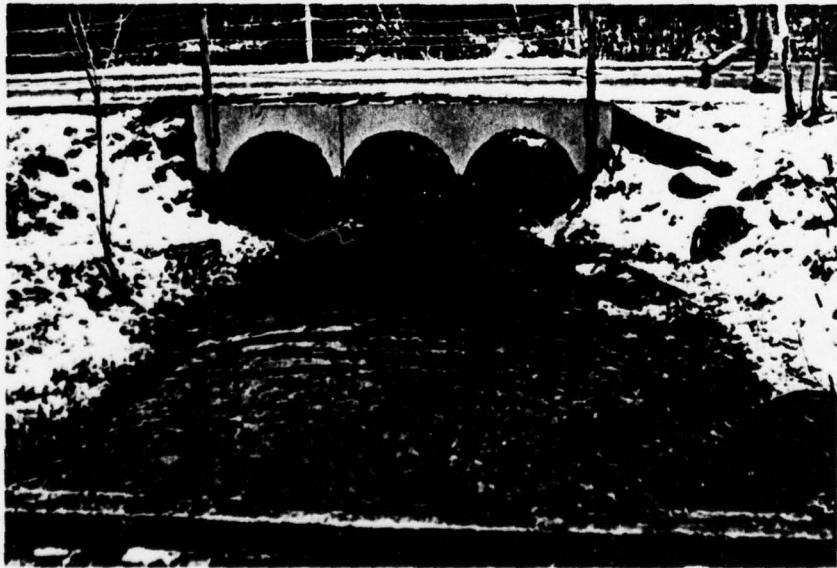
c. Appurtenant Structures. The spillway, which consists of a battery of twelve 42-inch diameter, 20-foot long pipes, located approximately 1,000 feet left (looking downstream) of the dam, is seriously inadequate. There are no trashracks upstream of the spillway pipes to prevent debris from reducing the flow. Earth swales on both sides of the battery of pipes function as auxiliary spillways.

A PORTION OF THE SPILLWAY FLOW  
ABOUT 1000 FEET TO THE LEFT OF THE DAM

1. The capacity of the spillway system should be increased in accordance with the results of detailed hydrologic and hydraulic studies.
