TROUT LAKE DAM

NDI - PA 00769
PA DER 45 - 43

PHASE I INSPECTION REPORT
NATIONAL DAM INSPECTION PROGRAM

Name of Dam: Trout Lake Dam
County and State: Monroe County, Pennsylvania
Inventory Number: PA 00769

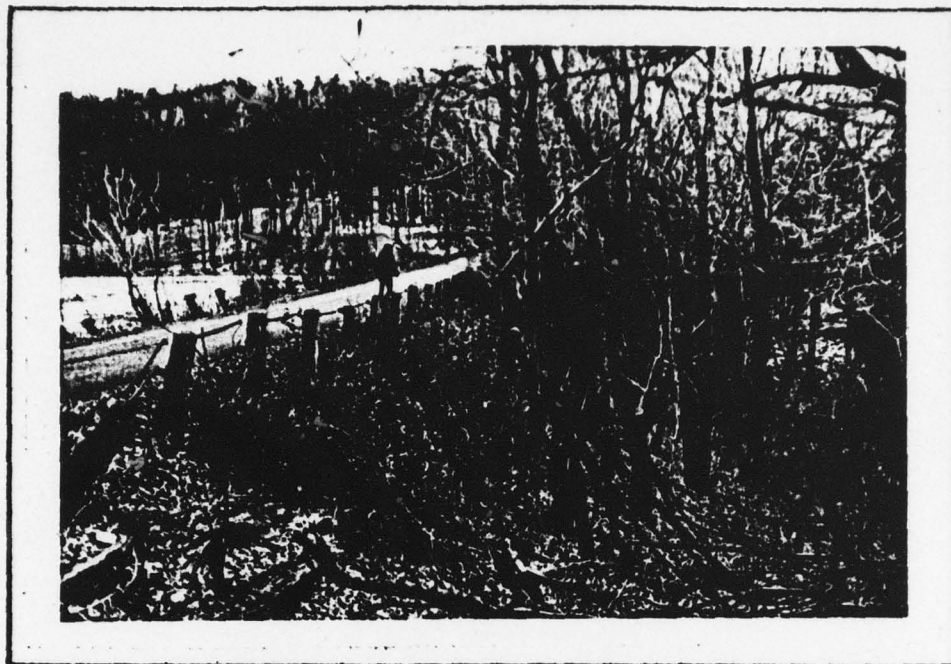
*OVERVIEW OF THE DAM FROM THE
DOWNSTREAM RIGHT ABUTMENT*

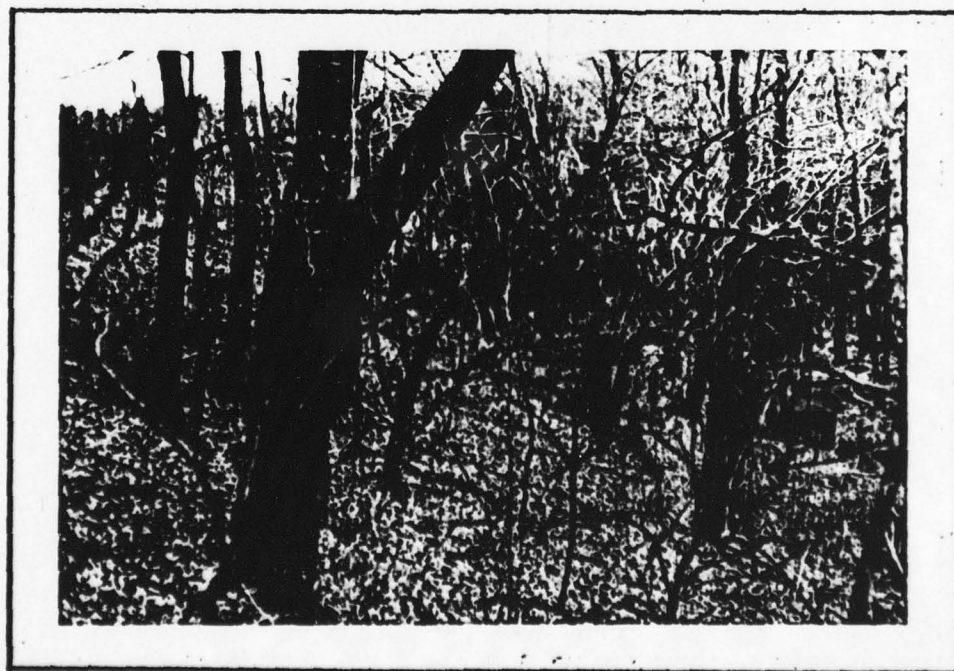
THE DOWNSTREAM SLOPE OF THE DAM

The heavy cover of large trees on the downstream slope may increase the seepage potential through the embankment. Uprooting of the trees by high winds could cause substantial volumes of embankment material to be displaced.

5. The trees and brush growing on the embankment slopes should be cut to root level and removed from the surface of the structure. A further investigation should be made to determine the extent of the root systems before remedial measures can be recommended. The downstream slope should then be seeded with suitable vegetation.

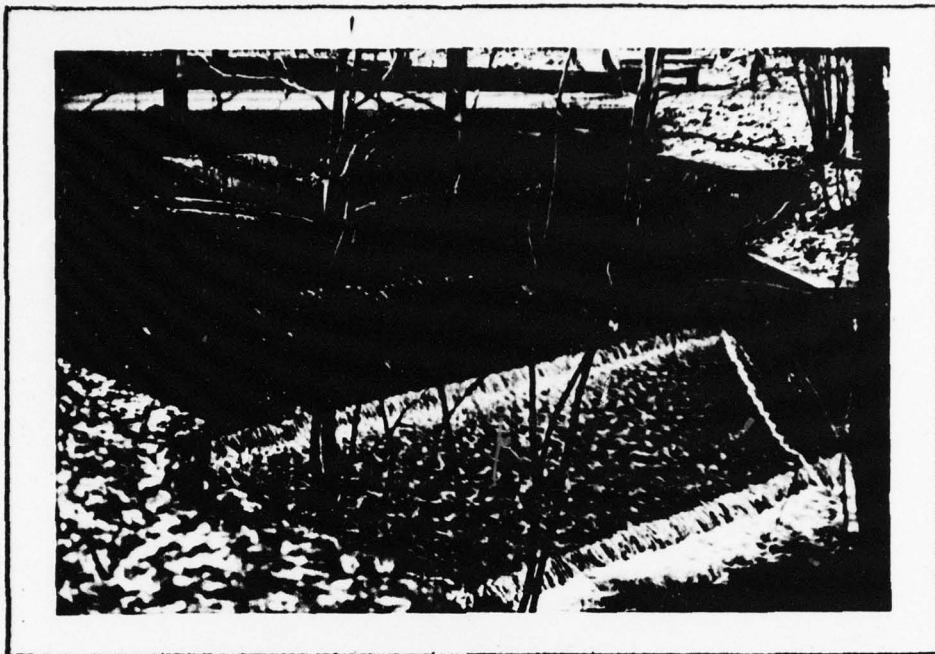
The spillway appeared to be in good condition and showed no signs of instability.

*DOWNSTREAM VIEW OF THE SPILLWAY NEAR
THE RIGHT ABUTMENT OF THE DAM*

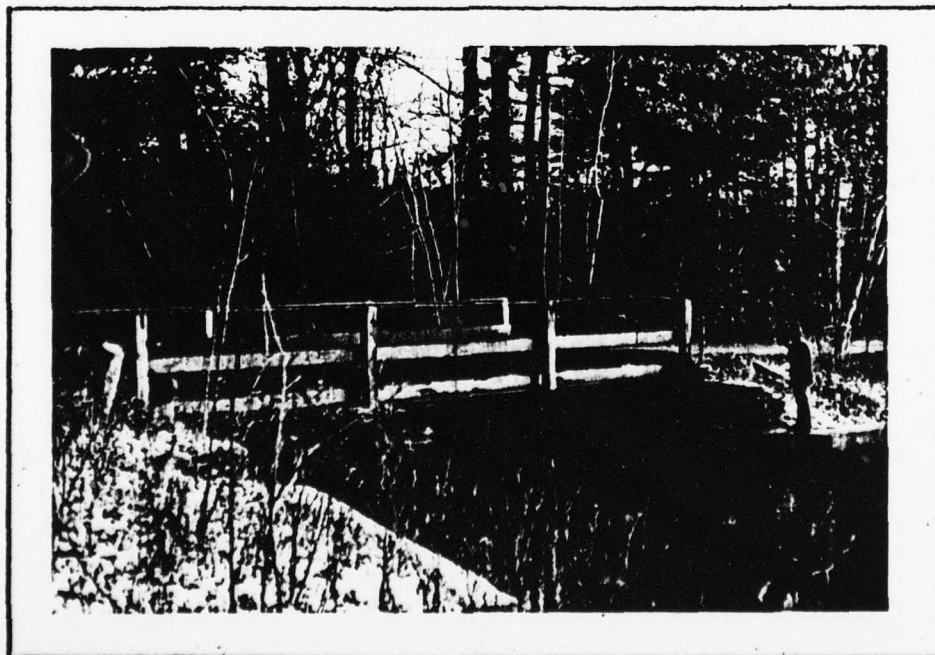
APPROACH CHANNEL TO THE SPILLWAY

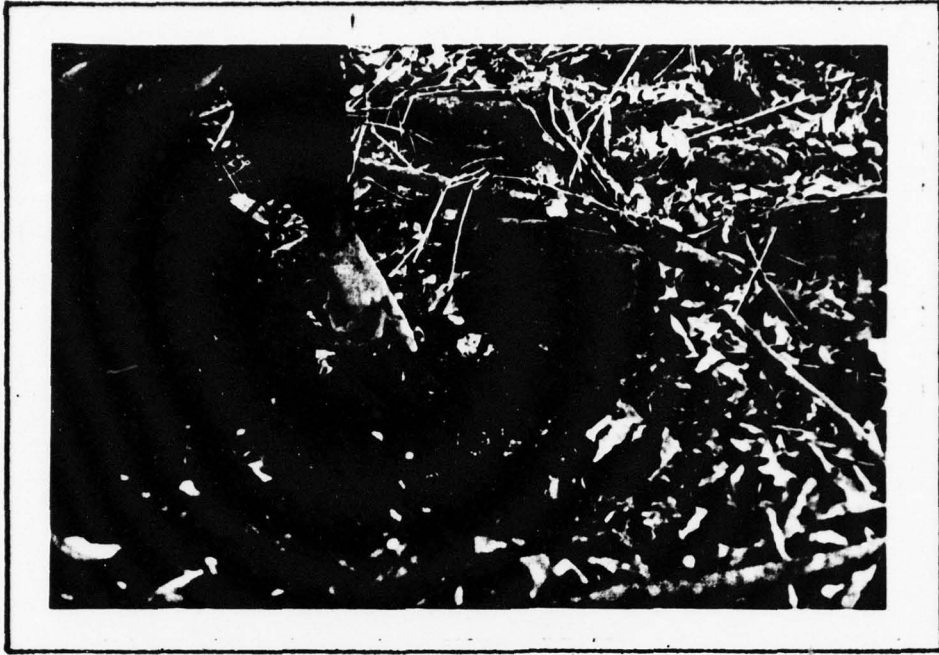
2. Immediately downstream of the embankment is an area of seepage, saturated silty deposits, and standing water. This area should be monitored regularly for signs of increased seepage and/or turbid water.

*SEEPAGE IMMEDIATELY DOWNSTREAM OF
THE RIGHT ABUTMENT OF THE DAM*

ANY NOTICEABLE SEEPAGE
There is seepage along the downstream right abutment.
A boring program should be initiated to determine the composition and in situ properties of the embankment and foundation. Piezometers should be installed in the bore holes to evaluate pore pressure development throughout the embankment.

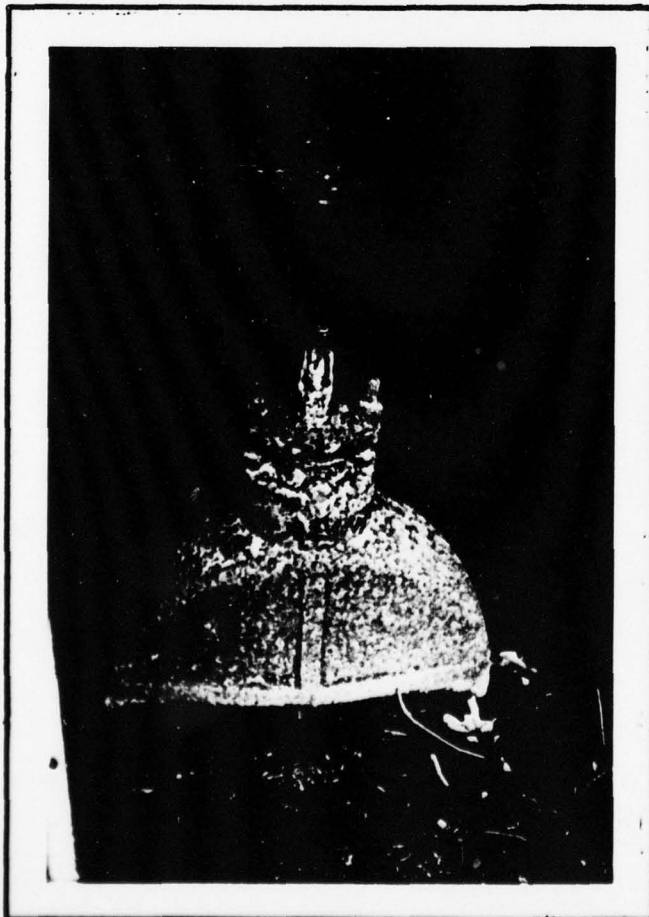
8. The low level outlet conduit and gate valve are silted-in at the downstream end, and no means of upstream control was evident at the time of inspection. The valve and outlet should be cleared of silt, and the adequacy of the outlet system should be assessed. A means of positive upstream control should be provided for the low level outlet.

*SLUICE VALVE ON
THE DOWNSTREAM
END OF THE RESERVOIR
DRAIN SYSTEM CONDUIT*

The operating condition of the gate valve should be assessed immediately. The dam should be monitored during periods of heavy rainfall, and downstream residents alerted in the event of an impending failure.

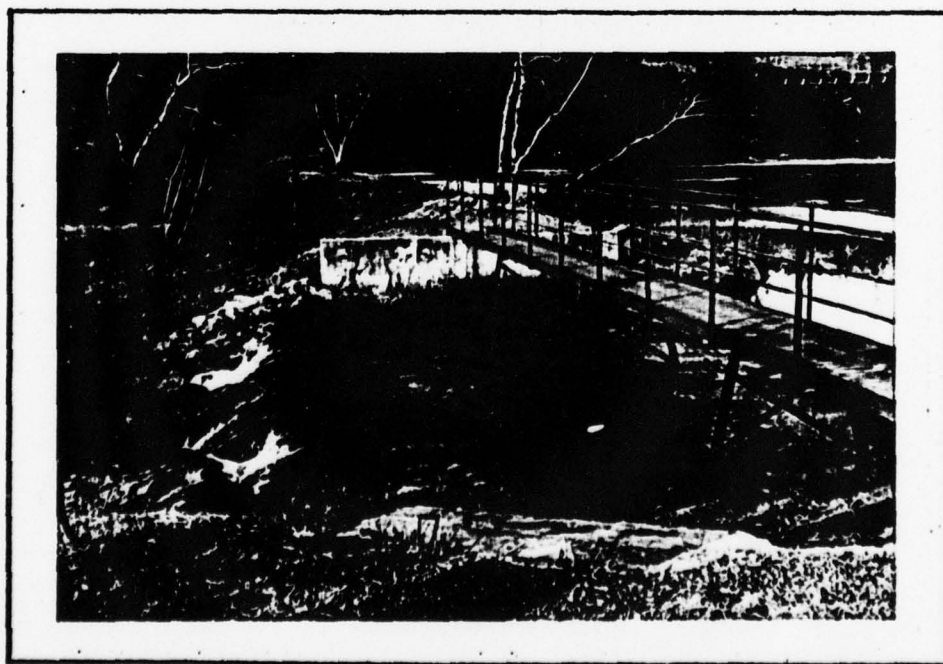
Gruber Lake, located about 400 feet downstream of Trout Lake Dam, is about $\frac{1}{2}$ mile long. Gruber Lake Dam is an earth embankment about 15 feet high and 300 feet long. The dam is provided with a 45-foot masonry, broad-crested weir constructed approximately 3 feet below the top of the embankment. The town of Appenzell is located about 3000 feet downstream of Gruber Lake. Several homes and a church are located along the banks of Appenzell Creek. Failure of Trout Lake Dam would cause significant property damage and probable loss of life.

*DAM AND SPILLWAY OF GRUBERS LAKE ABOUT
ONE HALF MILE DOWNSTREAM OF TROUT LAKE DAM*
