National Dam Inspection Program, Colyer  
Lake Dam (NDS ID Number PA-00448,  
PENNDER ID Number 14-112), Susquehanna  
River Basin, Sinking Creek, Centre  
County, Pennsylvania.

Phase I Inspection Report.

COLYER LAKE DAM  
NDS I.D. No. PA-00448  
PENNDER I.D. No. 14-112

PHASE I INSPECTION REPORT  
NATIONAL DAM INSPECTION PROGRAM

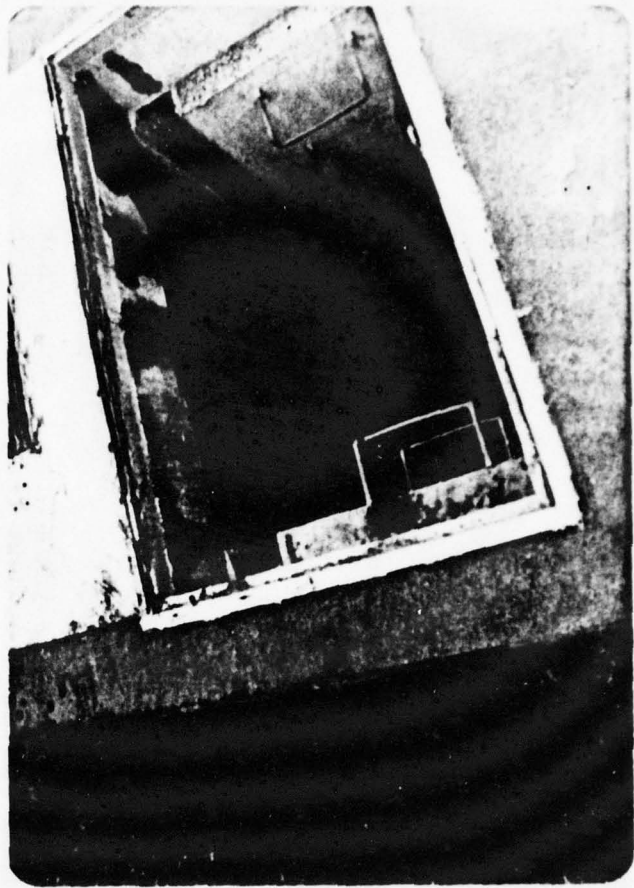
2. Outlet Conduit. Discharge through the outlet works at Colyer Lake Dam controlled by stop logs within the vertical riser (see Photograph 4). The Fish Commission was lowering the reservoir level at the time of inspection; consequently, only the exposed portion of the vertical riser could be inspected. Field team members did enter the horizontal portion of the 4-foot square outlet conduit to a point about 10 feet from the vertical riser. Cracking and efflorescence were observed within the conduit approximately 10 to 15 feet downstream of the riser (Figure 7 indicates a concrete cutoff collar extends into rock in this area).

PHOTOGRAPH 4 Close-up view of the concrete vertical riser portion of the outlet works. Note the stop logs laying to the left of the riser.

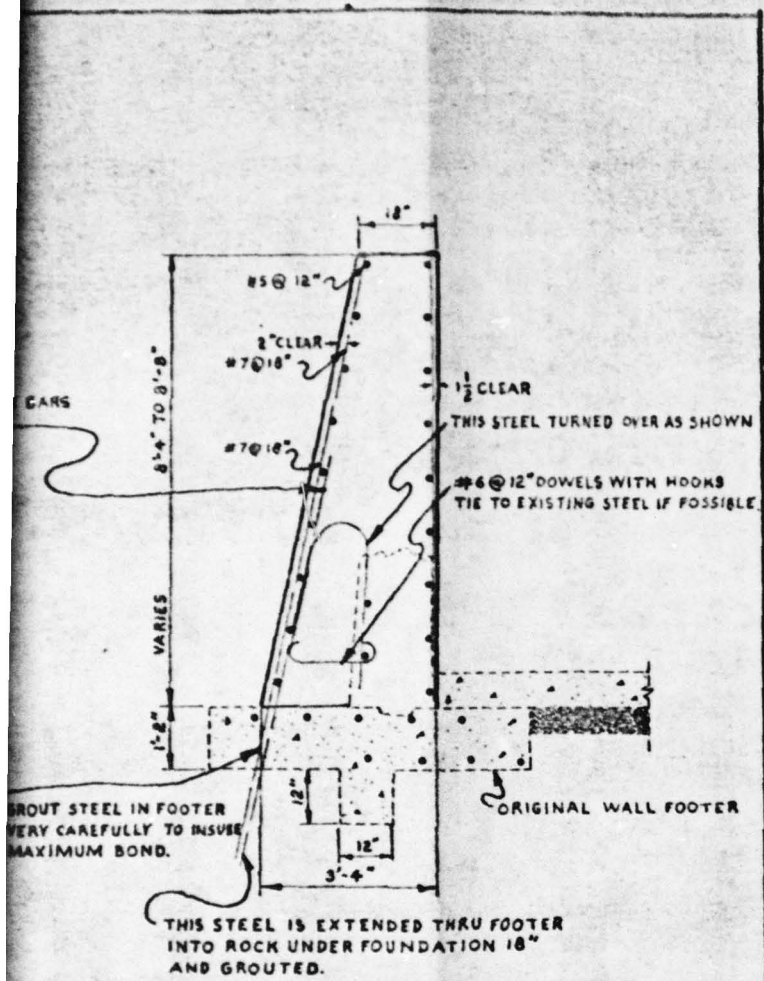
At the time of inspection, the Pennsylvania Fish commission was drawing down the reservoir so as to drain the forebay of the spillway. This is done every winter to reduce ice pressures on the wall separating the trapezoidal weir section and flume section of the spillway. The wall was replaced in 1968 following ice damage (see Figure 11).

b. Appurtenant Structures. In 1968, the wall separating the trapezoidal weir section and flume section of the spillway was replaced following damage incurred from ice pressures within the forebay. Since that time, the Pennsylvania Fish Commission has lowered the water level about 4 feet in the late autumn to drain the forebay prior to the winter season.
