FATE OF OIL SPILLED FROM THE
SUPERTANKER METULA

ROY W. HANN, JR.
HARRY N. YOUNG, JR

JANUARY 1979

FINAL REPORT

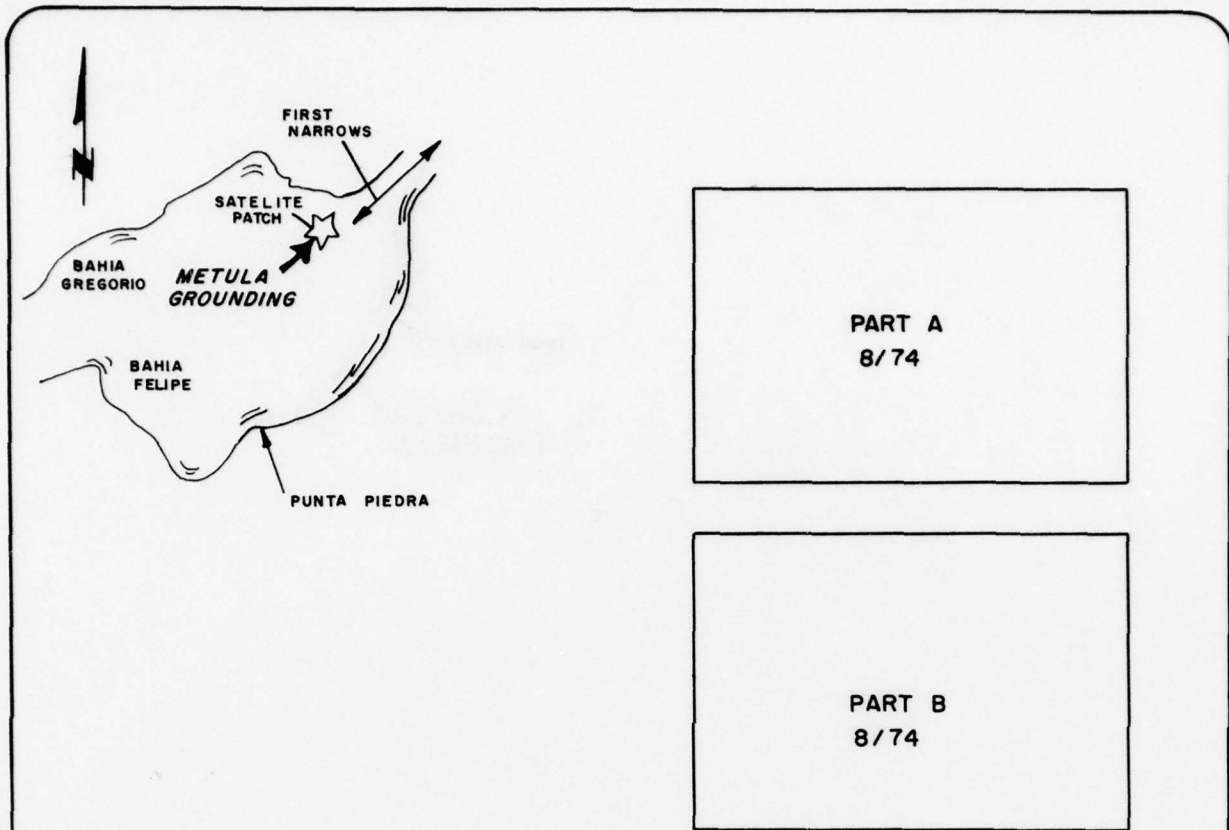
FIGURE 7

- A - Grounded tanker METULA on Satellite Patch with south shore of South American Continent in the background.
- B - Grounded tanker METULA with lighting tanker HARVELLA alongside. Oil is shown spreading over the water surface.

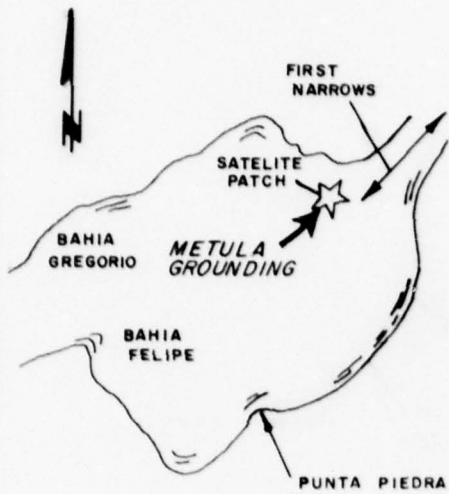
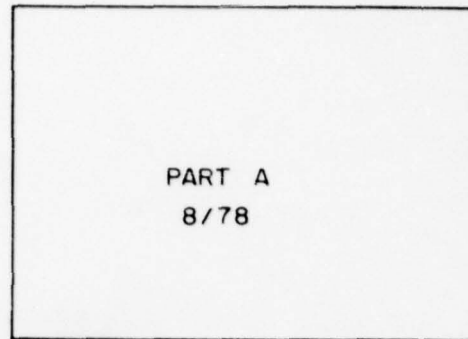
FIGURE 12

Figure 12 Parts A and D show the general area and Parts C and E show closeup of the marine community on, around and under the cobbles. The only oil found in this area has been a tar residue on occasional rocks found at the upper intertidal zone. A handful of rocks gathered over a half-hour period is shown in Figure 12 Part B.

- A - Typical view of uncontaminated beach showing steep sand beach, stranded detritus and near top of beach and cobble area in lower Intertidal Zone.
- B - Tarred rocks found on Gregorio Beach.
- C - Crustacea living under cobbles in lower Intertidal Zone.
- D - Lower Intertidal community with cobbles, algae and marine life.
- E - Close-up of limpets and mussels in lower Intertidal Zone.

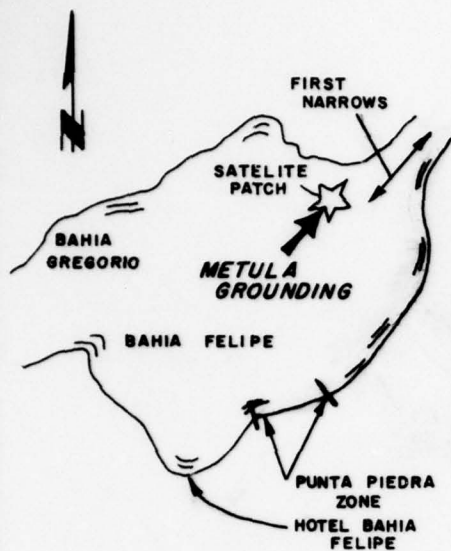
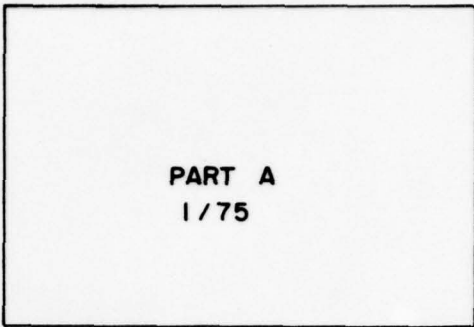
FIGURE 13

Figure 13 shows a series of photographs for this area. Part A and Part B show the deposit at the beach top in January of 1975 and Part C shows the still soft mousse appearance of the deposit at that time. Parts D and E show the same zone two years later. In one case a stretch is shown which has been little changed in coverage whereas in the other only small patches of the oiled crust remain.

- A - Deposition of oil at top of beach near Hotel Bahia Felipe.
- B - Closeup of deposit at top of beach.
- C - Closeup of disturbed surface showing soft mousse which has not yet penetrated into the sand.
- D - Similar area near Punta Piedra two years later.
- E - Area two years later where crust has been eroding away.

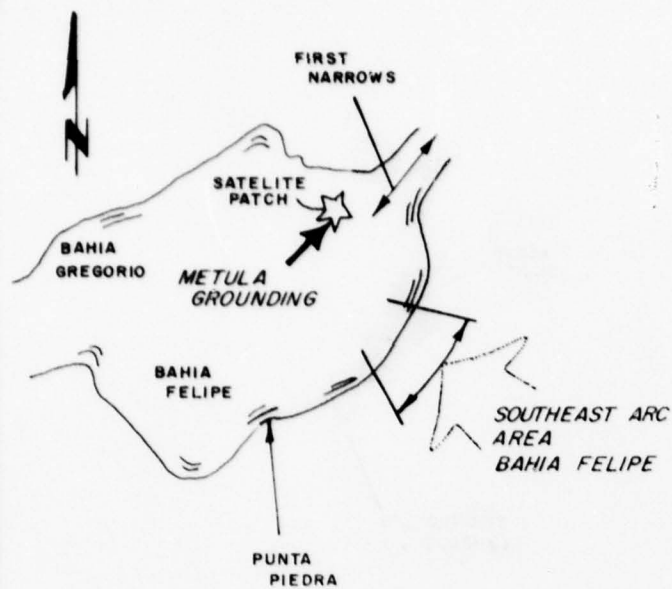
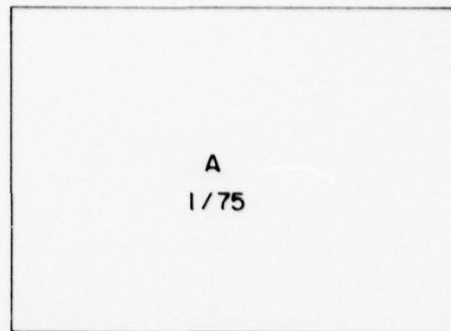
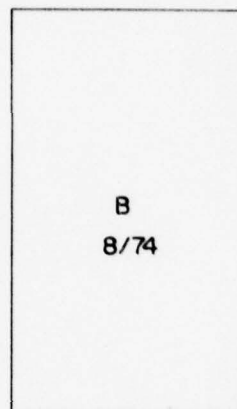
FIGURE 15

The wave on the beach in this zone had brown oil stained edges from resuspended oil which would leave random wavy lines in the lower zones of the beach as the tide would come in and go out. Figure 15 Part A shows a typical view of this stretch of beach in January of 1975. Figure 15 Part D shows a group of tarballs found at the base of the beach slope in January 1976.

- A - View of oiled beach top in maximum impact area on Bahia Felipe, exposed oil is to the left of the picture and covered oil under the sand on the right.
- B - Aerial photo of southeast arc area of Bahia Felipe during the time of the spill.
- C - Aerial photo of similar area five months after the start of the spill.
- D - Tar balls found at the base of the beach slope.

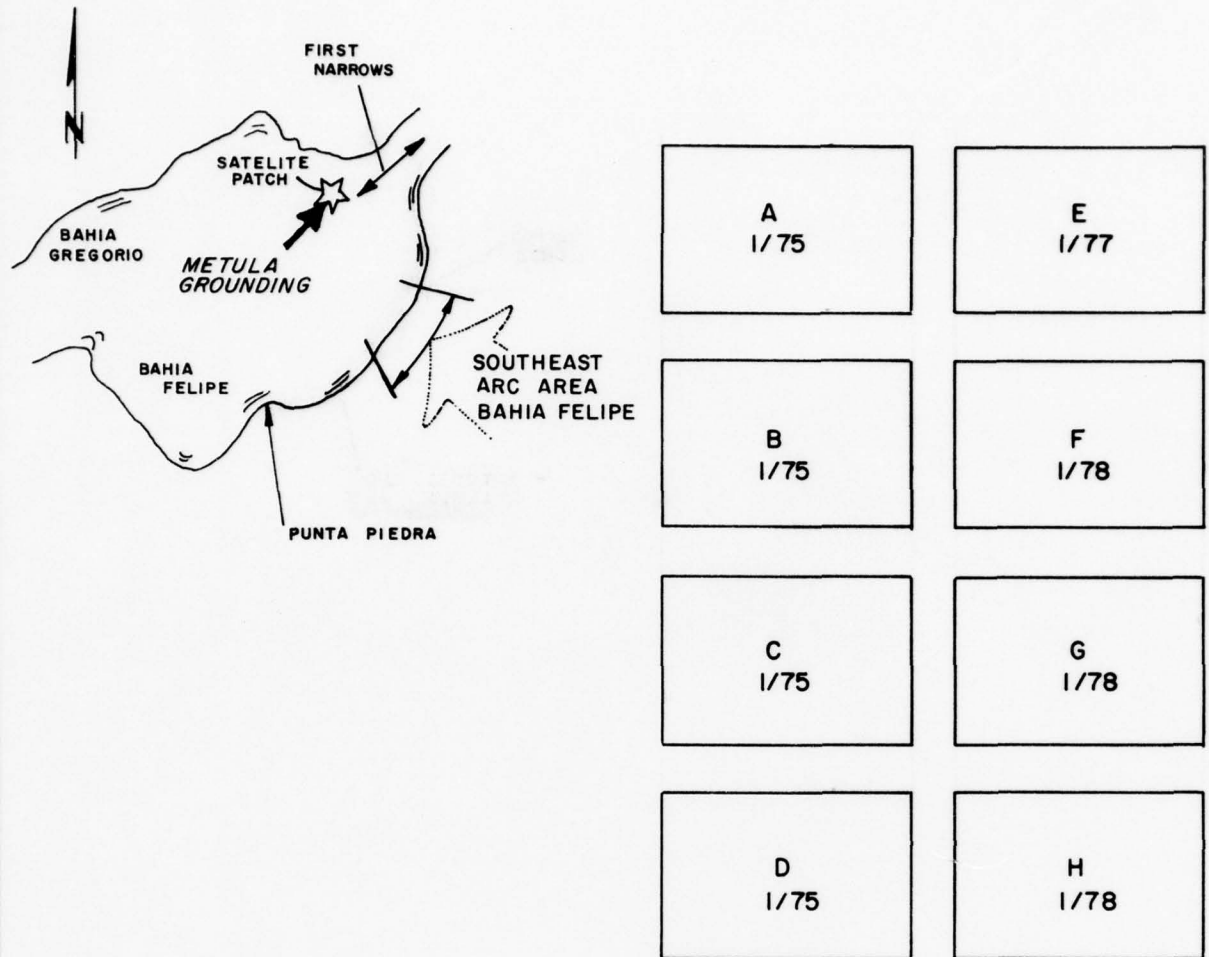
FIGURE 16

- A - Oiled beach top southeast arc.
- B - Weathered oil outcropping in beach.
- C - Oil outcropping in beach.
- D - Close-up of oil outcropping in January 1975.
- E - View of oil deposits at top of beach.
- F - View of oiled outcrop 3 1/2 years after the spill.
- G - Close-up of oiled outcrop after 3 1/2 years.
- H - Hole through oiled layer at top of the beach.

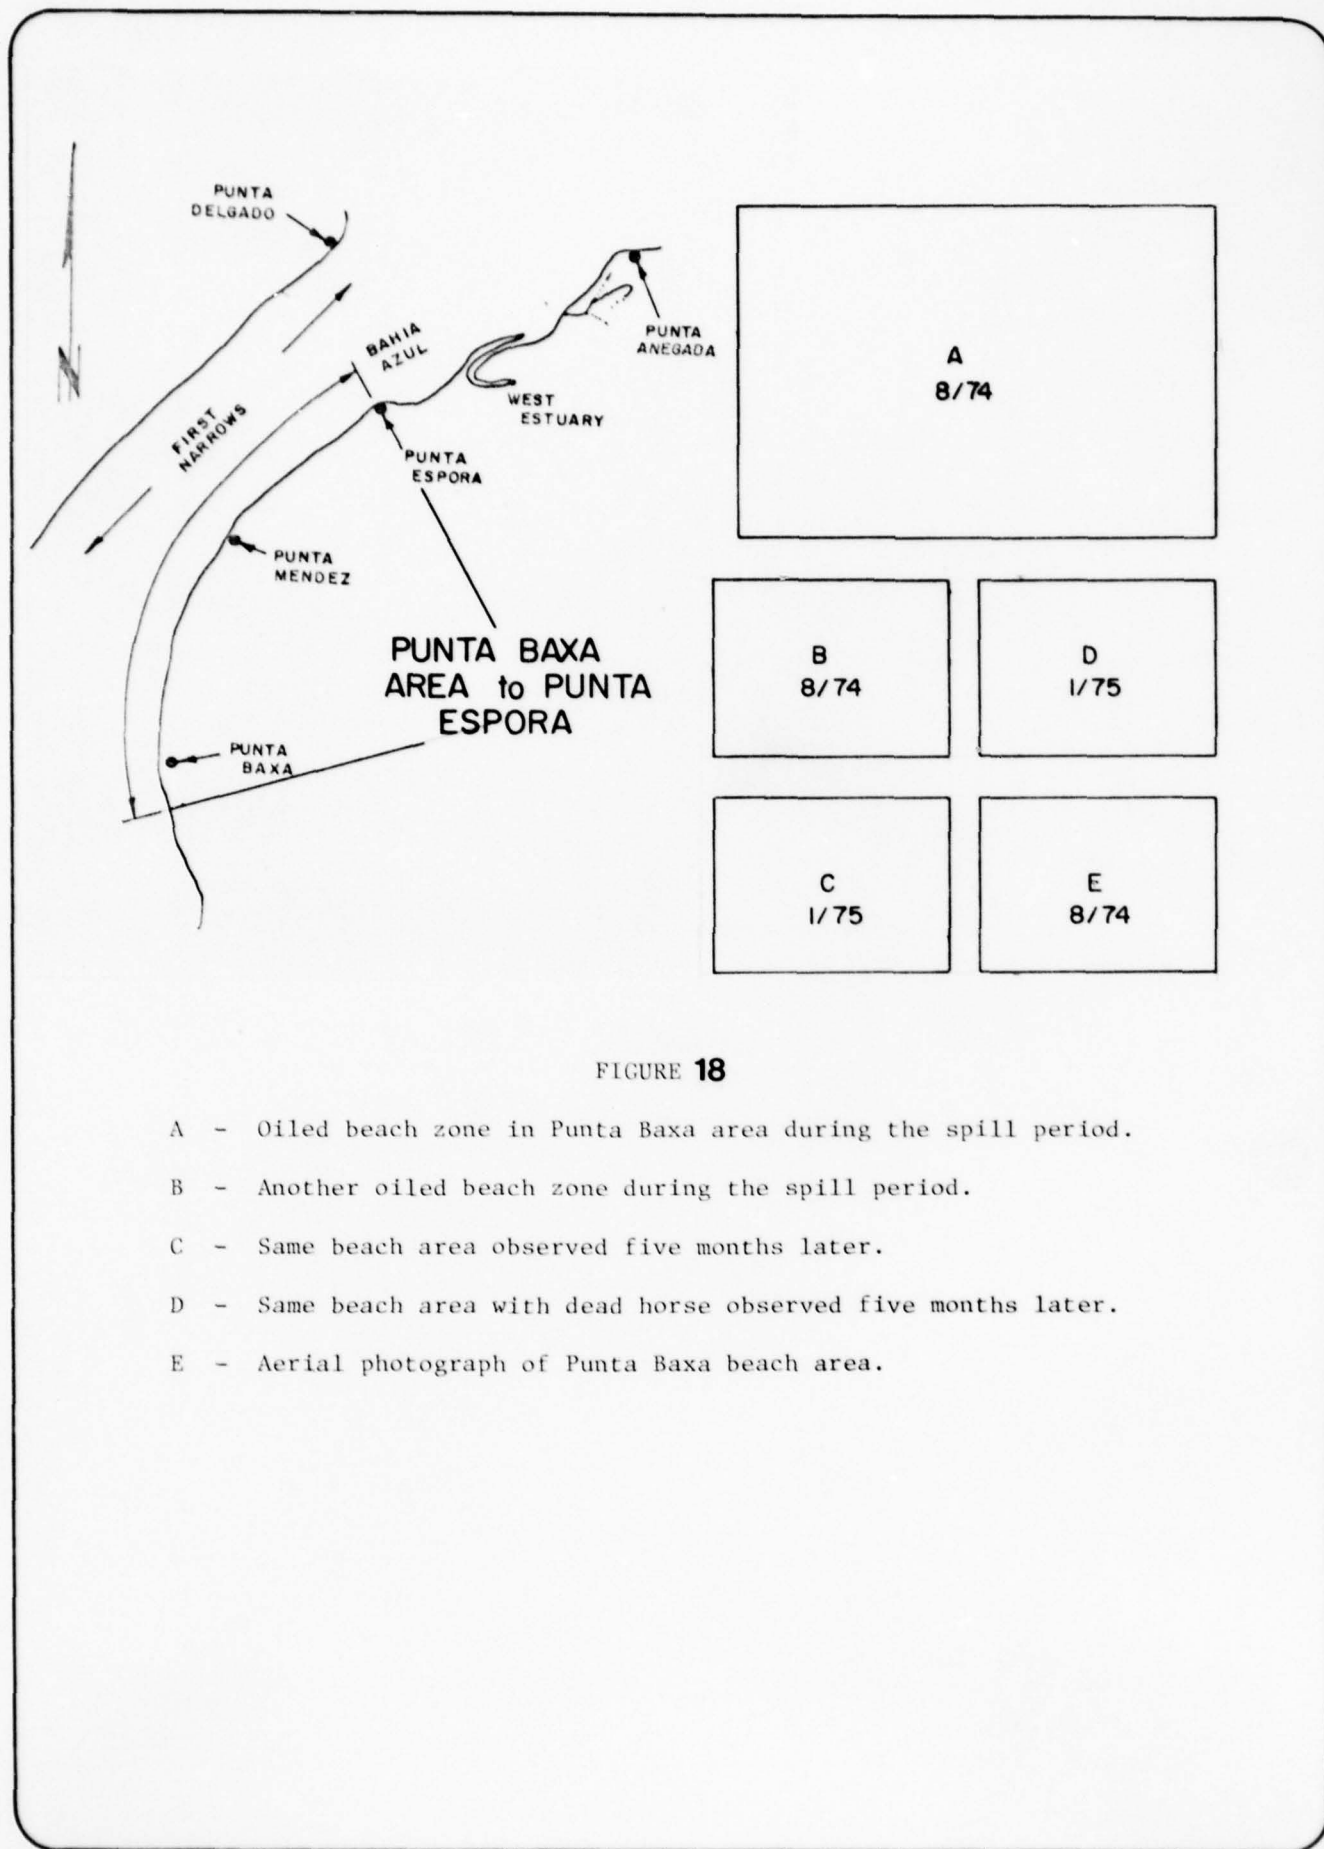
FIGURE 18

The cliff zone which stretches south from Punta Baxa at the entrance to the Narrows to where it intersects the Southeastern Arc was also heavily oiled at the time of the spill. Figure 18 Parts B and E show aerial photographs of this zone at the time of the spill and Figure 18 Part A shows a view from a cliff top of the same general area. This area differs from the Southeast Arc in that cliffs are found at the top of the beach. This resulted in the oil being retained at a zone where future wave action could work on the deposits. At the time of the spill it was noted that the action of the surf against the base of the cliffs had in some places thrown oil on the top of cliffs 8 to 10 meters high. The deposits on the beaches at the time of the spill generally ranged from 30 to 100 meters wide (98 to 328 ft) depending on the beach slope.

- A - Oiled beach zone in Punta Baxa area during the spill period.
- B - Another oiled beach zone during the spill period.
- C - Same beach area observed five months later.
- D - Same beach area with dead horse observed five months later.
- E - Aerial photograph of Punta Baxa beach area.

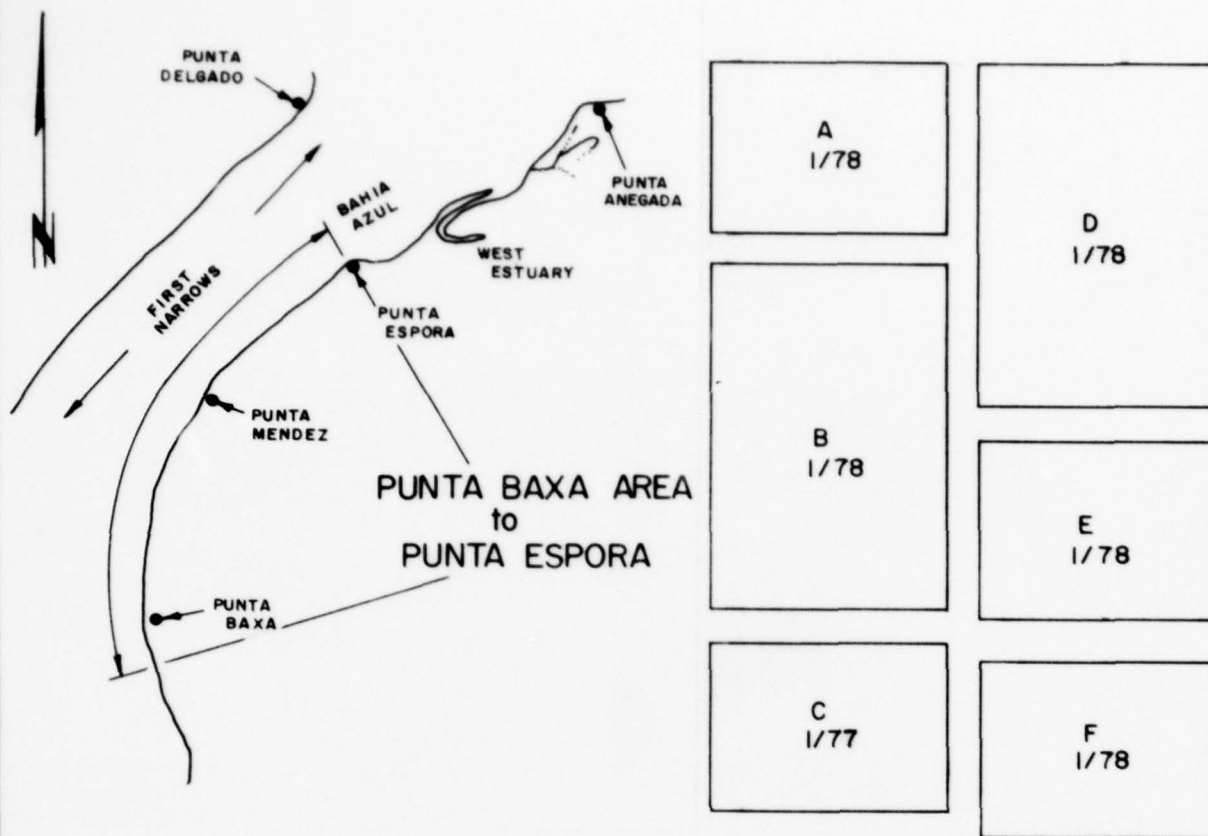
FIGURE 19

Unique in this area are the large number of tar balls and tar slabs found at the base of the beach slope. These are shown in Figure 19 Parts A and B. These may have resulted from the erosion of the oiled zones at the beach top. Since the beach in this area was building at the time the question is raised as to whether there is a large amount of buried oil under the bottom of the beach slope.

- A - Tar slabs at bottom of beach face in Punta Baxa area.
- B - Tar balls at bottom of beach face in Punta Baxa area.
- C - Tarred rock face on south shore of First Narrows.
- D - Eroded oil layers at foot of cliffs in Punta Baxa area.
- E - Heavy mussel population on large rock in cobble area near Punta Baxa.
- F - Oil on top of small cave at top of beach near Punta Baxa.

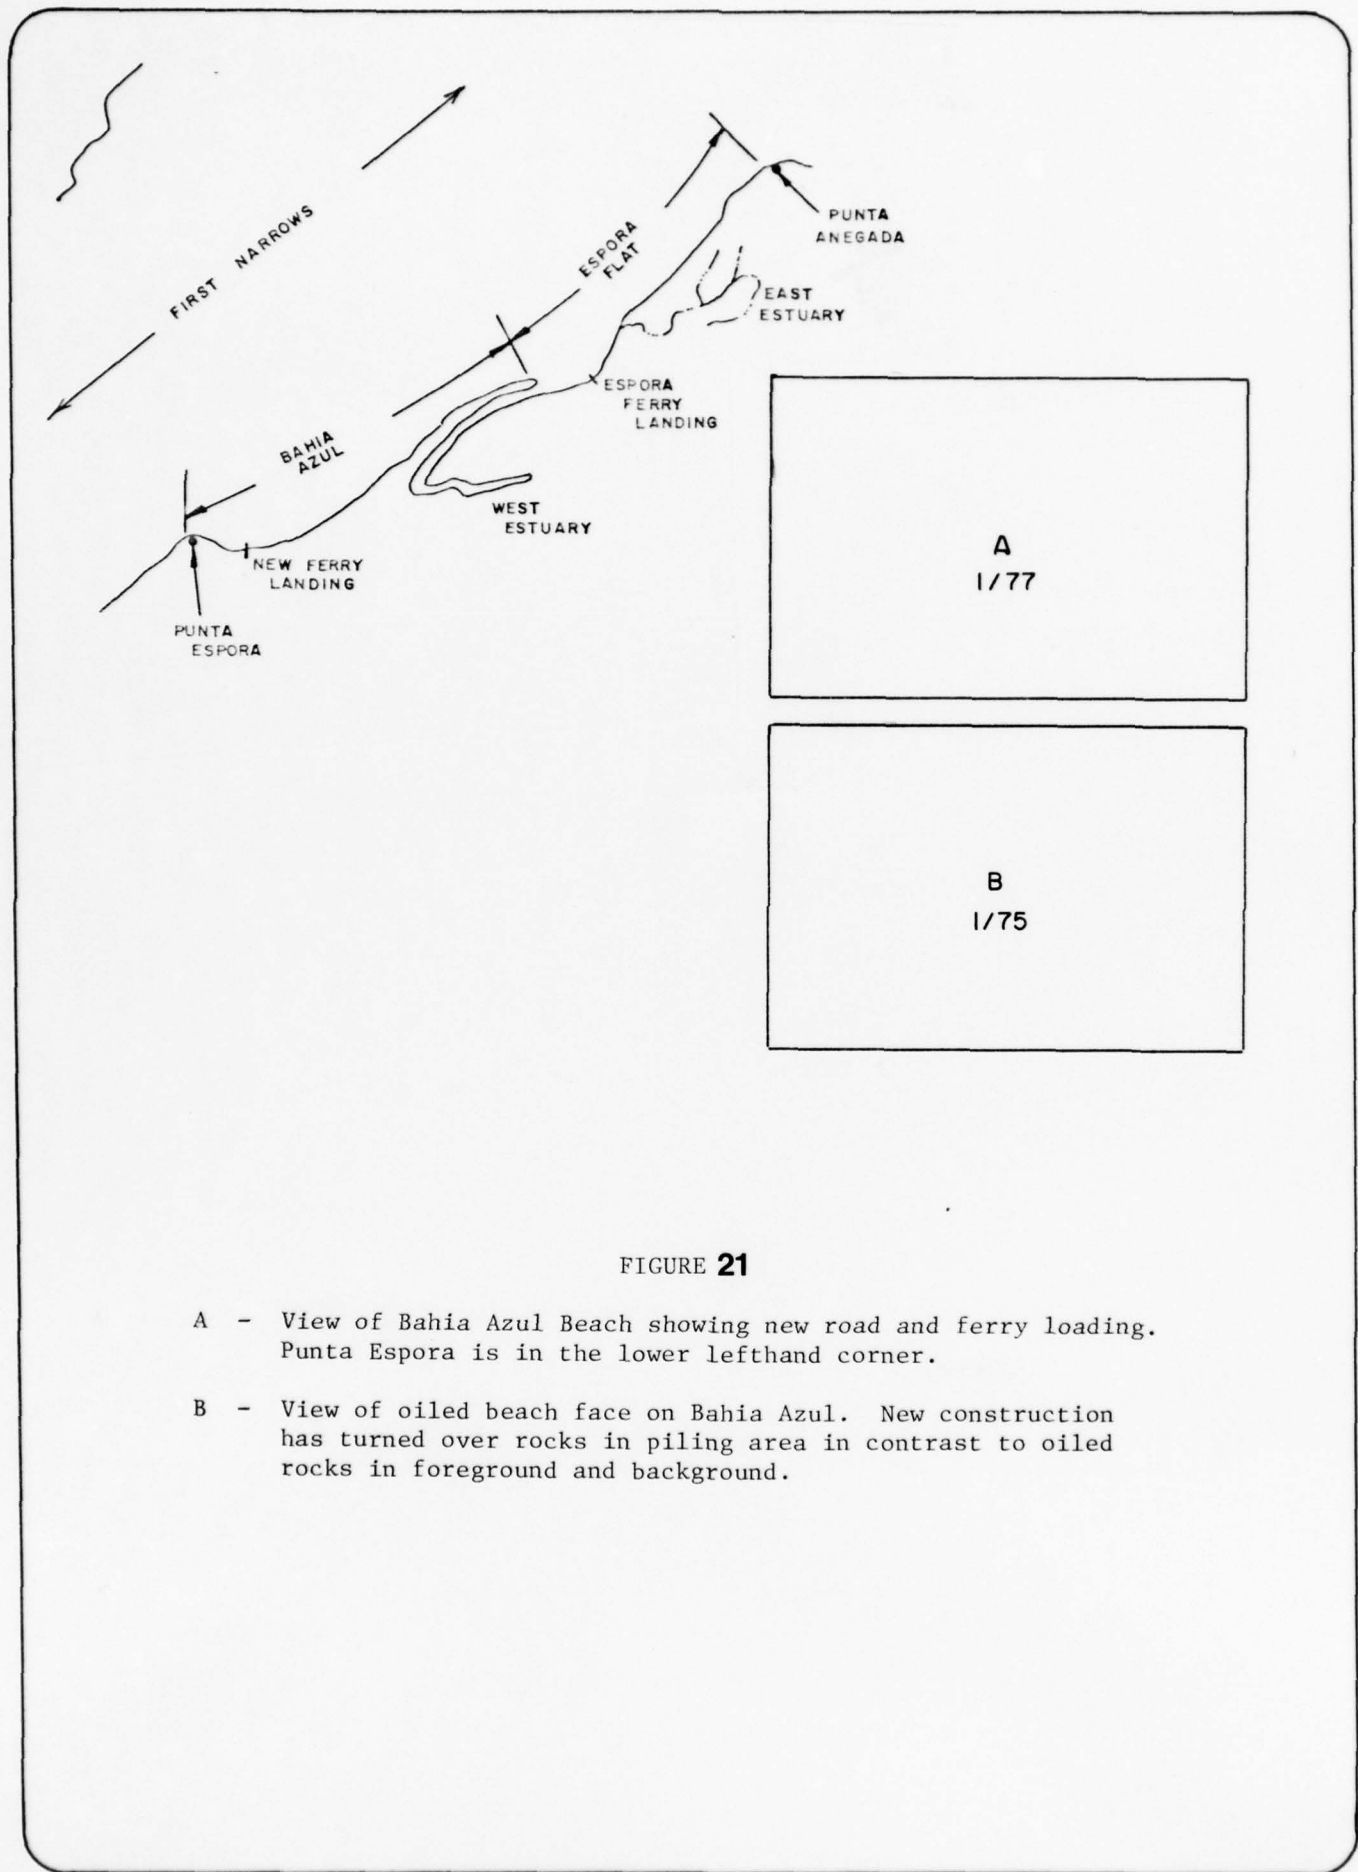
FIGURE 21

The Bahia Azul Beach was not observed at the time of the spill but the construction of the new ferry landing and access road in late 1974 made observation possible in January of 1975. Figure 21 Part B shows the Azul Beach at the new ferry landing. The clean undersides of rocks disturbed by the construction contrasted drastically with the oiled beach face in the foreground and background.

- A - View of Bahia Azul Beach showing new road and ferry loading. Punta Espora is in the lower lefthand corner.
- B - View of oiled beach face on Bahia Azul. New construction has turned over rocks in piling area in contrast to oiled rocks in foreground and background.

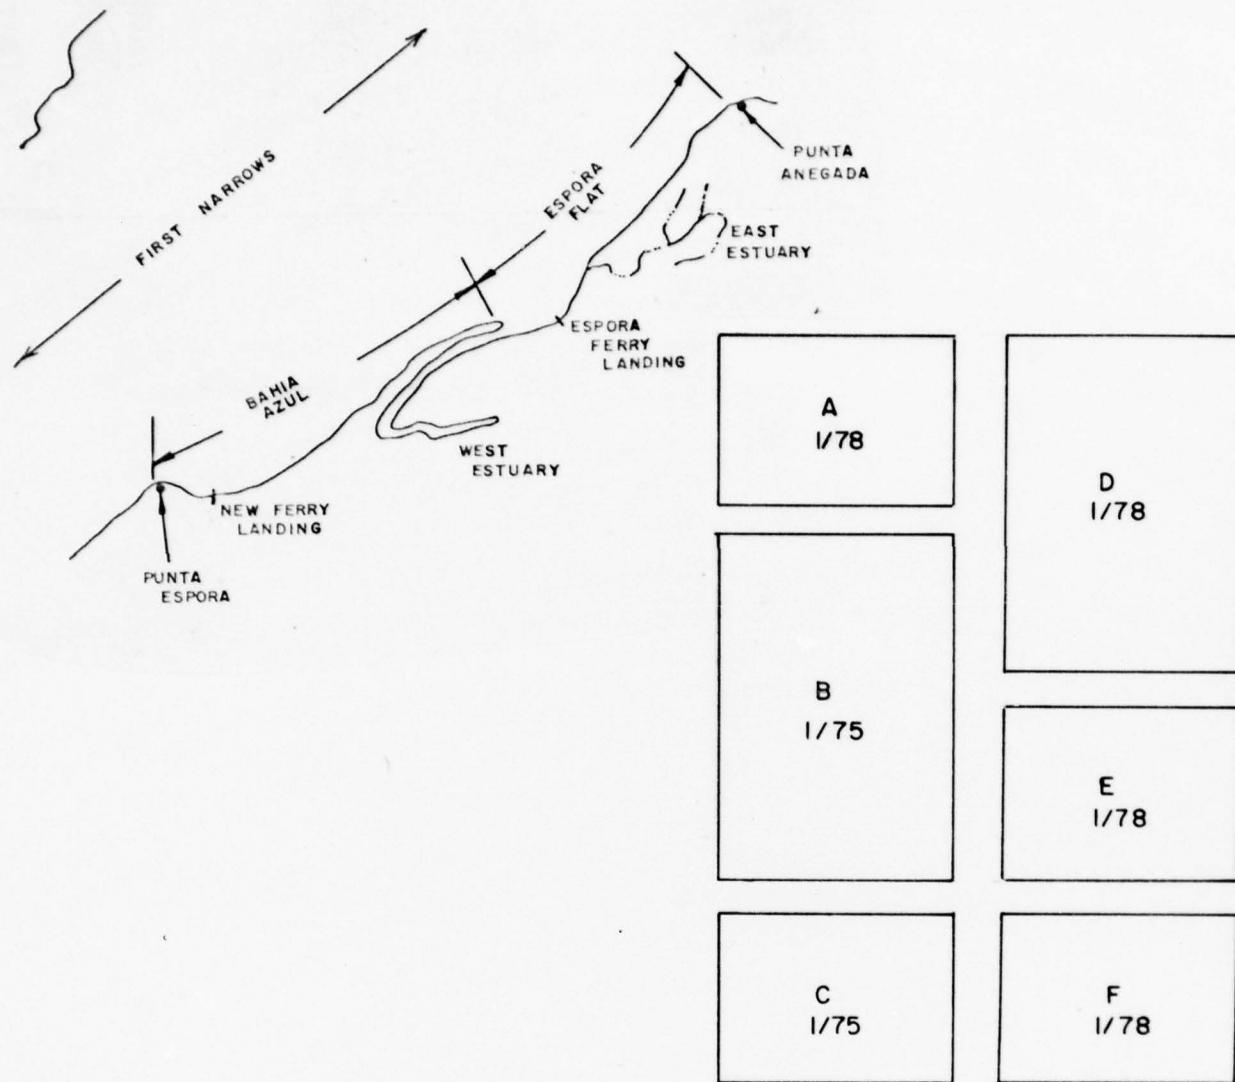
FIGURE 22

The entire beach zone in this area is heavily oiled. Figure 22 Parts A through F shows views of this beach in 1975 and 1978. Figure 23 shows a beach profile made in 1975. Almost an identical profile was observed in 1978 except for the relative absence of oil in the sandy zone between the oiled layer at the top (Figure 22 Parts C and F) and the paved cobble area shown in Figure 22 Parts A, B, D and E.

- A - Paved beach to south of New Ferry landing on Bahia Azul.
- B - Closeup of oiled pavement on Bahia Azul Beach.
- C - Oiled shell and flat stone beach top deposit in January 1975.
- D - Series of sampling pits perpendicular to the beach on Bahia Azul shore.
- E - Closeup of oiled pavement.
- F - Oiled shell and flat stone beach top deposit in January of 1978.

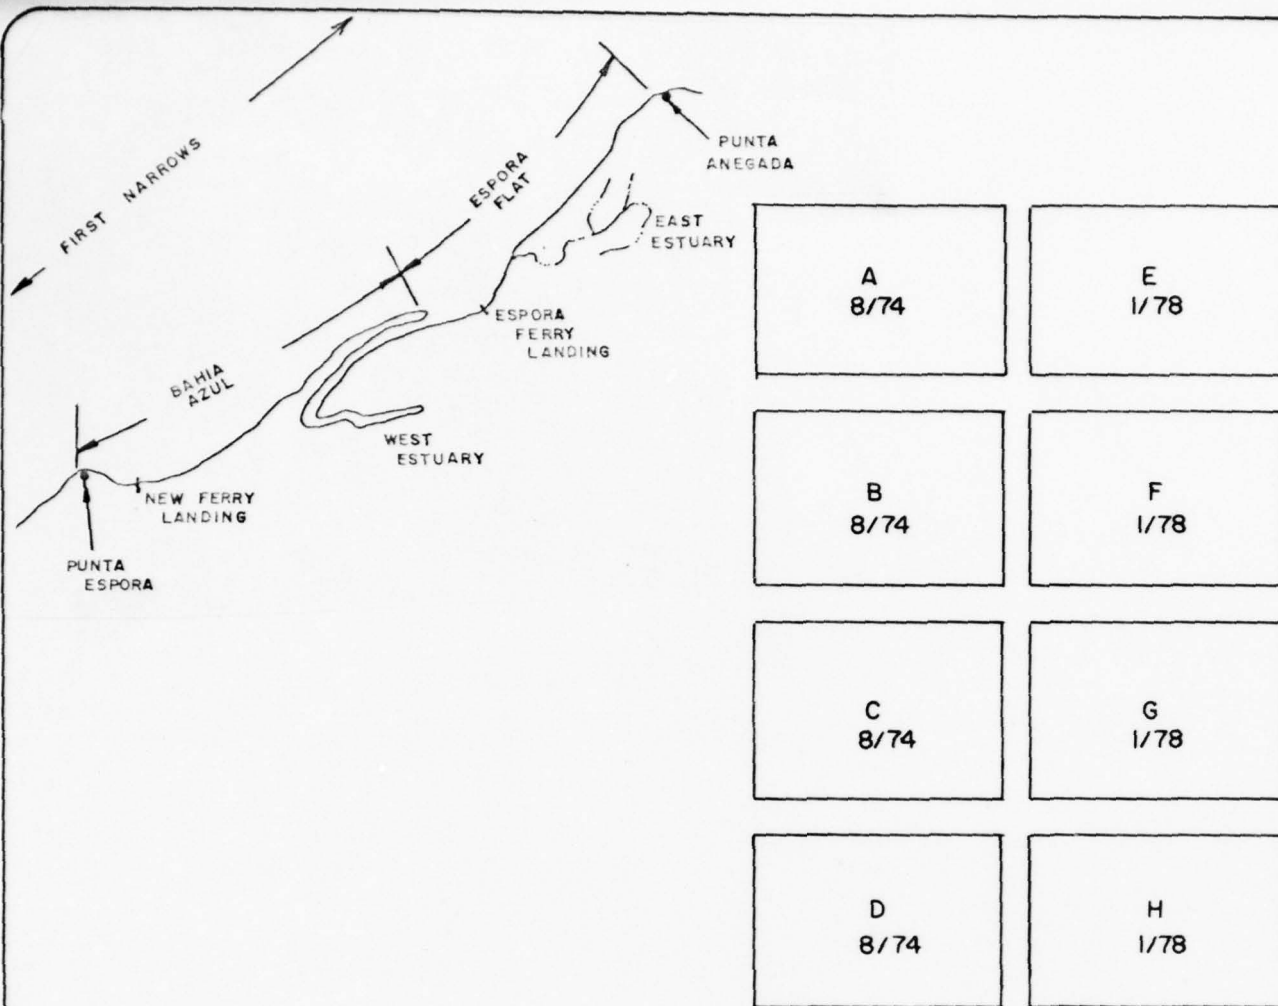
FIGURE 24

- A - Espora beach top at time of the spill.
- B - Old Ferry Landing at Puerto Espora at low tide during the spill.
- C - Stranded oil draining down beach face during time of the spill.
- D - Ferry Unloading on oiled Espora beach.
- E - Weathered oiled beach top looking west at Espora in January 1978.
- F - Weathered oiled beach top looking east at Espora in January 1978.
- G - Close-up of weathered sediments at top of Espora beach.
- H

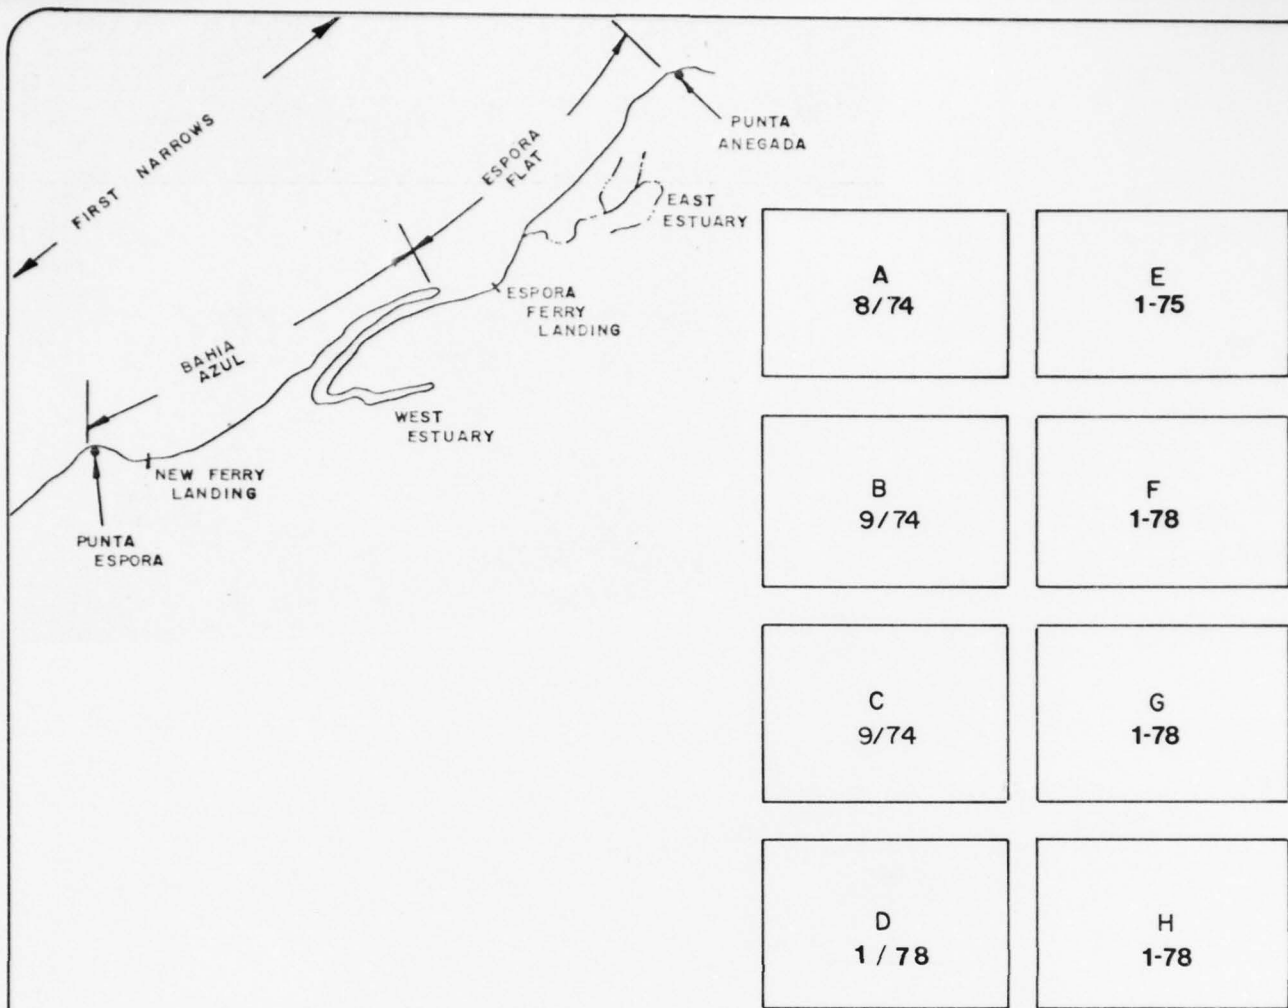
FIGURE 25

- A - Espora flat in late August 1974.
- B - Movement of oil into Espora area on September 2, 1974.
- C - Deposited oil in Espora Flat at low tide on September 2, 1974.
- D - Algae on oil surface and mousse under surface.
- E - Oiled sediment in Espora Flat on January 1975.
- F - Oiled sediment in Espora Flat in January 1978.
- G - Oiled Espora tidal flat looking seaward.
- H - Close-up of algae growing on oiled sediment.

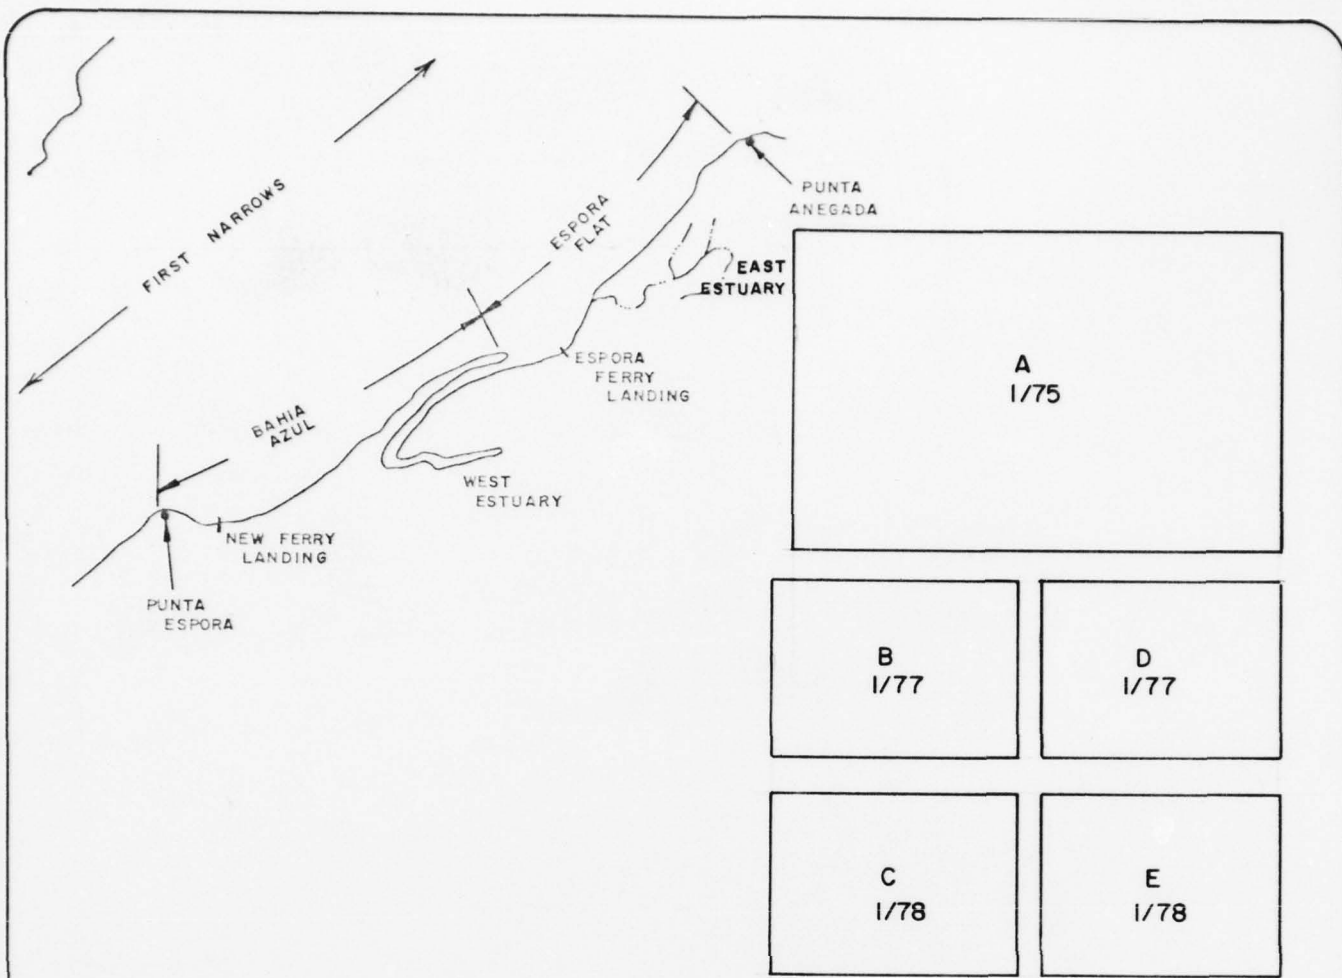
FIGURE 26

The dramatic aerial extent of the deposits may be noted in Figure 26 Part A and the depth of the pavement-like moussecrete may be noted in Figures 26 Parts B, C, D and E. These latter pictures were taken in 1977 and 1978 where the edges of the pavements are eroding.

- A - View along oiled tidal flat toward Old Ferry landing.
- B - Eroded edge of sediment at bottom of beach slope.
- C - Close-up of eroded edge showing 11 inch thickness.
- D - Additional close-up of eroded edge taken in January of 1978.
- E

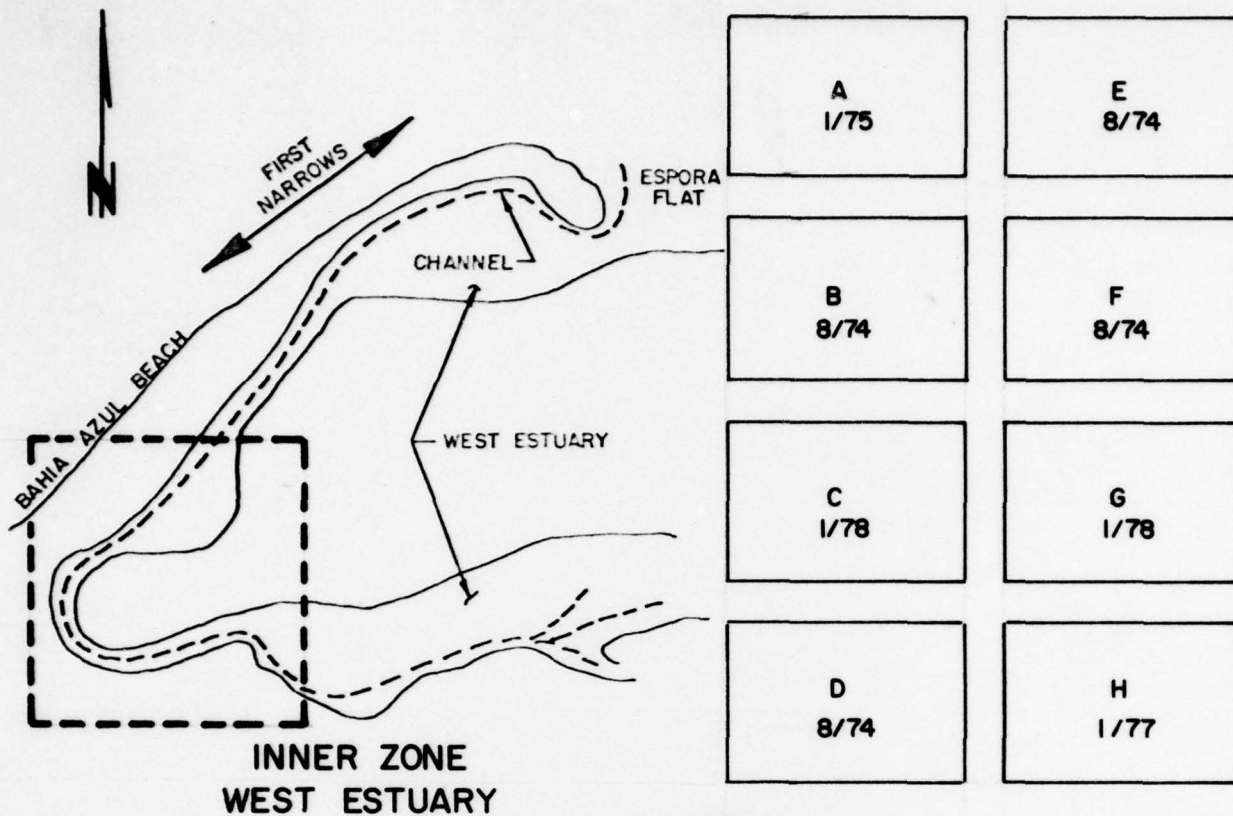
FIGURE 32

- A - Oiled Salicornia area in tidal marsh.
- B - Oil stranded on mud flat inside West Estuary bend.
- C - Oiled Salicornia and pool of oil.
- D - Oil stranded on mud flat.
- E - West Estuary Marsh 8/74
- F - West Estuary Marsh 1/75
- G - West Estuary Marsh 1/77
- H - West Estuary Marsh 1/78

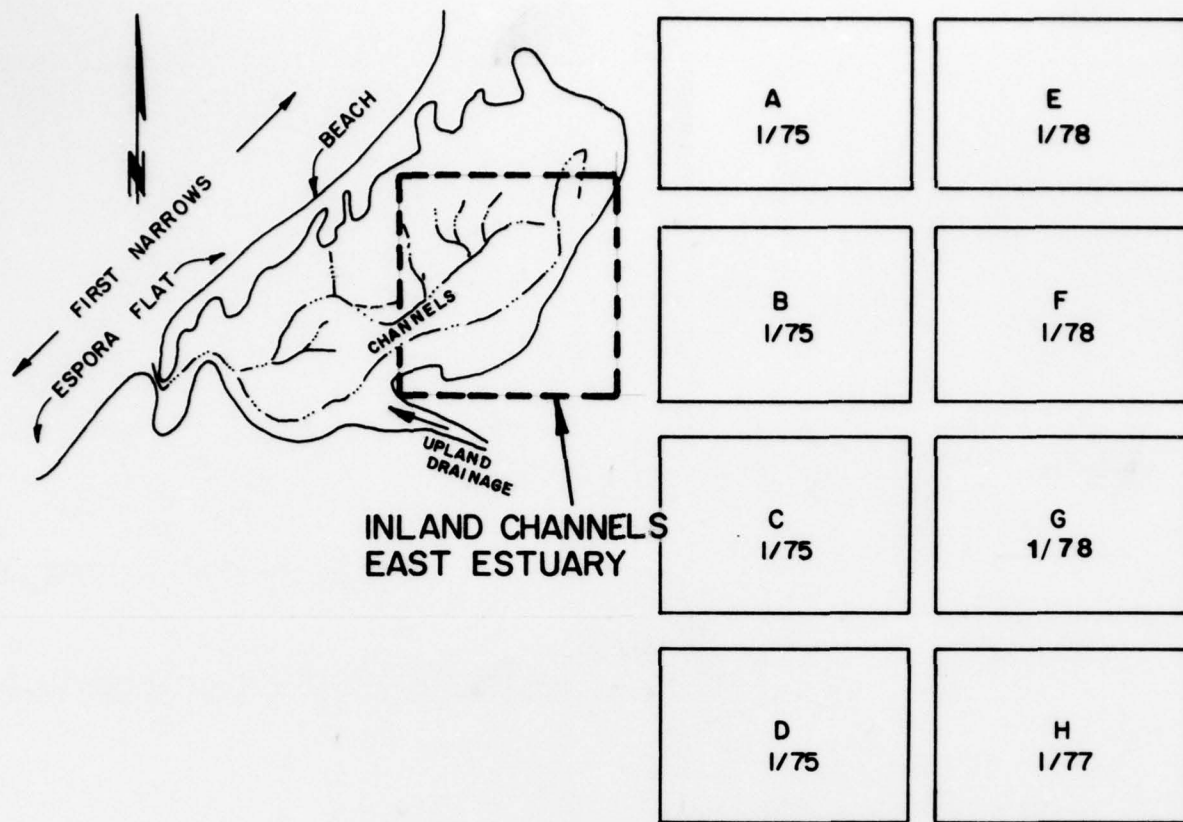
FIGURE 36

The mousse had been flushed from the channels by January of 1976, but the flat areas between channels and the channel bank as shown in Figure 36 Part D in 1975 and Parts E, F, G and H in 1977 and 1978 remained heavily oiled. This liquid mousse or oil on the surface remains in a soupy liquid form which has changed little in the three and a half years since the spill. Only in the areas where the mousse was not thick has the deposit thickened and hardened. This area will probably have evidence of the METULA spill for 15 to 20 years unless it is ultimately cleaned up.

- A - Aerial view of inland channels showing oil on channel banks.
- B - Close-up of channel edges showing oiled vegetation.
- C - Thick pool of oil remaining in channel five months after the spill.
- D - Isolated oiled vegetation on tidal grass flat.
- E - Oiled channel at later date.
- F - Oiled vegetation on banks 3 1/2 years after the spill.
- G - Oiled channel 3 1/2 years after the spill.
- H - Oiled pool on tidal grass flat 3 1/2 years after the spill.

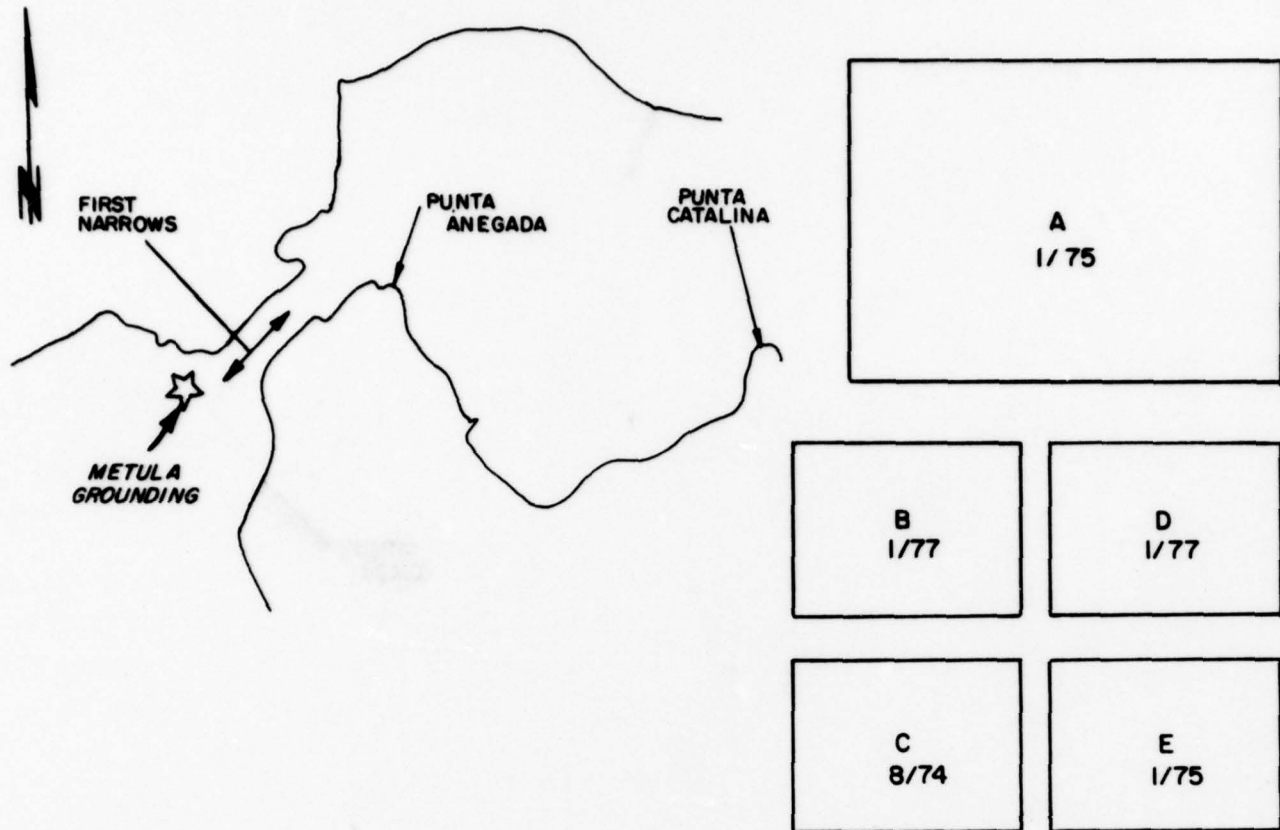
FIGURE 37

- A - Oil at top of beach east of Punta Anegada.
- B - Weathered oil at top of beach east of Punta Anegada.
- C - Pooled oil sheen southwest at Punta Catalina.
- D - Weathered oil crust at top of beach east of Punta Anegada.
- E - Weathered oil at top of broad beach southwest of Punta Catalina.
