FATE OF OIL SPILLED FROM THE
SUPERTANKER METULA

ROY W. HANN, JR.
HARRY N. YOUNG, JR

JANUARY 1979

FINAL REPORT

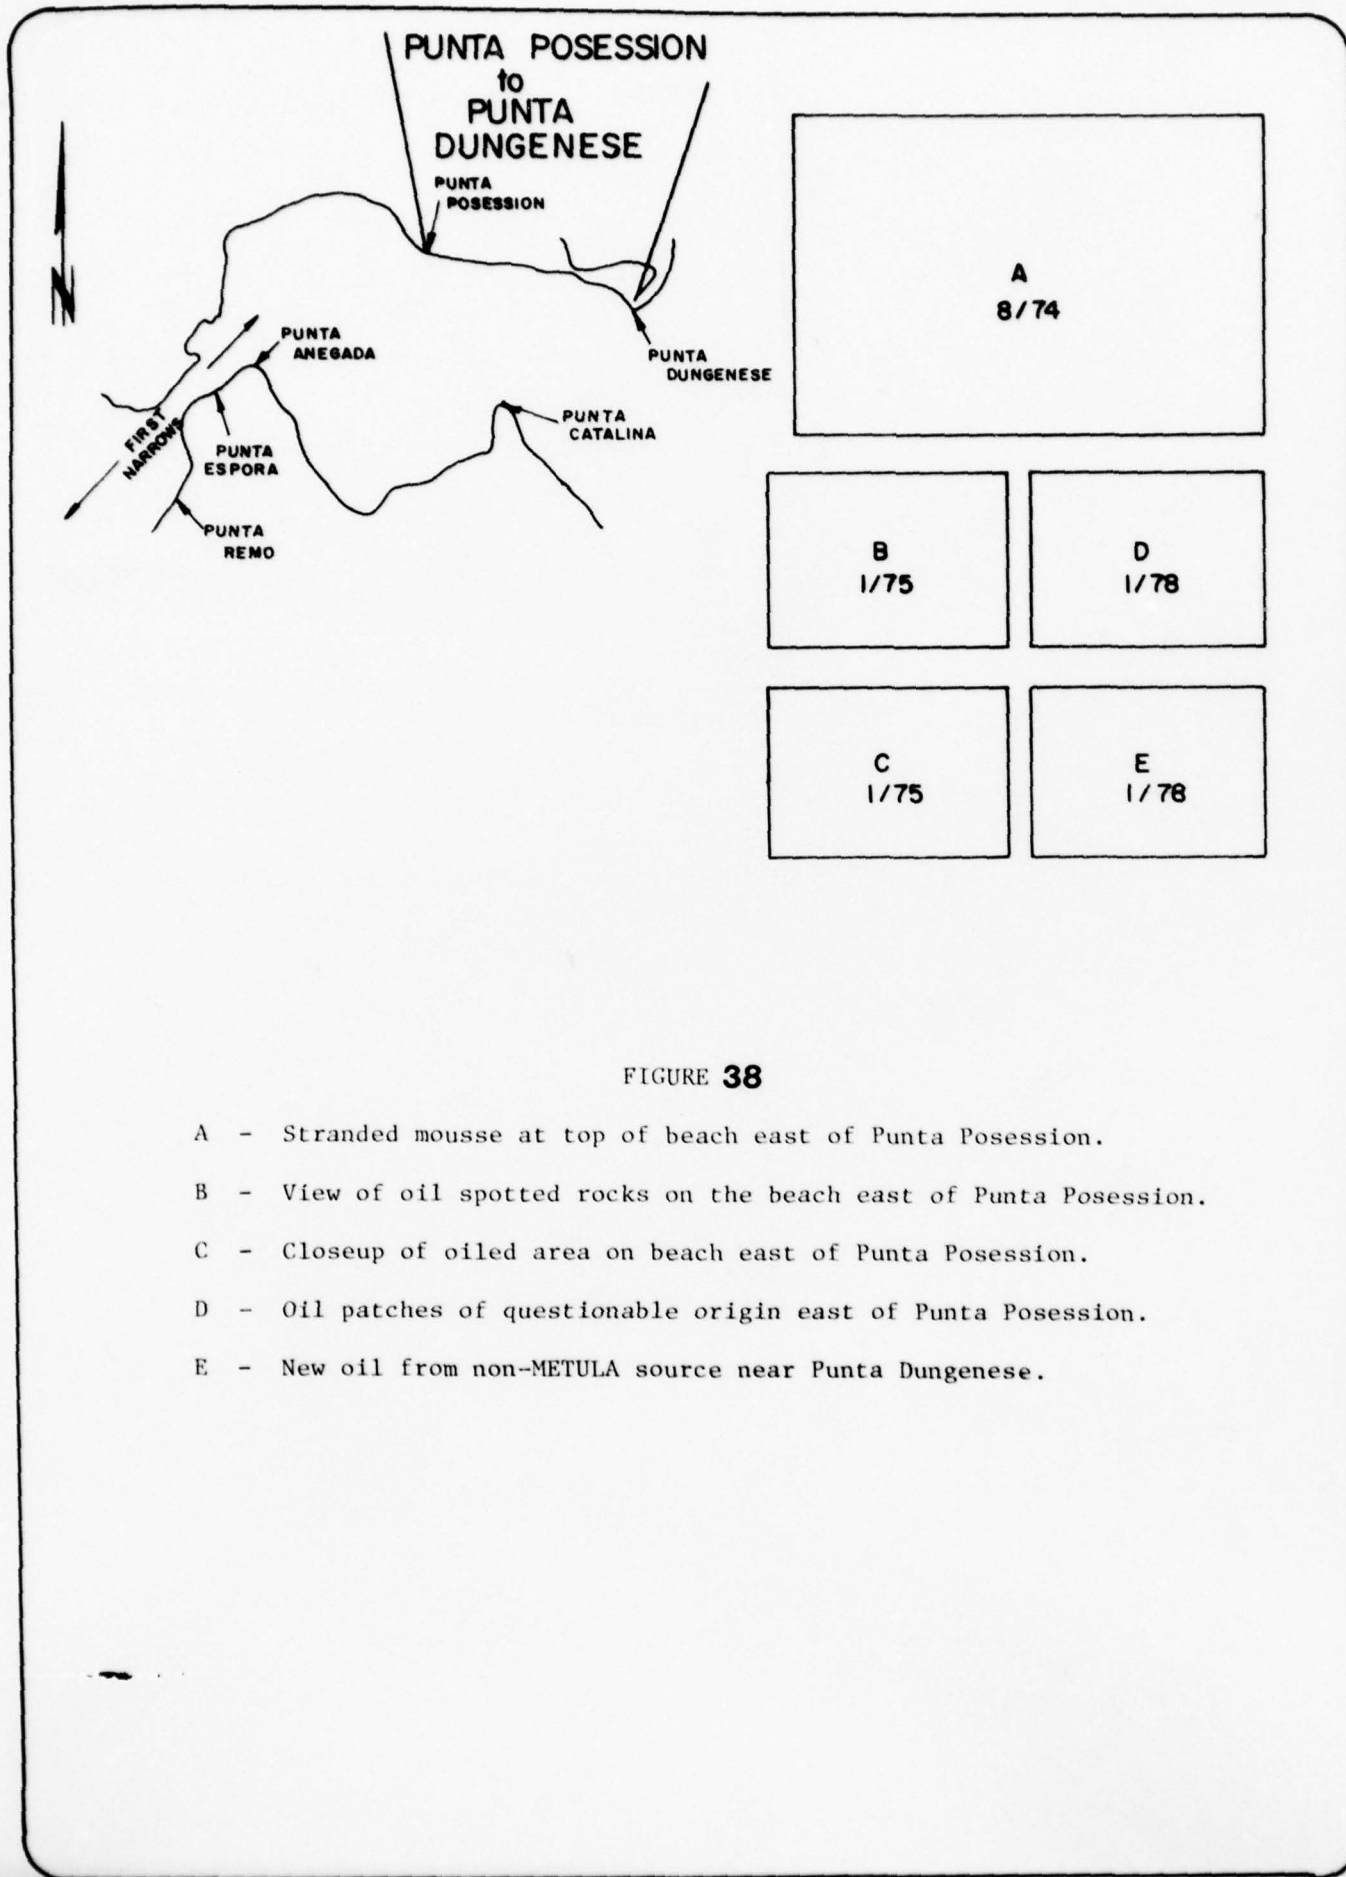
FIGURE 38

place. Figure 38 Parts D and E show examples of these later spills. No oil was found, however, that appeared to be METULA oil. It is believed the location of these beaches so as to receive heavy surf from the strong westerly winds caused the oil to quickly dissipate into the water column.

- A - Stranded mousse at top of beach east of Punta Posession.
- B - View of oil spotted rocks on the beach east of Punta Posession.
- C - Closeup of oiled area on beach east of Punta Posession.
- D - Oil patches of questionable origin east of Punta Posession.
- E - New oil from non-METULA source near Punta Dungenese.
