Special Report 79-16

ROOF MOISTURE SURVEY— U.S. MILITARY ACADEMY

Charles Korhonen and Wayne Tobiasson

The roofs and upper story walls of buildings 745E, 752 and 756 at the U.S. Military Academy in West Point, New York, were surveyed for entrapped moisture with an AGA Thermovision 750 infrared camera on the nights of 17 and 18 April 1978. These multi-storied stone and masonry buildings are used for barracks and classrooms.

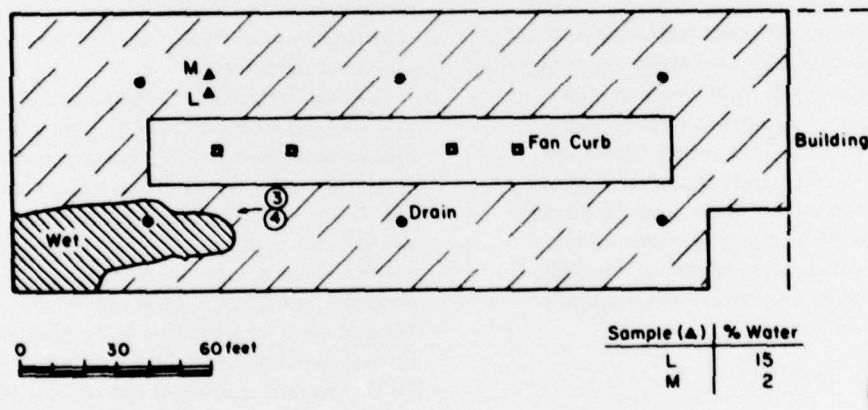
Core samples taken the following day in light and dark mottled areas indicated that the insulation in the light areas contained more moisture than that in dark areas. The water content from a light area (sample L, Fig. 2) was 15% and that from a dark area (sample M) was 2%. It is estimated that over half of the insulation in this roof contained about 15% moisture. Tests underway at CRREL suggest that the thermal resistance of urethane insulation is decreased by 5 to 10% when it contains 15% moisture by weight. Therefore, the thermal implications of this amount of moisture are minor. Removing such insulation cannot be justified by energy conservation alone.

Only one well-defined bright thermal anomaly was detected with the infrared camera. This anomaly is shown by the tight hatching in Figure 2. Figures 3 and 4 are, respectively, a thermogram and a daytime photograph of this area. This thermal anomaly was much more intense than the light mottled areas over most of the roof and thus a stronger indication of moisture. No samples were obtained from this area but it is felt that the insulation therein contains substantially more than 15% moisture by weight.

Figure 2. Plan view of Building 745E. The tight hatching indicates an area of entrapped moisture. The open hatching indicates that small amounts of moisture are randomly dispersed throughout the roof. The arrow and circled numbers indicate the viewing direction of Figures 3 and 4.

Normally it would be recommended that the membrane and insulation in the very wet area be removed and replaced with dry insulation and a new membrane. However, the entire membrane on this roof is blistered and probably will require replacement in a few years. Therefore, it is suggested that the wet urethane insulation remain in place until it becomes necessary to remove and replace the membrane and insulation over the entire roof.
