HARRY DIAMOND LABS ADELPHI MD
STRUCTURAL FIRING TESTS OF THE M735 PROXIMITY FUZE.(U)
MAY 79 J M MILLER, S A BORING

HDL-TM-79-6

REPORT DOCUMENTATION PAGE		READ INSTRUCTIONS BEFORE COMPLETING FORM
1. REPORT NUMBER 14 HDL-TM-79-6	2. GOVT ACCESSION NO.	3. RECIPIENT'S CATALOG NUMBER
4. TITLE (and Subtitle) 6 Structural Firing Tests of the M735 Proximity Fuze	5. TYPE OF REPORT & PERIOD COVERED Technical Memorandum

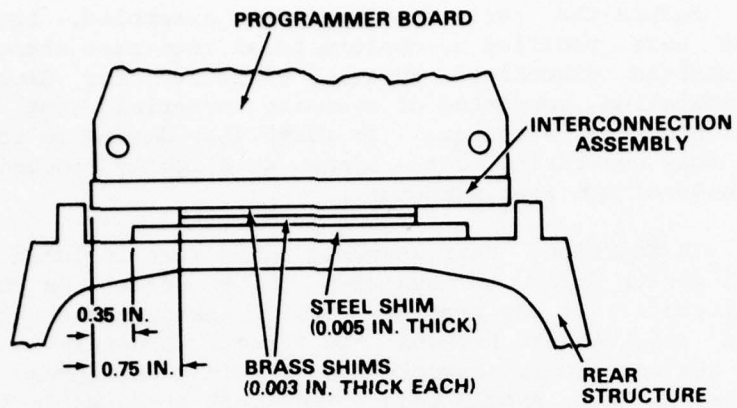
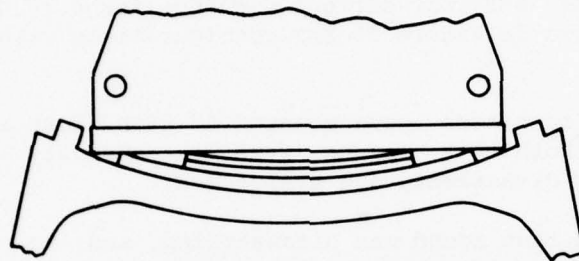
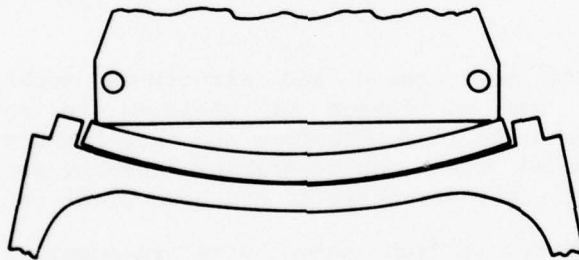
The second test round and structural mockup fuzes were disassembled. There was no damage or yielding to any fuze part. Markings found on both the rear structure and interconnect boards along the shim edges indicated that the programmer assembly support reaction was transmitted to the rear structure as had been predicted.

The rear assembly shims appeared to spread the programmer assembly support as predicted. However, since no programmer board failure occurred on any of these tests, it is not possible to determine their effect on reducing the programmer board peak stress. Further testing is needed before a design change can be recommended.

The shims between the rear structure and programmer assembly will be incorporated into the design since they apparently distribute the programmer load with no damage to the assembly. However, in later Group 4C/D electronic fuze vertical recovery tests the programmer mounting-block studs were found to be inadequate. Higher strength studs will have to be investigated in the next group of structural fuzes.

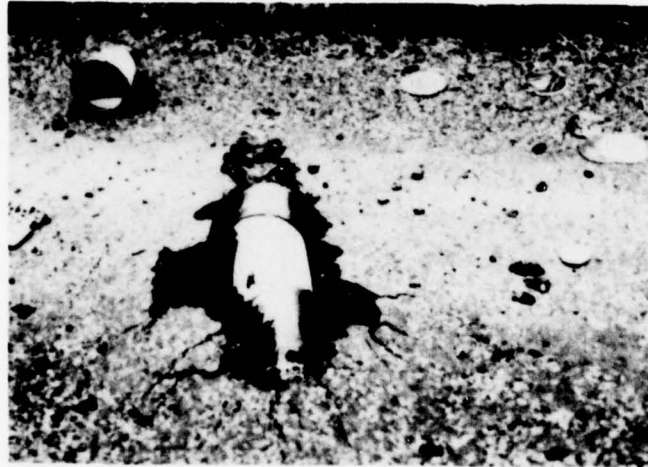
Figure 14. Group 5 structural fuze, hard impact.

Fuze 2 was fired vertically on 21 May 1976. The round went unstable and landed sideways on an asphalt road behind and to the left of the gun. The impact is shown in figure 14. The spoiler plate was never found, but the impression left on the road indicates that it was attached at impact (fig. 15). It was determined that the smaller spoiler plate was ineffective at the higher velocities produced by the gun and charge. Firing was terminated for the day. It was decided that fuzes 1 and 3 be fired down-range on PXR 6165 parachute recovery rounds at YPG.
