ARMY ENGINEER DISTRICT NEW YORK  
NATIONAL DAM SAFETY PROGRAM. SALISBURY MILLS DAM, INVENTORY NUM--ETC(U)  
APR 78 C H BENN

REPORT DOCUMENTATION PAGE		READ INSTRUCTIONS BEFORE COMPLETING FORM
1. REPORT NUMBER	2. GOVT ACCESSION NO.	3. RECIPIENT'S CATALOG NUMBER
4. TITLE (and Subtitle) Phase I Inspection Report Salisbury Mills Dam Moodna Creek Basin, Orange County, New York Inventory No. N.Y. #4		5. TYPE OF REPORT & PERIOD COVERED Phase I Inspection Report National Dam Safety Program

INVENTORY NO. 4

DATE: 19 April 1978

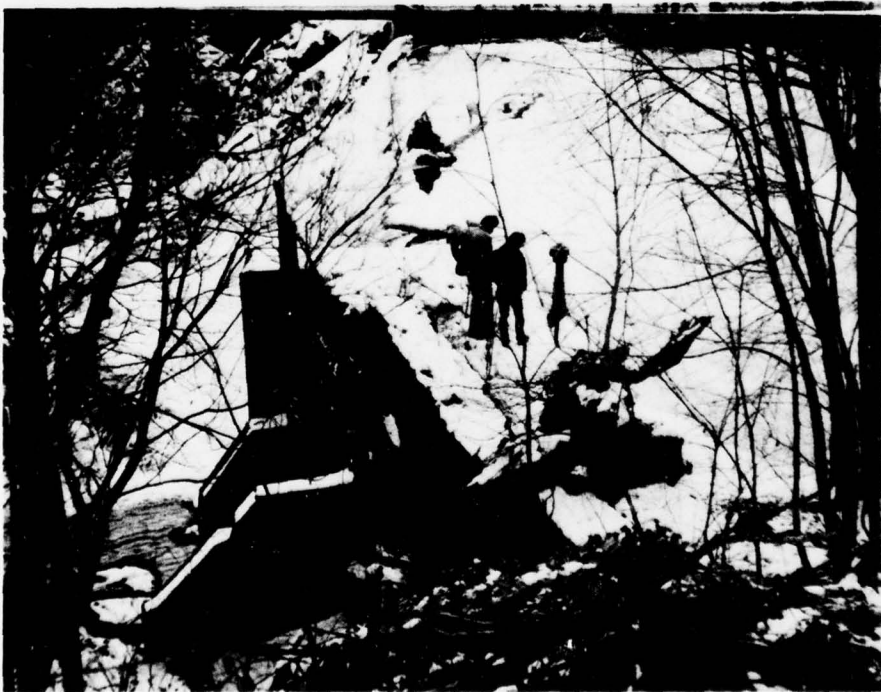
④

LEFT ABUTMENT TIE IN WALL

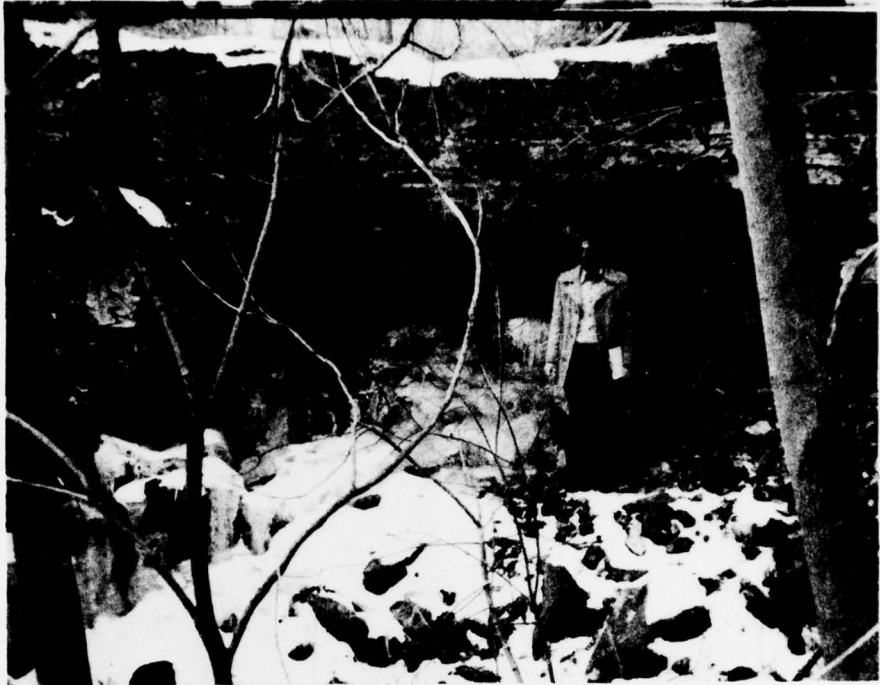
⑤ VOID AND SEEPAGE AT D/S FACE LEFT ABUTMENT  
TIE IN WALL

Visual inspection revealed the left masonry abutment tie-in wall to have significant seepage and extensive loss of stone on the downstream face which could result in imminent failure at the abutment. The dam is evidently founded on ledge rock and failure of the wall would not undermine the spillway section or the road at the left bank. Visual reconnaissance of the immediate downstream area indicates an absence of development in the floodplain which would be affected by a partial failure of the dam. A fire in the mill at the right bank and subsequent demolition has left the dam in an

a. Safety - This dam exhibits serious operational and maintenance deficiencies. The left masonry tie-in abutment wall exhibits extensive loss of stone at the downstream face and significant seepage and is considered to be in imminent danger of failure. The dam is considered to be unsafe in its present condition.

VISUAL EXAMINATION OF	OBSERVATIONS	REMARKS OR RECOMMENDATIONS
ANY NOTICEABLE SEEPAGE	D/S FACE OF LEFT MASONRY ABUTMENT TIE-IN WALL LOSE OF MASONRY STONE (NO X 6 X 4) and significant seepage	See Photo # 5
STRUCTURE TO ABUTMENT/EMBANKMENT JUNCTIONS	SEEPAGE AS OBSERVED ABOVE ABUTMENTS ARE LEDGE ROCK	
DRAINS	NON - OBSERVED	
WATER PASSAGES	4' DIA. GATED INTAKE CONDUIT & TRASH RACK AT RIGHT ABUTMENT LEADING TO 6' DIA. PENSTOCK & OUTLET. GATE HOIST MECHANISM UNBLOCKED CLOSED. CONDITION OF PENSTOCK AND OUTLET IS QUESTIONABLE BECAUSE DEBRIS FROM DEMOLISHED DAM. OWNER STATES THAT GATE IS OPERABLE. INOPERABLE AS IN CONDUIT AT LEFT ABUTMENT.	See Photos 3, 2, 6
FOUNDATION	COULD NOT BE OBSERVED. APPEARS TO BEAR ON SHALE LEDGE ROCK

- (1) Draining the pool
- (2) Breaching or removing the dam and restoring the creek to the pre-construction conditions.
- (3) Repairing the left abutment tie-in wall.

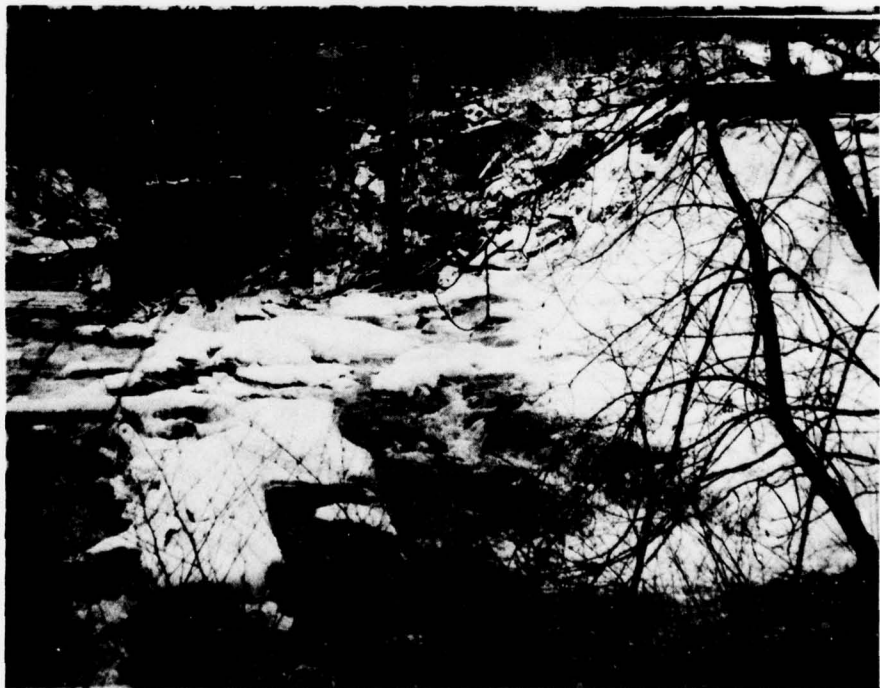
⑥ DEMOLITION OF OLD MILL AT RIGHT BANK  
(LOOKING S-W)

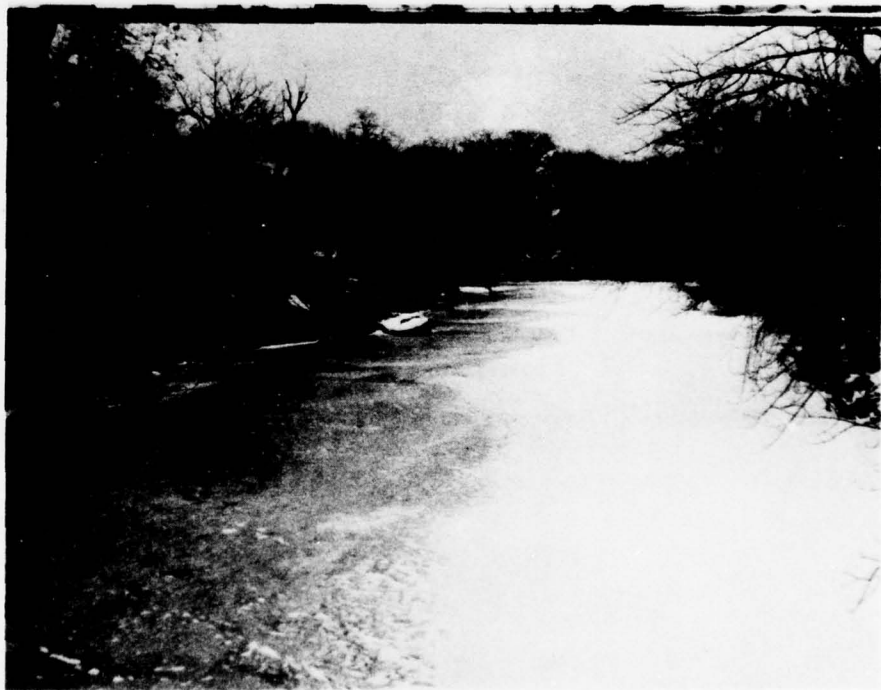
⑧ LOOKING UPSTREAM
