CONSTRUCTION ENGINEERING RESEARCH LAB (ARMY) CHAMPAIGN IL F/G 13/11
DURABILITY AND FIRE-SPREAD ASPECTS OF PLASTIC PIPE SYSTEMS.(U)
JUL 79 A SMITH, R B WILLIAMSON

TECHNICAL REPORT M-264
July 1979

DURABILITY AND FIRE-SPREAD ASPECTS
OF PLASTIC PIPE SYSTEMS

by
Alvin Smith
R. Brady Williamson

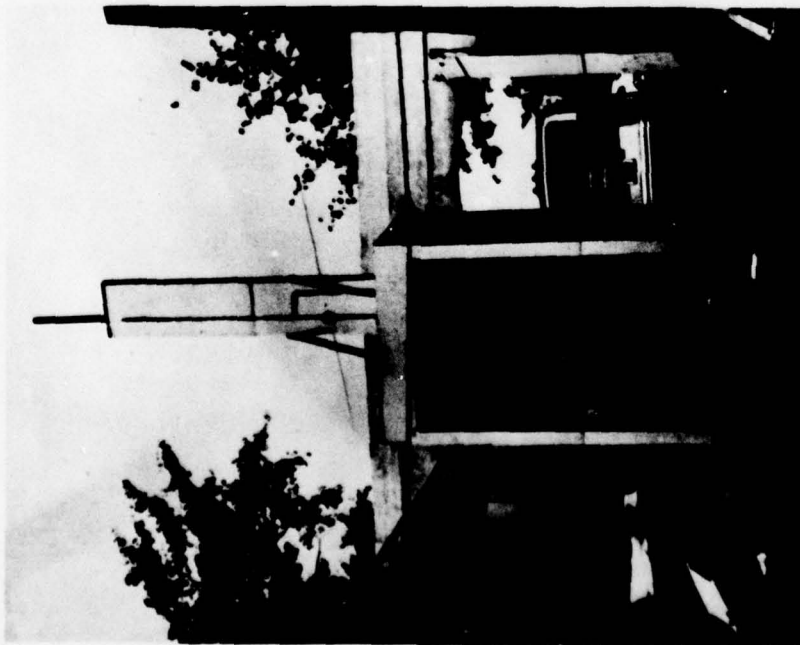
A photograph of the burning wooden kitchen sink cabinet is shown in Figure A1(b) at approximately 11 minutes into the test. The fire was extinguished after 22 minutes, and the remains of the kitchen cabinet can be seen in Figure A1(c). The redwood siding was removed and is illustrated in Figure A1(d). There was little damage to the ABS piping. The horizontal part of the tee for the sink was partly burned, and approximately 2 feet of the vent pipe above the tee had been elongated to 3 feet and had sagged down and folded over at the tee to close this pipe. Troxell noted that "the very hot fire resulting from the burning of the plywood cabinet so overshadowed the slight flaming of the ABS tee and pipe as to make the ABS fire inconsequential." In discussions of all of the experiments, Troxell noted that "burning of the exposed ABS pipe does not tend to transmit a fire into the stud space." Further, he observed that "the pipe softens when heated, so that it sags or collapses within the stud space and covers the opening in the plate so that the fire generally does not tend to follow the pipe into the stud wall." These early experiments set the background for the more recent ASTM E119 tests of walls containing DWV systems. There were a number of ad hoc experiments conducted in the middle 1960s, but those of Troxell's are the most well-documented for fire growth.

Figure A1. (a) Two-story mock-up in foreground has ABS DWV pipe in wall as drawn on surface of gypsum wallboard.
(b) Flames engulf the wooden cabinet and reach ceiling at 11 minutes into experiment.

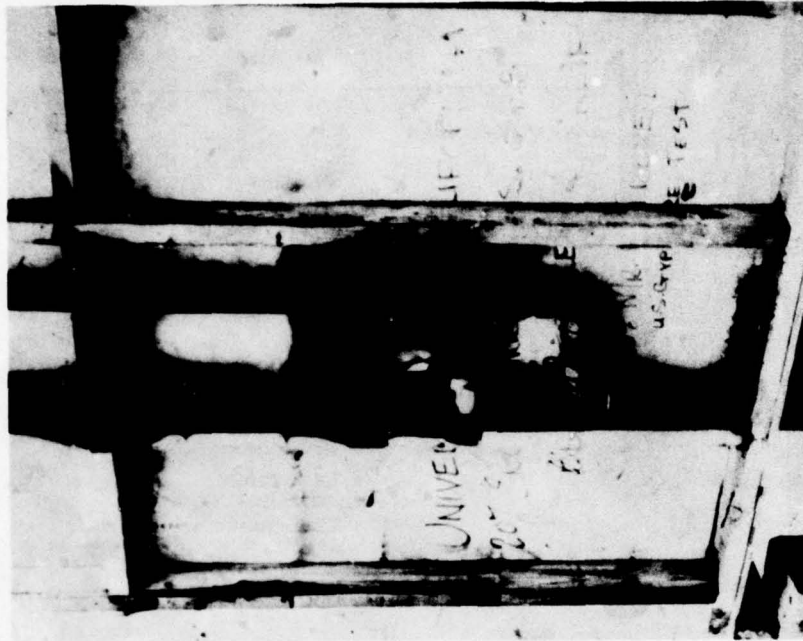
(d) After the exterior redwood siding was removed, part of the sink tee was burned and the vent pipe had folded over at the tee to close itself.

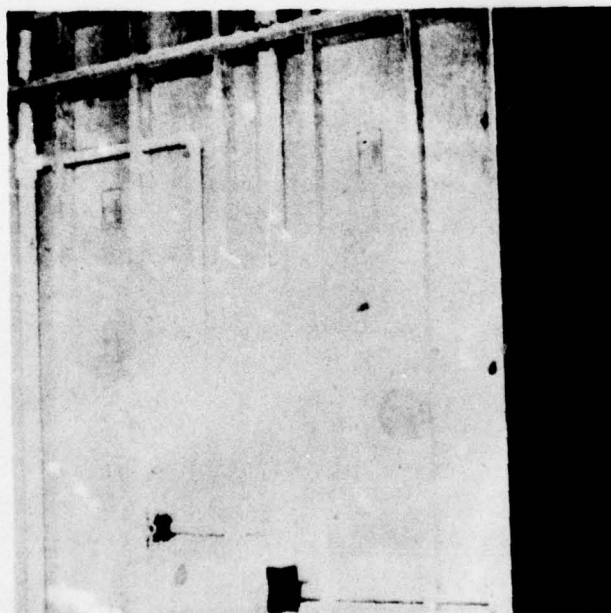
Figure A3. Shows typical DWV system in OSU tests before the gypsum wallboard had been installed on the exposed face. The black patches visible around penetrations were made with a commonly available furnace setting cement.

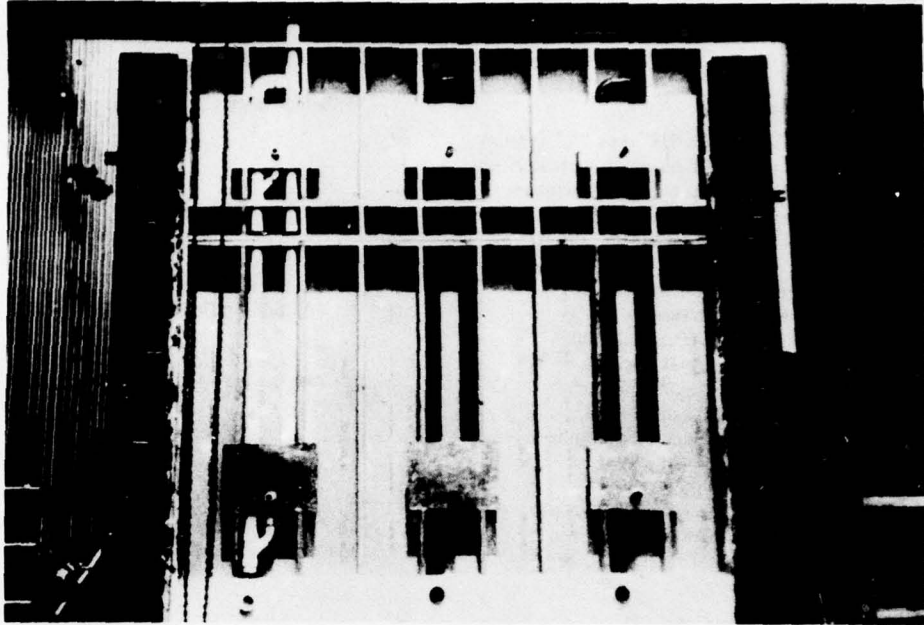
Figure A5. (a) UCB wall assembly prior to test. Note the two floors and the simple sheet metal sheets at each penetration.

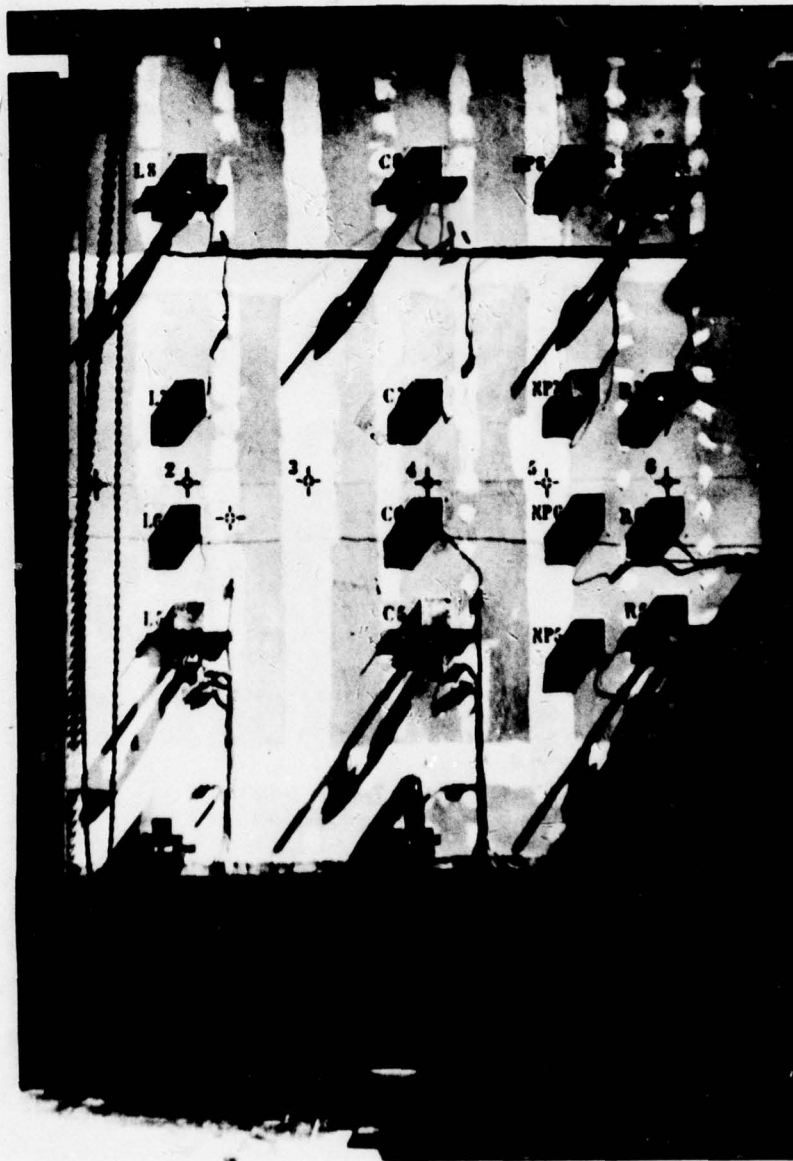
Figure A6. The unexposed face of the wall specimen shown in Figure A5 after the 1-hour fire exposure. There was no flame-through or hot spots observed during the test.

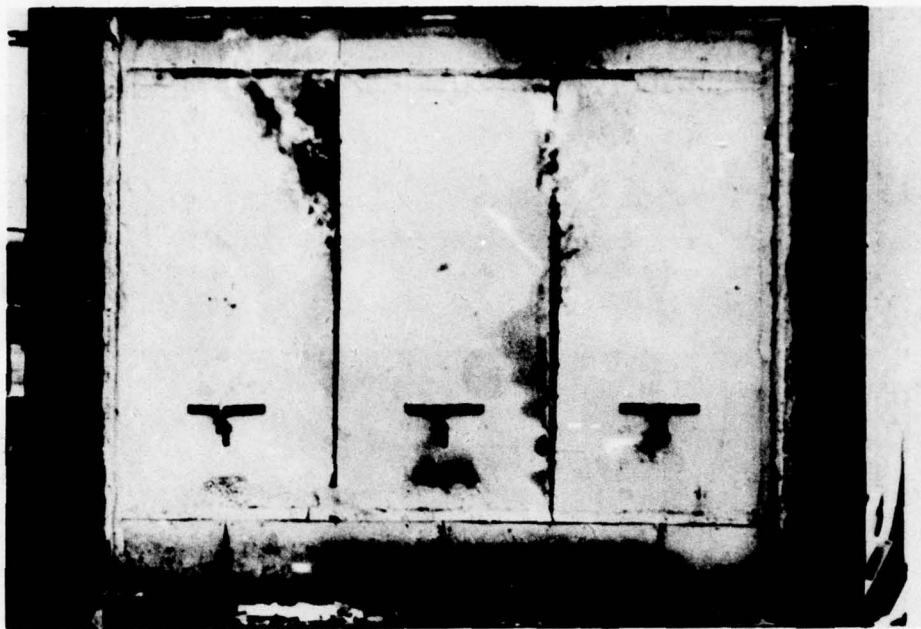
Figure A7. (a) Exposed face of the wall specimen shown in Figures A5 and A6 after the 1-hour fire exposure. Note that the gypsum wallboard is still in place.

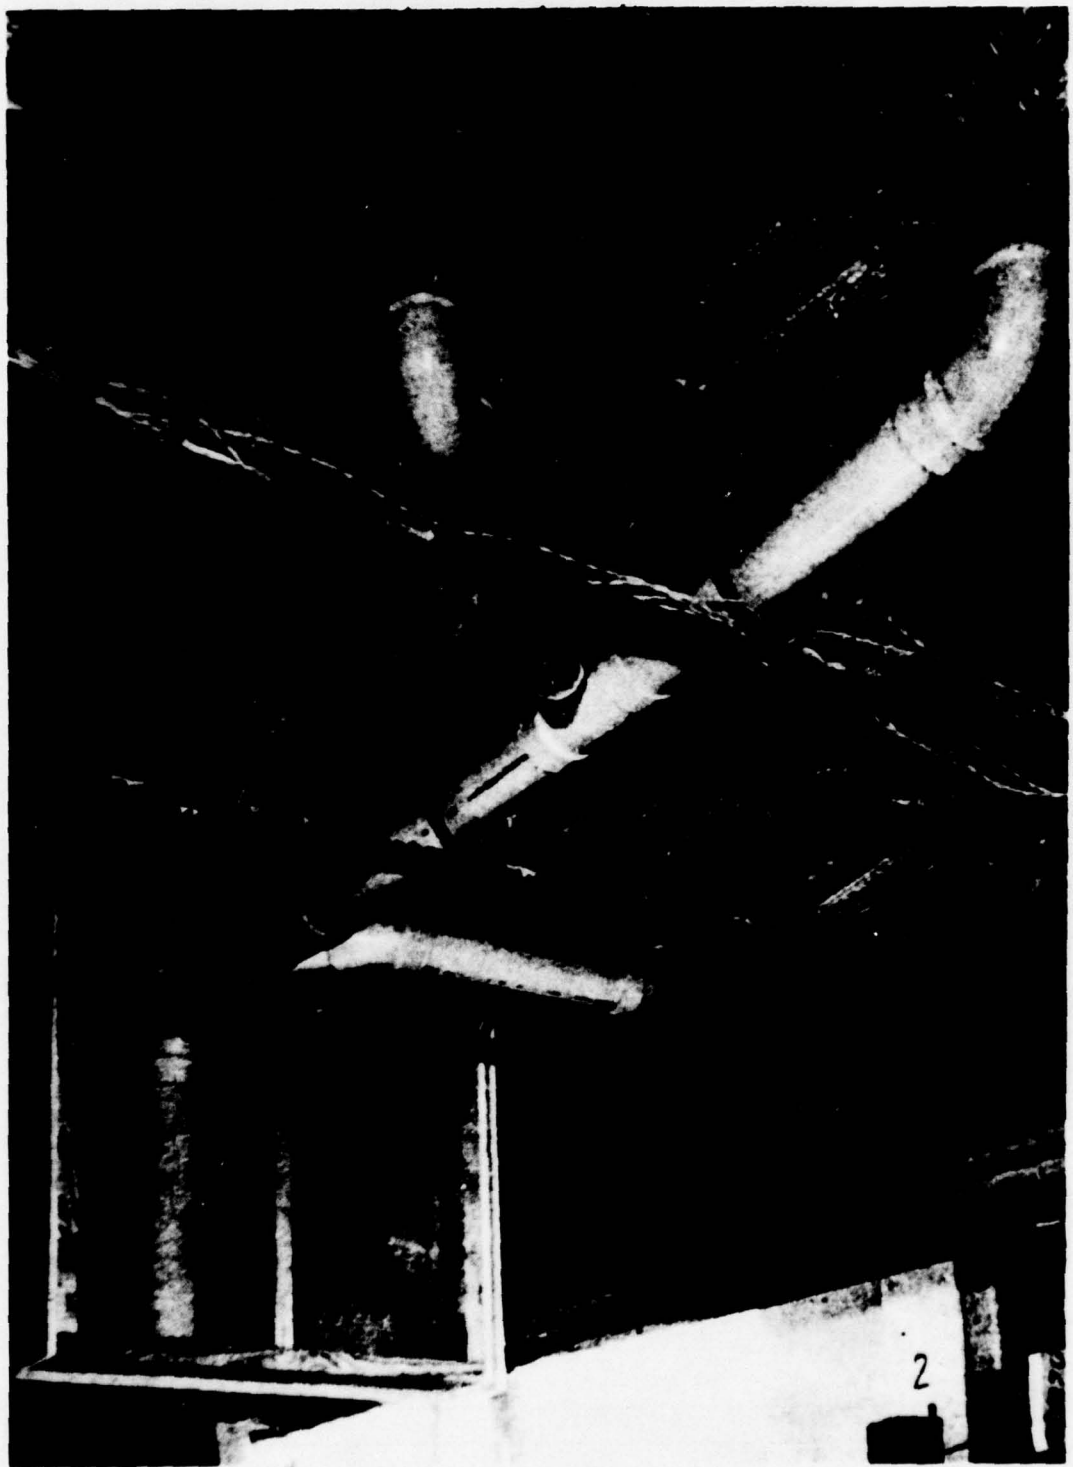
Figure A13. Photograph of the PVC plumbing run and stub wall before test. Note that the wallboard on one side of the stub wall was not yet in place.

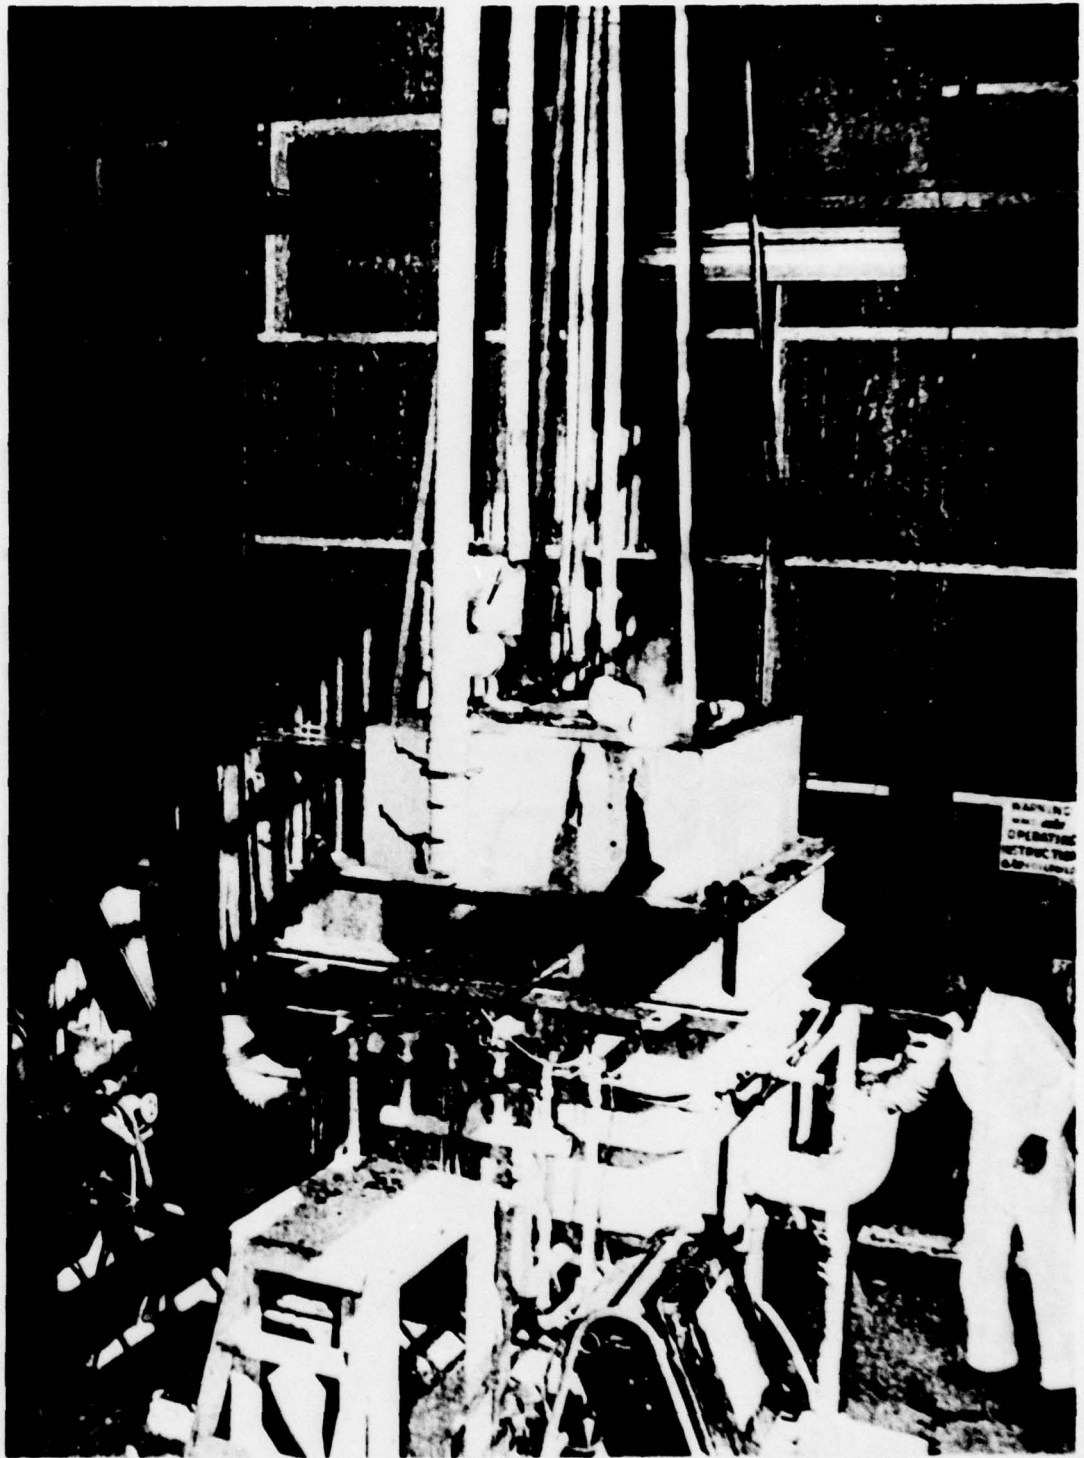
Figure A20. A view at the conclusion of the Australian test of May 26, 1975.

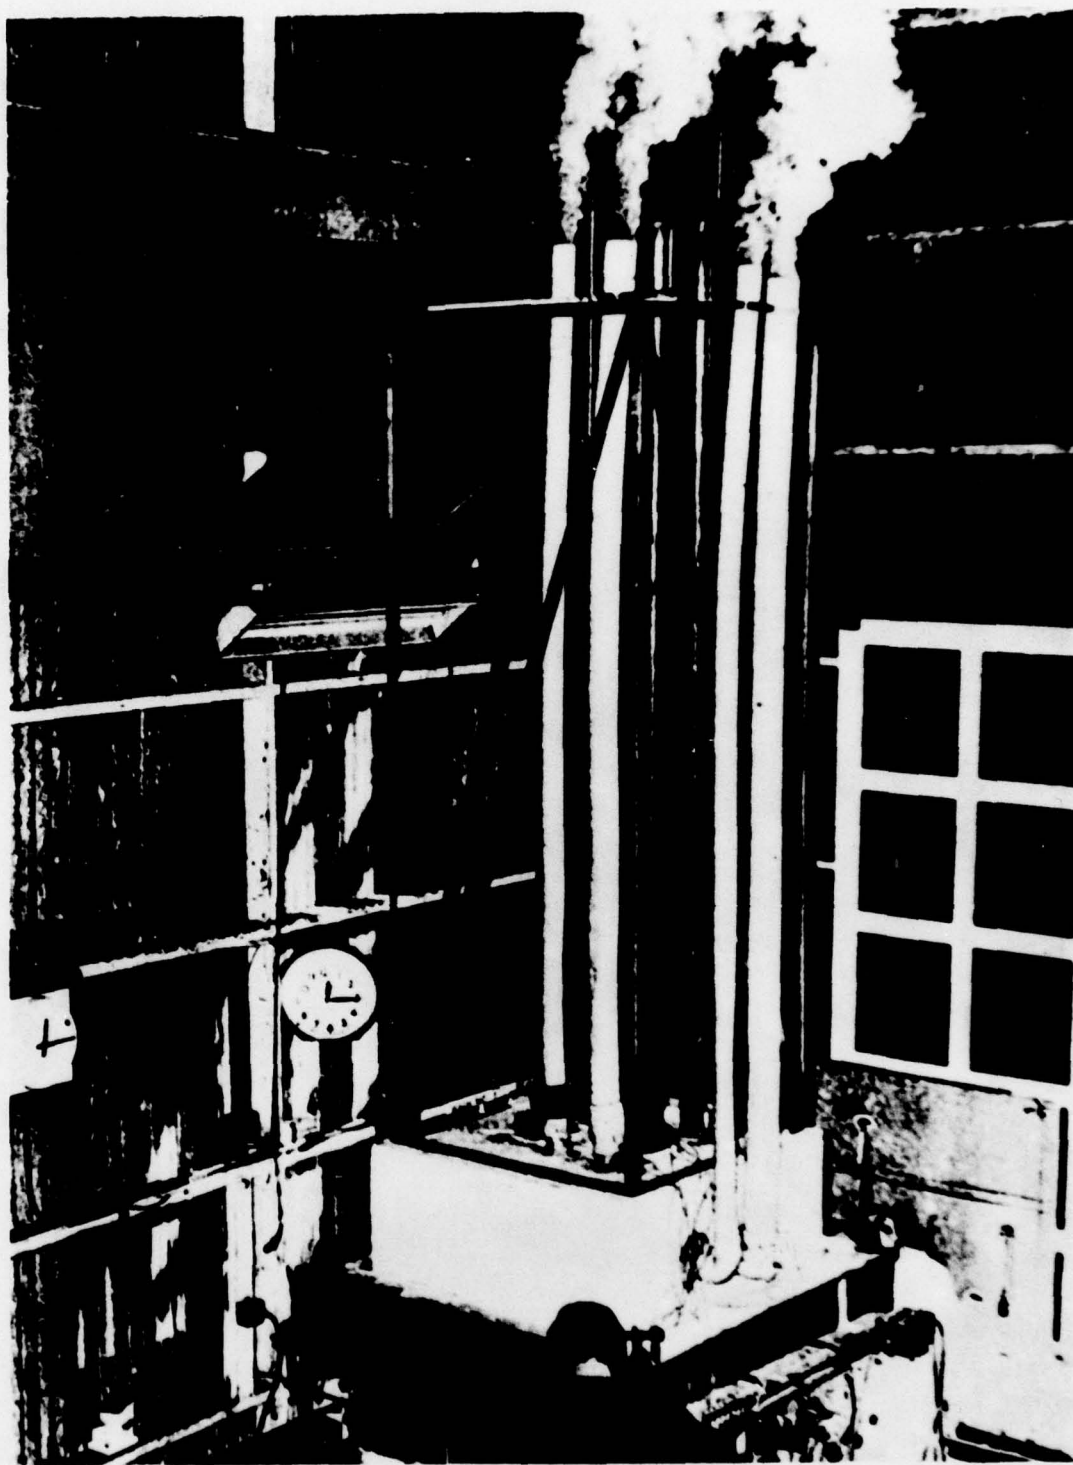
Figure A21. A view of the Australian test conducted on July 21, 1975 at approximately 15 minutes. Note there is some softening of the PVC pipes and there is smoke issuing from each vent. It should be recognized that plumbing systems are normally trapped within the buildings, and thus the smoke visible in this photograph would be vented outside the building under actual fire conditions.

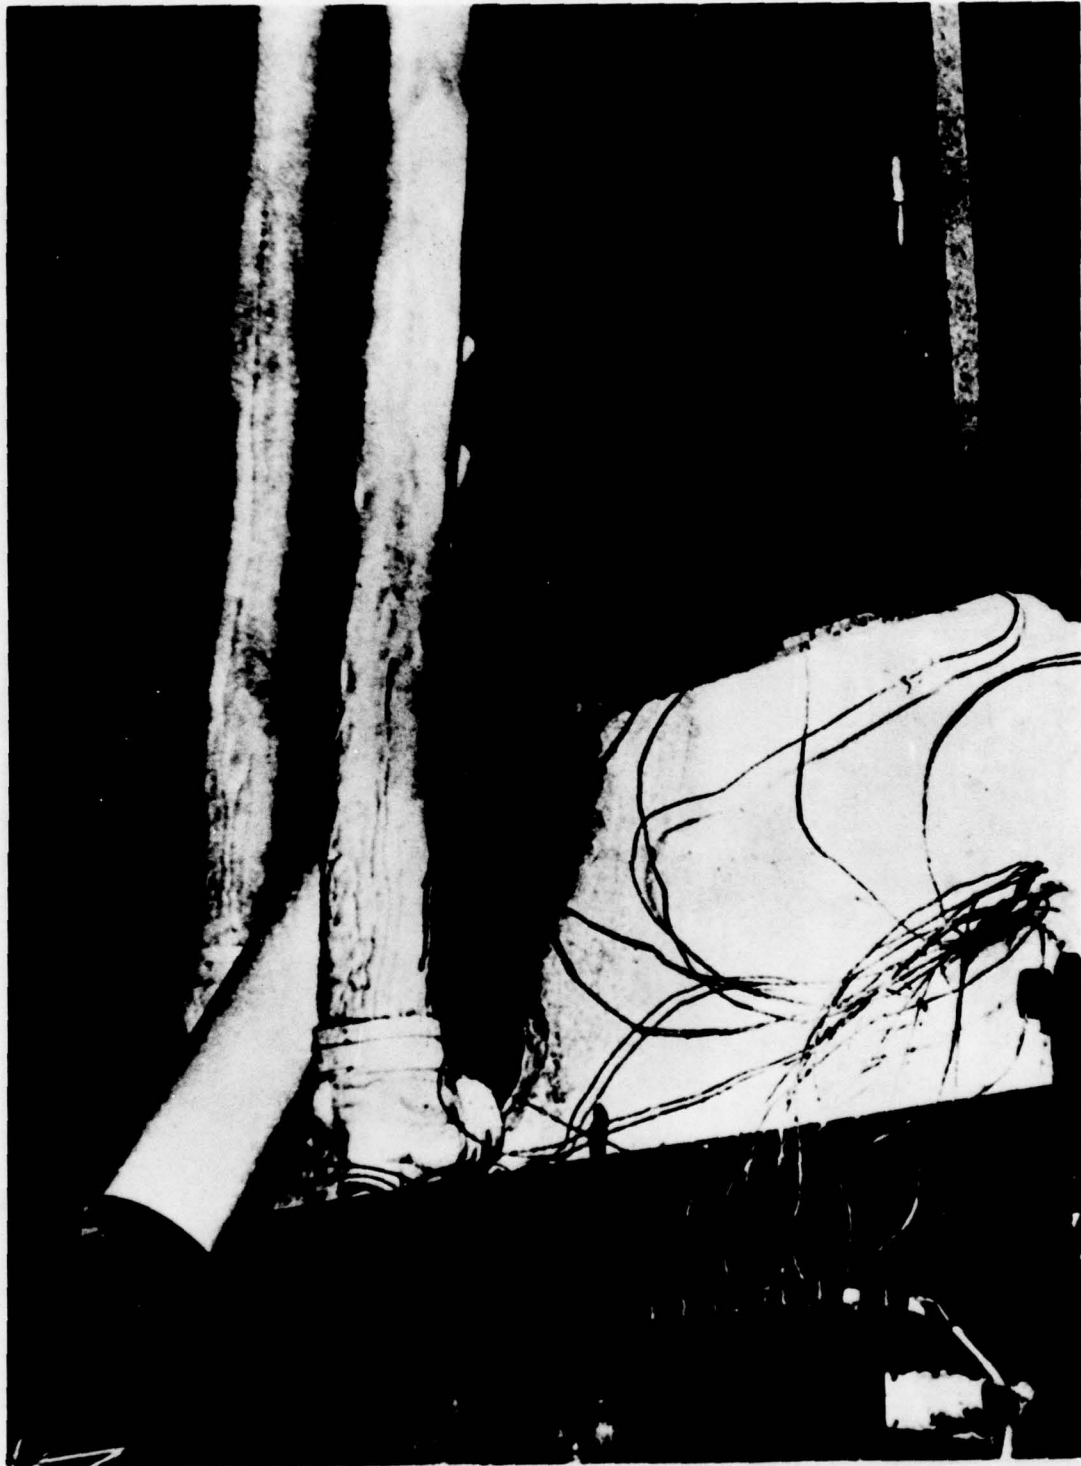
Figure A22. At approximately 30 minutes into the July 21st test, there was collapse of one pipe and considerable softening of the other pipes. Note that one pipe has fallen away from the sidewall and left an open hole.

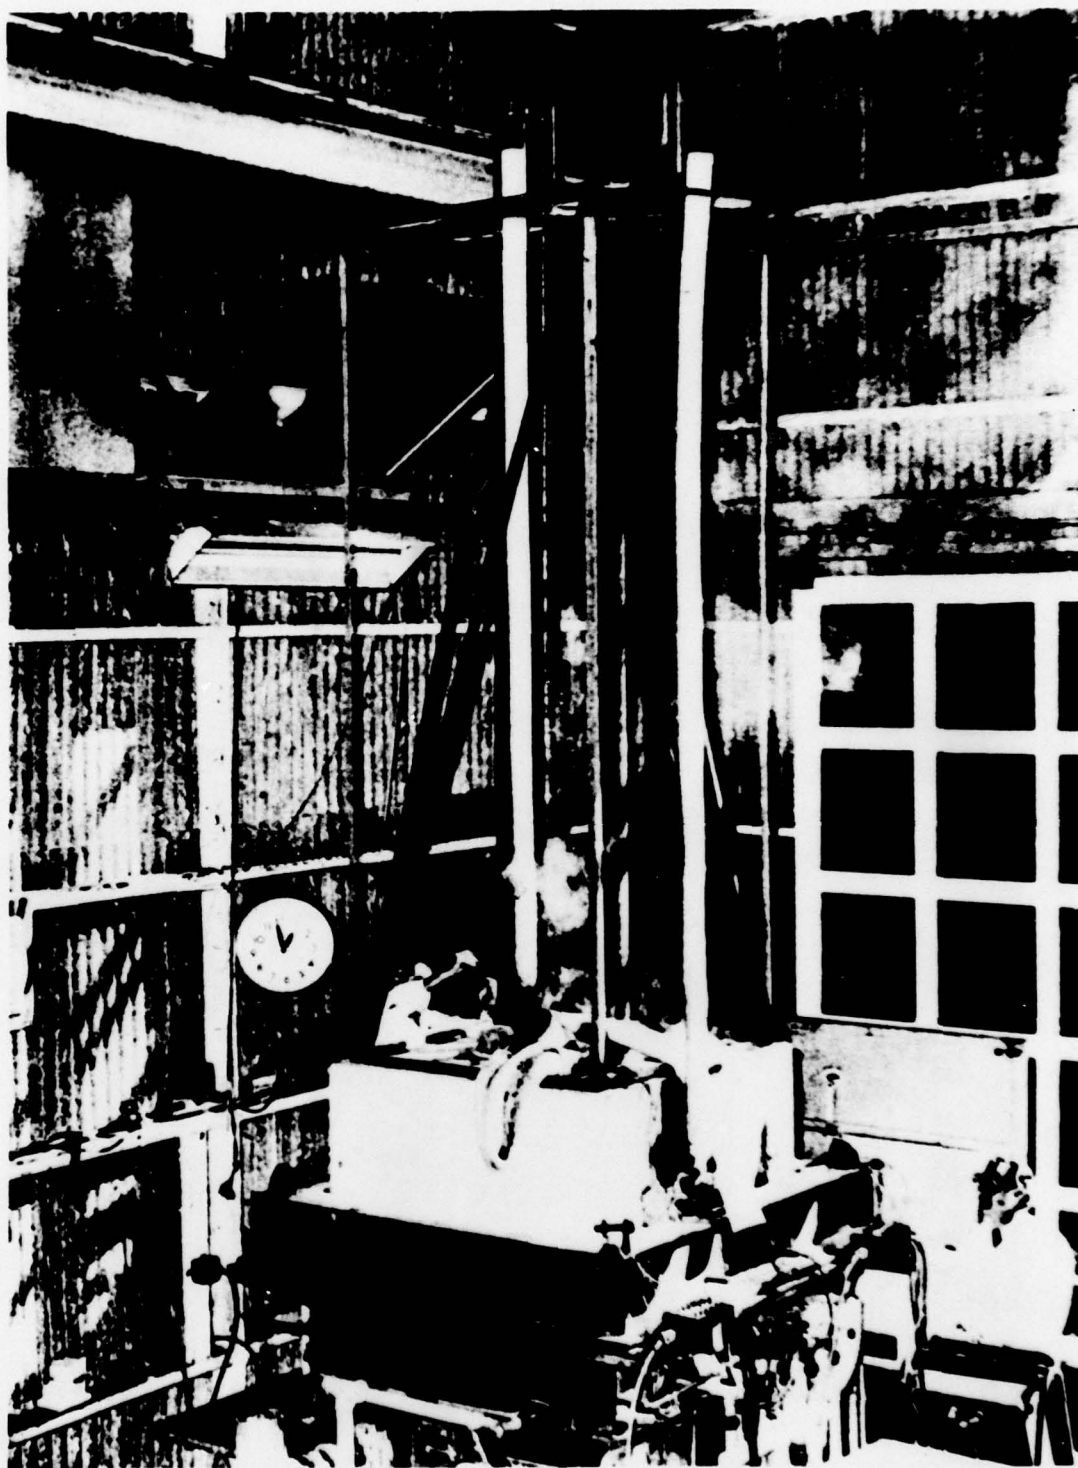
Figure A23. Near the conclusion of the 55-minute-long test performed on July 21.

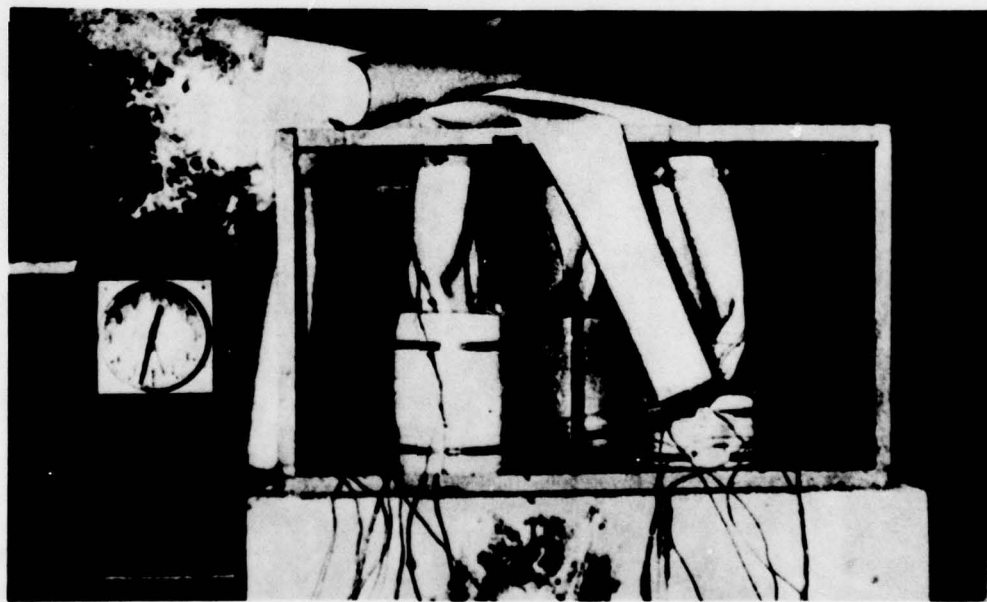
Figure A25. After 32 minutes of the September 15th test. Note the collapse of the pipe; however, the steel frame prevented the complete sealing of the pipe.
