PRINCETON UNIV N J DEPT OF ELECTRICAL ENGINEERING F/G 19/1
THE INFLUENCE OF CONTACT AND INTERFACE EFFECTS OF THE ELECTRONI--ETC(U)
JUL 79 P MARK DAAG29-76-G-0017

FINAL TECHNICAL REPORT:

SCANNING AUGER MICROSCOPY (SAM) STUDIES OF WORN BORE SURFACES*

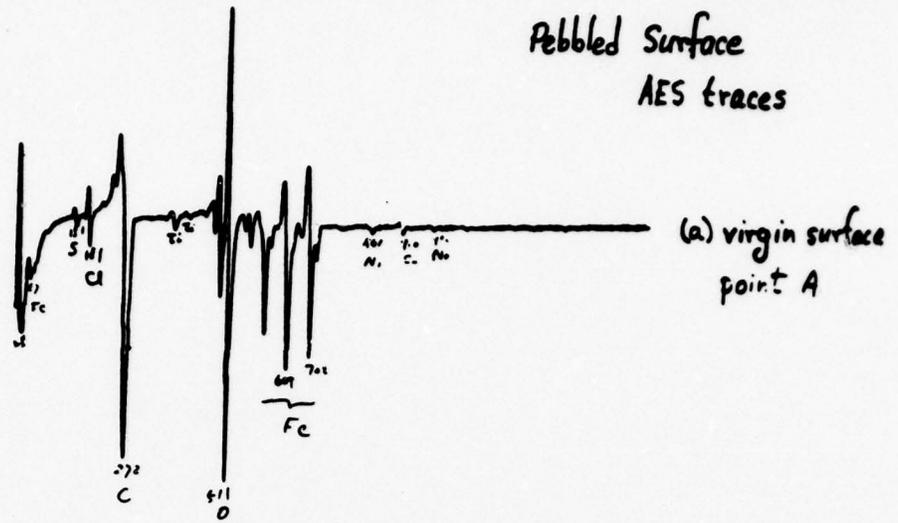
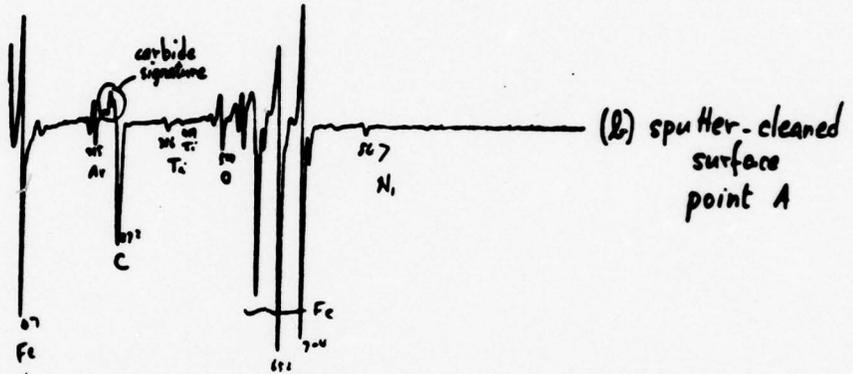
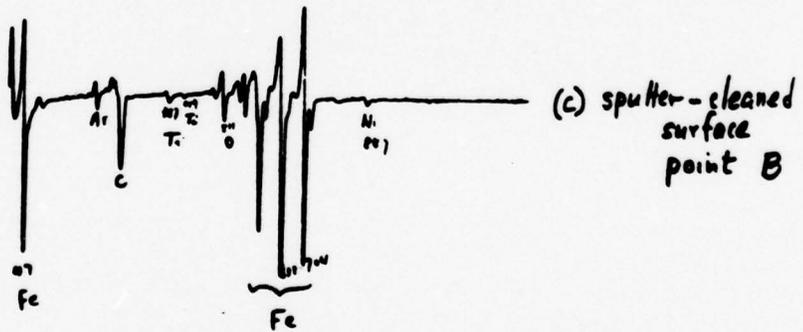
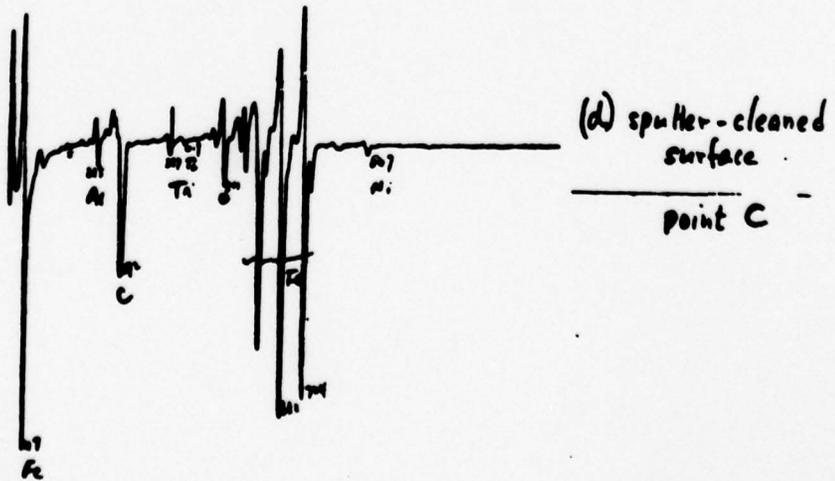
Figure 1

An Auger electron spectroscopy (AES) trace of a virgin pebbled surface (washed in methanol) is shown by trace a of Fig. 1. The predominance of carbon and oxygen signals is typical of any virgin surface. These elements represent the residues of organic surface contaminants that have been cracked by the 3kV primary electron beam of the CMA. The presence of chlorine and sulfur is also frequently observed on virgin surfaces as environmental contaminants. The small size of the low voltage (47V) iron signal is also evidence of a surface contamination coating. The escape depth of these low energy electrons is of the order of 7Å so that they are easily absorbed by very thin contamination layers. The small Ni and Cu signals are not unusual for a steel surface. The Na and Ti are unexplained at this point in the analysis.

Pebbled Surface
AES traces

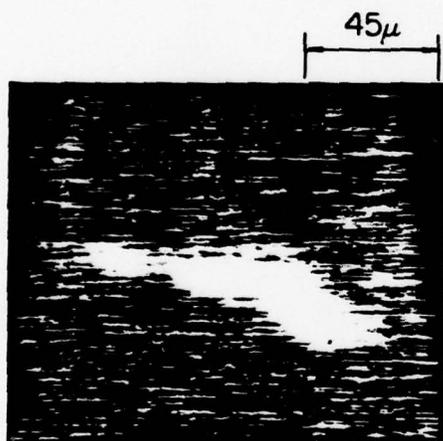
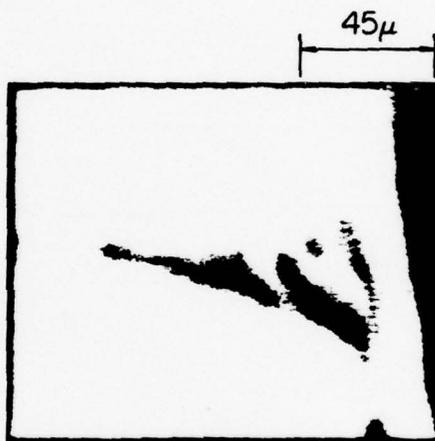
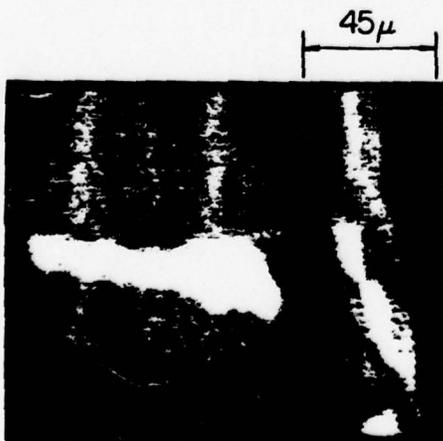
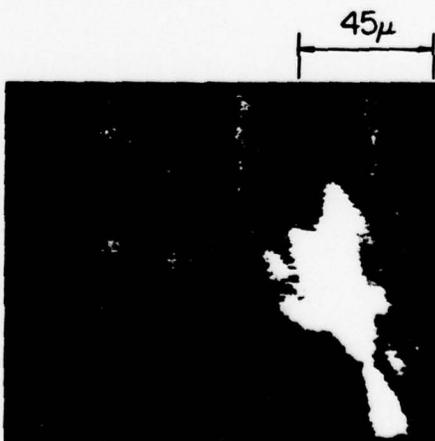
FIGURE 6

The photograph of Fig. 6, panel a, shows the low magnification SEM image of three cracks (labelled A, B and C) running into the bore surface. This is shown by the tapered dark images running from the wide ends at the pebbled surface to the left into the bore material. The surface containing the cracks was machine-cut. Fractured surfaces will be studied later. The AES traces a, b and c of Fig. 5 were recorded with the primary electron beam incident at the surface-end (wide-end) of cracks A, B and C, respectively.

Panel b of Fig. 6 is an SEM image of crack A at higher magnification. The remaining photographs are N-(c), Fe-(d), C-(e) and O-(f) SAM images of crack A. The photographs of Figs. 7 and 8 are similar analyses of cracks B and C, both arranged as follows. Panels a are SEM images. The remaining photographs are N-(panels b), Fe-(panels c), C-(panels d) and O-(panels e) images.

Although there are clear differences in the elemental distributions in these cracks, there are also some common features. For example, the C-images all show that carbon is distributed along the entire length of each crack. The C-signals of AES traces of Fig. 5 are clearly carbide signatures indicating that the carbon in the cracks are most likely metal carbides that have segregated there during the embrittlement of the steel. On the other hand, the N-images all show nitrogen distributions that tend to aggregate at the middle of each crack. The nitrogen is probably in the form of metal nitrides which were formed by reactions between the metal on the crack surfaces and the nitrogenous constituents of the hot propellant gases under pressure during the firings. The absence of nitrogen at the open end of the cracks can be attributed to competing reactions with oxygen to form volatile components. This is suggested by the fact that the O-images show the oxygen more or less concentrated at the open ends of the cracks, in part bonded to carbon (because of the partial correlation with the C-images) and in part as iron oxides because of the correlation with the iron images. No Ti was detected in the cracks. At this point in our work it is not clear why. It may have to do with the fact that the cracks were not clearly correlated with the austenitic grain boundaries of the pebbled surface.

From these preliminary examinations of the surface cracks, it is evident that propellant reactant constituents are non-uniformly distributed in the cracks and that some of the chemistry occurring at the crack surfaces with the propellant gases can be traced by SAM techniques. Laying the crack surfaces bare by low-temperature fracture will yield additional information about crack formation and chemical activity at crack surfaces.

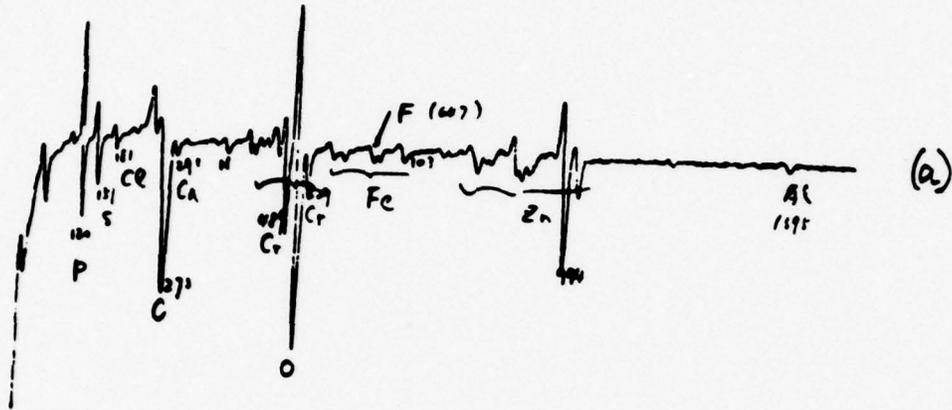
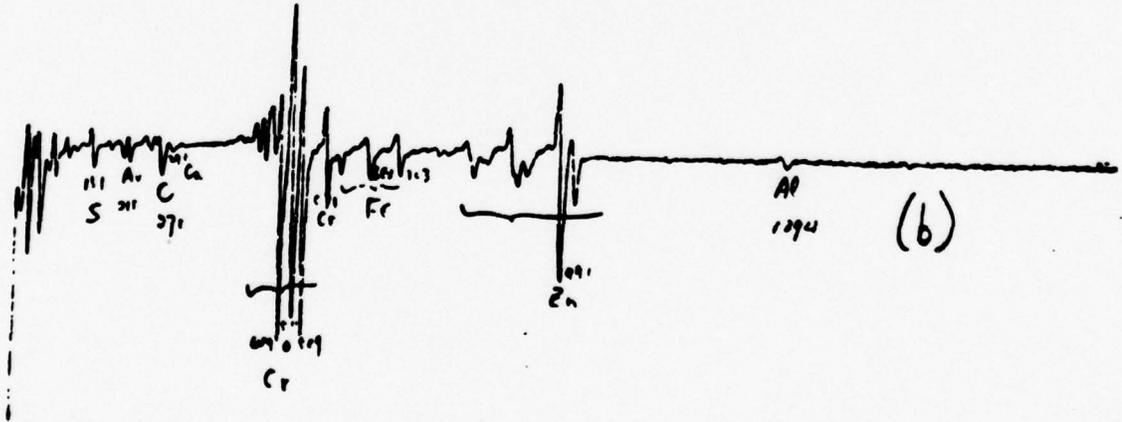
To resolve these issues, the surface of the specimen was scratched with a diamond scribe. Panel a of Fig. 13 is an SEM image of the scratch. The surface damage is clearly evident. The virgin-surface AES trace is trace a of Fig. 12. It shows the strong C- and O-signals typical of environmental surface contamination. Also, a strong Cr-signal is now evident, suggesting that the original Cr-coating may have been revealed by the scratch.

Scratched Cr-coated Surface: AES traces

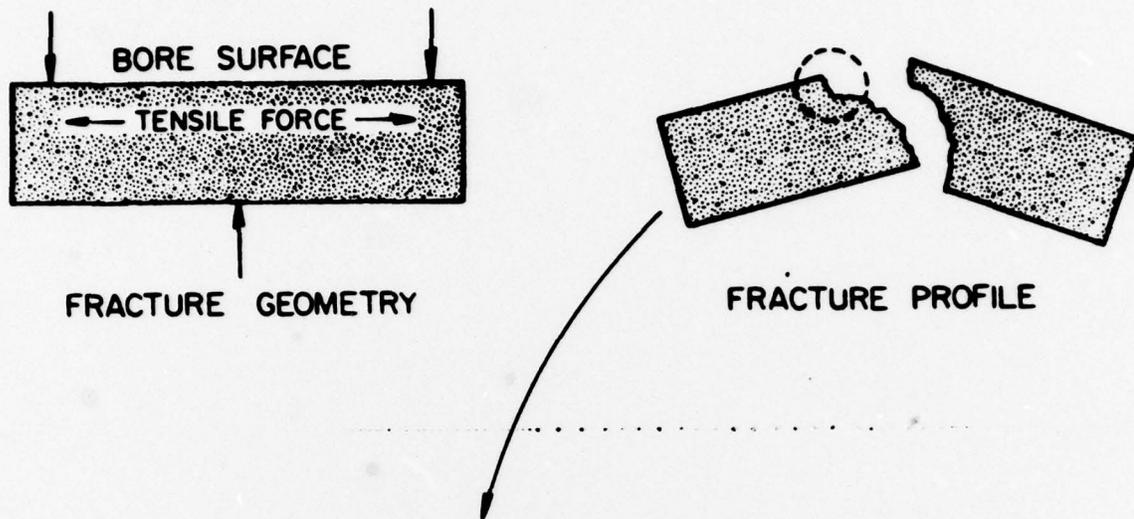
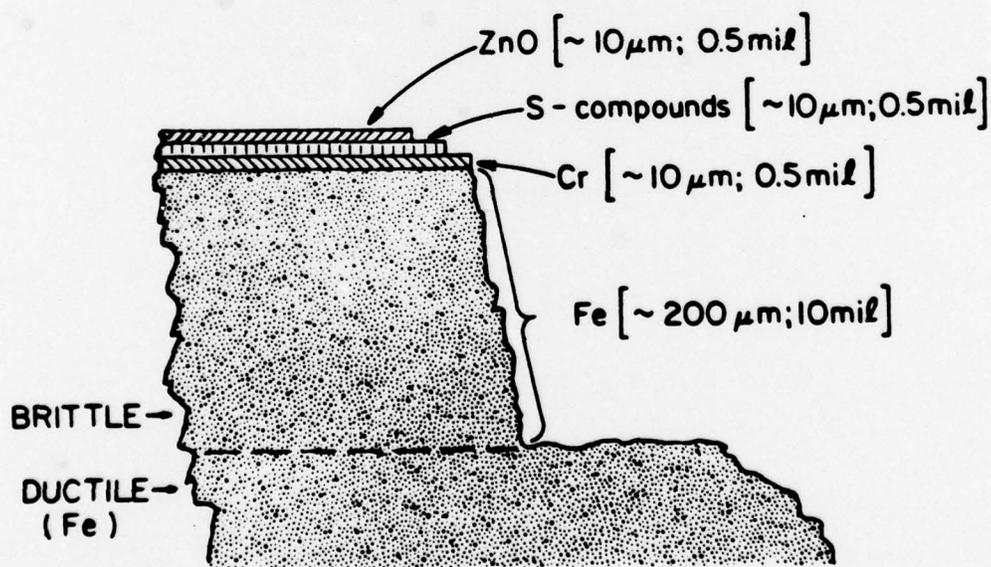
The geometry is illustrated schematically by the top, left panel of Fig. 6. The specimens were fractured with the force components shown in this panel which resulted in a tensile force parallel to the bore surface. The fracture profile observed with both specimens is shown schematically by the top, right panel of Fig. 6. An enlargement in the vicinity of the bore surface is shown schematically by the bottom panel and will be discussed below after the experimental information has been presented. At this point what is important is that both specimens had similar fracture profiles as illustrated by the top, right and bottom panels of Fig. 6. There is an "altered layer" about 200 μm deep whose fracture face was nearly perpendicular to the surface tensile force. This can also be seen from the optical micrographs of Fig. 7, which show the fracture surfaces of the Cr-plated specimen and of the unplated specimen in the top and bottom panels, respectively. Below the altered layer, the fracture face is nearly parallel to the tensile force for both specimens. This indicates that the altered layer is brittle and that the interface between the altered layer and the unaltered substrate cannot sustain a shear force. This same interface is parted when material is spalled from the bore surface.

6. Schematic sketches of fracture analysis.

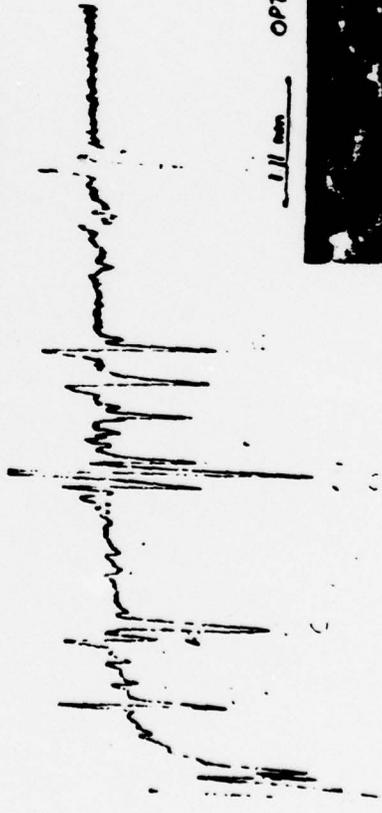
To probe this conclusion further, a SAM analysis of the fracture face of the Cr-plated specimen was also performed. This is described best with reference to Fig. 8 which is a composite showing a reproduction of the optical micrograph (top panel, Fig. 7) in the lowest image, an SEM image obtained in a high-resolution, AMR scanning electron microscope viewed from

8. Fracture profiles and AES trace of 105 mm Cr-plated bore surface.
