SIXTH LAKE DAM
HAMILTON COUNTY, NEW YORK

NY 318
PHASE I INSPECTION REPORT
NATIONAL DAM SAFETY PROGRAM

CONVERSE WARD DAVIS DIXON
CONSULTING ENGINEERS
91 ROSELAND AVENUE, P.O. BOX 91
CALDWELL, NEW JERSEY 07006

11. CONTROLLING OFFICE NAME AND ADDRESS New York State Department of Environmental Conservation/ 50 Wolf Road Albany, New York 12233				12. REPORT DATE 21 September 1978

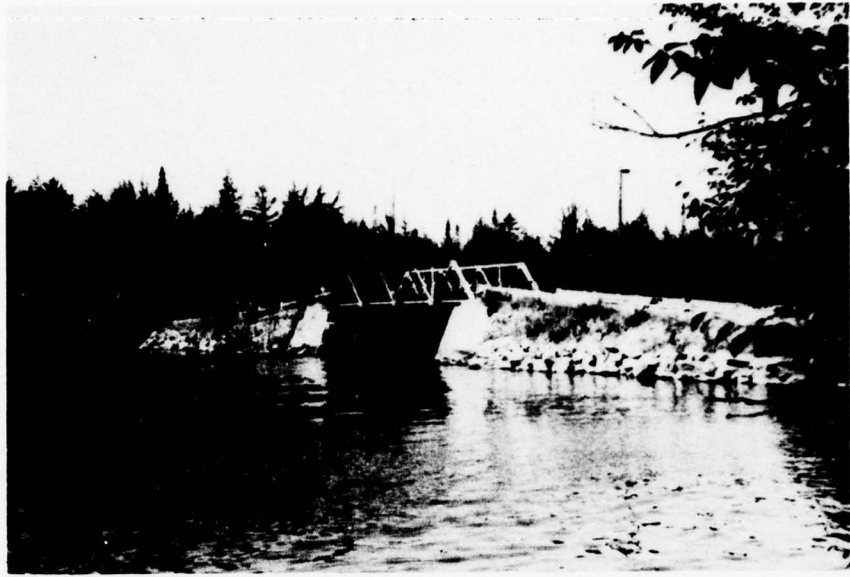
Sixth and Seventh Lakes are at the same elevation with the connection occurring through a free inlet beneath a steel truss bridge (Fig. 3, Appendix D). The opening is approximately 35 feet wide from abutment to abutment, and the distance from the bottom of the bridge steel to the top of water was approximately 11 feet on the day of the inspection. Judging from the high water stains on the bridge abutments, this structure does not appear to seriously constrict flow from Seventh Lake to Sixth Lake.

FIGURE 3. JUNCTION OF SIXTH AND SEVENTH LAKES

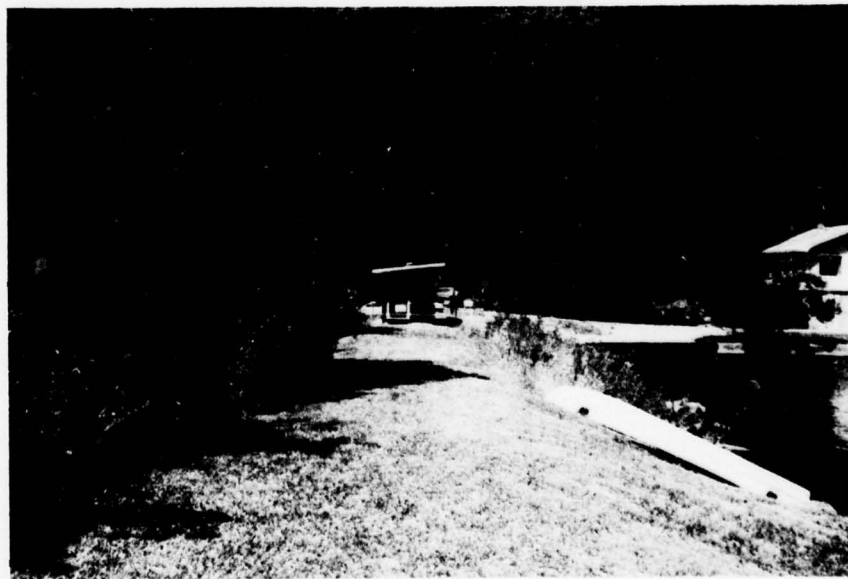
The earth embankment section of the dam appeared to be in generally good condition. Inspection of the upstream face to the left of the spillway section disclosed that the rip-rap was in place and in good condition. Some brush and small trees were beginning to grow above the rip-rap line on the left embankment (left side of spillway). (Refer to Overview Photo.) Inspection of the concrete wing wall on the upstream side of the left embankment revealed that there was a large spall (steel exposed) just at the water line near the spillway approach. The rock crib of the original structure could be seen submerged just upstream of the wingwall near its junction with the left side wall of the spillway.

FIGURE 4. LEFT EMBANKMENT CREST

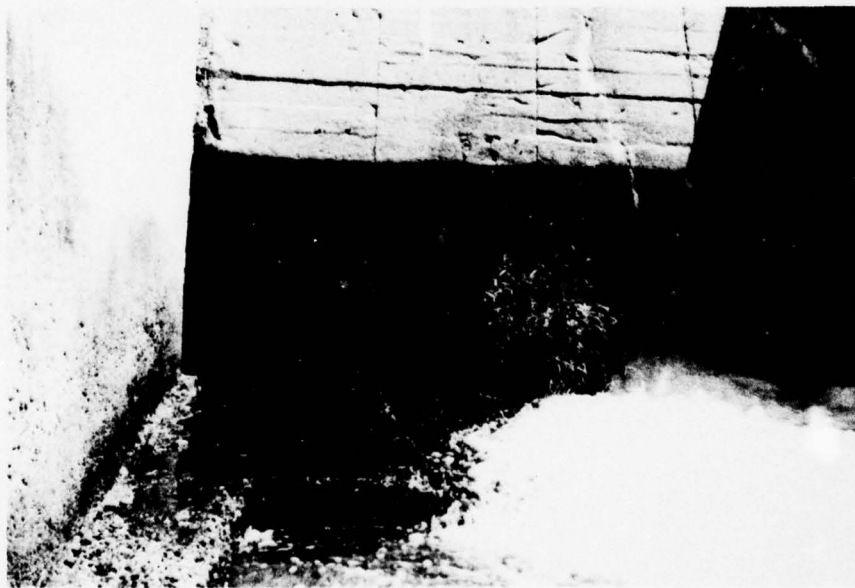
The gate house substructure including the gate portals is in generally good condition. There is some minor erosion of the base slab and right retaining wall footing just downstream of the portal openings (Fig. 10, Appendix D). The massive concrete buttress installed in 1929 is also showing signs of minor cracking and scaling (Fig. 11, Appendix D). The air vent for the right gate was clogged with small debris.

FIGURE 10. GATE HOUSE SUBSTRUCTURE AND GATE PORTALS

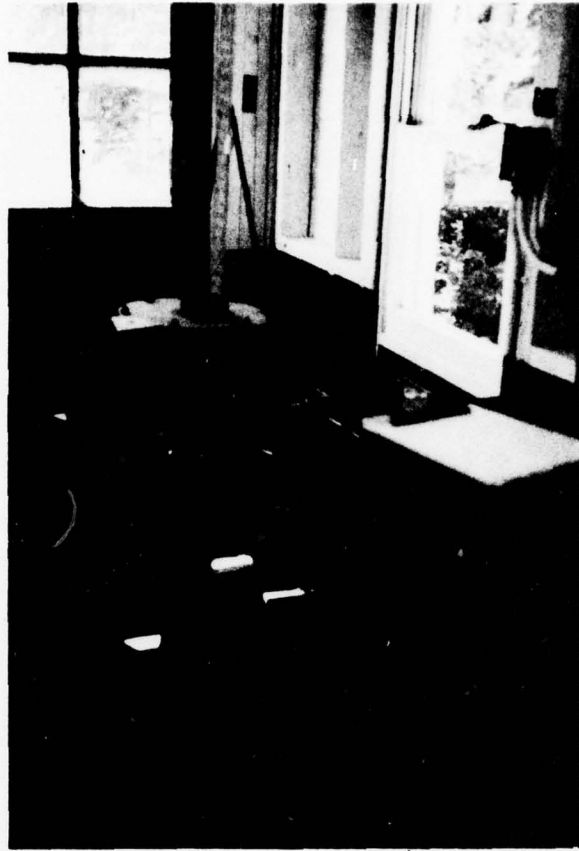
The gate house superstructure is in generally good condition. It is a wood frame structure and has been recently painted. The area around the structure is well maintained and guard rails protect the public from accidentally falling off the retaining walls. No-trespassing signs are clearly displayed (Fig. 12, Appendix D). The interior of the gate house is well lighted and clean. The gate stands are readily accessible and appear to be well maintained (Fig. 13, Appendix D).

FIGURE 13. GATE CONTROL FOR SOUTH GATE

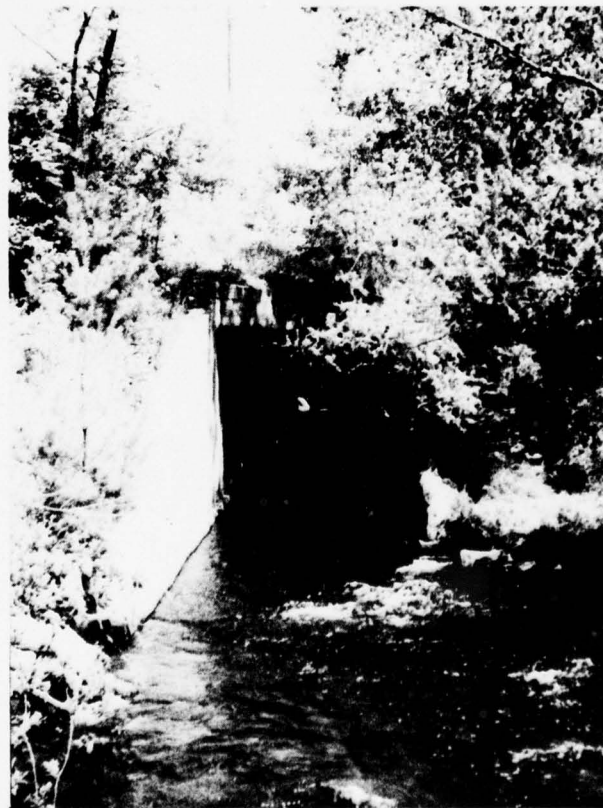
Evaluation of the hydraulic characteristics of the 10-foot by 10-foot concrete box culvert downstream of the dam indicates that it too cannot pass the SDF. Computations in Appendix C show that it has a capacity of approximately 2000 cfs under ten feet of head. This corresponds to 77% of the PMF. Failure of the culvert to pass the PMF would result in overtopping of the State Route 28 embankment and possible flooding of this vital communications link.

FIGURE 16. BOX CULVERT DOWNSTREAM UNDER STATE ROUTE 28
