# MIDDLE BRANCH DAM

## PHASE I INSPECTION REPORT

### NATIONAL DAM SAFETY PROGRAM

NY 00034

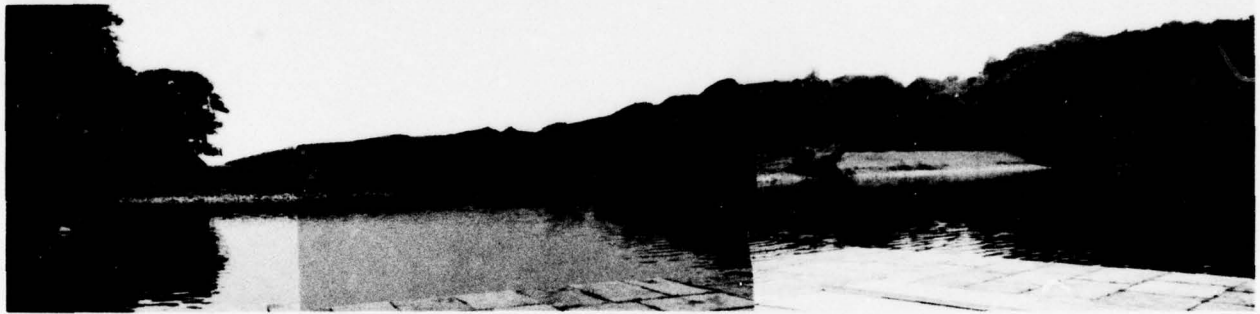
OVERALL VIEW OF UPSTREAM SLOPE

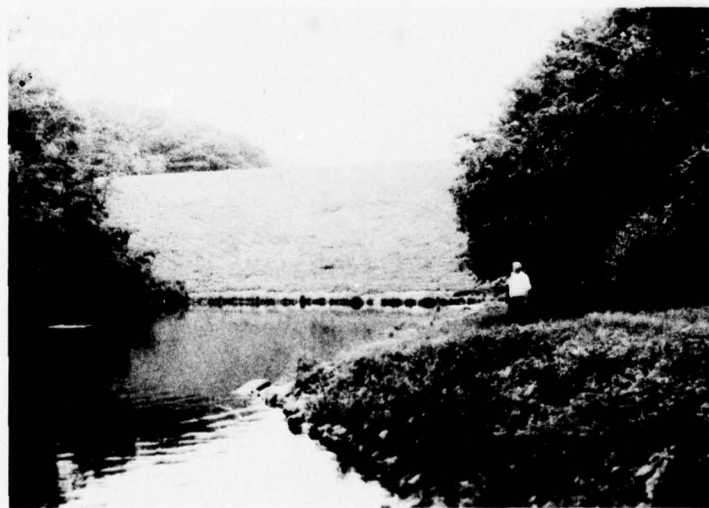
OVERALL VIEW OF DOWNSTREAM SLOPE
