DIVERTING RESERVOIR DAM

PHASE I INSPECTION REPORT

NY 00056

Prepared by: O'Brien and Gere Engineers, Inc.

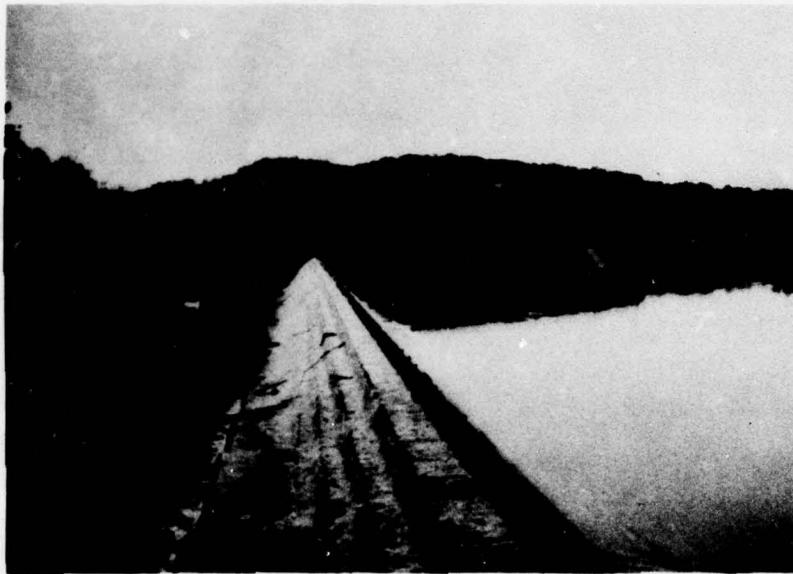
VIEW OF SPILLWAY LOOKING SOUTHWEST

b. Dam - The cut stone masonry spillway shows no apparent horizontal or vertical misalignment. The stone blocks have worn less than 1 inch. The silt level appears to be at the spillway crest. A sketch included in an inspection report, prepared by the State of New York, Department of the State Engineer and Surveyor, (no date), shows a rolled earth embankment abutting the upstream face of the masonry spillway (See Figure 5). The northeast abutment of the spillway appears to be in good condition. No serious cracking or spalling of the concrete was observed. The concrete of the southwest abutment of the spillway has undergone surface spalling at several locations. A horizontal crack in the abutment was observed near the spillway crest elevation. The crack is continuous about the visible portion of the abutment. No seepage was observed in the abutment areas. The observed crack and localized surface spalling do not appear to adversely affect the safety of the abutment. An outcropping of what appears to be a tough micaceous gneiss or schist was observed next to the abutment.

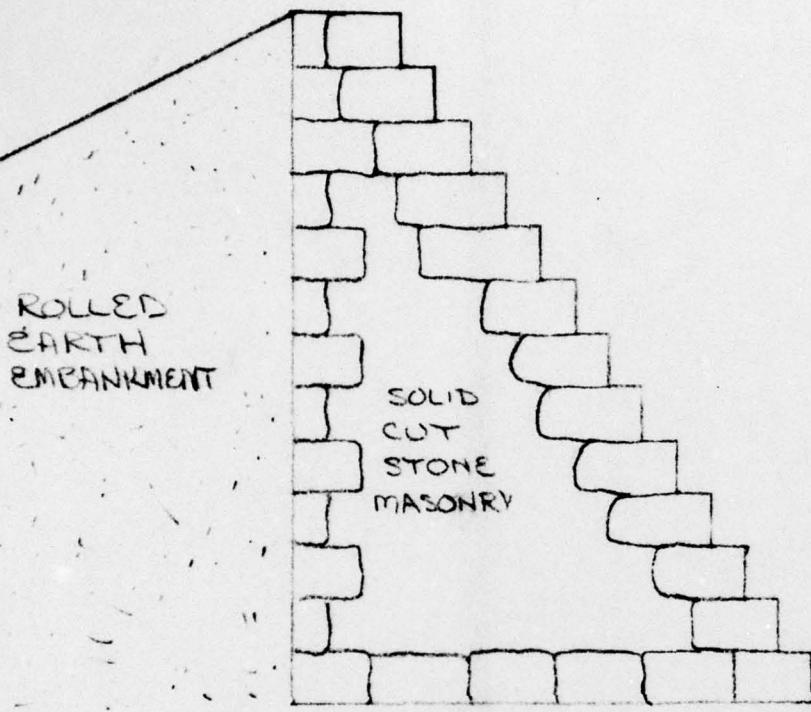
SECTION A-A *
(SPILLWAY)

Stability analyses were performed for the spillway section for normal pool, normal pool and earthquake, and the PMF. The foundation reactions were outside of the central third for all analyzed loadings. A synopsis of the results is listed below. Details of the analyses are located in the appendix.

Condition	Factor of Safety		Pressures (psi)	
	Overspeed	Sliding*	Heal	Toe
Normal Pool	1.41	7.09	6.25(T)	43.5
Normal Pool & Earthquake	1.35	6.67	9.3(T)	46.6
Probable Maximum Flood	1.09	6.76	17.1(T)	43.3

No indications of instability were observed during the field inspection of the Diverting Reservoir Dam. Review of the stability analyses for the spillway indicates that the requirements of the Recommended Guidelines for Safety Inspection of Dams are not met. The foundation reaction is outside of the middle third of the base for all conditions analysed.

The gravity overflow section should be strengthened to provide adequate factors of safety for extreme loading conditions. This could be accomplished by making the structure more massive, or by the installation of post-tensioned tendons through the structure.

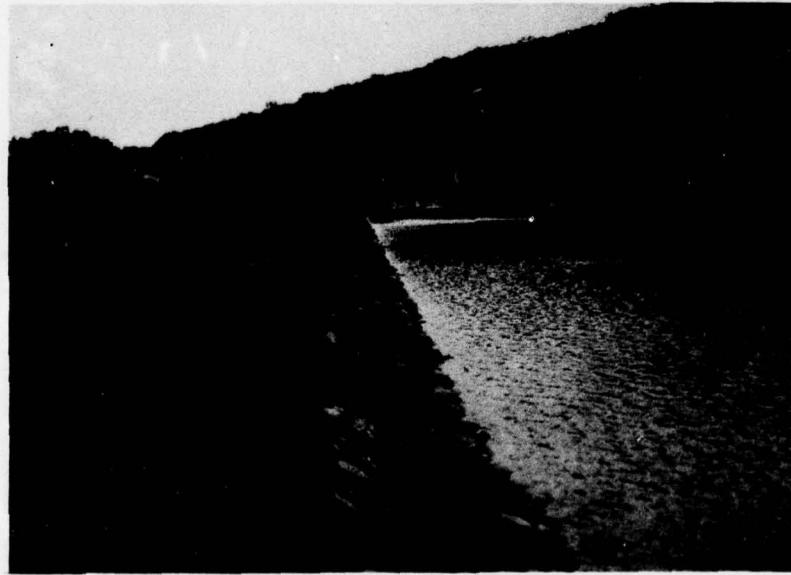
The earth embankment is constructed perpendicular to the spillway, as shown on Figure 5. The horizontal and vertical alignment appear to be good. Riprap slope protection for the upstream face consists of large, near rectangular stone (12 to 15 cubic feet), set in place with smaller angular stone and gravel wedged between the large stone. The riprap appears in excellent condition. Brush was noted at several locations near the top of the upstream slope. A concrete retaining wall is constructed along the earth embankment near the railroad embankment. The wall extends about 100 feet along the railroad embankment and along the reservoir shoreline for about 150 feet as shown on Figure 5. Mr. John Birrell stated that a broad crested weir is constructed from the ends of the retaining wall. Mr. Birrell said that the weir is about 150 feet long, with the crest elevation about 5 feet below the normal pool.

UPSTREAM SLOPE OF EARTH EMBANKMENT
