MISCELLANEOUS PAPER SL-79-17

**TESTING OF 6-IN.-DIAMETER CONCRETE
CORES FROM MARTIN DAM
ALABAMA POWER COMPANY**

**Structures Laboratory
U. S. Army Engineer Waterways Experiment Station
P. O. Box 631, Vicksburg, Miss. 39180**

Prepared for Alabama Power Company
Birmingham, Ala. 35291

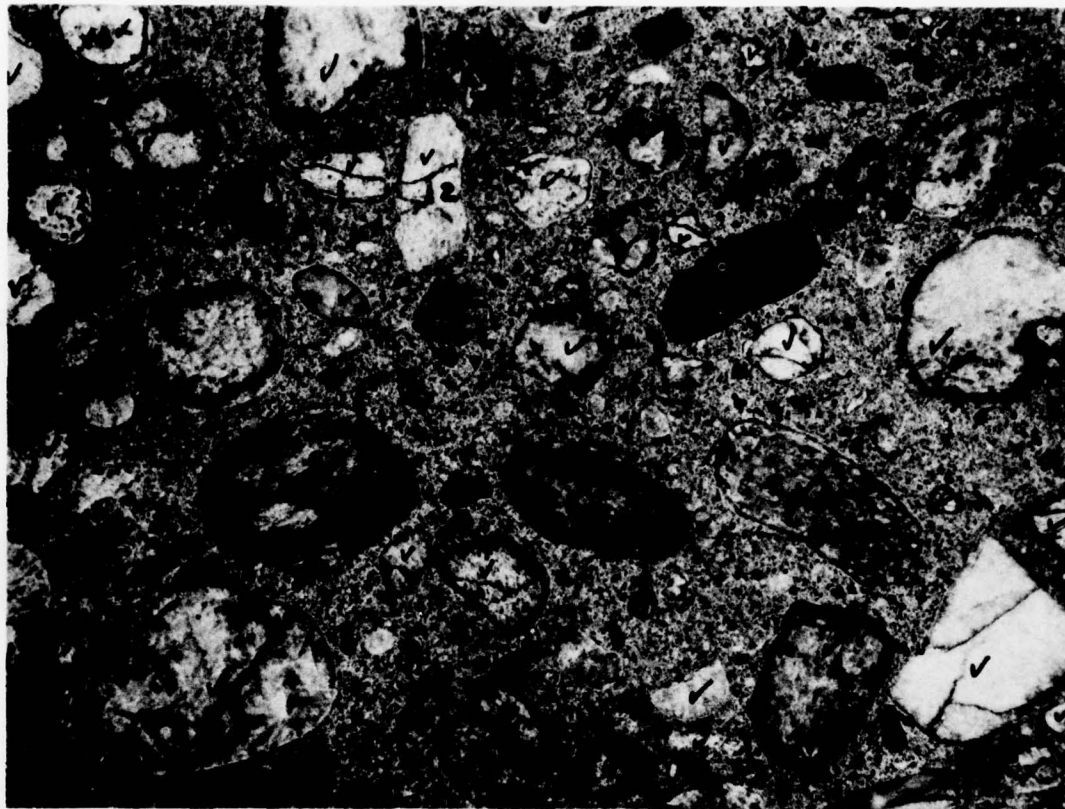
12. "Main cracks" in the coarse aggregate are shown in Photo A2. Main cracks were described and illustrated by Idorn (1964). Photo A2, at 1X, has every piece of coarse aggregate marked in which either main cracks or disintegration of the siliceous cement in the center of quartzite particles could be recognized at 10X to 30X. Main cracks were much more abundant than disintegration of the siliceous cement. The extension of main cracks into the mortar represents a more advanced degree of reaction than was often found in the cores from Martin Dam examined here. Two plates reproduced from Idorn's report are shown as Figures A1 and A2 to clarify the concept and details of main cracks in aggregate and mortar. Alkali-silica gel was found coating the surfaces of the crack shown in the upper left-hand corner of Photo A2.

The evidence was white to translucent alkali-silica gel in voids, in aggregate sockets, and in cracks; reaction rims on quartz and quartzite particles; and as cracks that could be traced across these aggregate particles into the paste (Photo A2).

Photo A2. Sawed ground surface of CL-24 DC-10A illustrates main cracks, 1X. Every particle with a check mark shows a main crack or disintegration of the interior of the aggregate at a magnification of 10X - 20X. At the upper left margin of the left side a crack in the mortar runs subparallel to the upper margin and is probably related to the main cracks in the particles marked 1 and 2. Rims or partial rims are common.

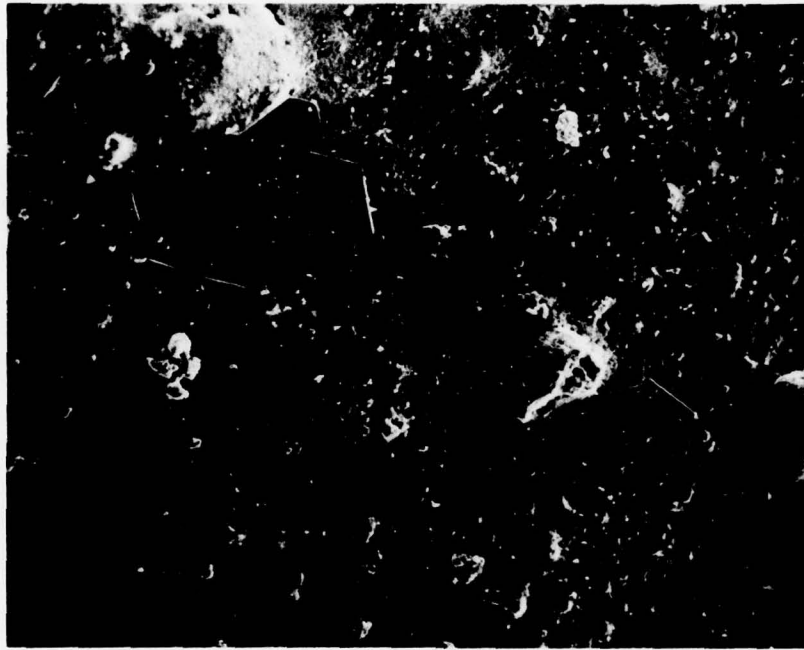
Photo A3. SEM photomicrograph of several elongated and platy monosulfoaluminate crystals found in a void in piece CL-24(3) DC-7C, 52X.

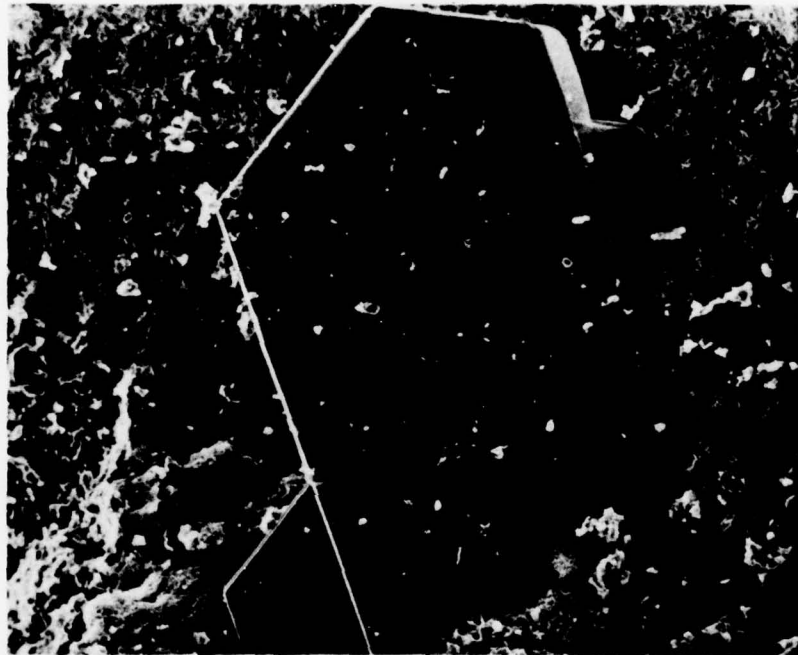
Photo A4. SEM photomicrograph of another group of monosulfoaluminate crystals found in a void in piece CL-24(3) DC-7C, 194X.

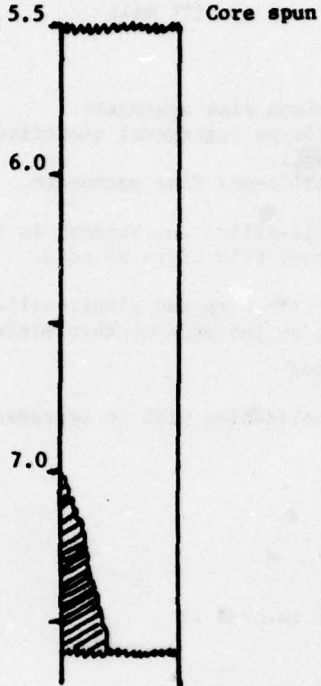
Martin Dam, Alabama Power Co. (CL-24 DC-1A)

Some alkali-silica gel was present in
voids throughout this piece of core.
Gel was of the pepper and salt type.

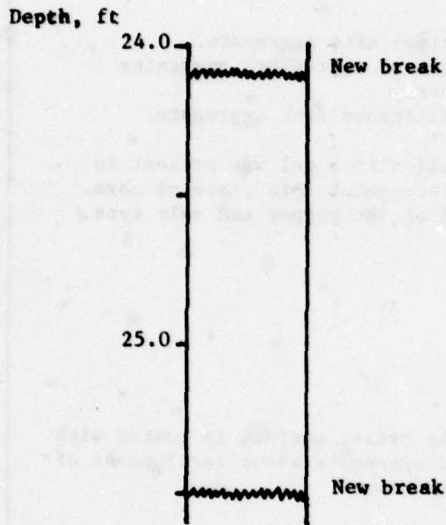
Martin Dam, Alabama Power Co. (CL-24 DC-2A)
Boring CH No. H3 (6-in. Diameter Vertical Concrete Core)

Some alkali-silica gel present in voids
throughout this piece of core.

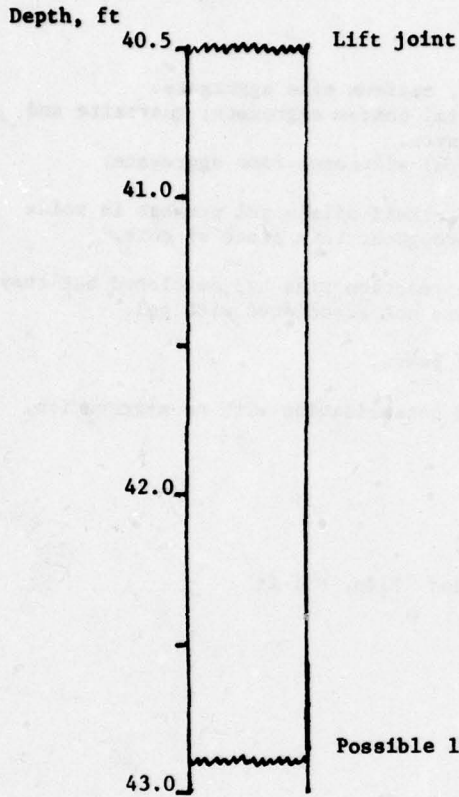
Martin Dam, Alabama Power Co. (CL-24 DC-3A)
Boring CH No. H3 (6-in. Diameter Vertical Concrete Core)

Some alkali-silica gel present in voids throughout this piece of core. Gel was of the banded type.

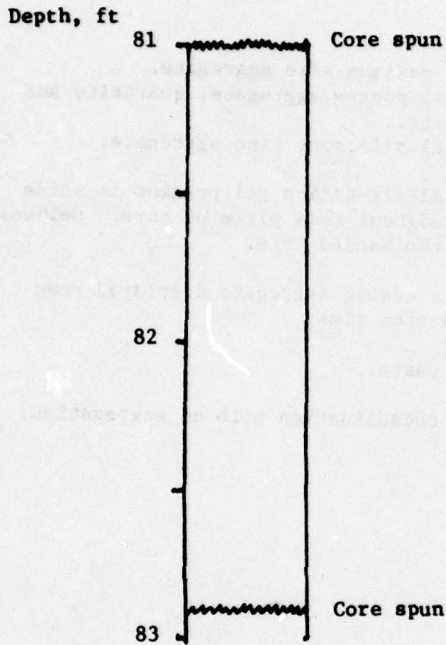
Depth (ft) 81.0 - 82.9
Elevation 420.5 - 418.6
(ft msl)

Some alkali-silica gel present in voids
throughout this piece of core.

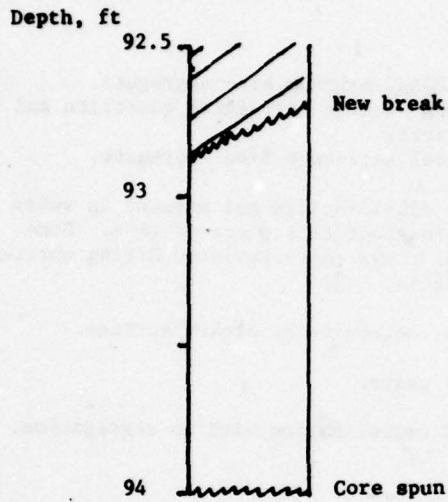
Depth (ft) 92.7 - 94.0
Elevation 408.8 - 407.5
(ft msl)

Some alkali-silica gel present in voids
throughout this piece of core.

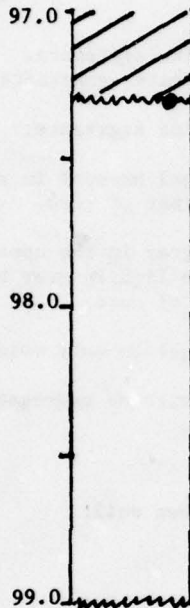
Depth (ft) 97.3 - 99.0
Elevation 404.2 - 402.5
(ft msl)

1-in. diameter steel cable;
possible lift joint

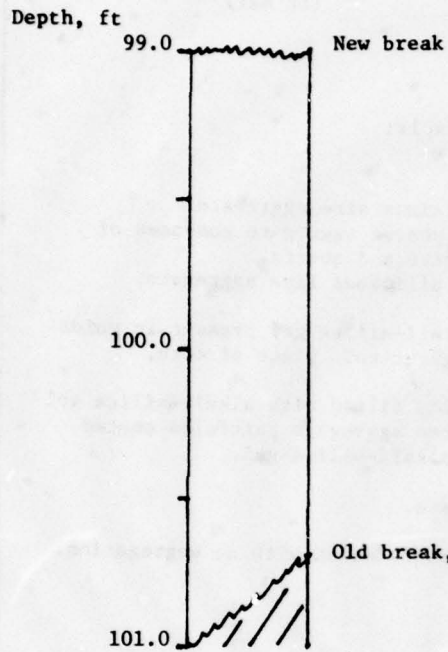
Depth (ft) 99.0 - 101.0
Elevation 402.5 - 400.5
(ft msl)

Some alkali-silica gel present in voids
throughout this piece of core.

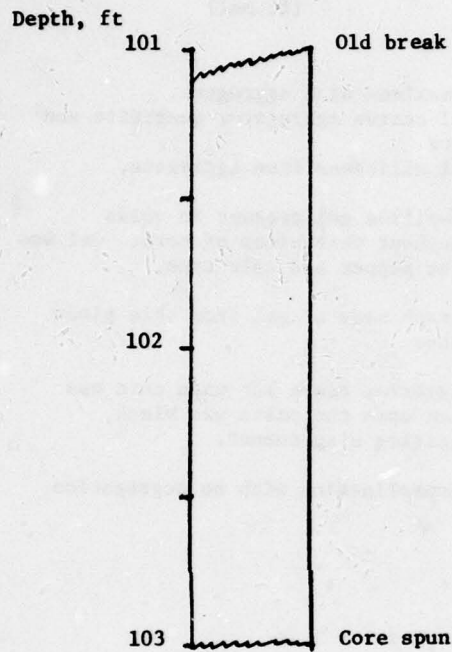
Depth (ft) 101.0 - 103.0
Elevation 400.5 - 398.5
(ft msl)

Abundant alkali-silica gel in voids
throughout this piece of core.

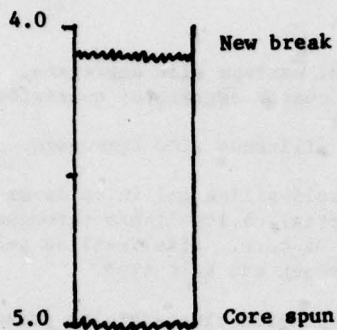
Depth (ft) 4.1 - 5.0
Elevation 497.4 - 496.5
(ft msl)

Some alkali-silica gel present in voids
throughout this piece of core.

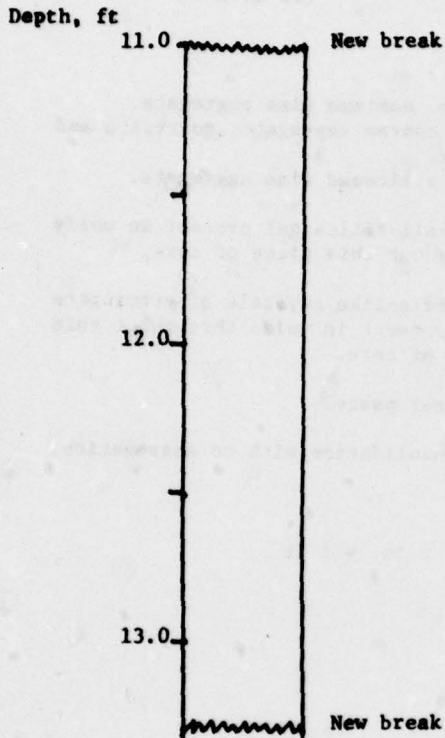
Depth (ft) 11.5 - 13.3
Elevation 490.0 - 488.2
(ft msl)

Some alkali-silica gel in voids as fillings
or partial cavity liners throughout this
piece of core. Alkali-silica gel is of
the pepper and salt type.

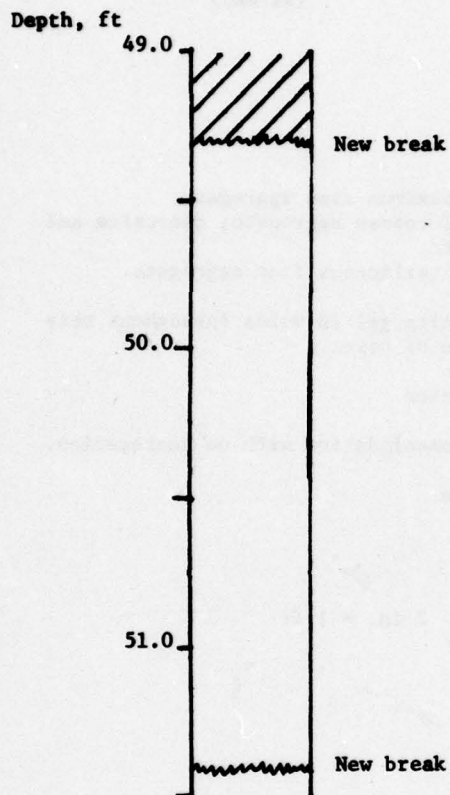
Depth (ft) 49.3 - 51.4
Elevation 452.2 - 450.1
(ft msl)

Some alkali-silica gel and possibly some ettringite in voids throughout this piece of core. Alkali-silica gel is of the pepper and salt type.

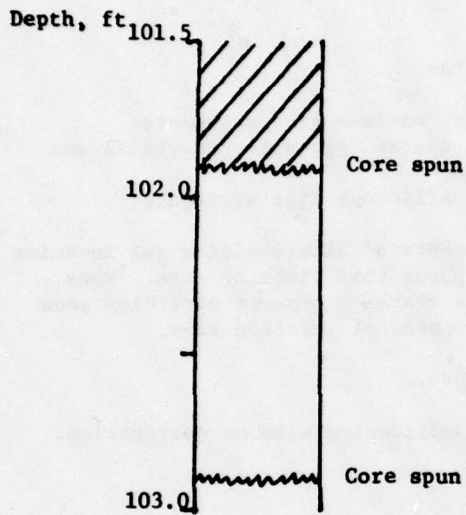
Martin Dam, Alabama Power Co. (CL-24(2) DC-10B)

Very limited amount of alkali-silica gel
present in voids throughout this piece
of core. Gel is of the pepper and salt
type. The aggregate shows some rim
development.

Gray paste but when the core was broken
open the paste was greenish black,
indicating slag cement.

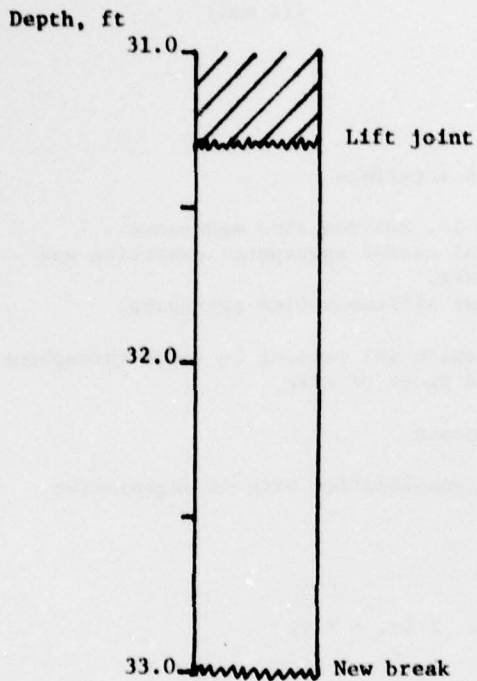
Depth (ft) 31.3 - 33.0
Elevation 470.2 - 468.5
(ft msl)

Some alkali-silica reaction products present
in voids on cored surface. Some coarse
aggregate shows the development of
reaction rims.

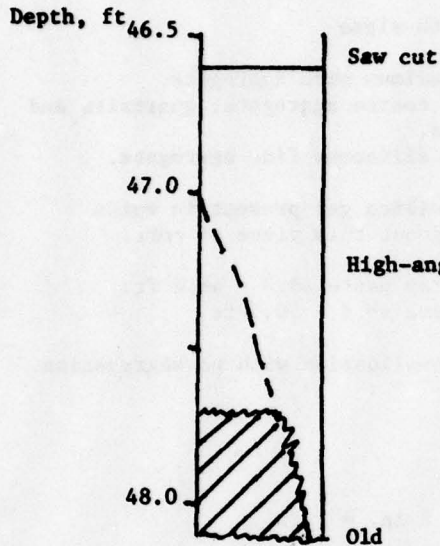
Depth (ft) 46.6 - 48.1
Elevation 454.9 - 453.4
(ft msl)

High-angle incipient crack

Some alkali-silica gel in voids and coating
some aggregates. The gel showed some
shrinkage cracking. Other voids were
filled with needles of ettringite.

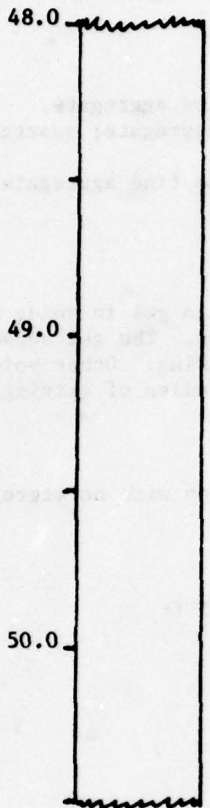
Depth (ft) 48.0 - 50.5
Elevation 453.5 - 451.0
(ft msl)

Old surface coated with algae

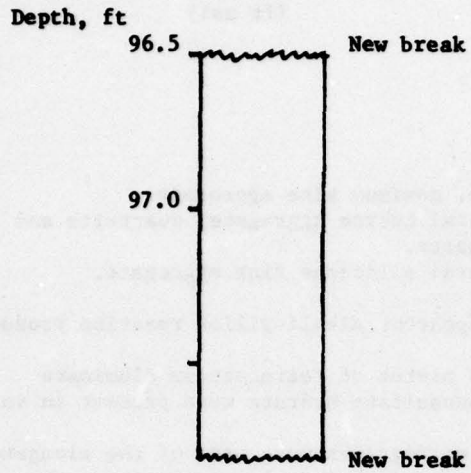
Depth (ft) 96.5 - 97.8
Elevation 405.0 - 403.7
(ft msl)

No alkali-silica reaction products detected.

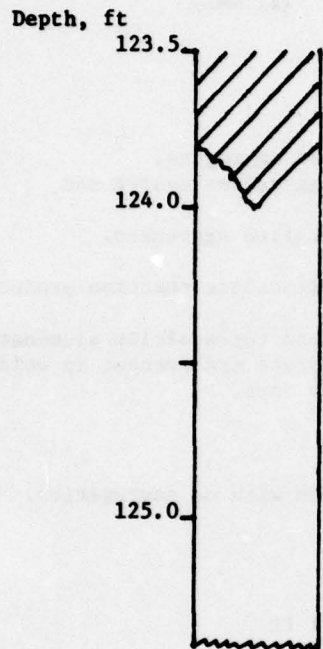
Depth (ft) 123.8 - 125.4
Elevation 377.7 - 376.1
(ft msl)

Old construction joint
