# Operation TEAPOT

## NEVADA TEST SITE

Project 35.1  
EFFECTS OF ATOMIC WEAPONS  
ON ELECTRIC UTILITIES

**EFFECTS OF ATOMIC WEAPONS  
ON ELECTRIC UTILITIES**

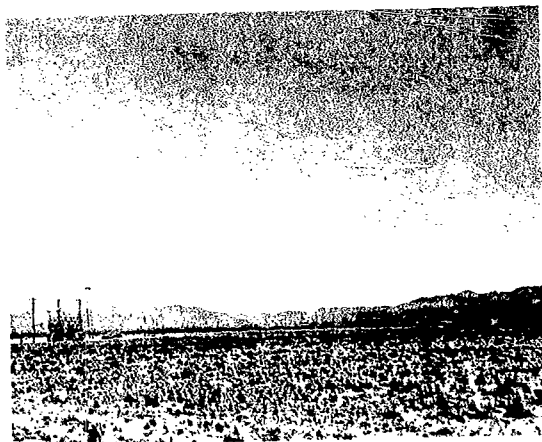
This section deals entirely with the electrical installation located in the 4700-ft area (Figs. 3.1 to 3.3) since there was no damage to electrical facilities at the 10,500-ft area, as determined by observations and tests.

Fig. 3.1—Postshot view of the transmission line at the 4700-ft area.

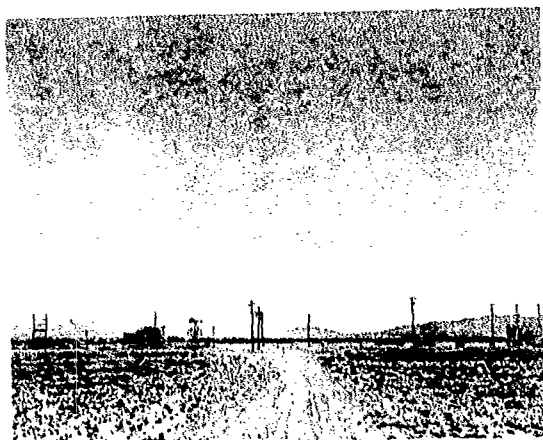
The substation had survived the blast with minor damage to its essential components. The metal cubicle itself, housing the motors and relays, was heavily damaged. However, this cubicle and its contents were not essential to the emergency operation of the system. The 4-kv regulators had been shifted on the concrete pad, resulting in separation of the electrical connections to the bus. The substation was in sufficiently sound condition to permit reenergizing on a nonautomatic basis.

Fig. 3.2—Postshot view of the substation at the 4700-ft line.

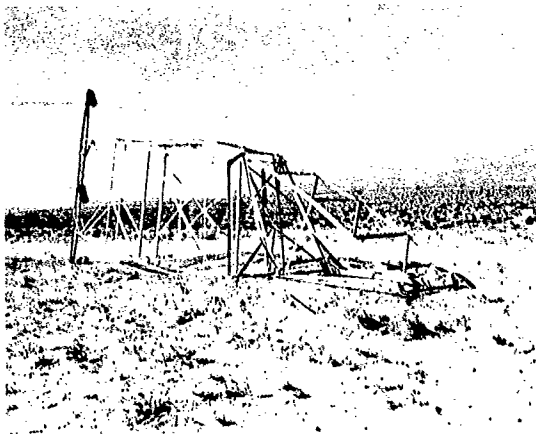
The only damage was to the suspension tower, which was blown over in a direction transverse to the transmission line (Fig. 3.4). The leg angles bent at the splice plates, which fastened them to the anchor stubs. The two leg members on the side of the tower away from the shot broke about 8 ft above the ground at a point where there were two 1/2-in. holes side by side on the 3-in. angle member. One insulator string was broken due to impact with the ground. The line conductors, splices, and hardware were undamaged.

Fig. 3.4—Structural failure of the suspension tower at the 4700-ft line.

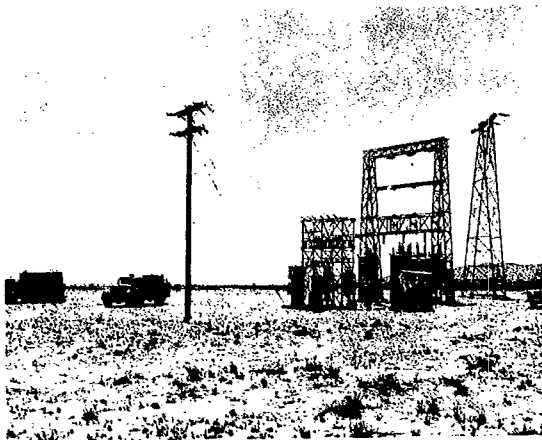
The steel dead-end structure supporting the 69-kv insulators, disconnects, and buses received minor structural damage (Fig. 3.5) in that two leg angles were slightly buckled at a point 3 ft above the foundation where several unused bolt holes were located.

Fig. 3.5—Postshot view of the substation at the 4700-ft line.

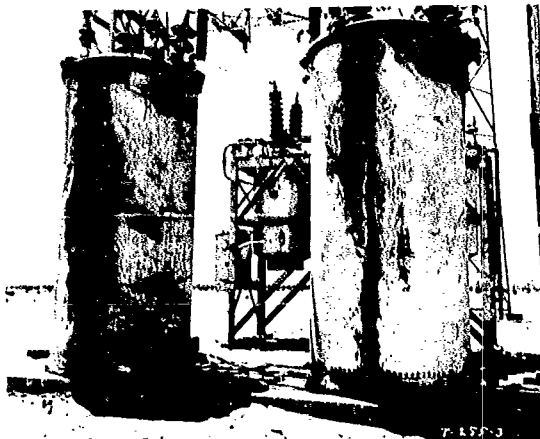
The two 1500-kva 69/11-kv transformers were undamaged and were not moved on the foundation pad. They later withstood a 30-kv a-c high-potential test to ground. The turn ratio between windings tested satisfactorily; and when meggered they gave the same values as was found in the pre-shot tests. The paint on the side of the case facing the blast was slightly blistered (Fig. 3.6). Neither the temperature nor the oil-level gauges were damaged.

Fig. 3.6—Thermal effect on the power transformer at the 4700-ft line.

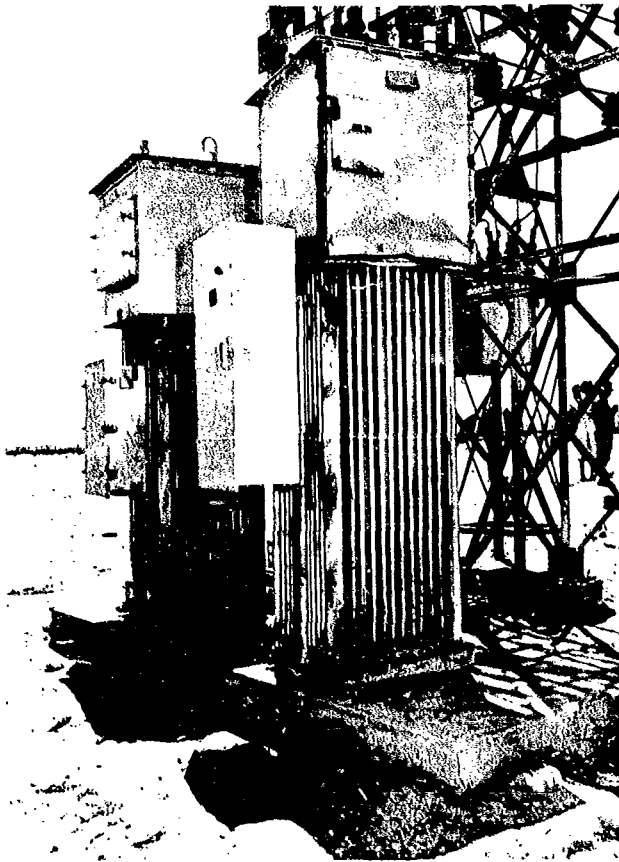
The two 4-kv 200-amp induction regulators were shifted on the foundation pad sufficiently to break electrical connections to the bus. In addition, the square flat-surf ced housing at the top of one regulator was dished on all four faces (Fig. 3.7). The flat-faced temperature-gauge glass was broken. The cylindrical oil-level gauge was not broken.

The regulators were tested and found to be electrically operative, but the raise and lower mechanism on one regulator was temporarily jammed. After approximately four operations of the raise and lower contactor, the mechanism was moving freely and was operating efficiently.

Fig. 3.7—Displacement of induction regulator and thermal effect on it at 4700 ft from GZ.

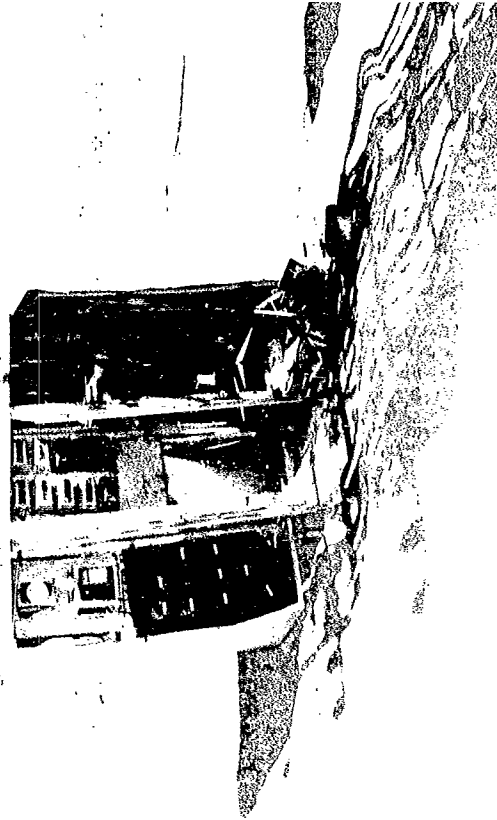
The three-compartment metal cubicle that housed meters, batteries, and instruments was severely damaged. The foundation pad to which this structure was bolted was noticeably tilted. See Fig. 3.8.

The battery cells were completely destroyed. All the glass cells were broken, acid was spilled over the ground, and most plates (both positive and negative) were damaged beyond repair.

The relays, instruments, and meters were tested identically to preshot tests and were found to be undamaged except for a broken cover glass on the recording wattmeter.

Fig. 3.8—Damage to the relay cubicle at 4.00 ft from GZ.

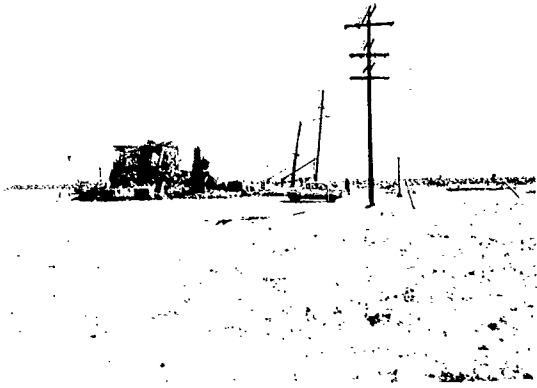
The distribution system sustained light to moderate damage. Of the poles in 14 positions, 5 were not damaged, 3 were very slightly damaged (to the extent of broken insulator pins on the 4-kv circuit only), 2 were extensively damaged, and 4 were down. No 11-kv metal insulator pins failed; and, except for down poles, the 11-kv circuit could have been reenergized. Slight scorching occurred to poles and crossarms. See Figs. 3.9 and 3.10.

Fig. 3.9—Failure of the distribution circuit at the rear of the 4700-ft property line.

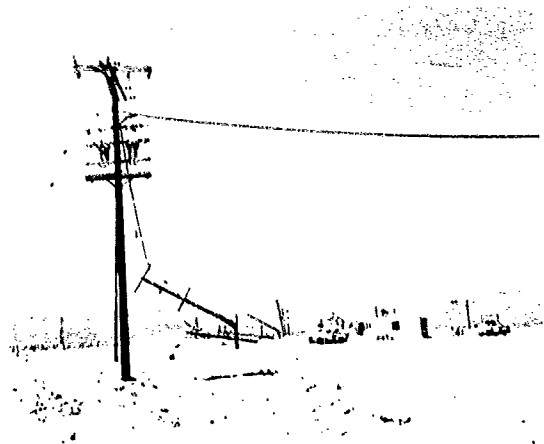
Fig. 3.10—Damage to pole 12 at 4700 ft from GZ.

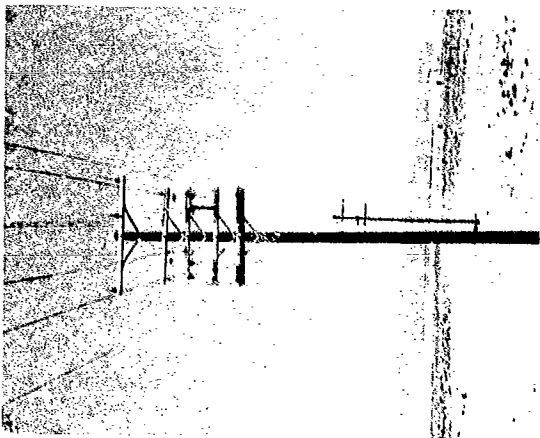
Pole 1 sustained one missing 11-kv insulator, but the pin was still in place in the crossarm. Poles 2 and 3 were undamaged. Pole 4 had two 4-kv wood insulator pins sheared and one pulled out of crossarm. The two 10-kva transformers were in place and undamaged although the crossarm on which they were hung was badly cracked. See Fig. 3.11. Pole 5 was undamaged. On pole 6 the 11-kv circuit was intact, but the 4-kv and secondary crossarms were splintered, apparently by house missiles. The 15-kva transformer was knocked to the ground at a distance of 36 ft from the pole. See Fig. 3.12. On poles 7A and 7B, the 11-kv circuit was intact, but four of the 4-kv wood insulator pins sheared, and two others pulled out. The crossarms were undamaged. The poles were displaced 4 in. at ground level and were leaning away from the blast due to the weight of adjacent down poles. See Figs. 3.13 and 3.14. The three 50-kva platform-supported transformers were blown to the ground, apparently by blast and missiles from the houses. See Fig. 3.15. The crossarms were undamaged. Pole 8 broke about 8 ft above ground level. The top portion leaned 60° from the vertical. One wood pin sheared on a 4-kv crossarm in the 4-kv circuit. The pothead was undamaged; the riser pipe bent, but the cable was undamaged. Secondaries between poles 7b and 8 snapped at the insulators on pole 8. See Fig. 3.16. Pole 9 broke at ground level, but the 11-kv circuit was intact. No damage was noted to the crossarms, capacitors, or insulators. The aerial cable was unbroken from pole 9 to pole 14. See Fig. 3.17. Pole 10 broke 1 ft below ground level. A 15-kva transformer was knocked to the ground and broken. The top of pole was split. The 11-kv crossarm was not broken but was separated from the pole. One 11-kv insulator was broken. The crossarm supporting the aerial cable was separated from the pole but was held on by the braces. One 11-kv conductor (#2/0 ACSIR) was frayed and cut in half by the radio-tower guy wire on which it fell. See Figs. 3.18 and 3.19. Pole 11 was broken 8 ft above the ground. One 11-kv insulator was broken. The riser pipe was bent, but the pothead and the aerial cable were not damaged. See Fig. 3.20. Pole 12 was undamaged; the two 10-kva transformers remained in place and were not damaged. The pole bent about 5° in the direction of the downed poles. Pole 13 had one 11-kv insulator missing. The mast arm of the luminaire was deflected about 10°. The globes, which were elliptically shaped, were not broken. Pole 14 was not damaged. The mast arm of the luminaire was deflected about 10°, but the elliptical globes were not broken.

Fig. 3.11—Damage to pole 4 at the 4700-ft line.

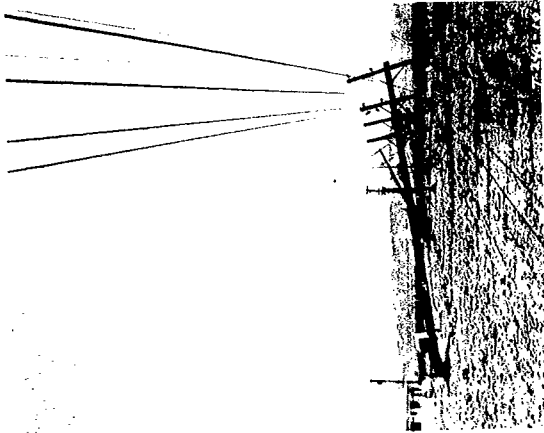
Fig. 3.14—Damage to distribution poles at the 4700-ft line.

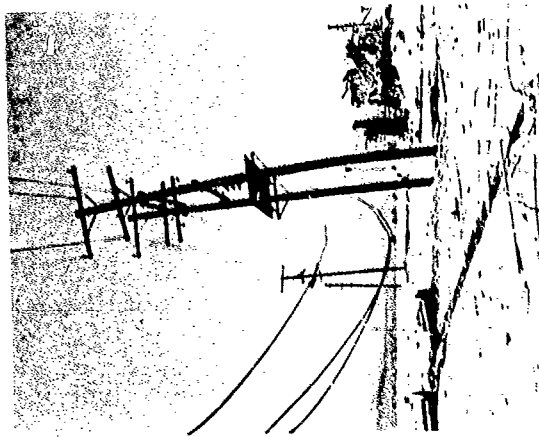
Fig. 3.13—Damage to poles 7-A and 7-B at the 4700-ft line.

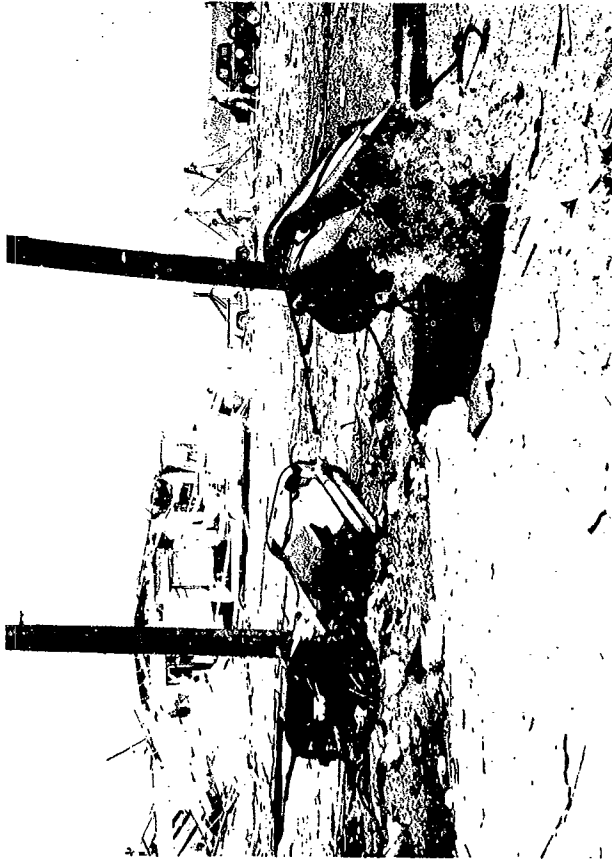
Fig. 3.15—Damage to transformers mounted on platforms at the 4700-ft line.

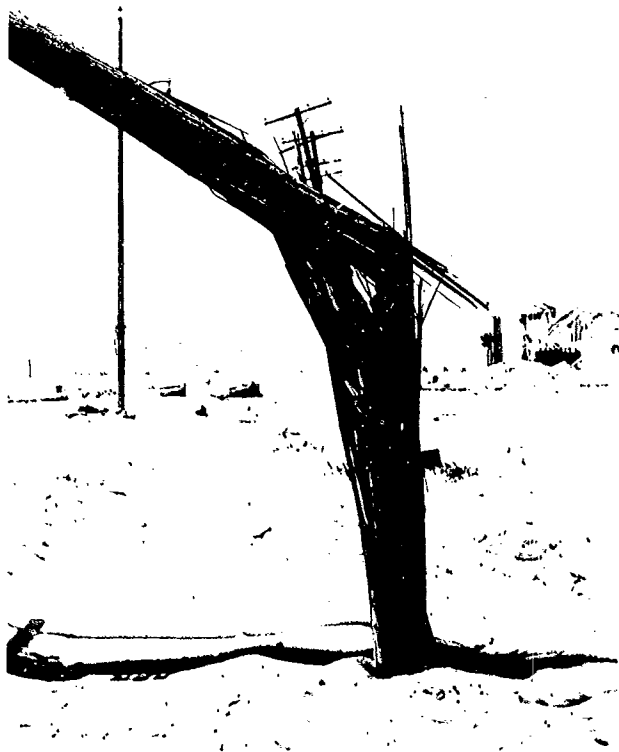
Fig. 3.10—Damage to pole 8 at the 4700-ft line.

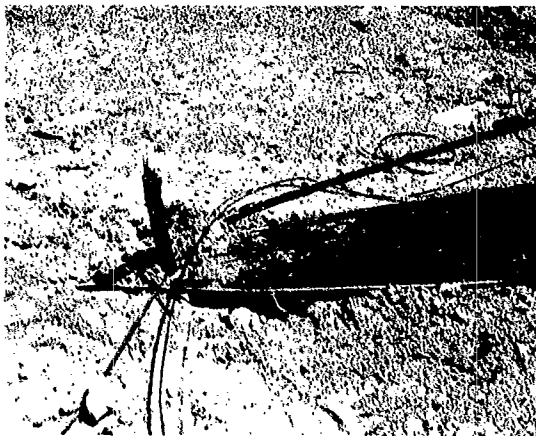
Fig. 3.18—Damage to pole 10 at the 4700-ft line.

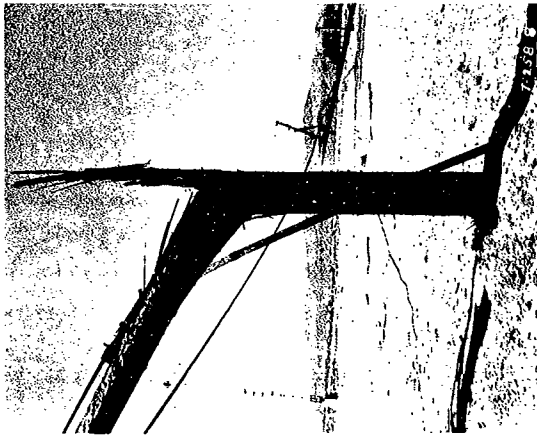
Fig. 3.20—Damage to pole 11 at the 4700-ft line.

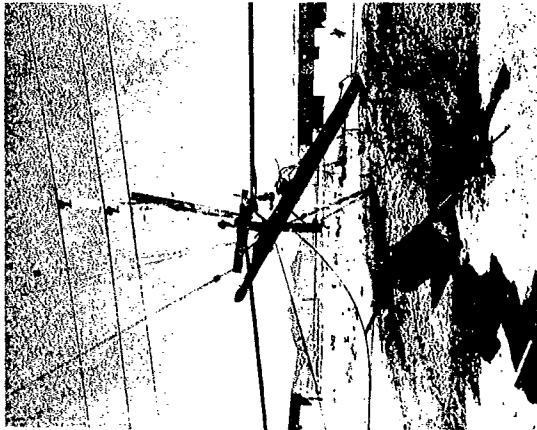
Fig. 3.19—Damage to transformer at the 4700-ft line.

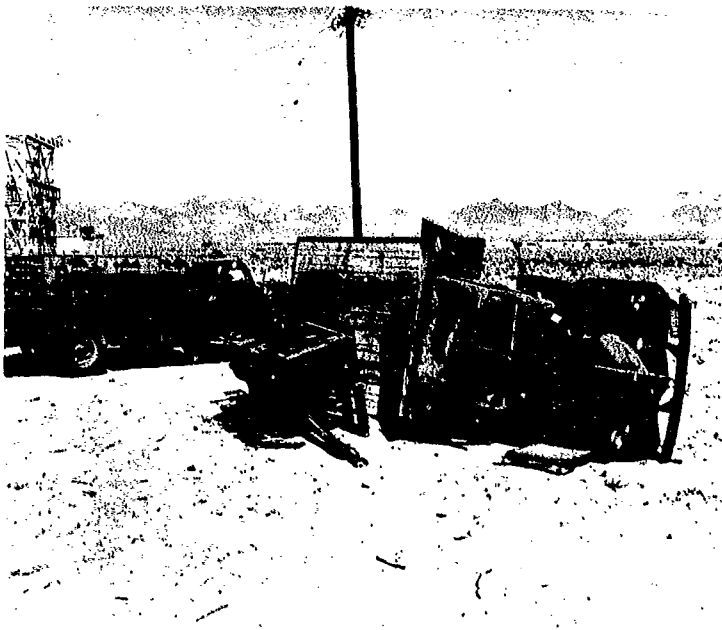
The heavy crew truck, exposed in Project 36.2, sustained broken windows and a bent hood, but its equipment was not damaged.

The truck that was equipped with an earthboring machine (also exposed in Project 36.2) tipped over, sliding the boring machine to the ground (Fig. 3.21).

Fig. 3.21 — Damage to service vehicles at the 4700-ft line.
