COLD REGIONS RESEARCH AND ENGINEERING LAB HANOVER NH F/6 14/5
INFRARED THERMOGRAPHY OF BUILDINGS: 1977 COAST GUARD SURVEY. (U)
JUN 79 S J MARSHALL MIPR-7LB731-CO-206
CRREL-SR-79-20 NL

4. TITLE (and Subtitle) INFRARED THERMOGRAPHY OF BUILDINGS: 1977 COAST GUARD SURVEY		5. TYPE OF REPORT & PERIOD COVERED
		6. PERFORMING ORG. REPORT NUMBER

7. AUTHOR(s) Stephen J. Marshall		8. CONTRACT OR GRANT NUMBER(s)
9. PERFORMING ORGANIZATION NAME AND ADDRESS U.S. Army Cold Regions Research and Engineering Laboratory Hanover, New Hampshire 03755		10. PROGRAM ELEMENT, PROJECT, TASK AREA & WORK UNIT NUMBERS U.S. Coast Guard Project MIPR 7LB731CO206

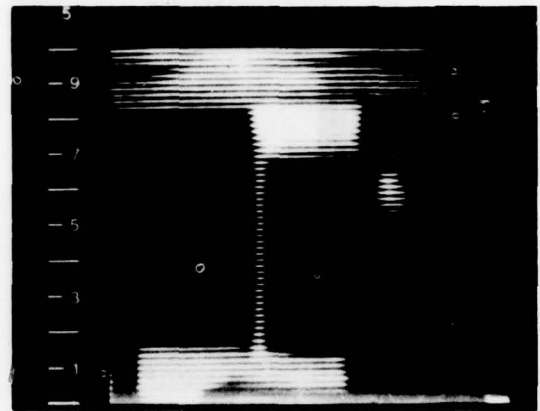
the south face, which reveals an excessive amount of heat loss through the glass transom and around the door. The door itself appears insulated. The concrete block walls appear uniformly insulated and in Figure 24 the actual outlines around each block can be recognized. The foundation is excessively warm, as are the concrete blocks immediately above the transom level and the horizontal precast beams above them.

Figure 23. Closeup of warm foundation, glass transom and door exfiltration.

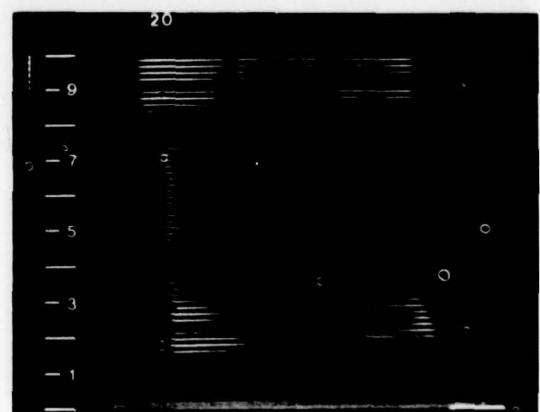
Figure 27. Main entrance door.

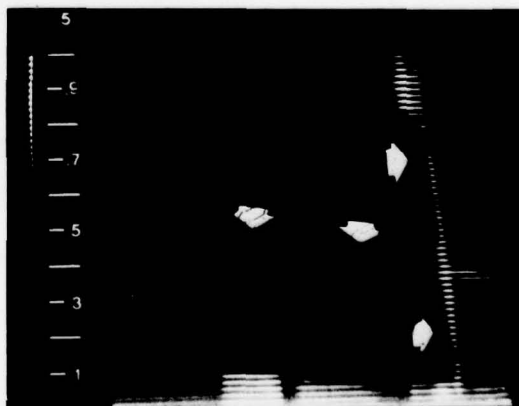
Figure 33. Exfiltration between wooden panels and at panel/wall interface.

Figure 32 shows upper and right-hand leakage between the window frame and concrete block wall interface (arrows). Figure 33 shows horizontal leakage between the upper and lower panels and between the panels and the concrete block wall (arrows). These wooden panels should be compared with the much superior insulated porcelain panels at the Portland Base (Fig. 93-97).

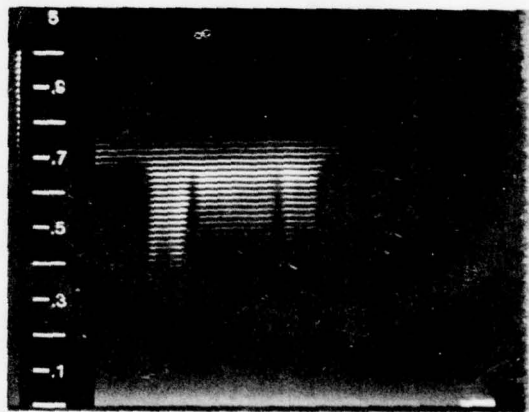
Figure 57. Excessive exfiltration from window/wall interface.

Figure 57 is of the third deck window on the upper right in Figure 54. The patterns on the glass suggest infiltration loss as well as the fact that the top horizontal interface is much warmer than most of the other windows on this face.

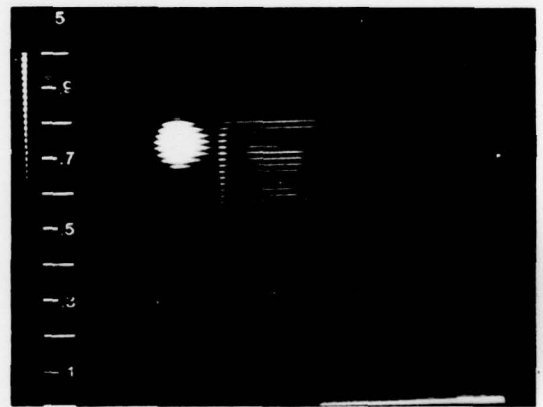
Figure 77. Badly sprung stairwell door on northeast corner of building.

Figures 77-79 are closeups of the stairwell door, garage door, and window, respectively. Figure 77 is a confirmed example of what a badly sprung metal door, i.e. a door bent by the strong winds, looks like in a thermogram. The upper horizontal and vertical interfaces show a wide thermal heat loss pattern where as there is little leakage along the bottom interface. This could result from the bottom interface experiencing infiltration of cold air while the top interface is allowing exfiltration of warm air. Other stations subjected to the same high winds (Boothbay Harbor and Jonesport) had doors with similar patterns.

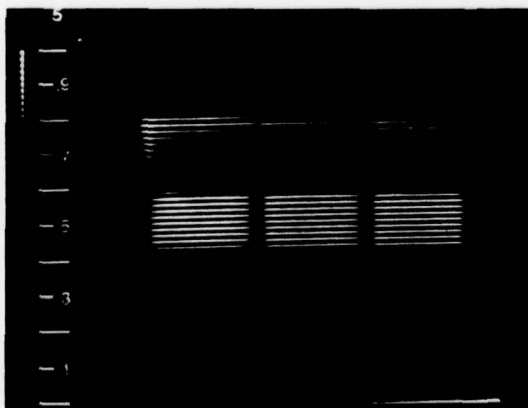
Figure 78. Garage door in northeast corner of building.

Figure 78 is a closeup of the wooden garage door showing the excessive top horizontal leakage and the warm window glass. However, this garage door was not as bad as those at some of the other stations. Figure 79 is the window over the garage door taken at scale 10. All the windows on the north face were closed and had drawn drapes but still exhibited some leakage. This station often has the problem of the entire north face being very cold and the entire south face very warm.

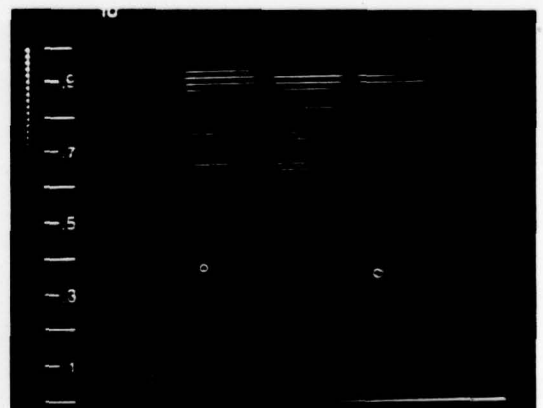
Figure 79. Windows on the north face with drawn drapes.

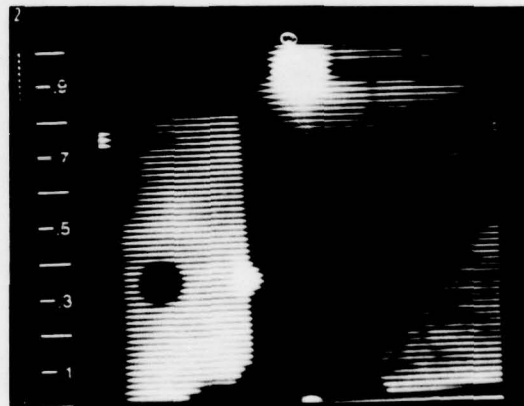
Figure 83. Mottled moisture pattern on west face of stairwell.

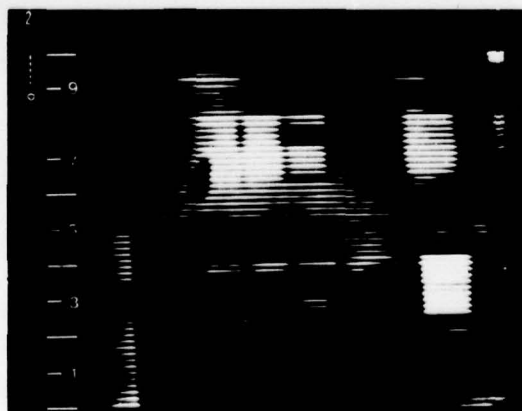
Figure 84. Open second deck windows on south face.

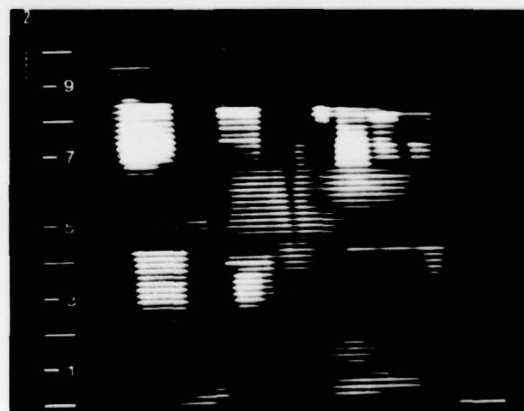
Figure 85. Radiator leakage under windows on south face.

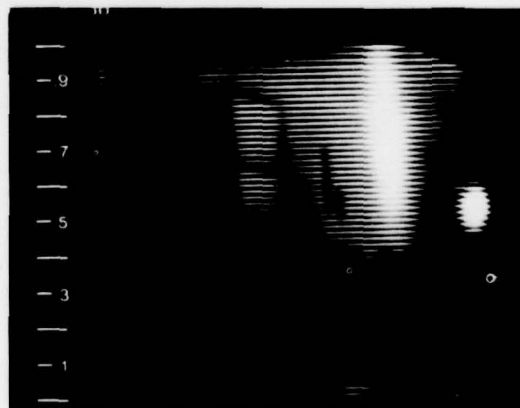
Figure 105. Vertical thermal pattern from chimney on north face of building.

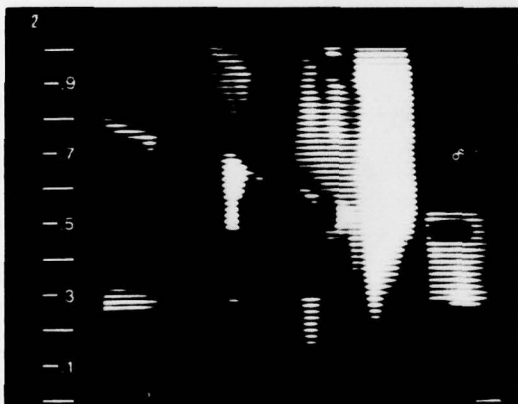
Figure 115. Cooler thermal pattern below the breeching on the chimney.

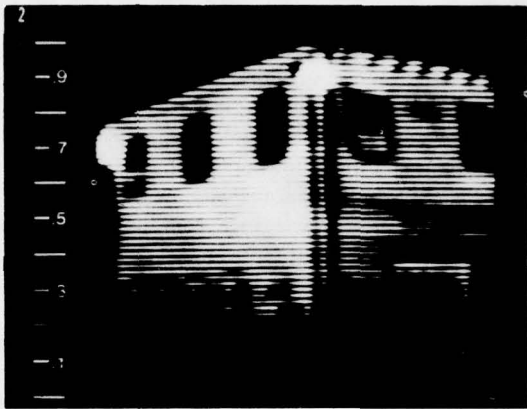
Figure 119. Apparent solar effect of cold windows and warm walls.

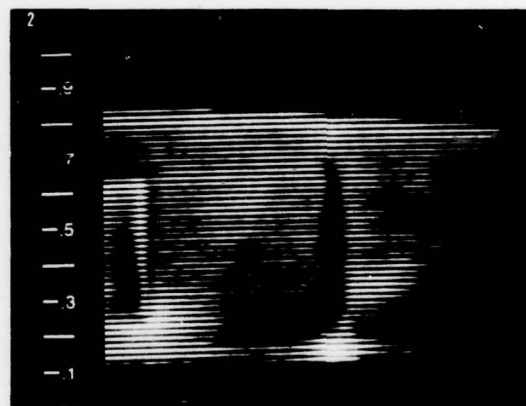
Figure 129. Cool foundation on east face of mess deck.

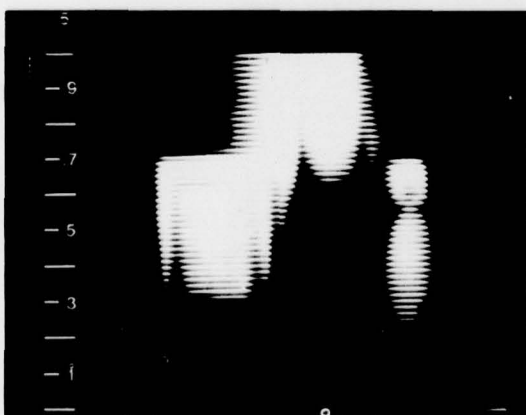
Figure 136. Plume of warm air from vent to right of chimney.

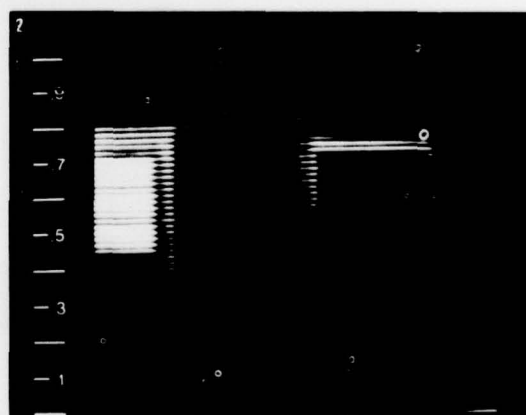
Figure 137. Paint storage locker doors losing heat.
