WARNER GAP HOLLOW DAM

(EDGEMONT RESERVOIR)

NDI NO. MD 00006

**PHASE I INSPECTION REPORT
NATIONAL DAM INSPECTION PROGRAM**

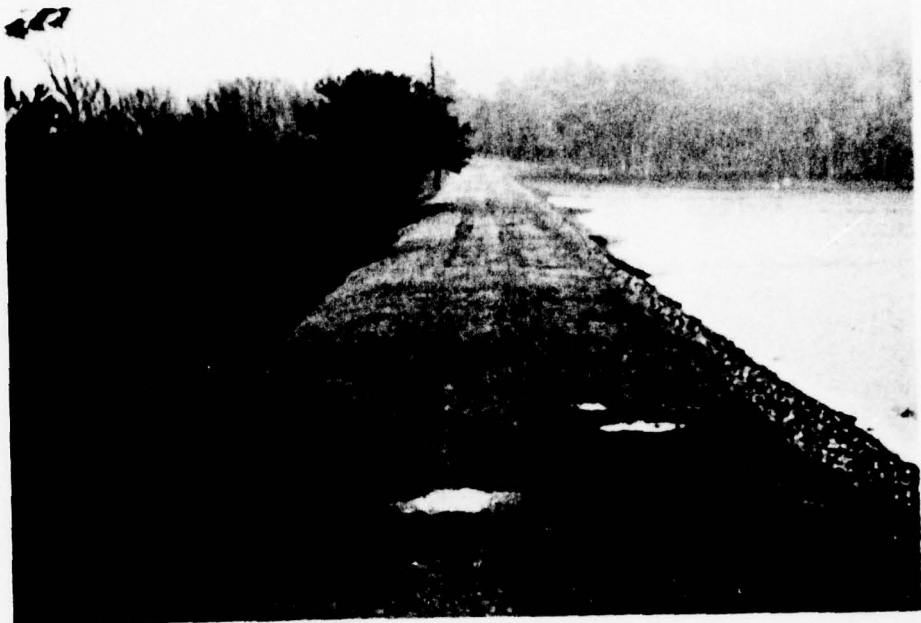
1. There is a six-inch depression in the vicinity of the observation well near the right abutment. Otherwise, the horizontal and vertical alignment of the embankment is good.
2. There are minor surface irregularities in the rip-rap on the downstream slope. The slope has scattered trees and brush growth. Based upon an October, 1978, photograph at low pool, the upstream rip-rap is in good condition.
3. Flow from left side of the dam and downstream of the toe (springheads) are conveyed via a system of tile and plastic pipe to a stone outlet beyond the 30" blow-off pipe. The flow was clear and estimated to be between 10 and 15 gallons per minute. The pipe system was damaged in several locations.

CREST

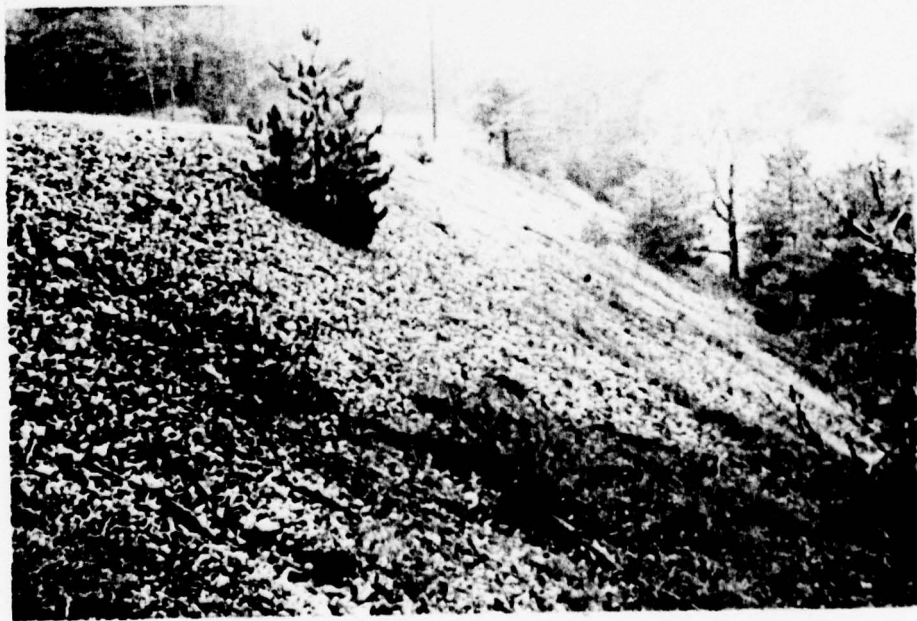
2. The recent dumping of replacement rip-rap over the downstream slope may account for the non-uniform slope surface noted during the inspection. Tension cracks, toe heave, and/or alignment irregularities which might indicate deep seated movement of the dam slopes were not observed.

DOWNSTREAM FACE-VIEWED FROM
RIGHT ABUTMENT

1. Document operating procedures in writing.
2. Remove woody vegetation from downstream embankment slope.
3. Develop a warning system to warn downstream residents of large spillway discharges during periods of heavy rainfall and runoff or failure of the dam.

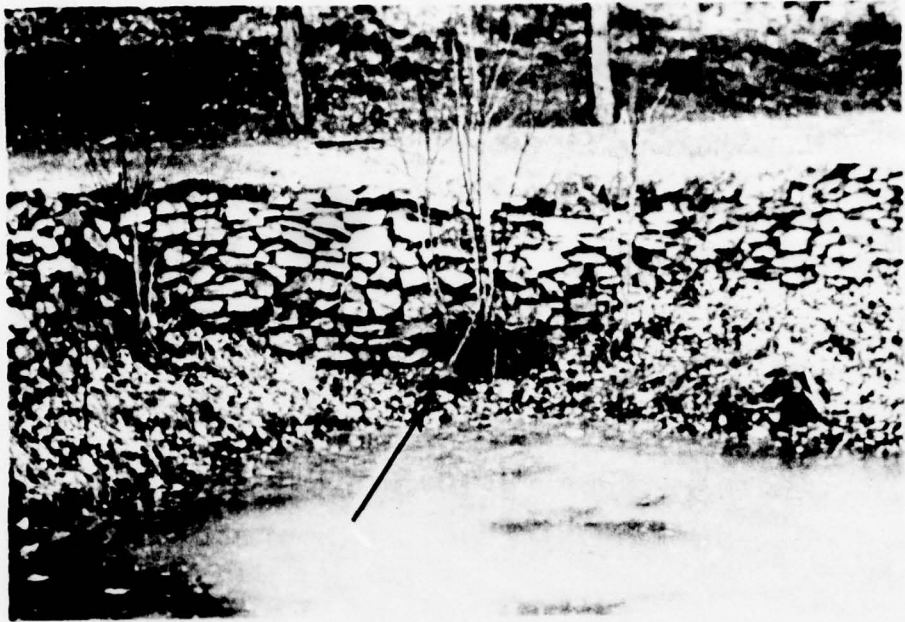
1. The concrete associated with the rectangular overflow spillway was in good condition.
2. Debris and sediment partially choke the outlet channel for the 30" blow-off pipe. The valve was inoperative at the time of the inspection.
3. The control and by-pass valves for the discharge mains are regularly operated.

30" BLOW-OFF (DRAIN)

1. Initiate an engineering study to evaluate spillway capacity and determine remedial measures to reduce the overtopping potential at the dam.
2. The 30-inch drain valve should be restored to an operable condition and should be provided with a positive seal on the upstream side of the dam.
3. The seepage at the left abutment should be monitored on a routine basis to detect any changed conditions in quantity or turbidity. Flow measurements should be made with the use of a weir.

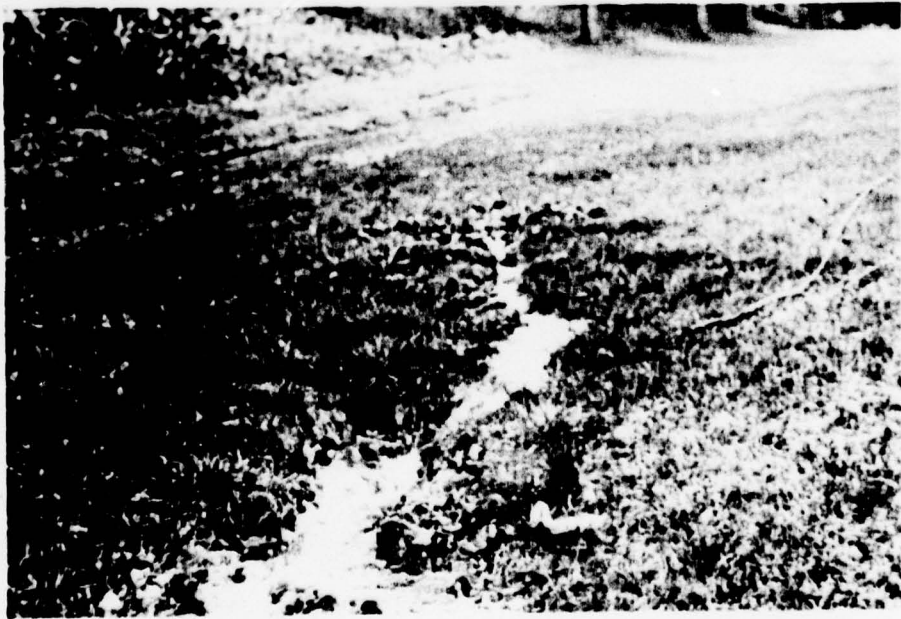
3. The 1968 investigation judged the seepage activity beyond the left abutment not as serious as the leakage at the right abutment and further evaluation was deferred until the spring of 1969. No record of the deferred evaluation was found during the data review. Based upon the relative clarity and apparent seasonal fluctuation of seepage, the source of discharge at the left abutment appears to be primarily spring activity not directly affecting the stability of the dam. However, the quantity and turbidity of seepage should be monitored on a routine basis.

Flow from left side conveyed via system of tile and plastic pipe.
precise location of sources, if any, within dam foundation unknown:
flow clear and approximated at 15 gpm.

SEEPAGE, LEFT SIDE BEYOND TOE
