NEW YORK STATE DEPT OF ENVIRONMENTAL CONSERVATION ALBANY F/G 13/2
NATIONAL DAM SAFETY PROGRAM, DIAMOND MILLS PAPER COMPANY DAM (N--ETC(U)
AUG 78 E A NOWATZKI, G S SALZMAN DACW51-78-C-0035

ENGINEERS FROM THE CONSULTING FIRM OF WARD-ZETLIN, UNDER CONTRACT TO THE STATE OF NEW YORK, DEPARTMENT OF ENVIRONMENTAL CONSERVATION INSPECTED THE DIAMOND MILL PAPER COMPANY DAM, ULSTER COUNTY, NEW YORK (I.D. NO. 89) ON 29 JUNE 1978 AS PART OF THE NATIONAL DAM INSPECTION PROGRAM.

BRIEF ASSESSMENT OF GENERAL CONDITION
AND
RECOMMENDED ACTION

APPENDIX D
PHOTOGRAPHS

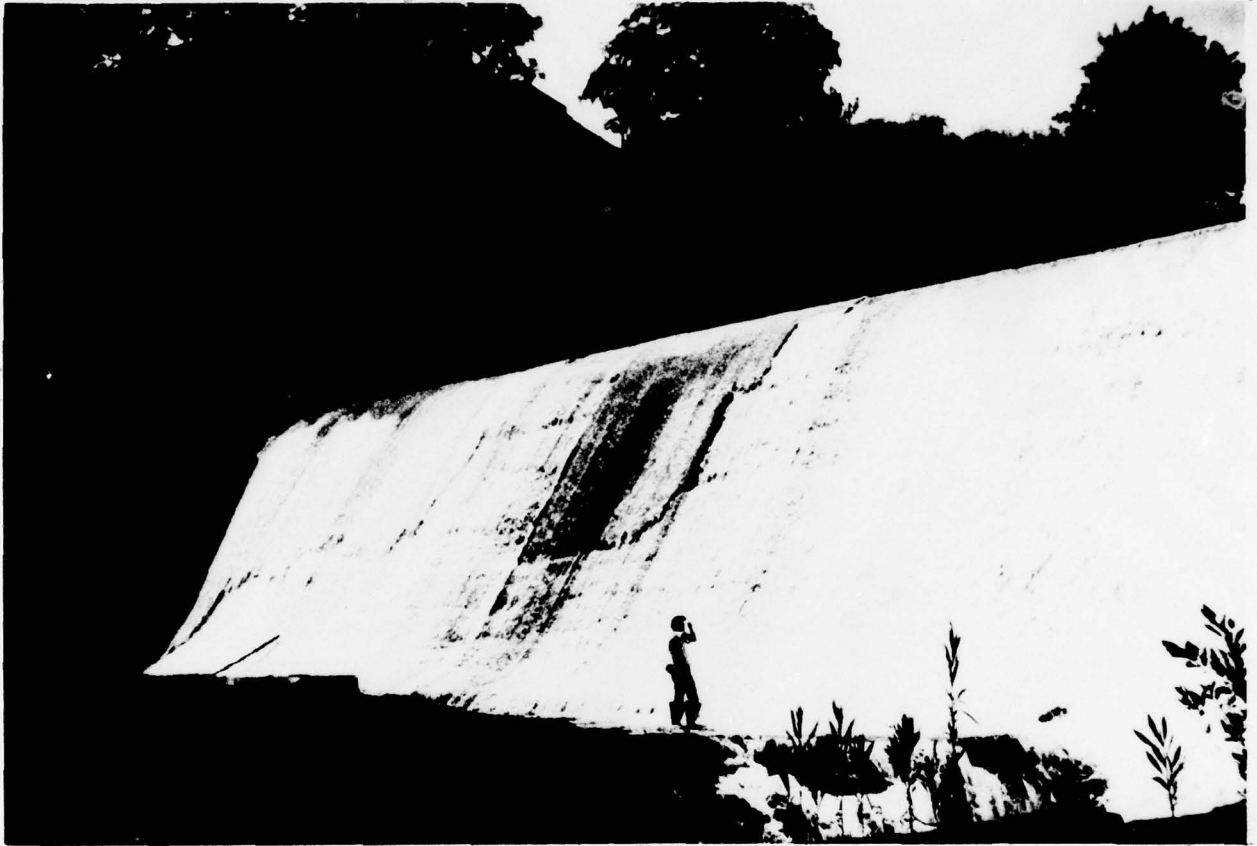
OVERVIEW - DIAMOND MILLS PAPER COMPANY DAM

apparent that the concrete face of the dam is badly cracked, scaled and spalled (Fig. 3, Appendix D; also Overview picture). Construction joints between the monoliths appear to be open to a significant depth (Fig. 4, Appendix D) and spalling on the joints at some sections along the crest has left what appear to be V-notches (Figs. 5 and 6, Appendix D). The monoliths at some sections appear to be offset horizontally 6± inches; however, it is difficult to tell whether there is actually an offset or whether there appears to be an offset because of the large amount of spalling that has taken place (Figs. 6 and 7, Appendix D). At some sections along the spillway crest it is apparent that a large amount of spalling has taken place (Fig. 24, Appendix D).

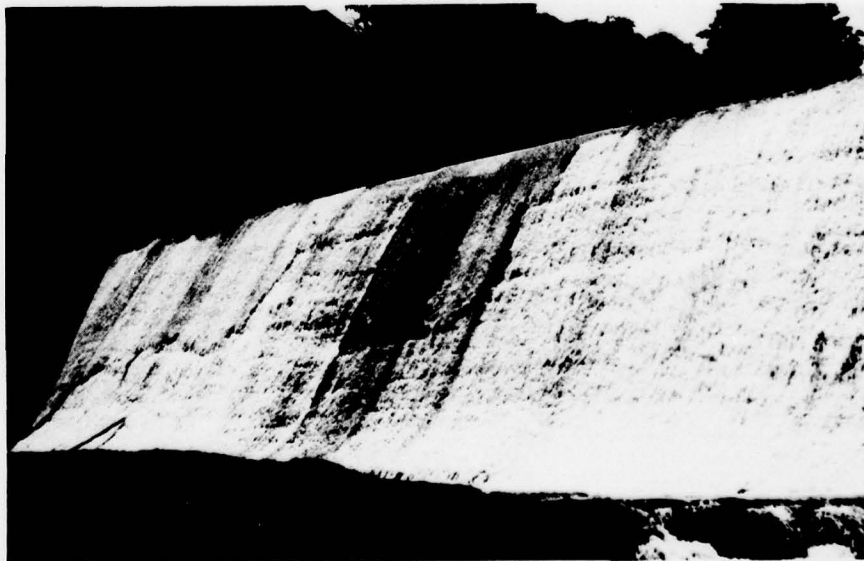
i. Spalling of concrete to a depth of from 3 to 6 inches over most of the downstream face of the main spillway section (Fig. 3, Appendix D) and along some sections of the spillway crest (Fig. 24, Appendix D). Some of this spalling may be of an unreported gunite resurfacing.

ii. Longitudinal cracking over much of the concrete gravity structure at all levels (Figs. 3, 5, 18, Appendix D). Because of the flow of water over the dam, we could not determine whether these were structural cracks or construction joints.

FIGURE 3 DOWNSTREAM FACE NEAR RIGHT ABUTMENT

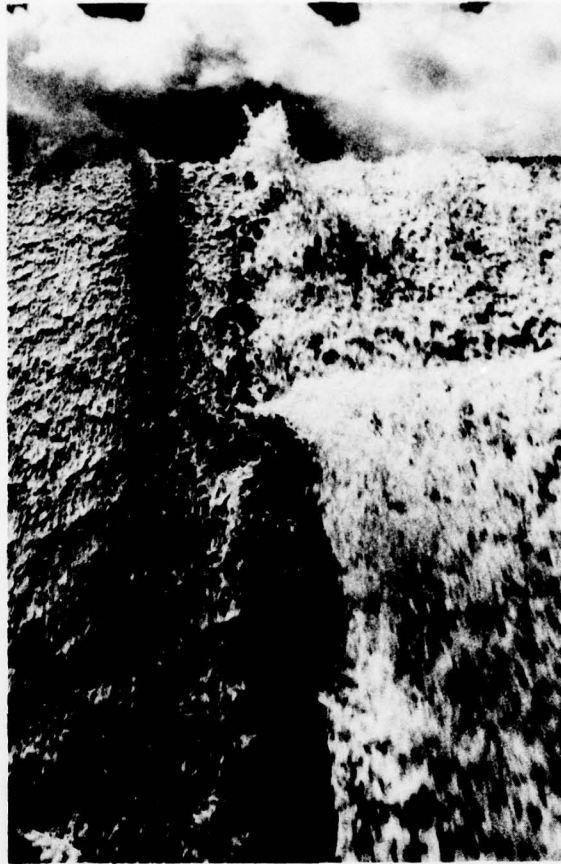
FIGURE 4 WATER SPLASH IN OPEN JOINT

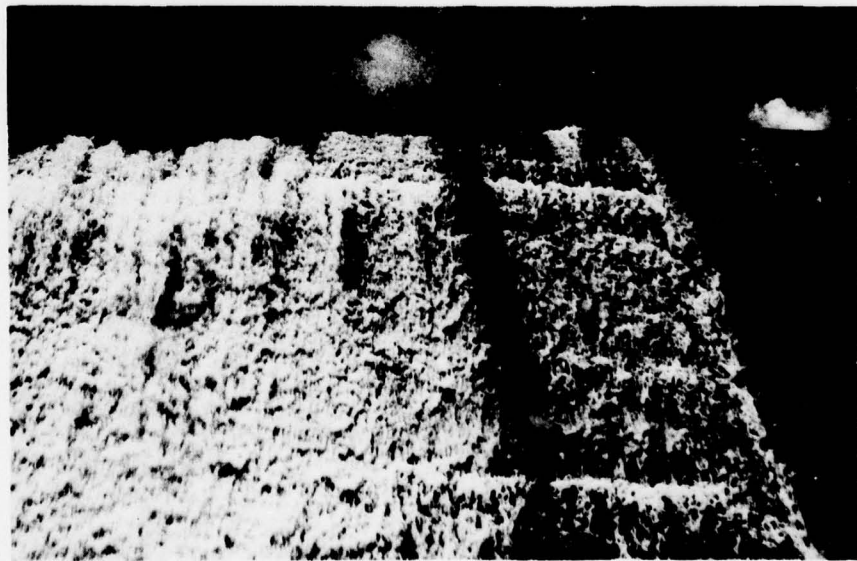
spalls (see, for example, Figs. 3, 4, 5, 9 and 18). A longitudinal crack was noticed on the upstream face near the right abutment about 6 inches below the crest. Should this crack develop to the extent that the crest is lost in that area, the hydraulic performance of the dam will be greatly altered.

FIGURE 5 WATER SPLASH OVER CRACKS AND SPALLS ON UPSTREAM FACE AND ALONG CREST

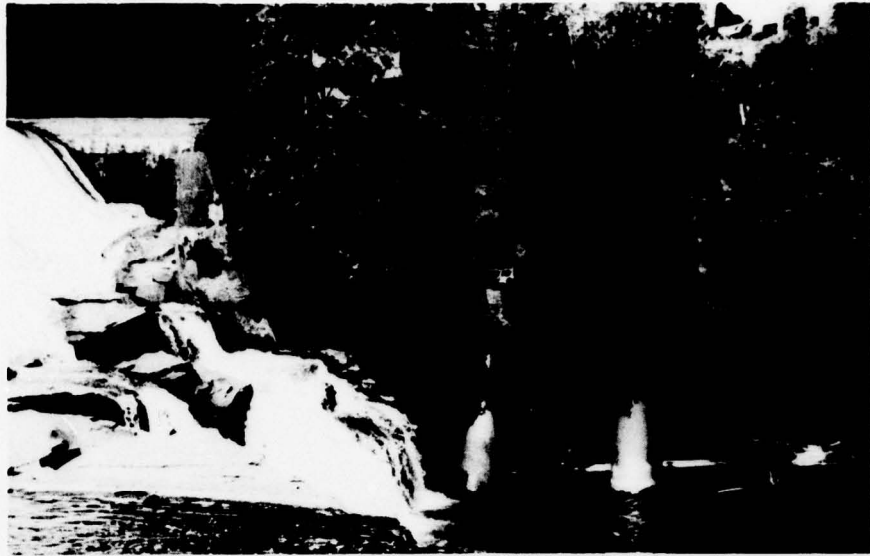
i. The side-channel spillway appeared to be in very poor condition. The concrete is severely scaled and spalled on the downstream face and seepage is clearly visible coming both through the concrete and under the spillway structure (Figs. 7 and 8, Appendix D). The junction with the main spillway section is badly eroded and there is a large longitudinal crack at about the main spillway crest elevation running the length of the side-channel spillway (Fig. 8, Appendix D).

The gate at the left abutment leads via a steel penstock into a turbine house that is located approximately 25 feet below the main spillway crest elevation (Fig. 8, Appendix D). The stairway leading from the cliff on the left side of the channel to the turbine house is in very bad condition. The building itself appears to be unsafe and in imminent danger of collapse. The upstream and left channel walls bulge and there is substantial leakage through them into the building. The floors are wet and covered with silt. The equipment itself is rusted and generally in disrepair (Figs. 14 and 15, Appendix D). The two penstock outlets leading to the tailrace are deteriorated (Fig. 16, Appendix D). There is some discharge coming from these pipes even though the gate to the turbine is closed; this indicates that the gate is probably leaking. Furthermore, the penstock in the turbine building is leaking through pinhole(s) just above its connection to the turbine nozzle chamber. There is substantial seepage coming through the rock foundation under the turbine building. This is evident in Figure 16 both by the wet spot on the pipe in the foreground and by direct observation of the seepage coming from the wall between the pipes. A close-up of this seepage is shown in Figure 17, Appendix D.

FIGURE 8 LEFT ABUTMENT AREA AND TURBINE GENERATOR HOUSE

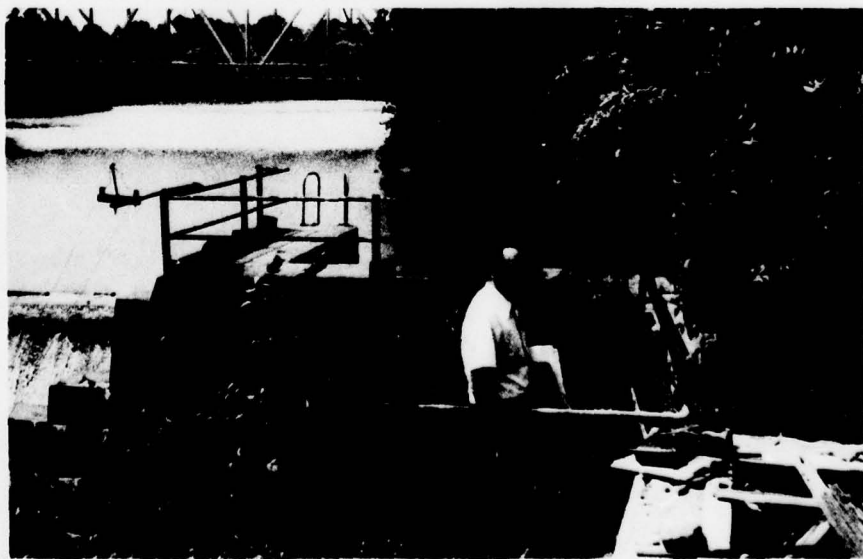
iii. The gate control platform is in good condition. The access to it is via a wooden stairway and bridge. The basic support for this access structure is a steel frame which seems to be in satisfactory condition, but the wooden boards are rotten and both the stairway and the bridge are

overgrown with vegetation. (Fig. 11, Appendix D.) The iron handrail and stairs leading from the control gate platform to the side-channel spillway crest are rusted out and could not be used safely. On the day of the inspection water was not flowing over the side-channel spillway. There was still water behind the spillway which submerged the vertical lift gate so that only the trash rack was visible. The gate controls are rusted and inoperative (Fig. 12, Appendix D). They are apparently driven by an electric motor and belt system but there is no electrical supply at or near the gate platform, so the gate cannot be operated. Even if there were an electrical supply at hand it is questionable whether the gate controls would work.

FIGURE 11 LEFT ABUTMENT AREA AND ACCESS STRUCTURES

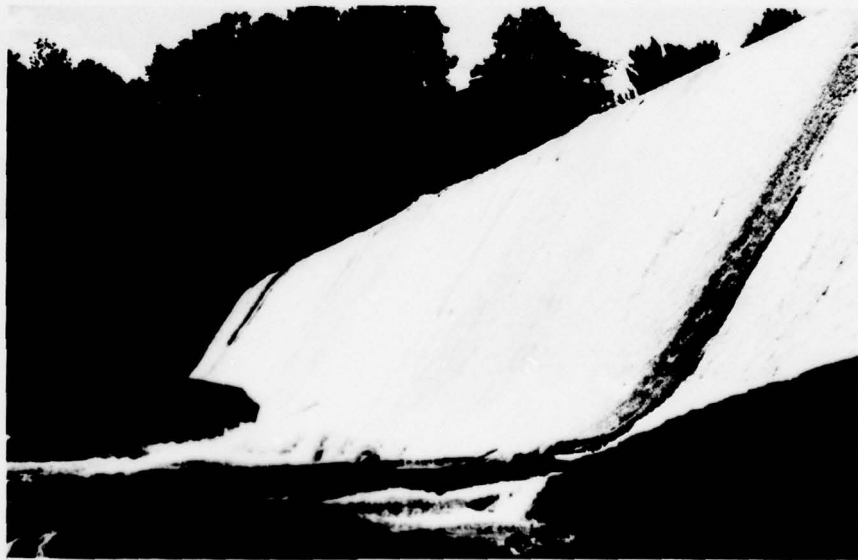
FIGURE 13 DOWNSTREAM FACE SHOWING POSSIBLE MONOLITH OFFSET

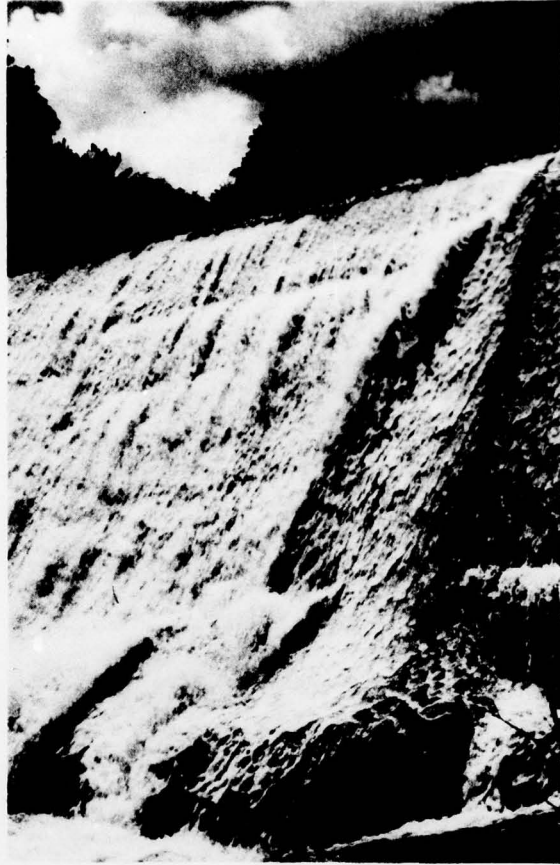
FIGURE 18 EXIT PORTALS OF TWO SLUICE PIPES ON DOWNSTREAM FACE

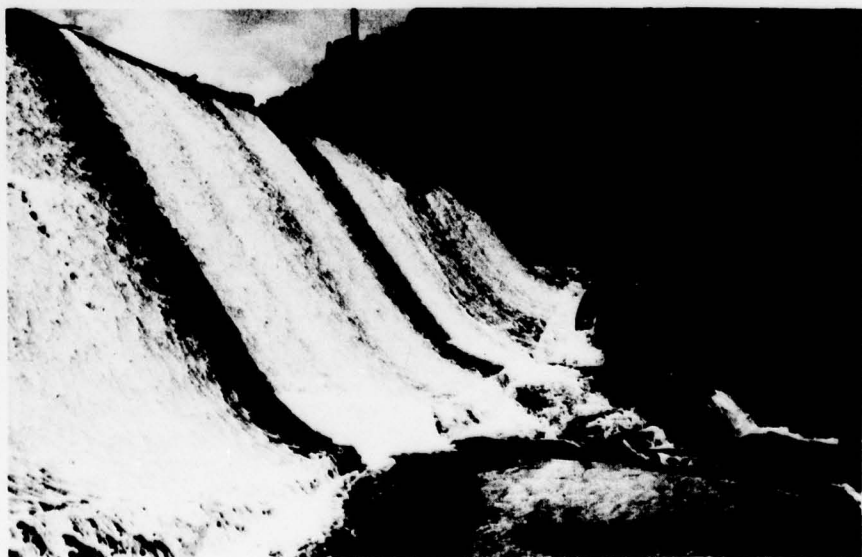
FIGURE 23 DOWNSTREAM FACE SHOWING POSSIBLE MONOLITH OFFSETS AND
LEAKAGE BENEATH AND THROUGH SIDE CHANNEL SPILLWAY
