**CROSS RIVER DAM
WESTCHESTER COUNTY
NEW YORK
INVENTORY NO 38**

**PHASE I INSPECTION REPORT
NATIONAL DAM SAFETY PROGRAM**

NEW YORK DISTRICT CORPS OF ENGINEERS
AUGUST 1978

PHASE I INSPECTION REPORT
NATIONAL DAM SAFETY PROGRAM
NAME OF DAM - CROSS RIVER ID# - NY38

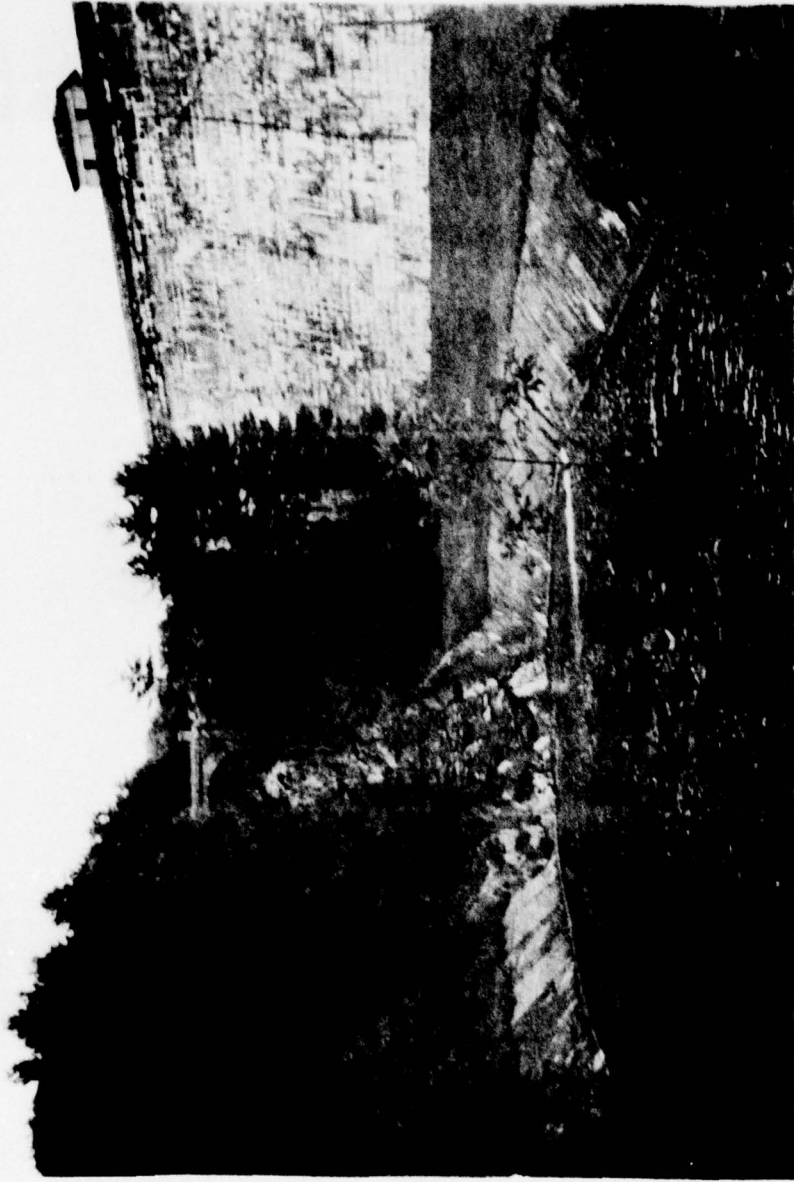
Overview of dam showing concrete block faced cyclopean masonry structure constructed in 1906. Side channel rock spillway is founded on north abutment.

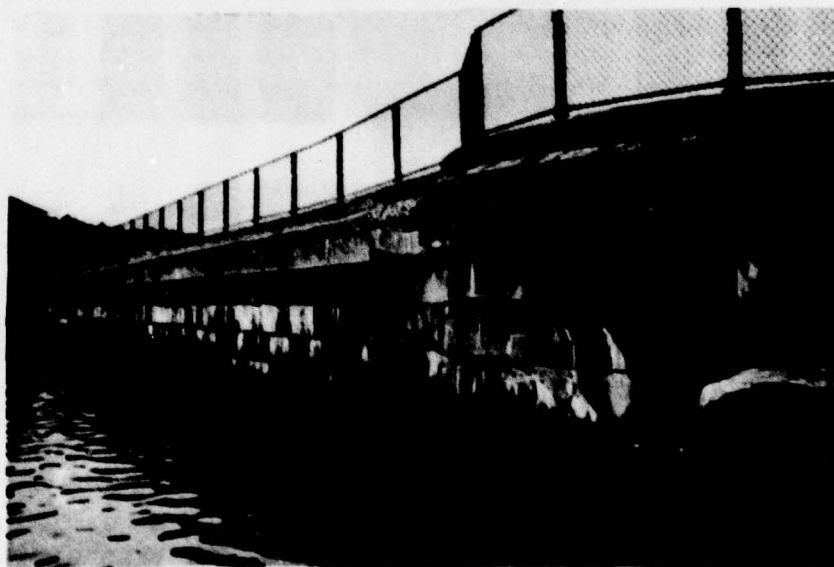
6. View across front of dam from spillway weir location. Circular portion of structure contains bastion room within dam. Floor of room is 0.66 feet above spillway. Room previously used to store flashboards which are no longer in use. Notice cracks in bastion area.

Photographs 6 through 11 show extensive damage to the bastion chambers. It is not known what caused this movement and cracking to occur. Possible causes for this damage are frost heave, thermal expansion, creep, pore pressure, foundation movement, reservoir head, vehicular traffic loads and seismic activity. The fracture and displacements seem to indicate expansion along the longitudinal axis of the dam. The bastion area being a circular (relatively) thin walled structure is the weakest point in the dams longitudinal axis and is between the south abutment and the north ends bridge arch. Expansion forces seem to have pushed the front wall of the bastion area out. Fractured column joints show movement to the North. Lateral torsion failures were visible in the roads floor beams. The cause of these fractures is not known, however, the most prevalent explanation appears to be frost heave.

of the bastion should be done as soon as possible, and the area should continue to be kept under close observation. The owner should determine the cause of the extensive structural damage in the bastion chamber.

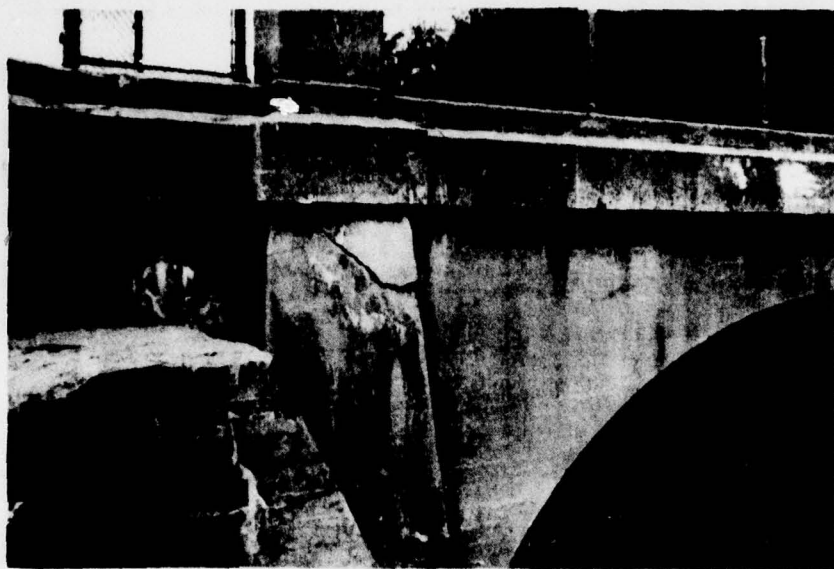
9. Detail of bridge abutment wall showing
in right portion of picture No. 8.

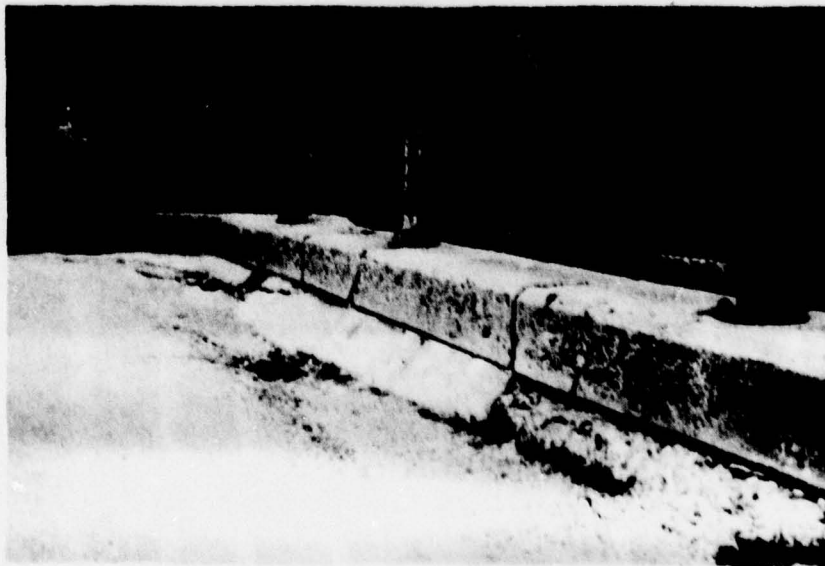
12. Road surface and repaired curb area above bastion.

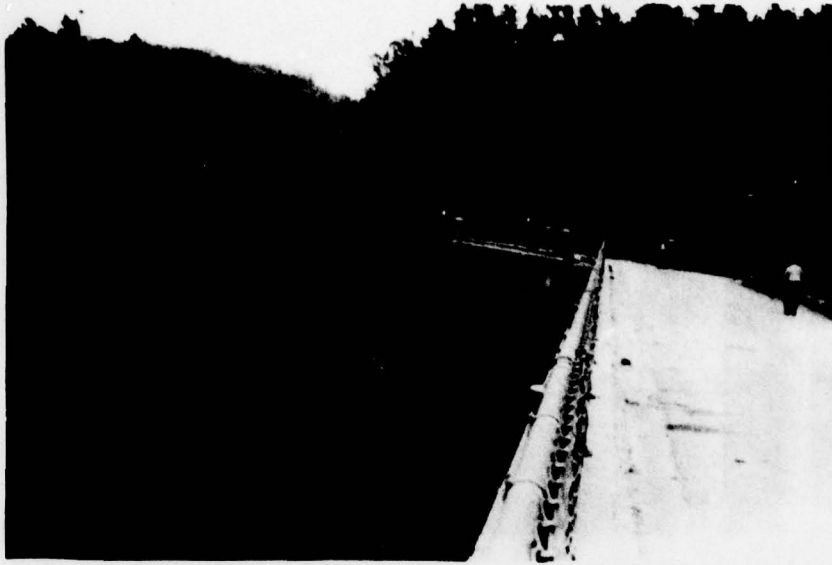
13. View across dam and of spillway bridge near bastion area.

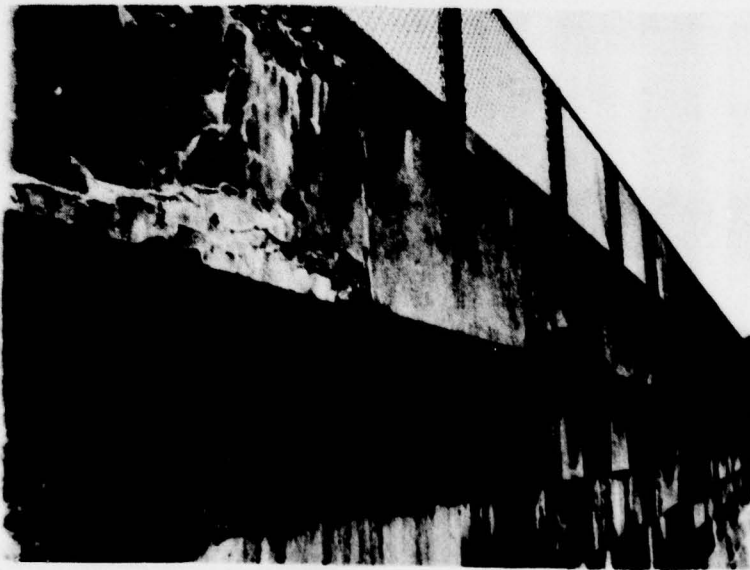
14. Detail of spalling of concrete facing on south side of downstream face of dam.

The concrete facing of the dam has deteriorated as can be seen in Photographs 14, 23, 24, 25, 26, 27 and 28. In Photographs 23 and 24 the surface of the dam was noted to be moist. This condition could be caused by absorbed moisture from rainfall or seepage. Photographs 25 and 26 show where spalling has occurred up to eight inches in depth (estimated), forming a surface crack up to the top of the dam. Another crack line occurs on the south side of the

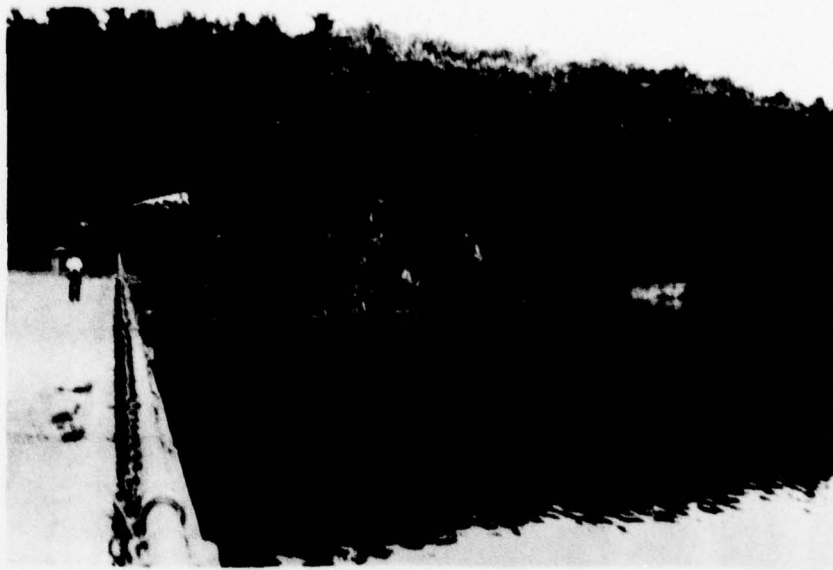
15. View of side channel spillway weir.

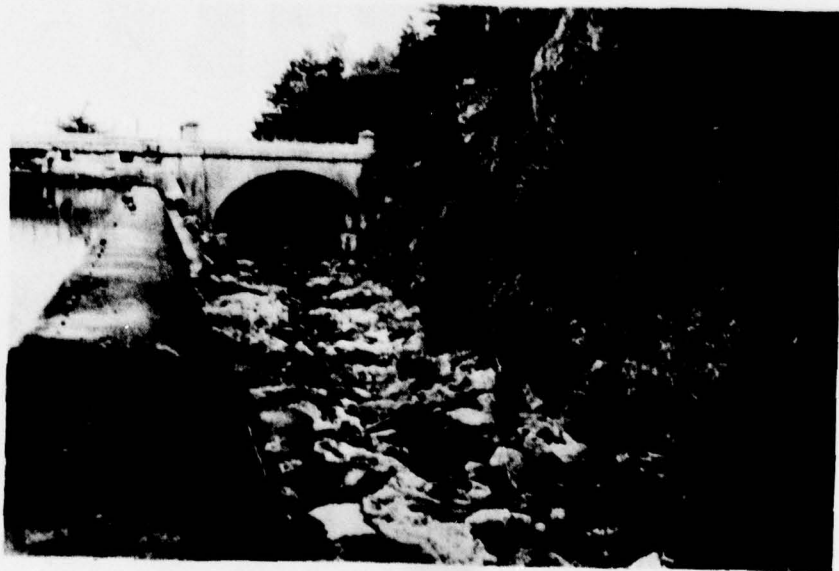
16. View down spillway side channel.

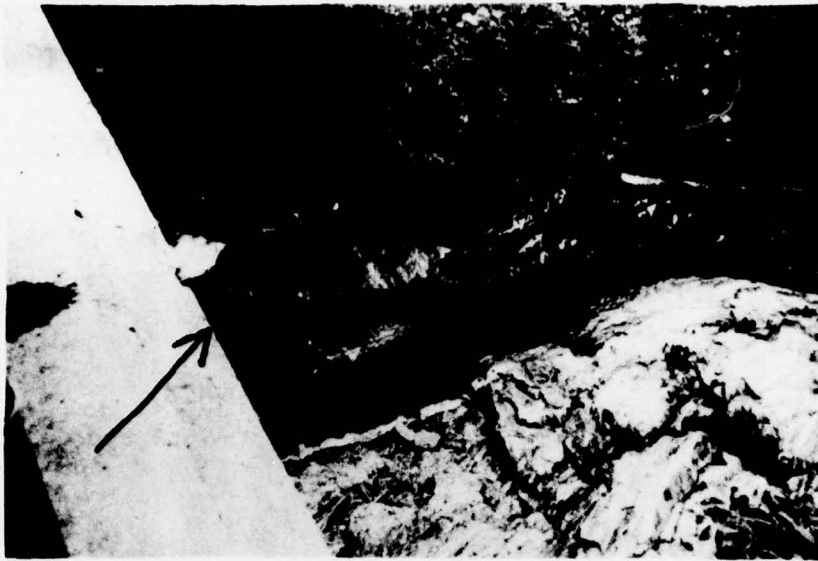
19. Detail of spillway side wall below bridge. Notice cavity in sidewall due to high discharge pressures.

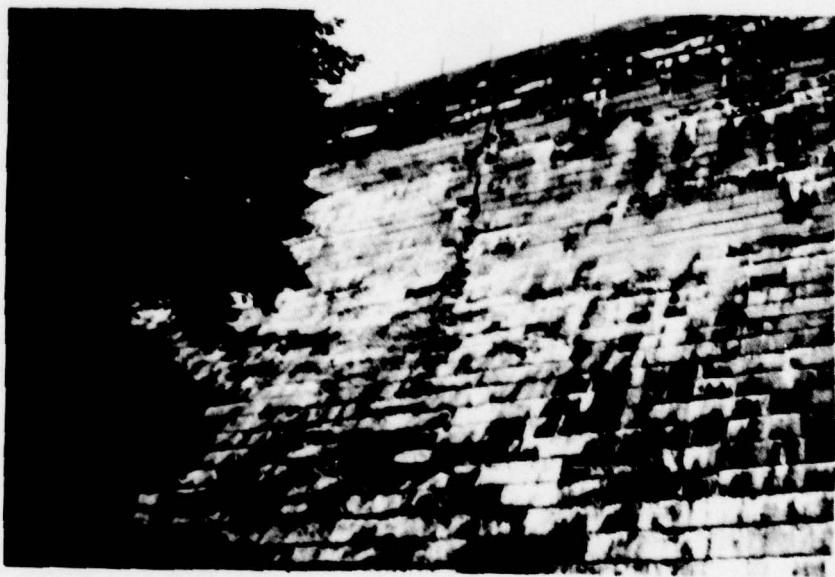
26. View of same area from a distance.

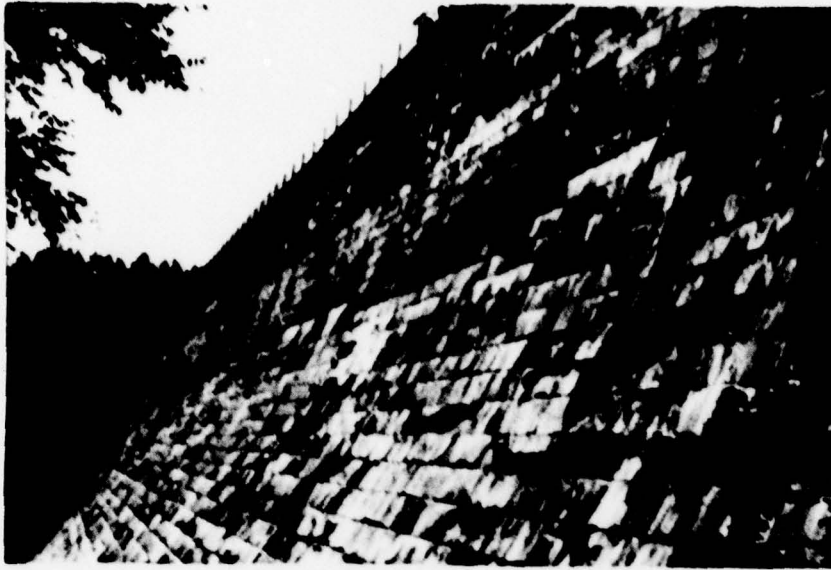
27. View of spalling and surface cracks on downstream face of dam above location of south abutment toe and valley section.

dam. Both of these cracks have formed at the quarter points of the downstream face of the dam very near the location where the abutment meets the valley section. Photograph 28 shows calcium deposits on the downstream face of the dam.
